**NATIONAL TRANSPORTATION SAFETY BOARD**  
Vehicle Recorder Division  
Washington, D.C. 20594

## **Electronic Devices – Recorded Flight Data**

**Specialist's Factual Report**  
**By W. Deven Chen**

Location: Lancaster, California  
Date: August 25, 2019  
Aircraft: Scoda Aeronautica LTDA Super Petrel LS  
Registration: N632MM  
Operator: Worldwide Missions Inc  
NTSB Number: WPR19LA240

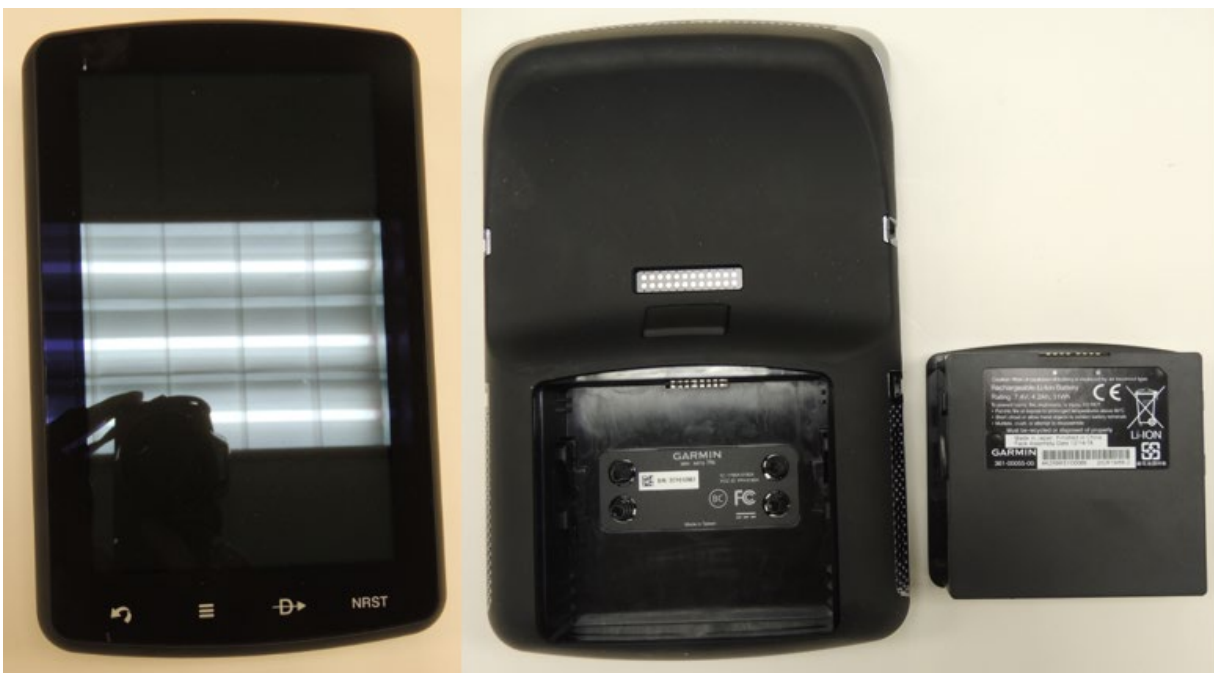
The device was undamaged upon arrival at the Vehicle Recorder Division, as shown in Figure 1. The device powered up normally and the data were extracted using manufacturer’s software.

**Figure 1: Front and back view of Garmin Aera 796 as received.**

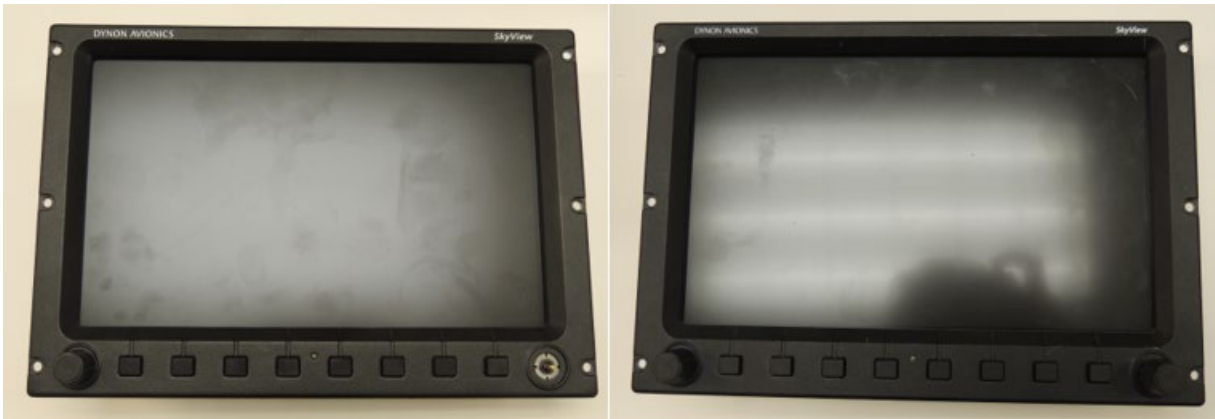
Both Dynon SV-D1000 units were in good condition upon arrival at the Vehicle Recorder Division. Figure 2 is a picture of the "left" display, functioning as the aircraft's PFD, and the "right" display, functioning as the aircraft's MFD. The data were downloaded using the manufacturer's procedure.

**Figure 2: Dynon SV-D1000 units as received, the PFD (left) and the MFD (right).**

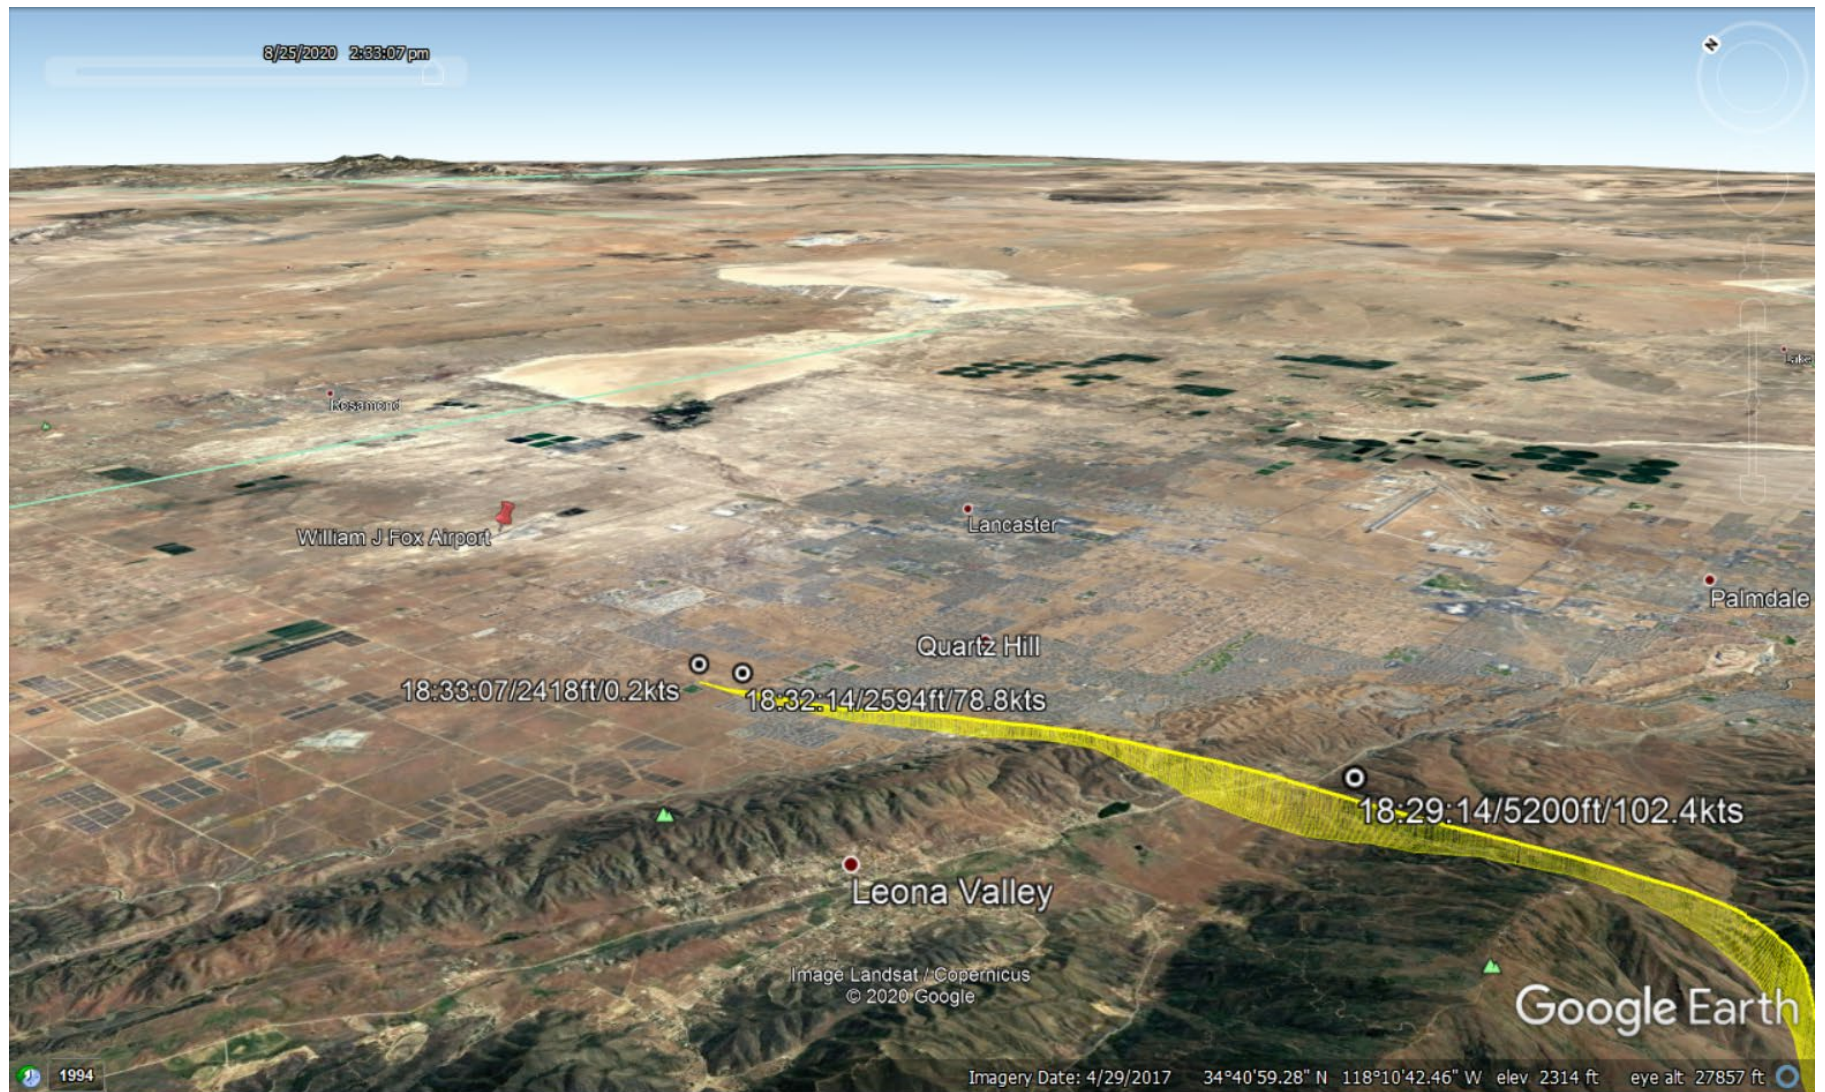
Figure 9 is a Google Earth overlay of the final portion of the accident flight. It shows the aircraft landed on a field near William J Fox Airport (WJF) at around 18:33:00 UTC.

Figure 9: Google Earth overlay of the final portion of the accident flight.

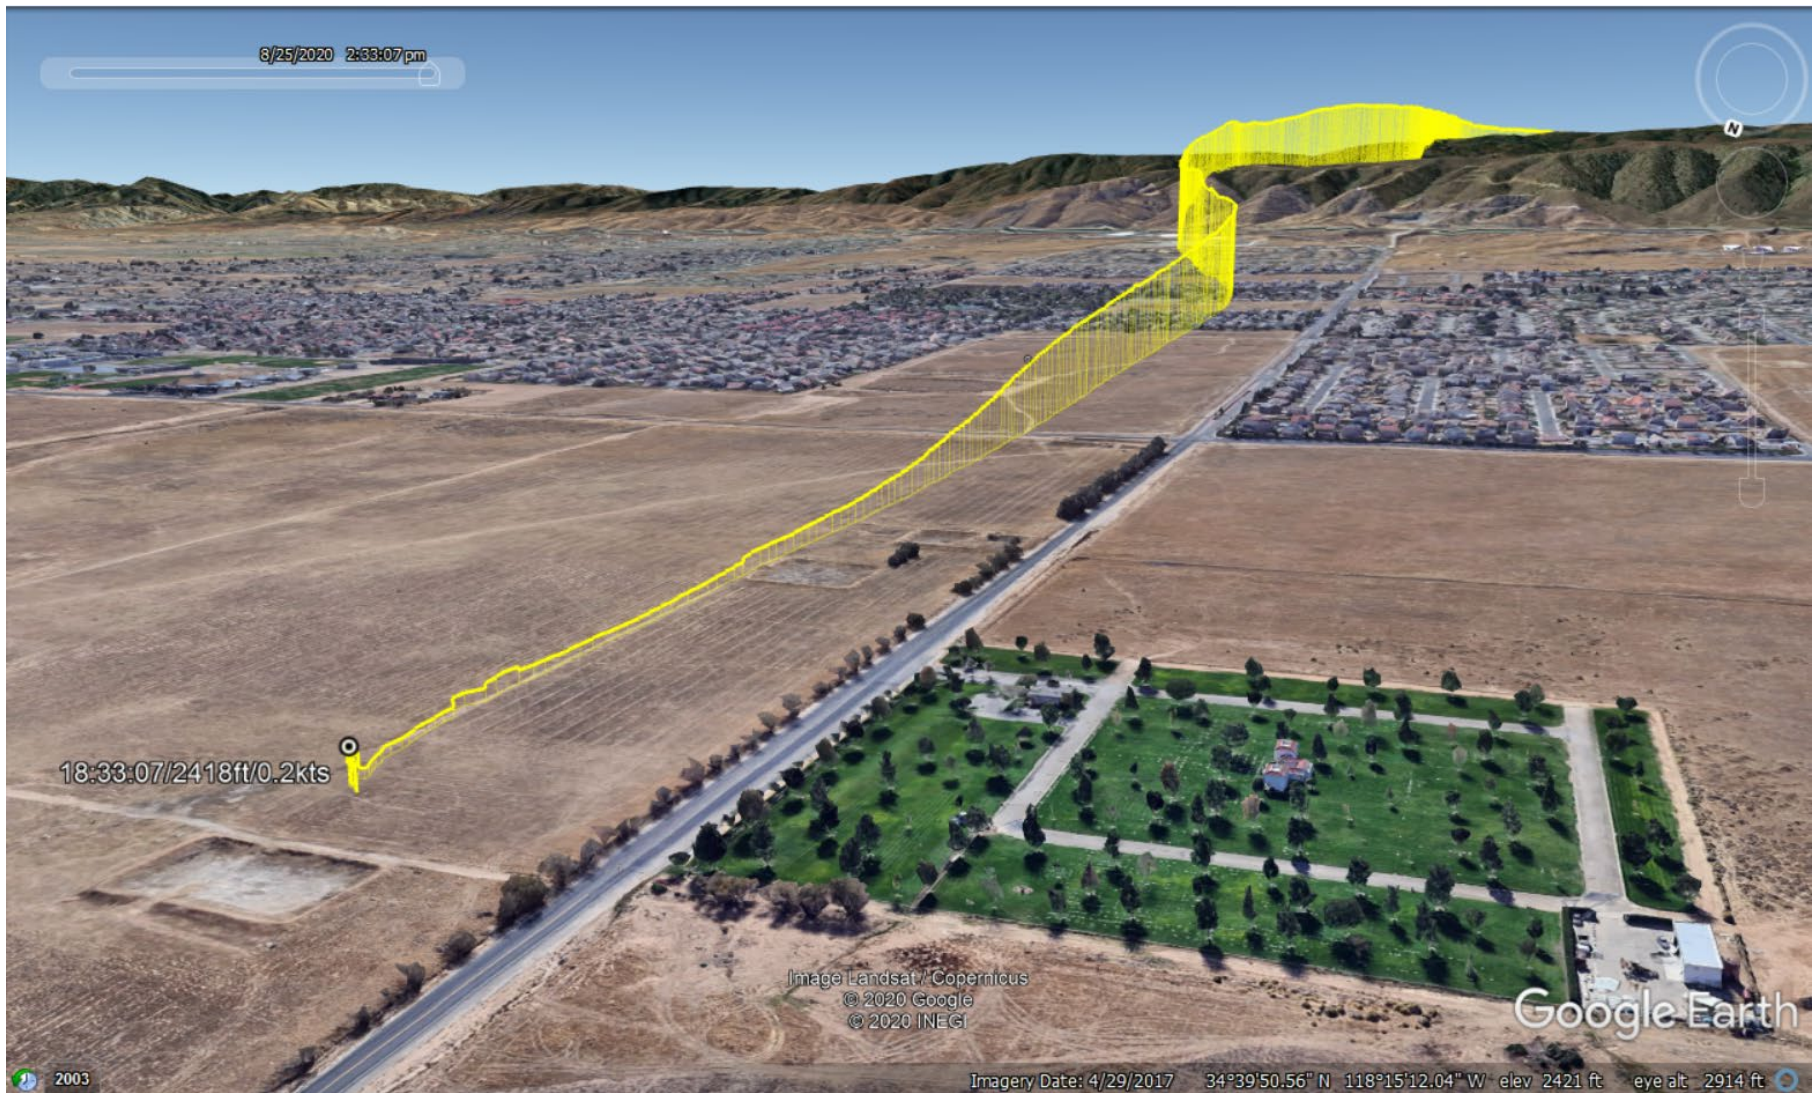
Figures 10 and 11 are Google Earth overlays of the final portion of the accident flight viewed at different angles.

**Figure 10: Google Earth overlay of the final portion of the accident flight.**

Figure 11: Google Earth overlay of the final portion of the accident flight.
