**Photo 1 –N1168U, showing damage to the tail rotor and vertical stabilizer. Photo courtesy of the pilot.**

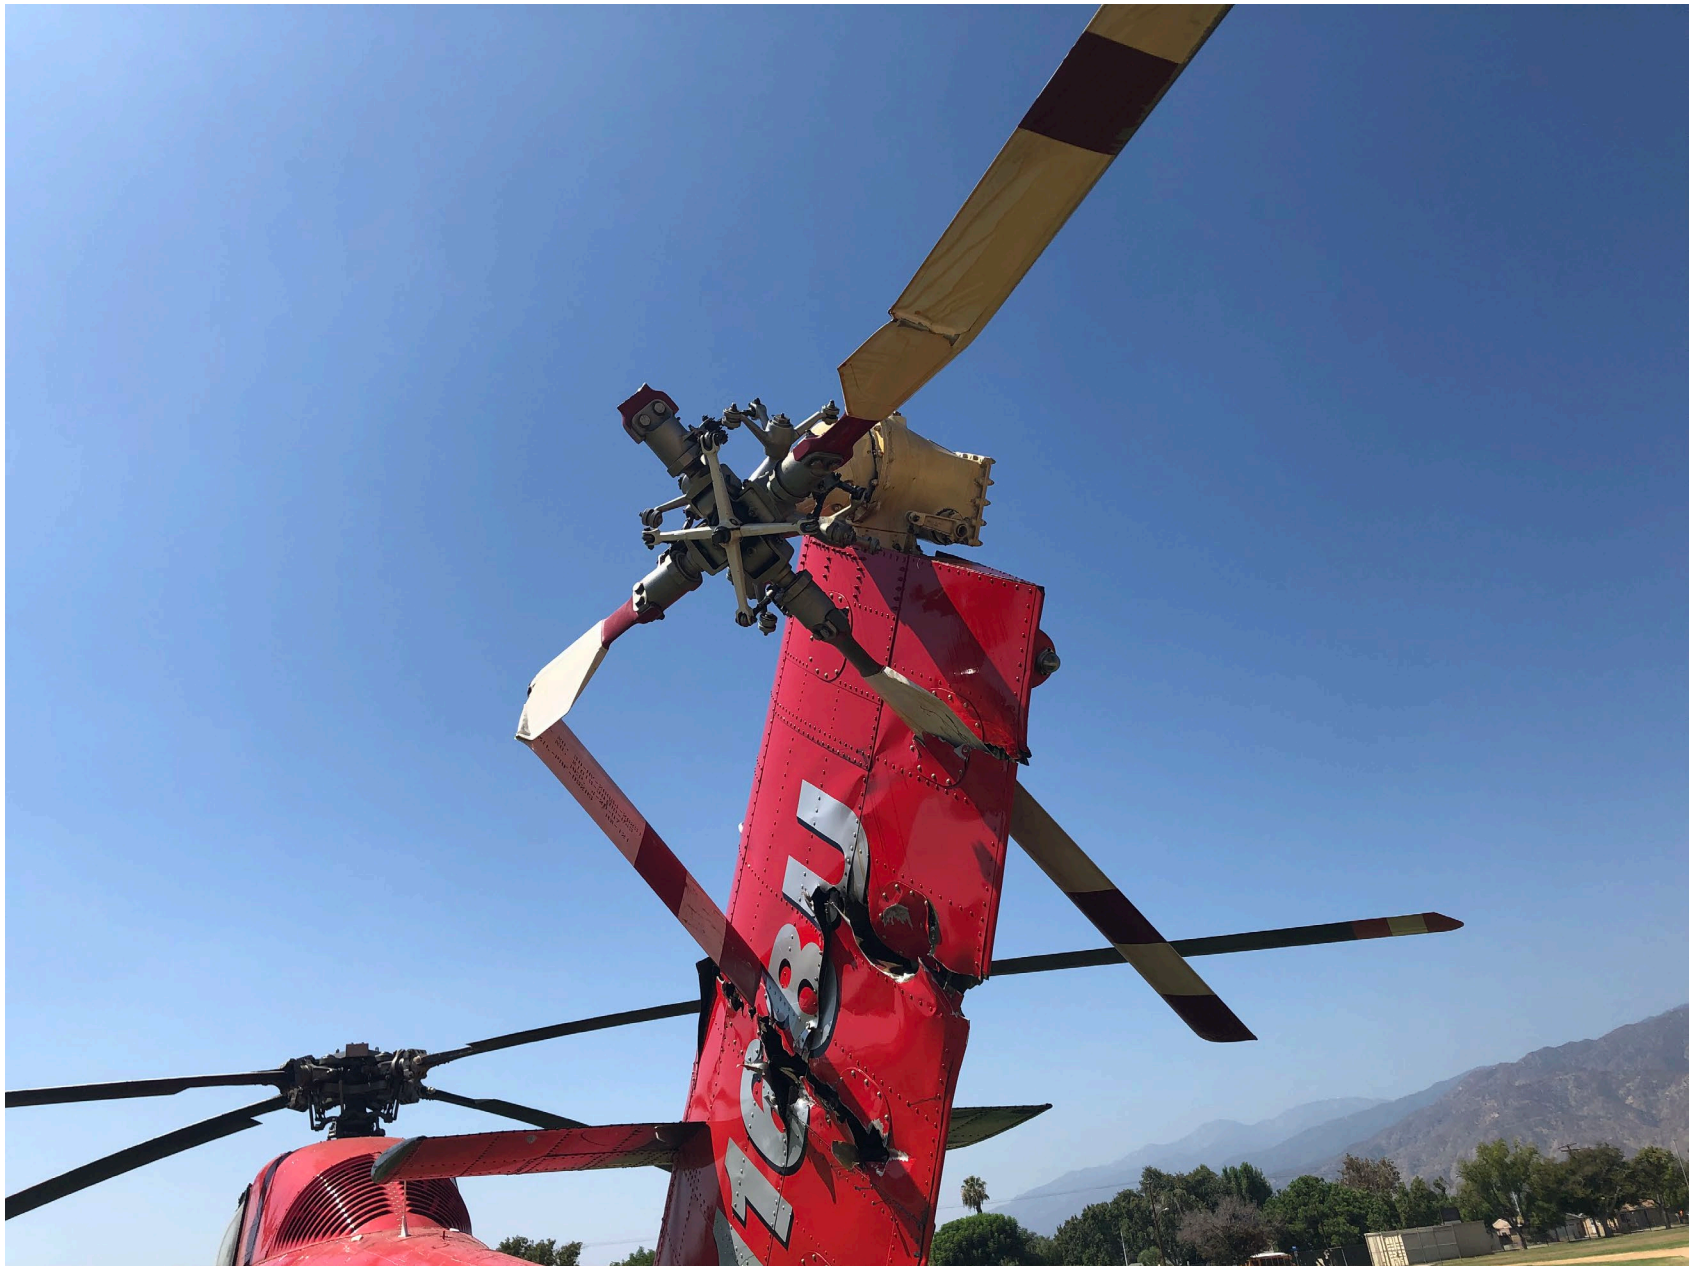
**Photo 2 -Close up view of the tail rotor assembly. Photo courtesy of the pilot.**

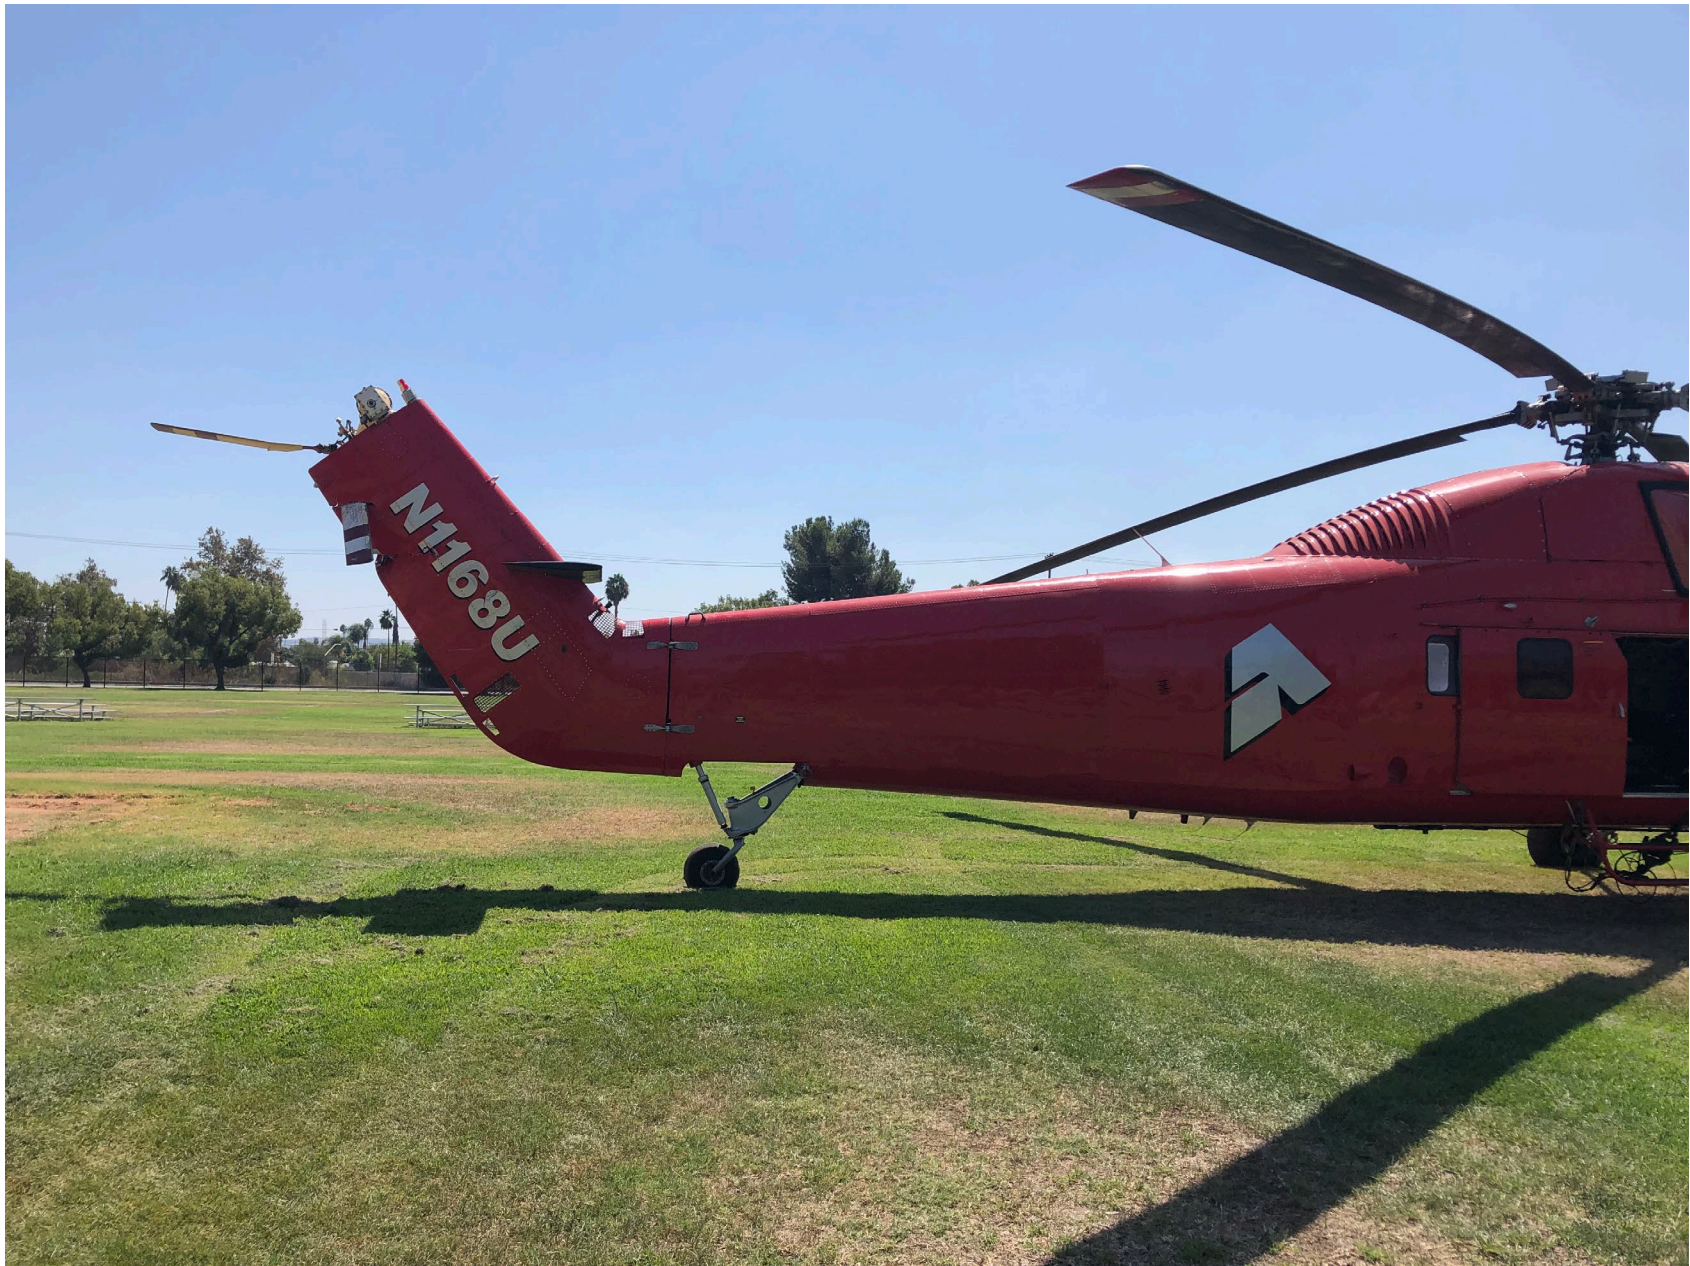
**Photo 3 – Right-side view of the vertical stabilizer. Photo courtesy of the pilot.**

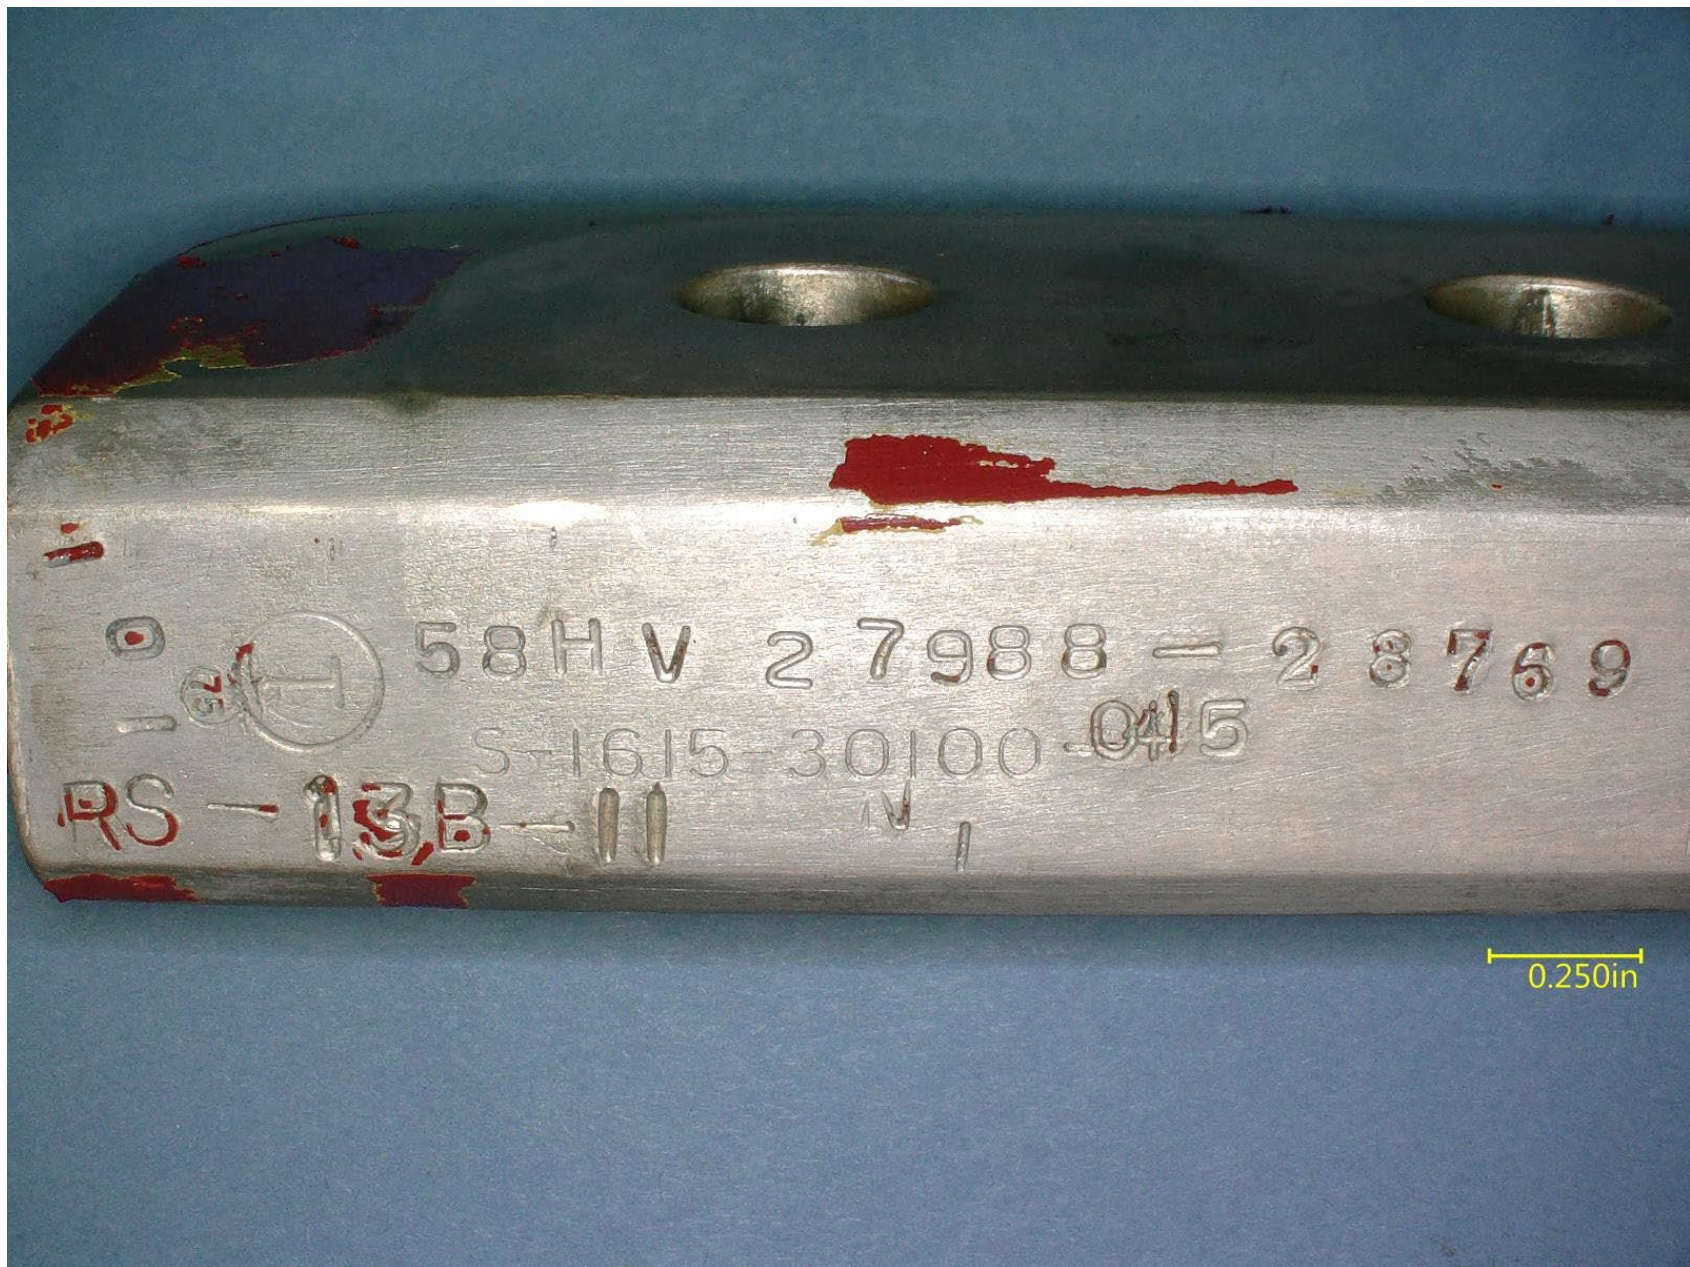
**Photo 4 – Tail rotor shank showing the part number S-1516-30100-45, and the serial number, 58HV27988-28769.  
Photo NTSB.**

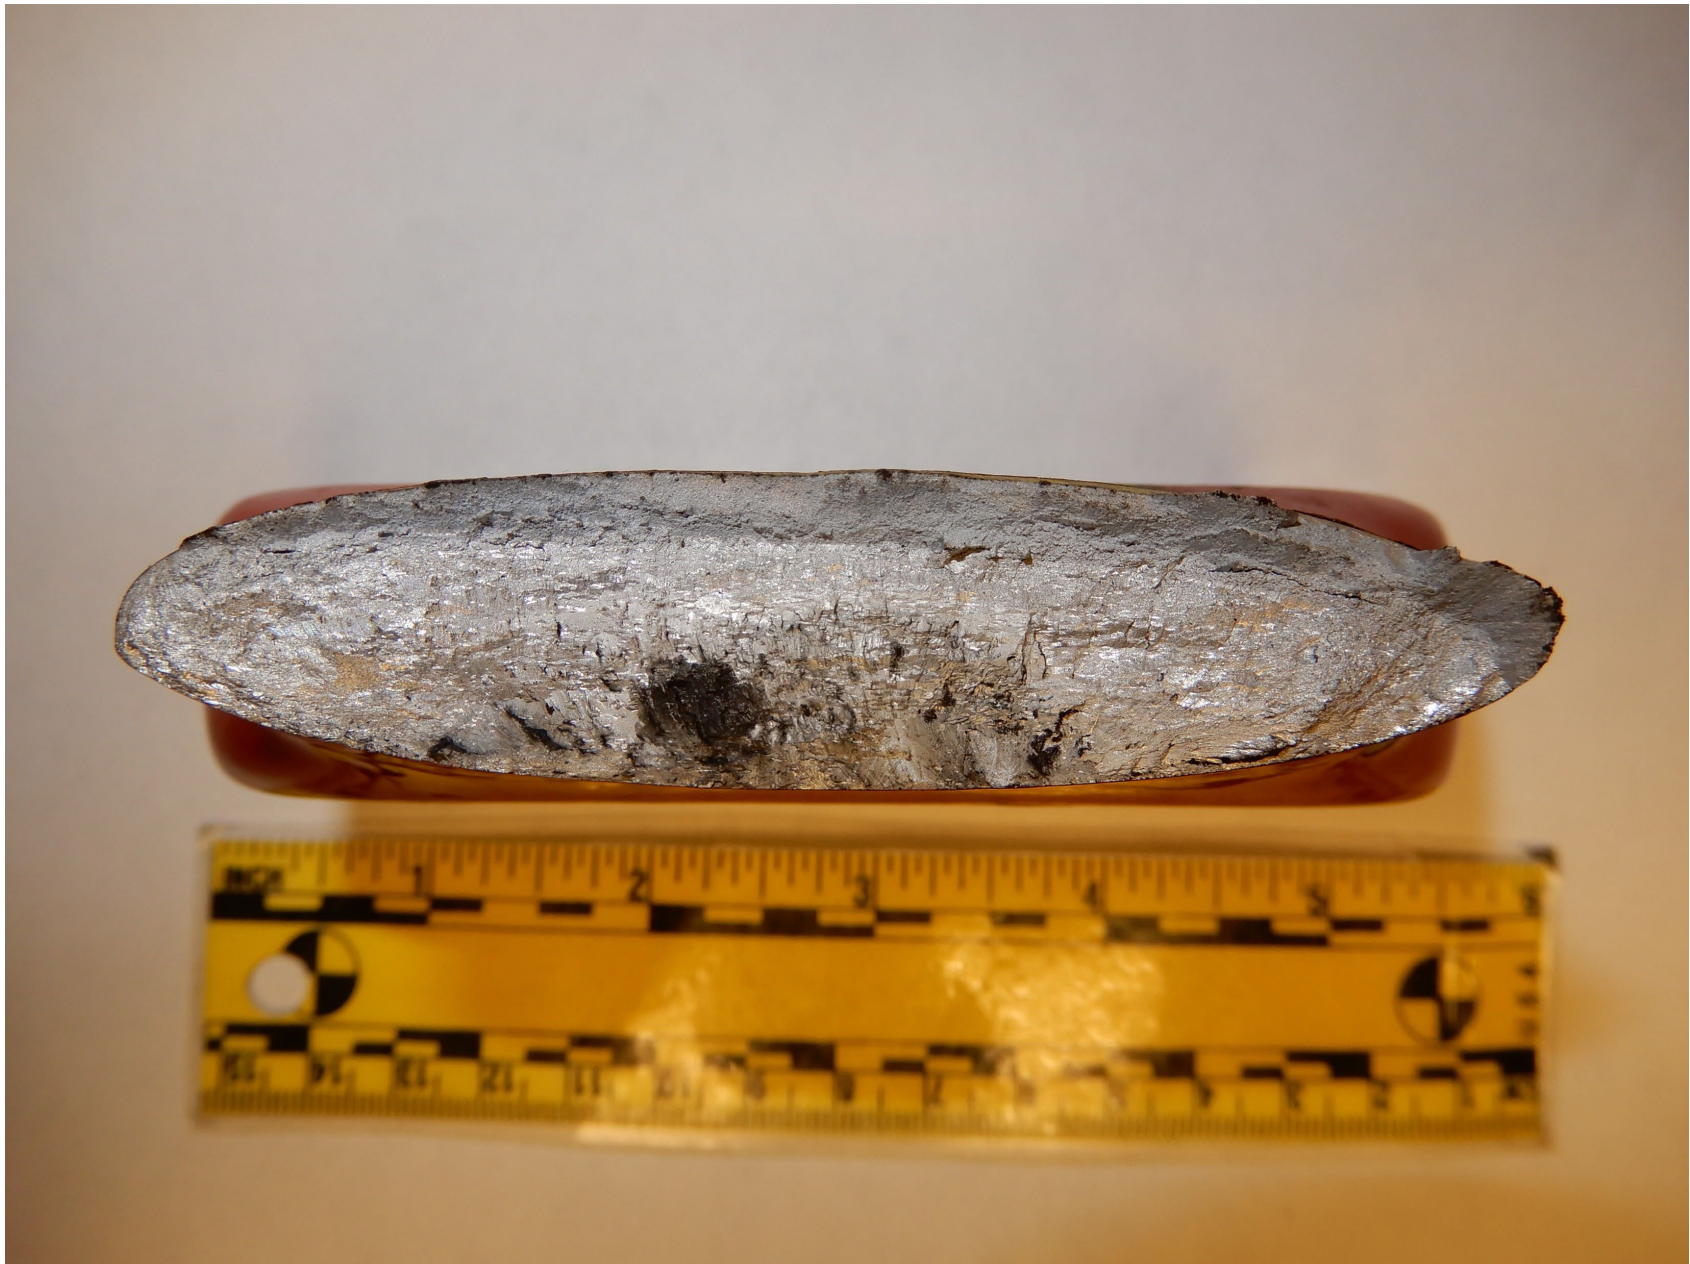
**Photo 5 – View showing the fractured end of the tail rotor blade. Photo NTSB.**

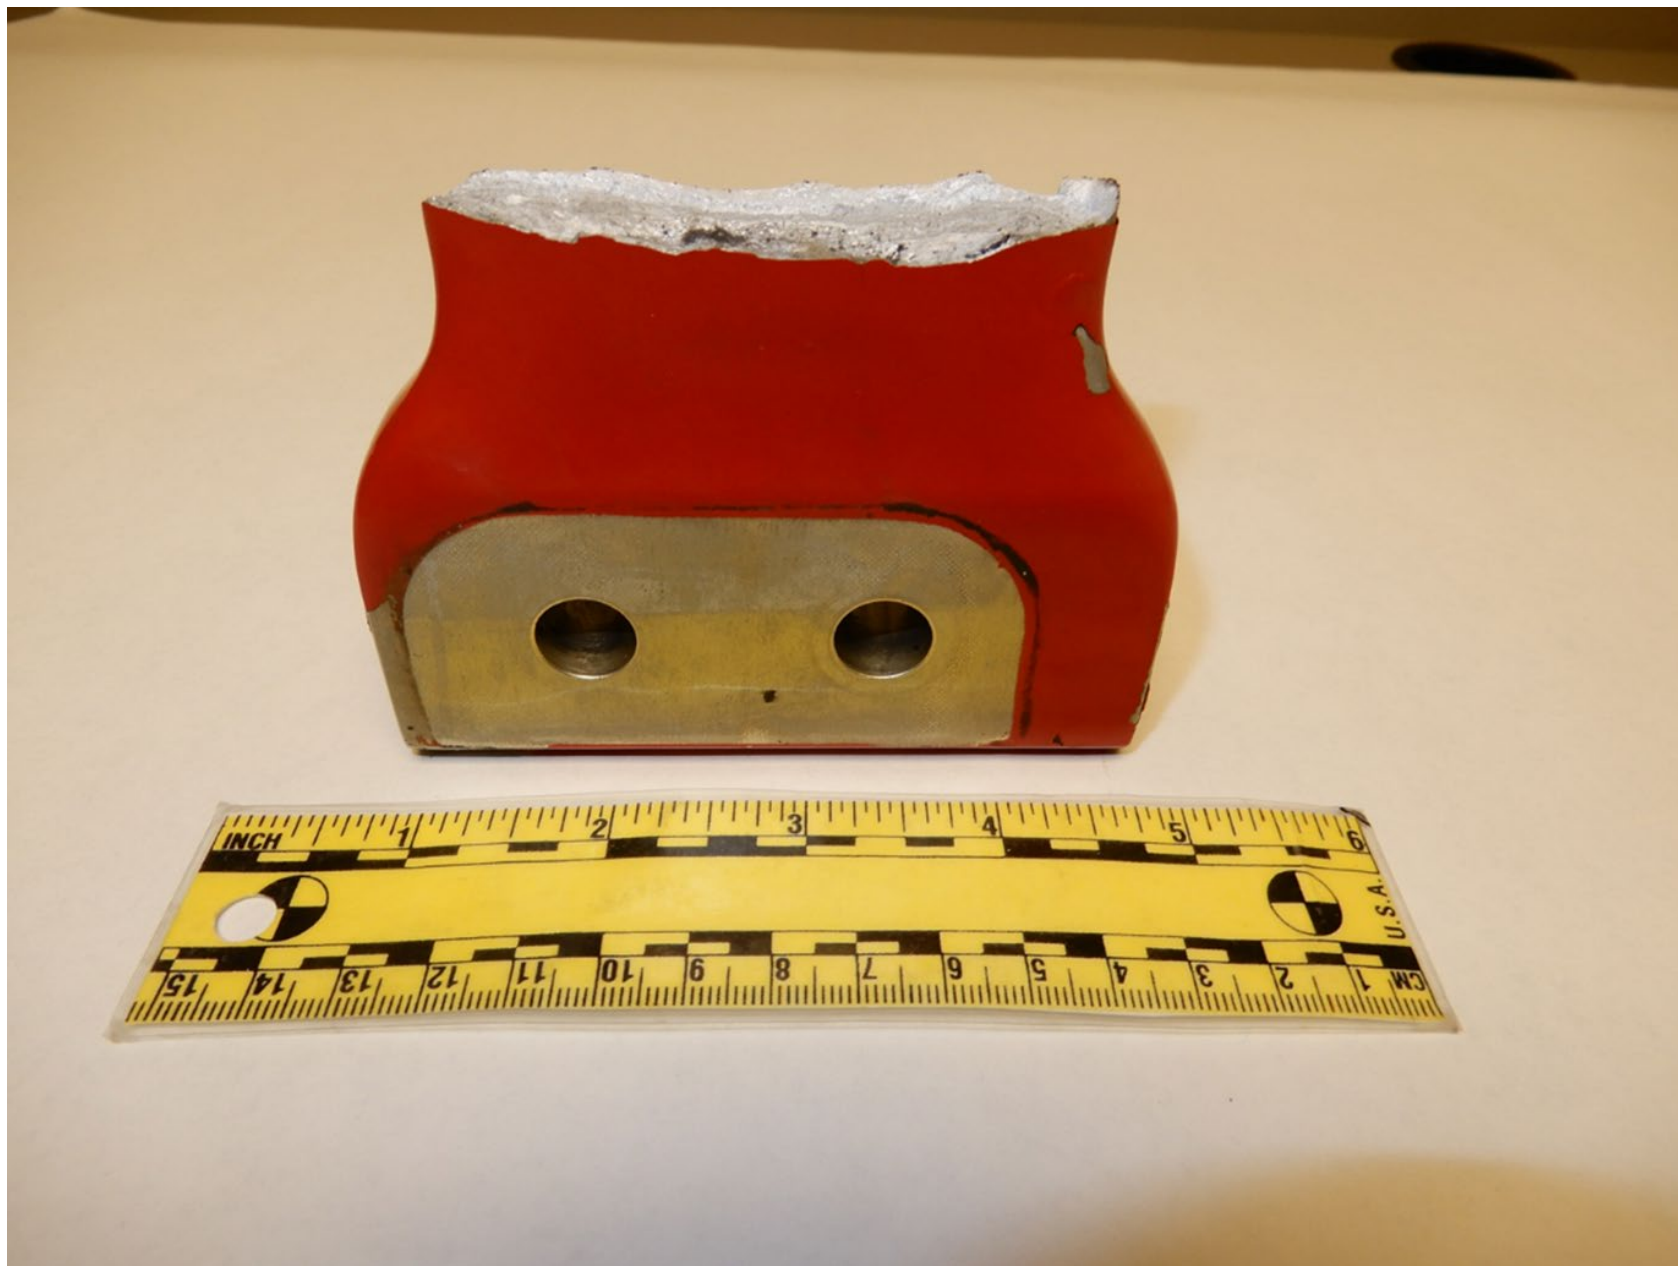
**Photo 6 -Side-view of the tail rotor shank. Photo NTSB**
