WPR19LA265 Accident Pictures

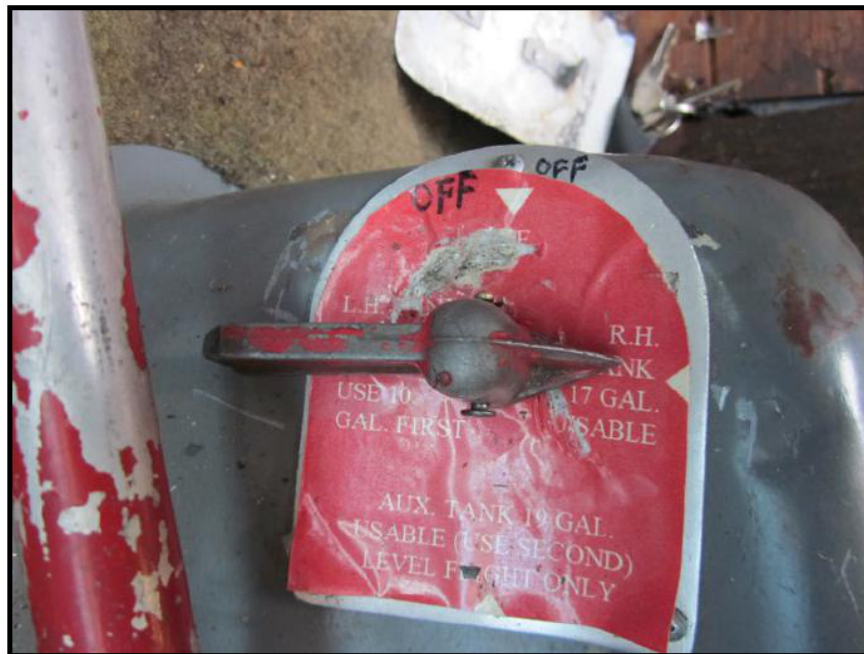
Figure 1: Fuel selector positioned to the right tank. (Courtesy of FAA)

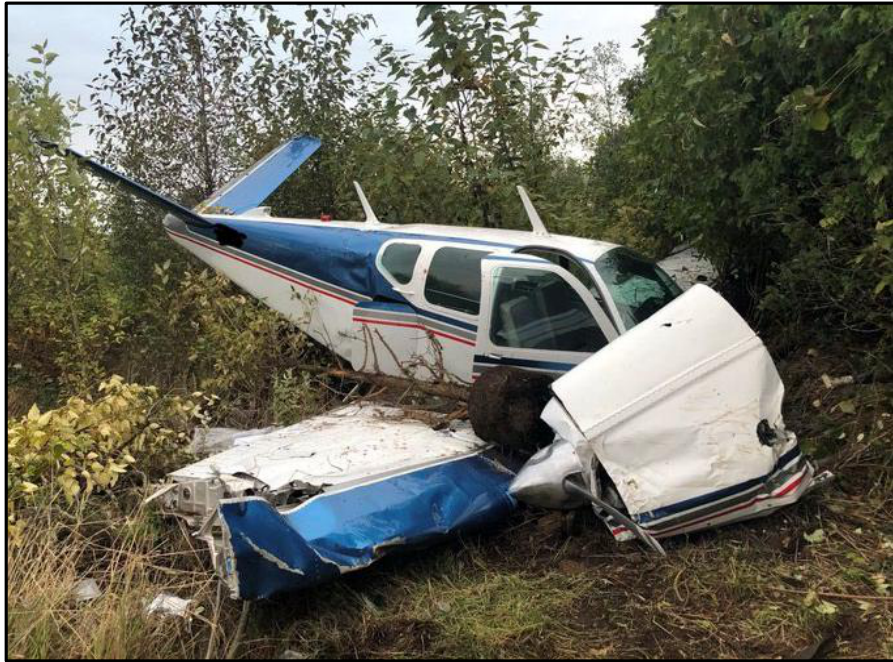
Figure 3: Airplane wreckage as viewed from the right. (Courtesy of FAA).
