## **NATIONAL TRANSPORTATION SAFETY BOARD**

### **Weather Study**

# **METEOROLOGY**

WPR20CA263

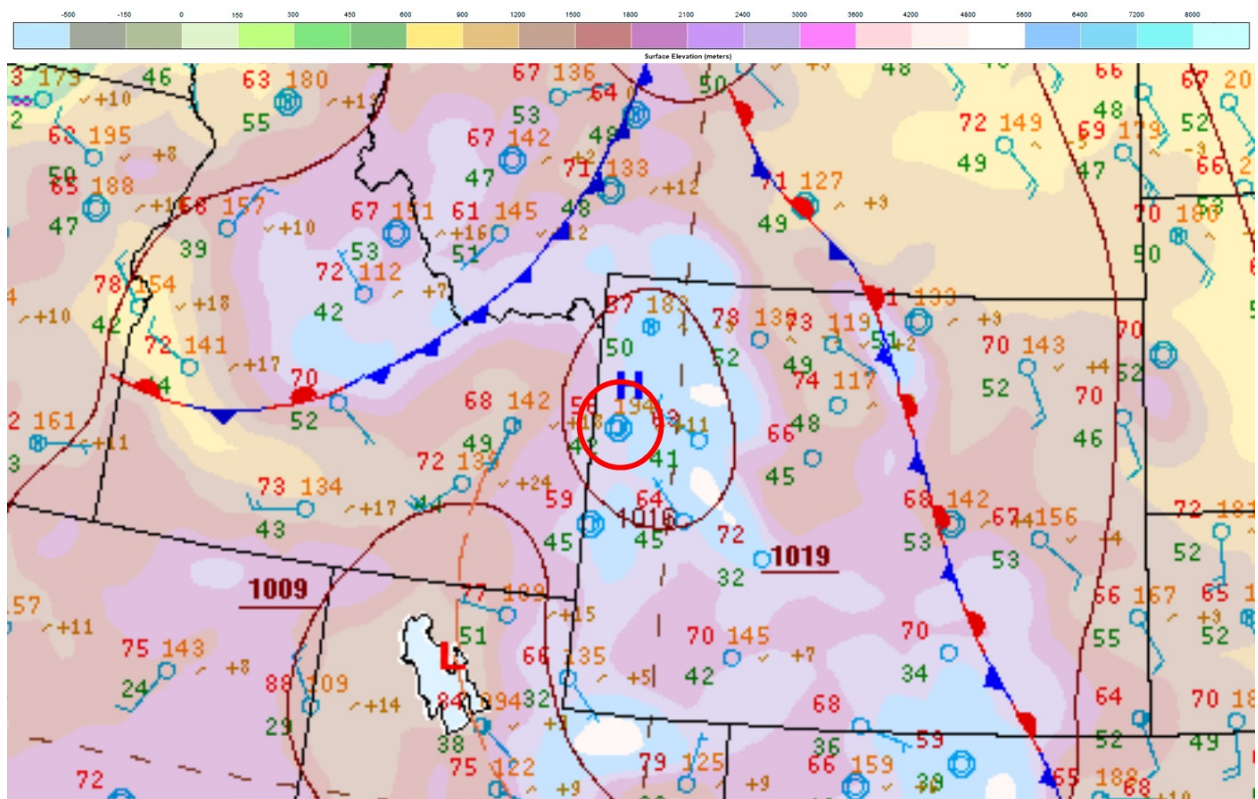
**Figure 1** - NWS Surface Analysis Chart for 0900 MDT. Accident location is inside the red circle.

A western portion of the National Weather Service (NWS) Surface Analysis Chart for 0900 MDT is presented in figure 1. The surface analysis chart identified a high-pressure center near the accident site. A cold front stretched from western Montana southwestward into southern Idaho, and a stationary front extended from central Montana in central Wyoming. A trough of low-pressure was also depicted extending from southeastern Idaho into northern Utah. Temperatures in the accident region were in the mid-50°s Fahrenheit (F) to mid-60°s F, with dew point temperatures generally in the low 40°s F. Station models in the region depicted clear skies and a calm wind was observed near the accident location.

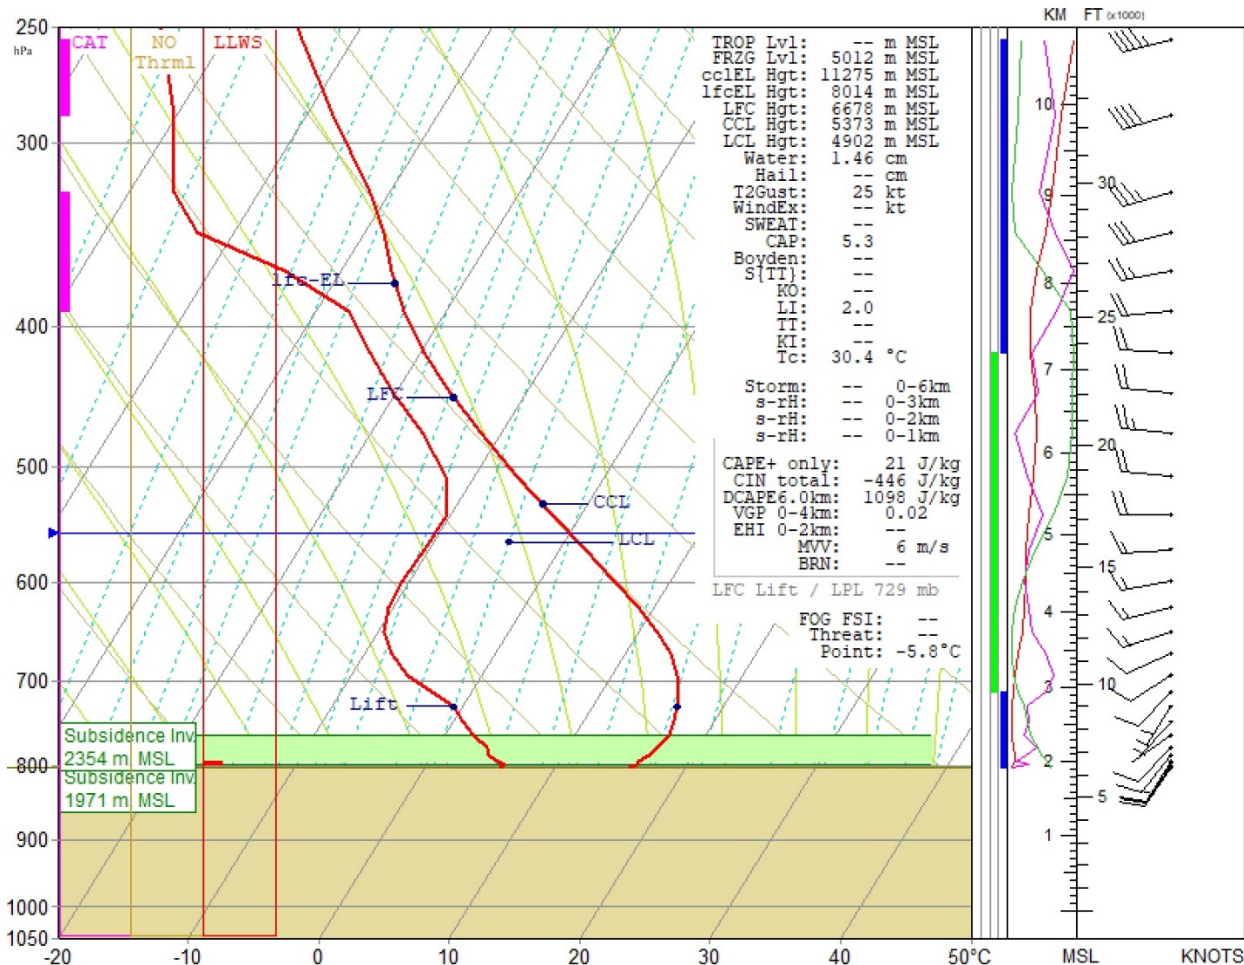
**Figure 2** – HRRR model sounding data in SkewT/LogP format for 0800 MDT at the accident site, surface to 250 hPa.

A High-Resolution Rapid Refresh (HRRR) model<sup>4</sup> sounding (figure 2) for the accident site at 0800 MDT was retrieved from the National Oceanic and Atmospheric Administration's Air Resources Laboratory. Nearest the surface the wind was from the southwest at 8 knots; the wind veered<sup>5</sup> slightly to an approximately west wind of 17 knots near 12,000 feet. Calculations made by the Rawinsonde OBservation Program (RAOB) indicated the potential for "light" low-level wind shear around 6,500 feet (about 200 feet agl). The sounding exhibited characteristics of an "Inverted-V" sounding<sup>6</sup>, and the downdraft convective available potential energy (DCAPE; 6 kilometers above ground level; density weighted average method) was measured at 1,098 Joules/kilogram which was considered a strong value.<sup>7</sup>

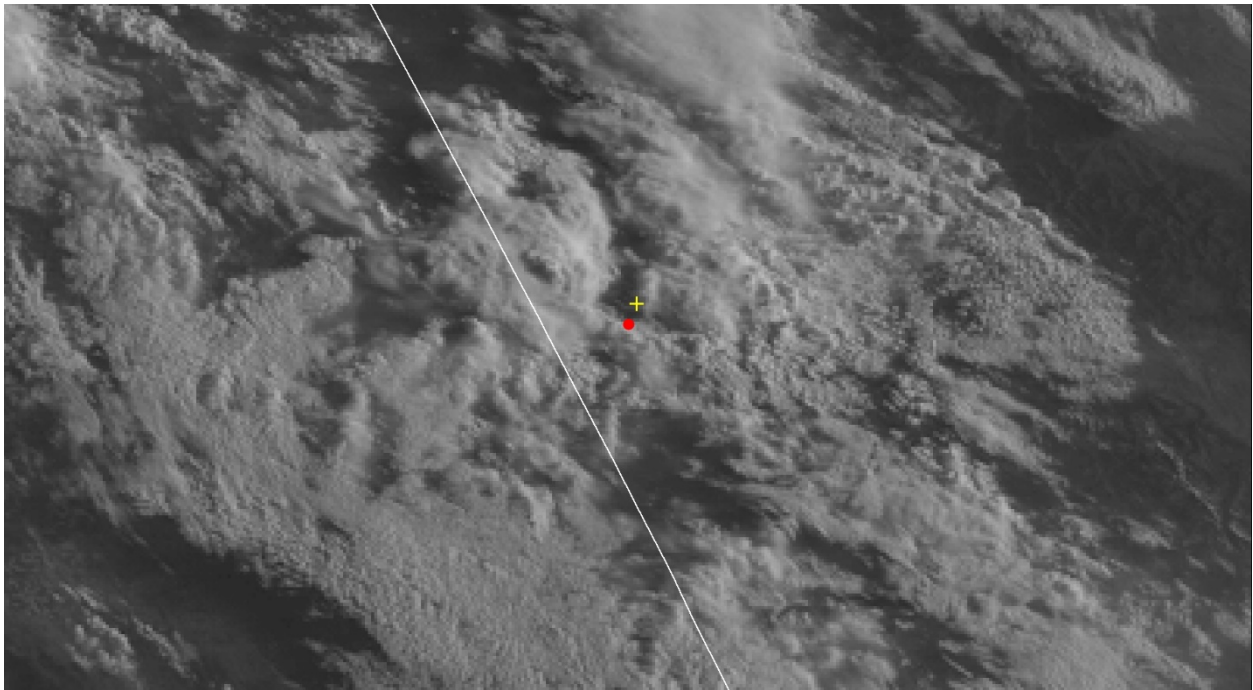
**Figure 3** – GOES-17 visible imagery from 0811 MDT. Accident location denoted by red dot. The yellow “plus” symbol is the accident location relative to clouds that were at the height of 15,000 feet.

Geostationary Operational Environmental Satellite (GOES)-17 visible (0.64 $\mu$ m) and infrared (10.3 $\mu$ m) data were obtained from an archive at the Space Science Engineering Center at the University of Wisconsin-Madison. Imagery from 0811 MDT are presented in figures 3 and 4. The GOES-17 visible imagery depicted cloudy conditions over most of the accident region. Infrared cloud-top temperatures over the accident site were about -13°C, which, when considering the 0800 MDT HRRR sounding, corresponded to cloud top heights of about 19,000 feet.<sup>8</sup> In the visible image, it appears that the accident location was under cloudy conditions with a small clear area to its north. Because the image is not corrected for parallax error<sup>9</sup>, to better understand if the accident

location was under clouds at the time of the satellite image, where the accident location would be moved to (in the image) if it was at a height of about 4.5 kilometers (about 15,000 feet) was calculated. The yellow “plus” symbols in figures 3 and 4 are the locations of the accident location relative to clouds that were at the height of 15,000 feet, and indicated that the accident location was more likely in clear conditions, or was under the eastern side of a cloudy area, at the time these satellite images were taken.

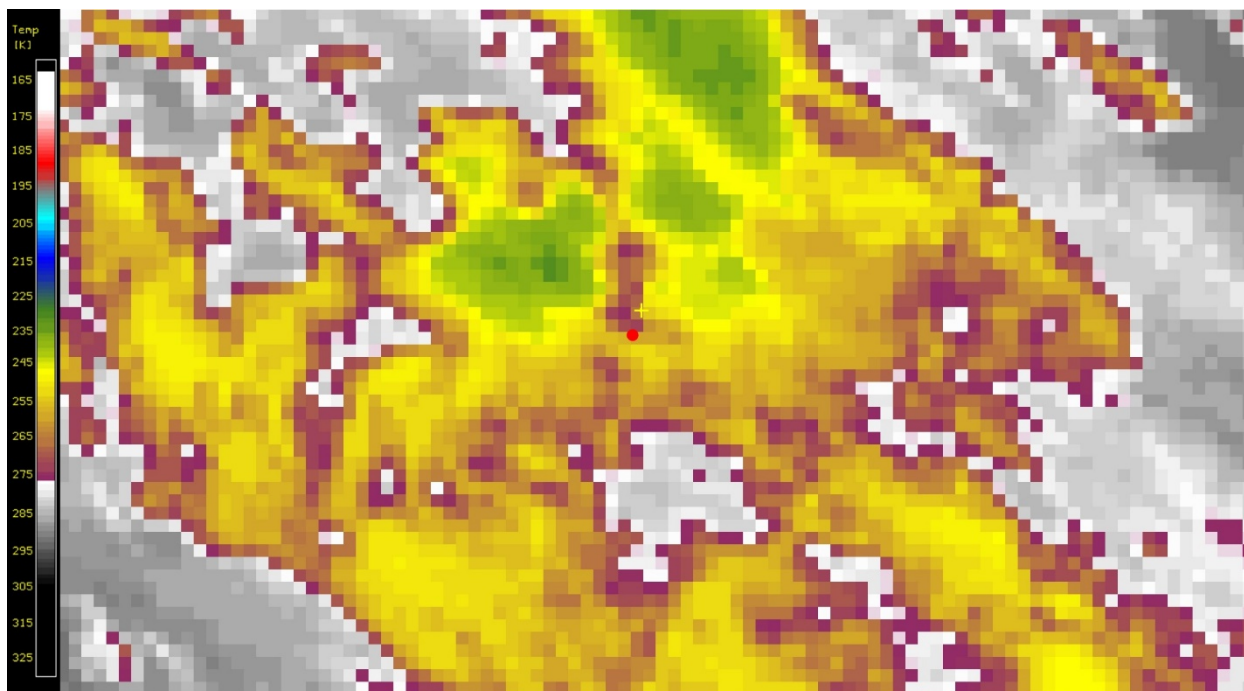
**Figure 4** – GOES-17 infrared imagery from 0811 MDT. Accident location denoted by red dot. The yellow “plus” symbol is the accident location relative to clouds that were at the height of 15,000 feet.

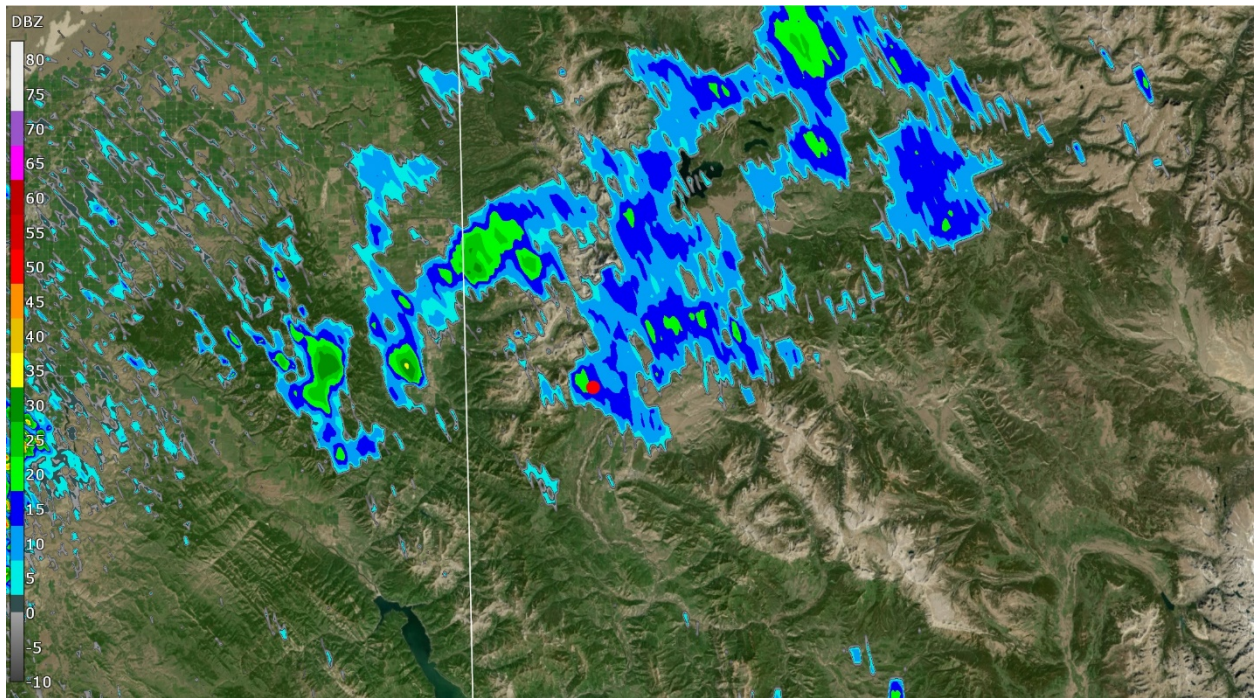
**Figure 5** – KSFx 0.527° Level-II base reflectivity product from a sweep initiated at 0807:05 MDT. Accident location marked by red circle.

The WSR-88D<sup>10</sup> Level-II base reflectivity weather radar imagery from the Pocatello, Idaho, site (KSFX) are presented in figures 5-7. KSFX was located approximately 86 miles west-southwest of the accident location at an elevation of about 4,540 feet. Assuming standard refraction and considering the 0.95° beam width<sup>11</sup> for the WSR-88D radar beam, the KSFX 0.527° tilt would have “seen” altitudes above the accident location of between about 9,900 and 18,600 feet above msl. Around the time of the accident, the weather radar depicted reflectivity with values of less than 25 dBZ moving from the west-southwest over the accident site.

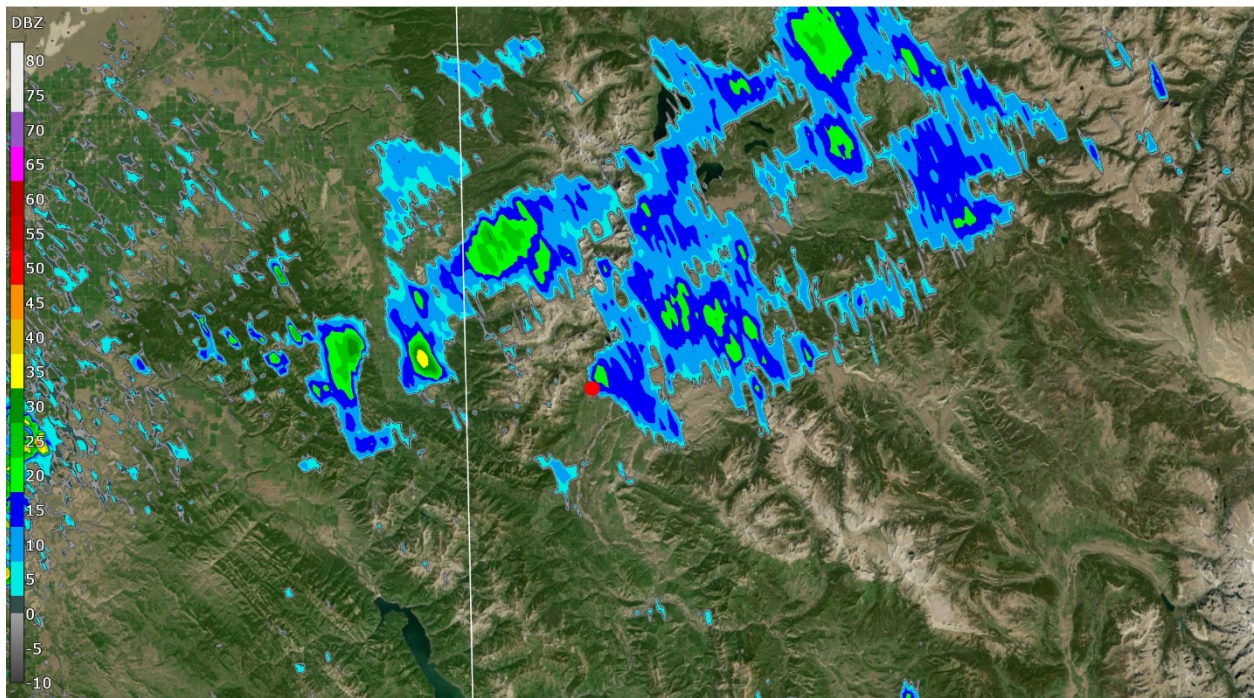
**Figure 6** – KSFx 0.527° Level-II base reflectivity product from a sweep initiated at 0811:24 MDT. Accident location marked by red circle.

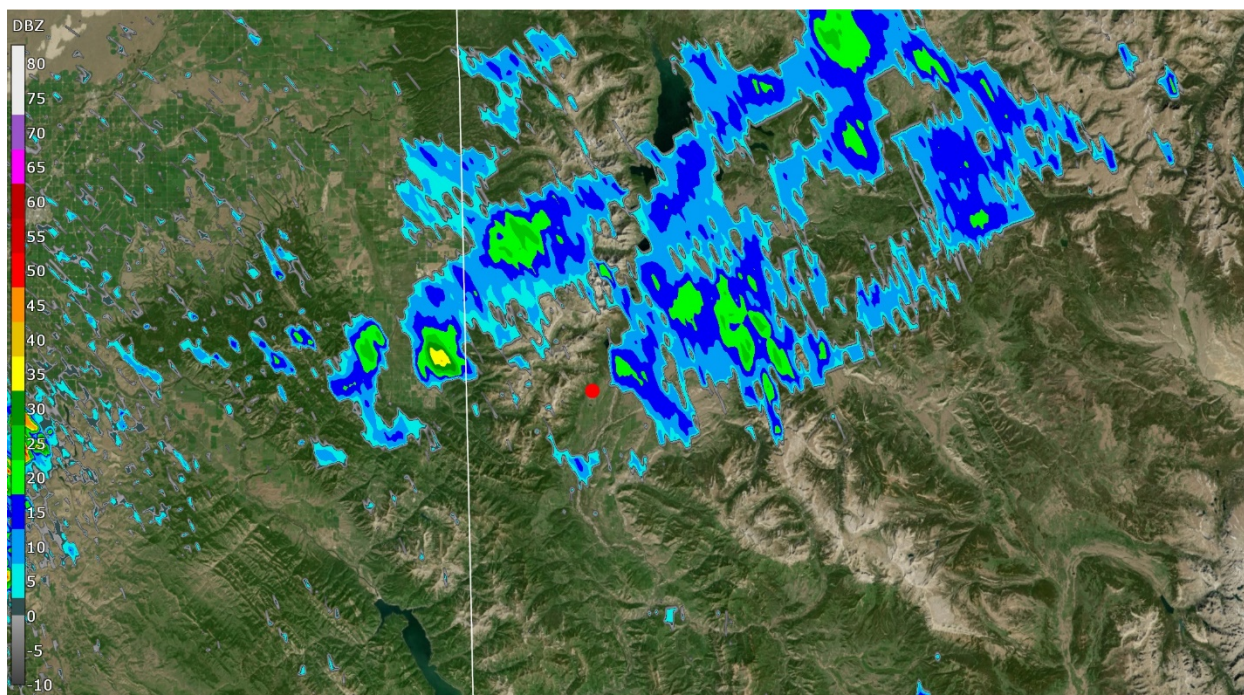
**Figure 7** – KSFY 0.527° Level-II base reflectivity product from a sweep initiated at 0815:43 MDT. Accident location marked by red circle.
