**NATIONAL TRANSPORTATION SAFETY BOARD**  
Vehicle Recorder Division  
Washington, D.C. 20594

## **Global Positioning System Device**

**Specialist's Factual Report**  
**By Gerald Kawamoto**

Location: American Falls, Idaho  
Date: October 25, 2019  
Aircraft: Mooney M-20J  
Registration: N201BJ  
Operator: Private  
NTSB Number: WPR20FA015

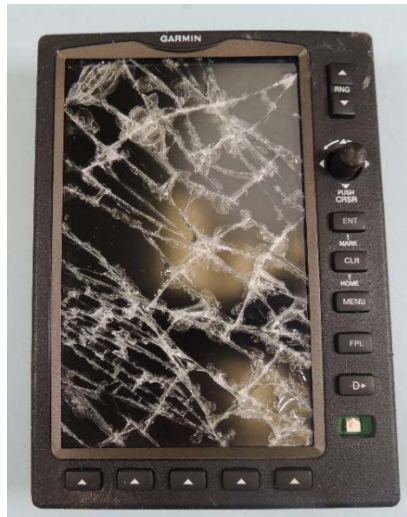
Upon arrival at the Vehicle Recorder Division, an exterior examination revealed the device had sustained impact damage, as shown in Figure 1, resulting in cracks to the display. An interior examination revealed that components on the logic board had been dislodged. The board was repaired and attempted to be powered on using surrogate lab parts, however, the device was unable to power on normally. The non-volatile memory chip was removed, read out, and converted to engineering units using laboratory tools.

Figure 1. Garmin GPSMAP 696 as received.

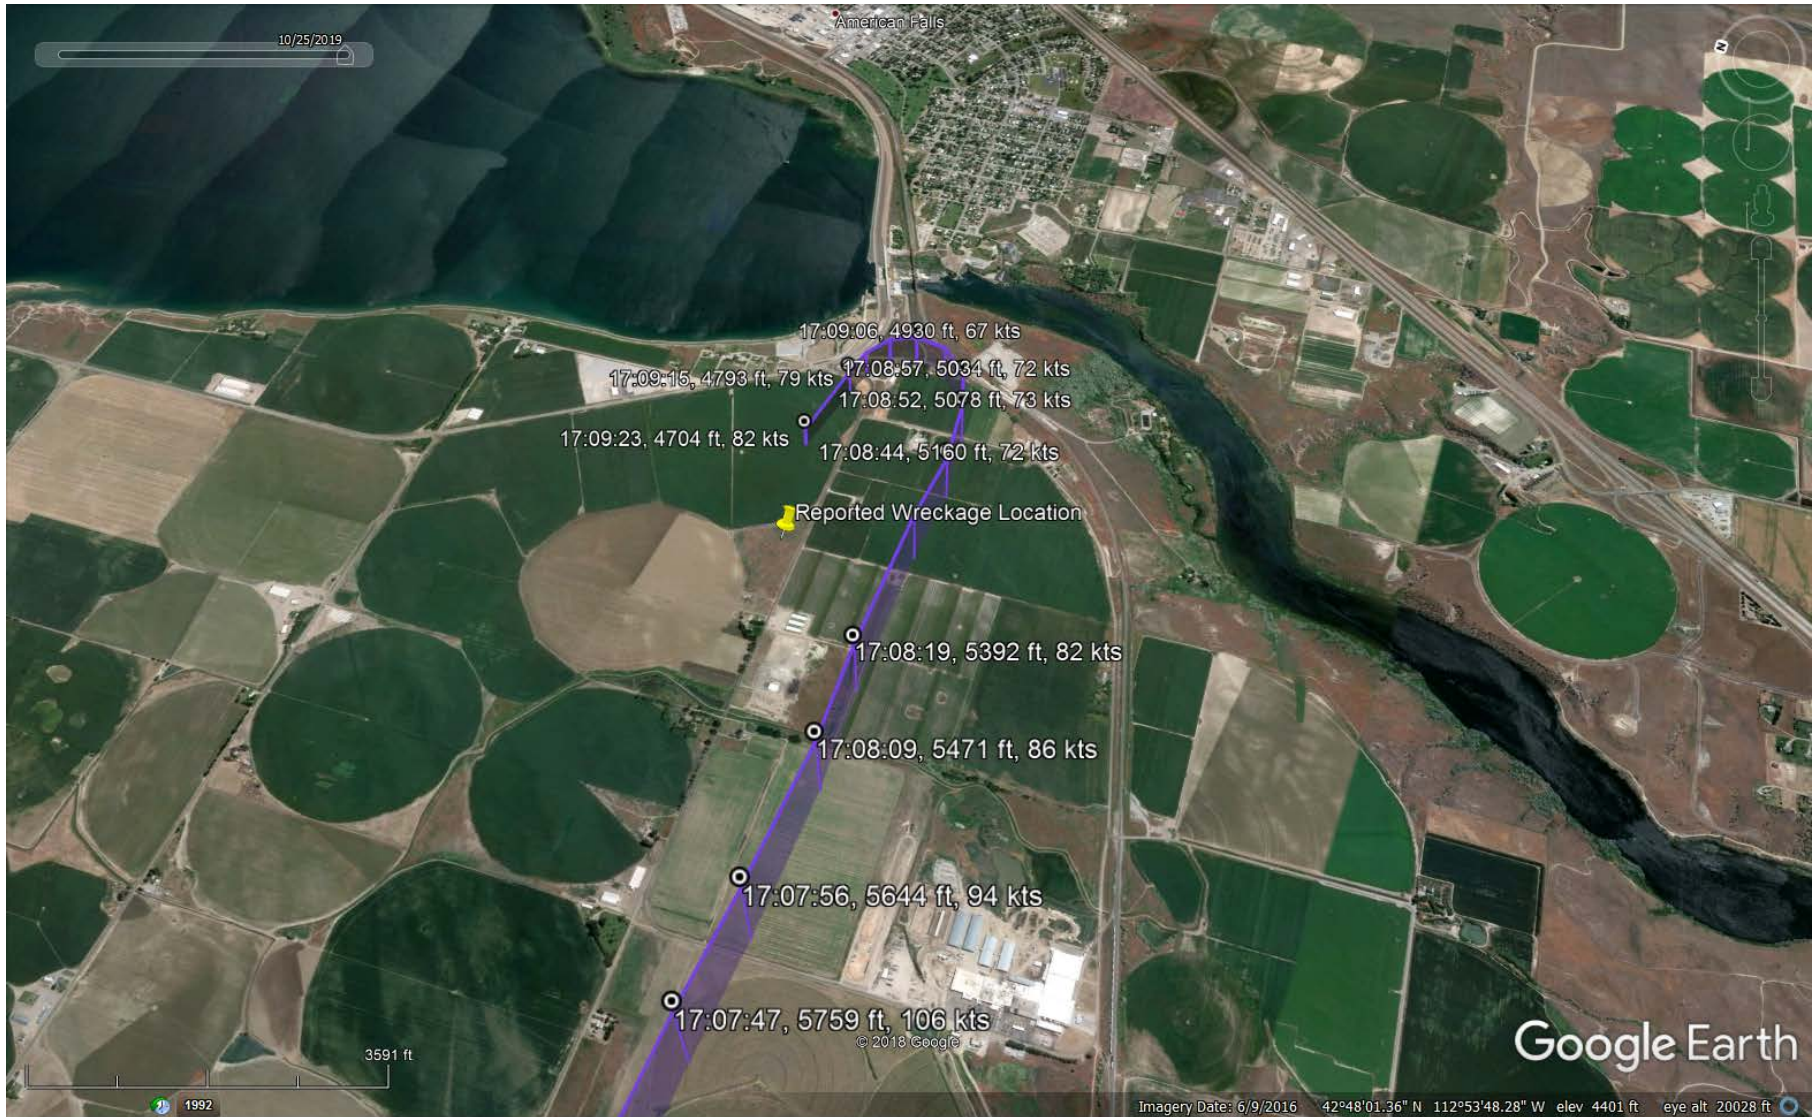
Figure 3 is a graphical overlay generated using Google Earth at the end of the accident flight.

Figure 3. Google Earth overlay of the end of the accident flight.
