## Recorders Summary Report

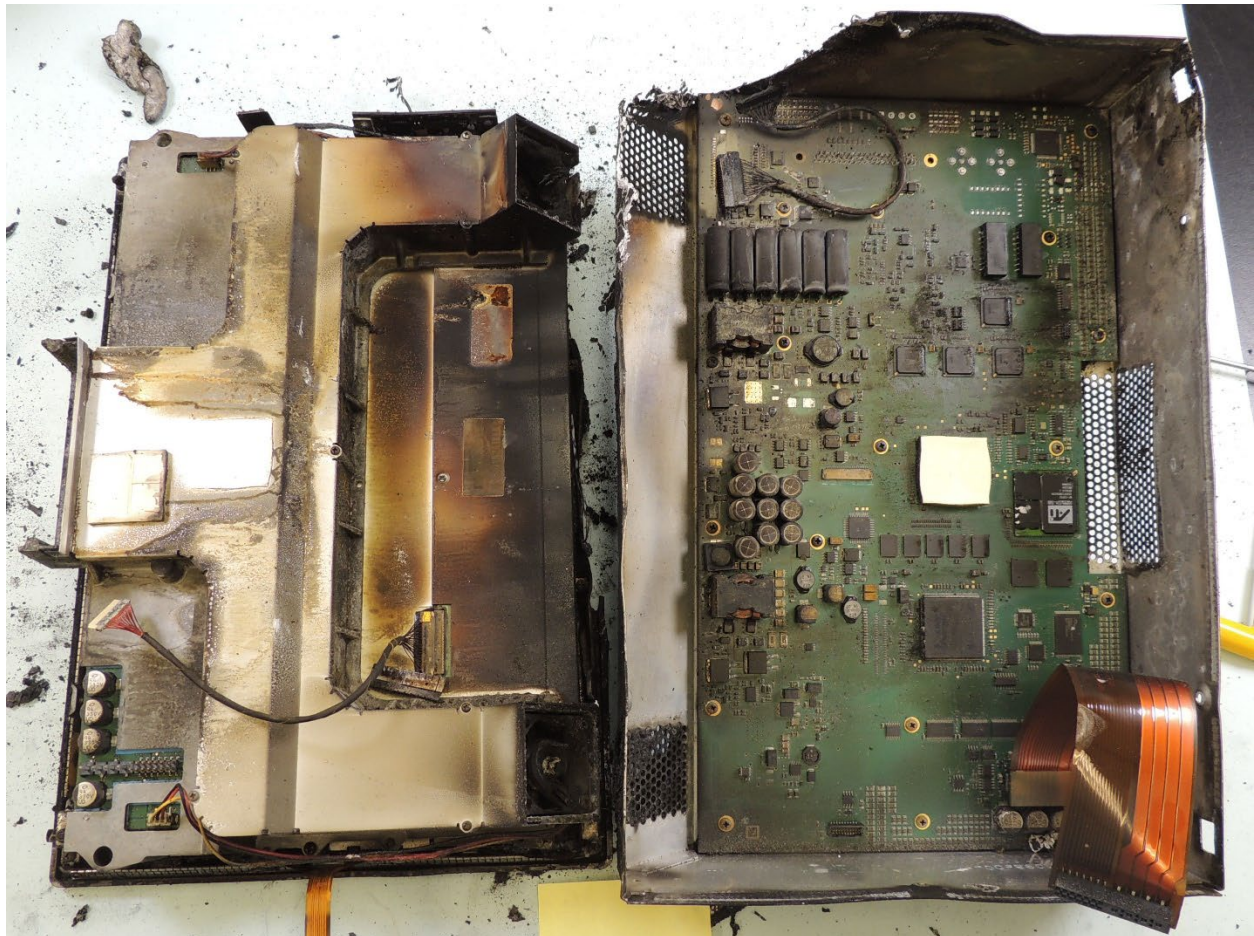
Figure 1 - MFD

The Vehicle Recorder Division received a RDM file, as well as a Garmin Perspective PFD (s/n unknown) and MFD (s/n unknown). The Garmin devices arrived exhibiting signs of thermal damage (PFD.JPG and MFD.JPG). Due to the damage, no data could be recovered from the devices.
