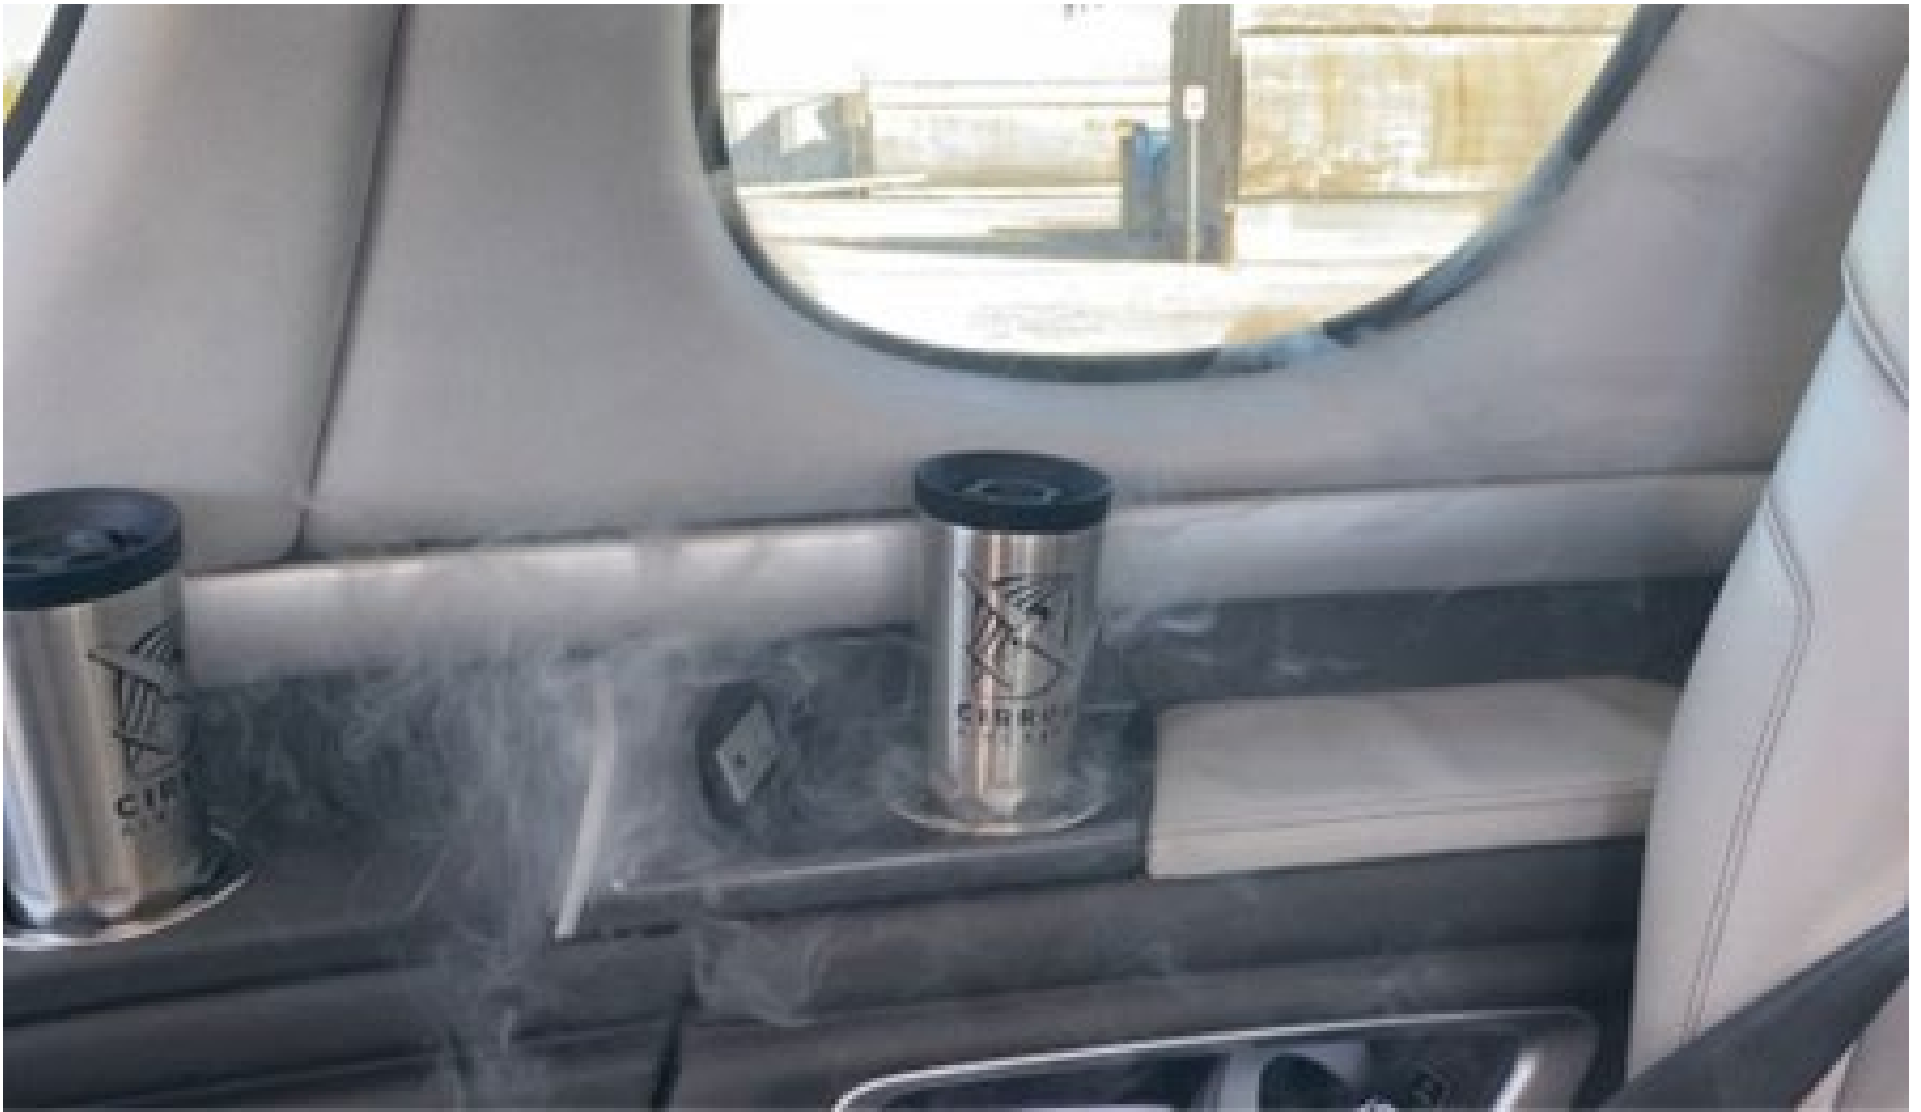
**Photo 1 – Smoke rising from armrest (Source: Pilot).**

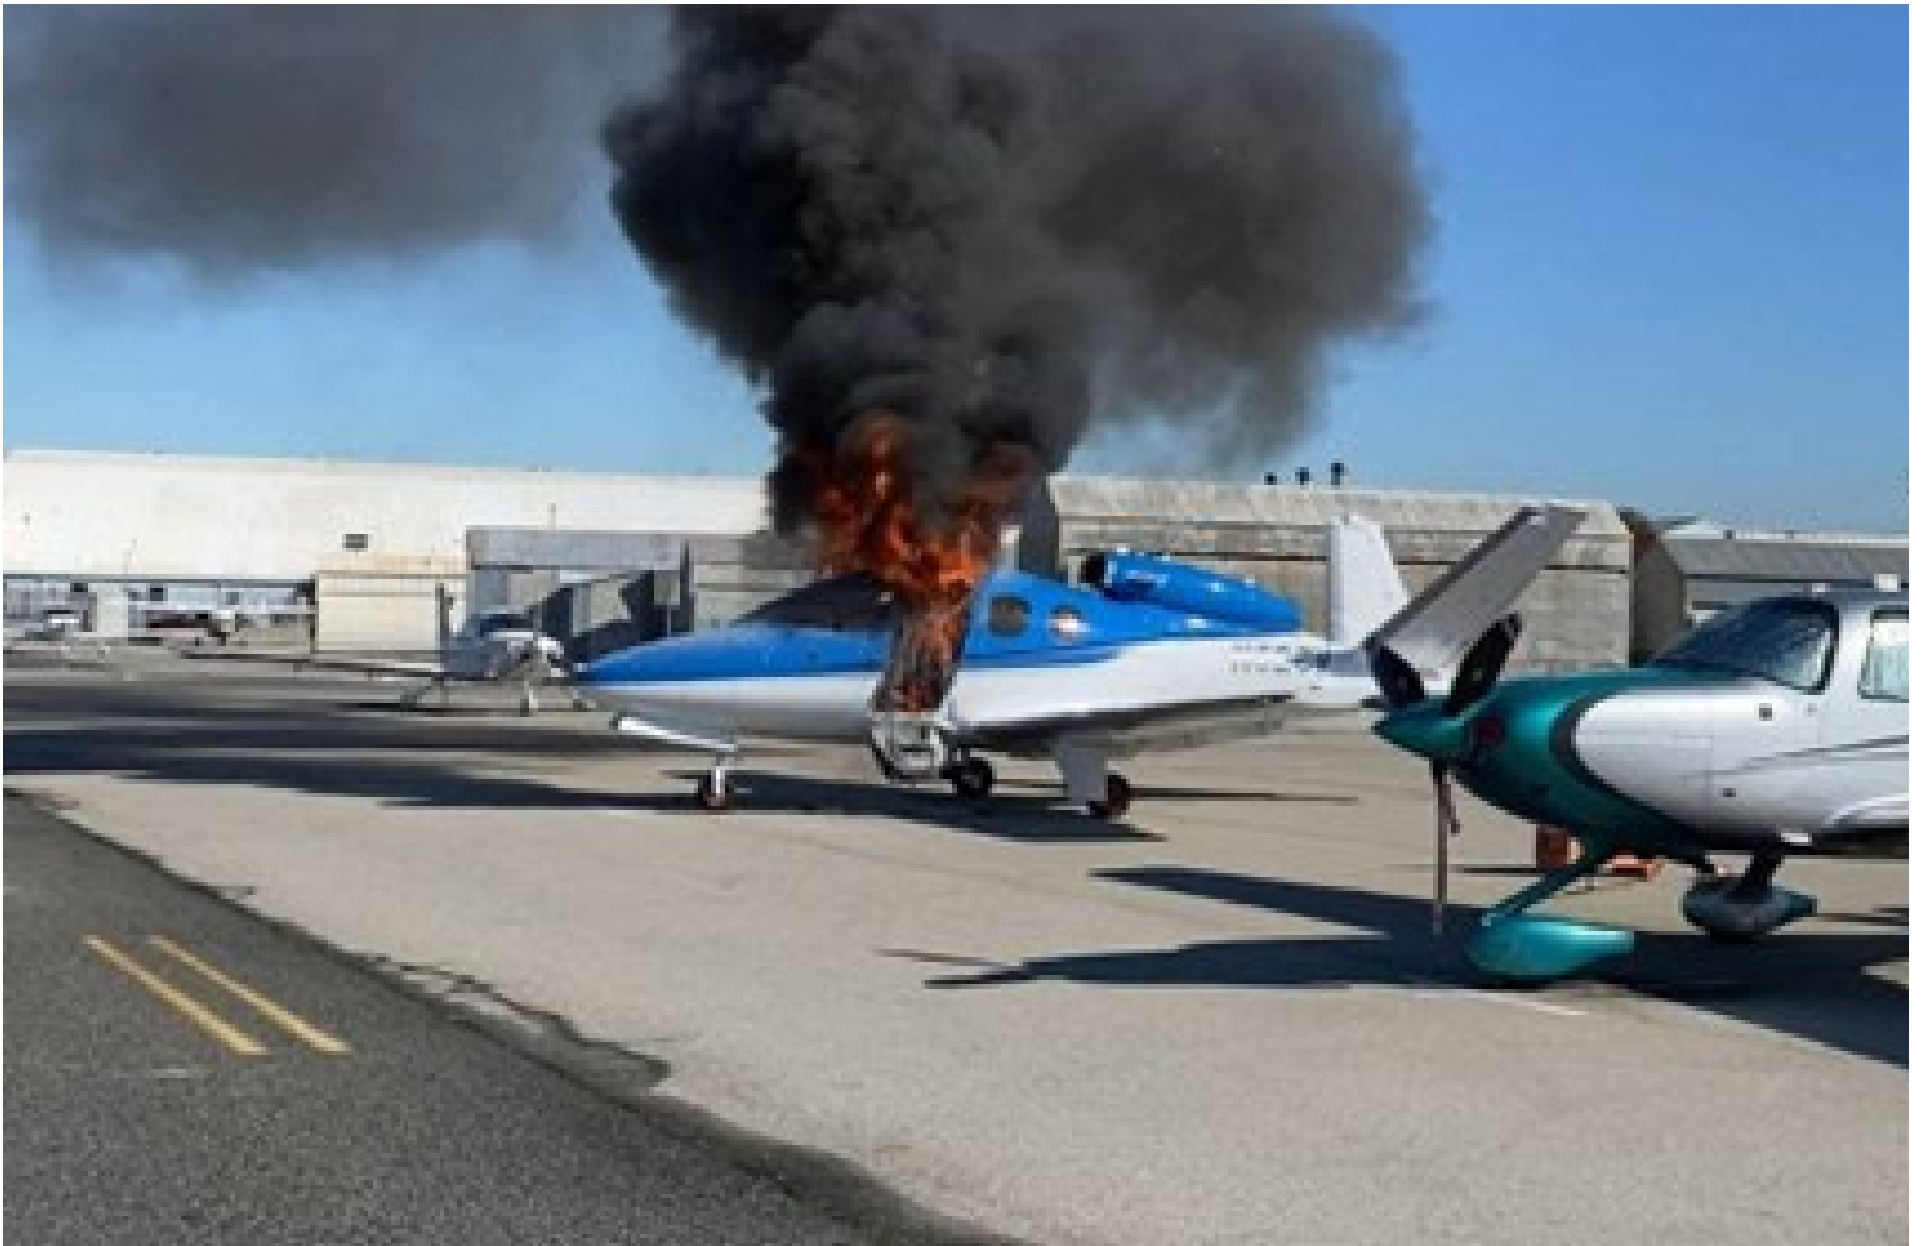
**Photo 2 - Flames engulfing airplane cabin (Source: Pilot).**

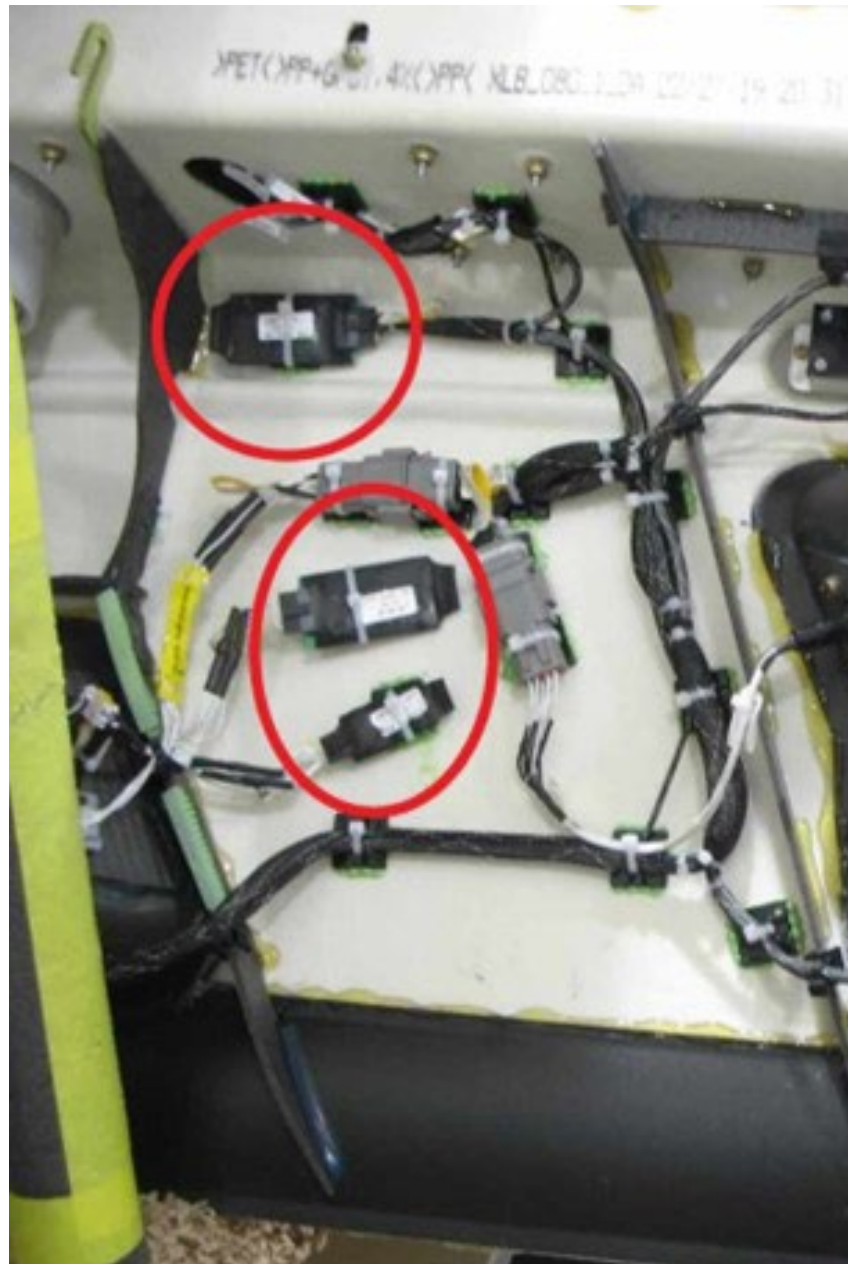
**Photo 3 - Audio cards and (smaller) microphone card inside the panel wall (Source: Cirrus).**

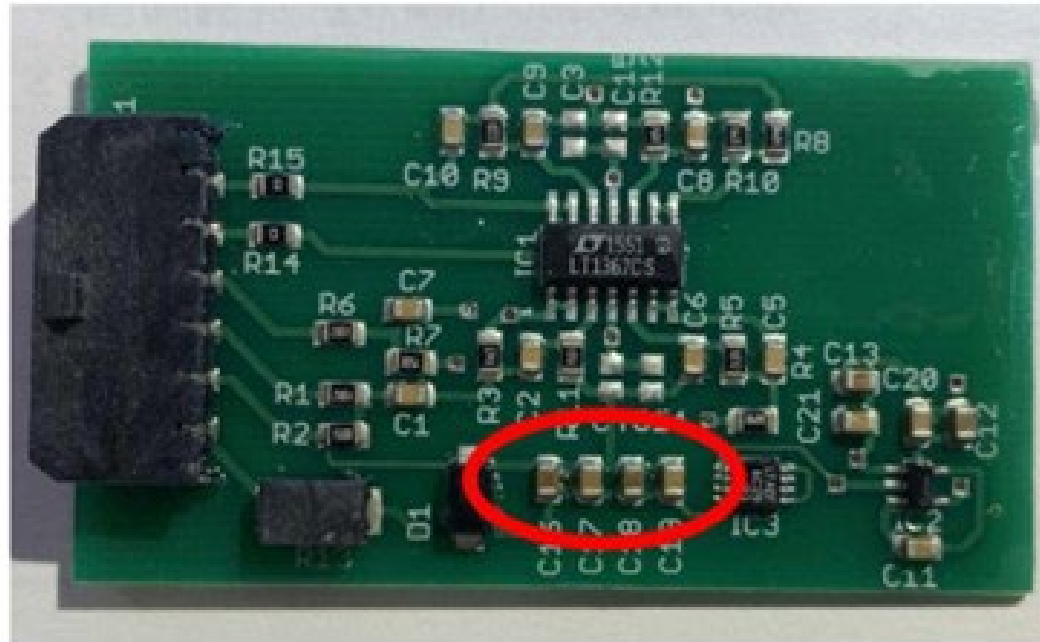
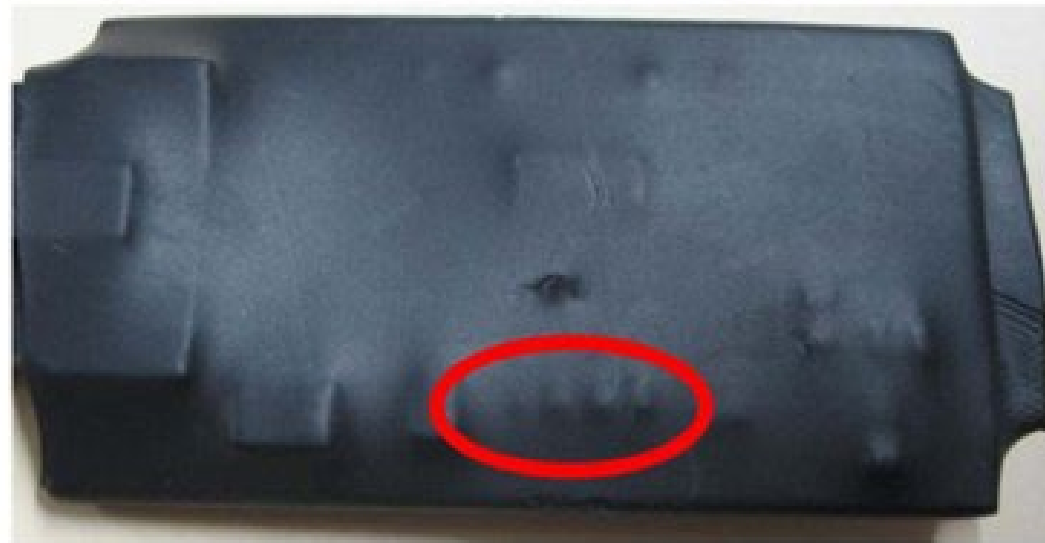
**Photo 4 - Audio card with (top) and without (bottom) heat-shrink sleeving and with the input filter capacitors circled.**

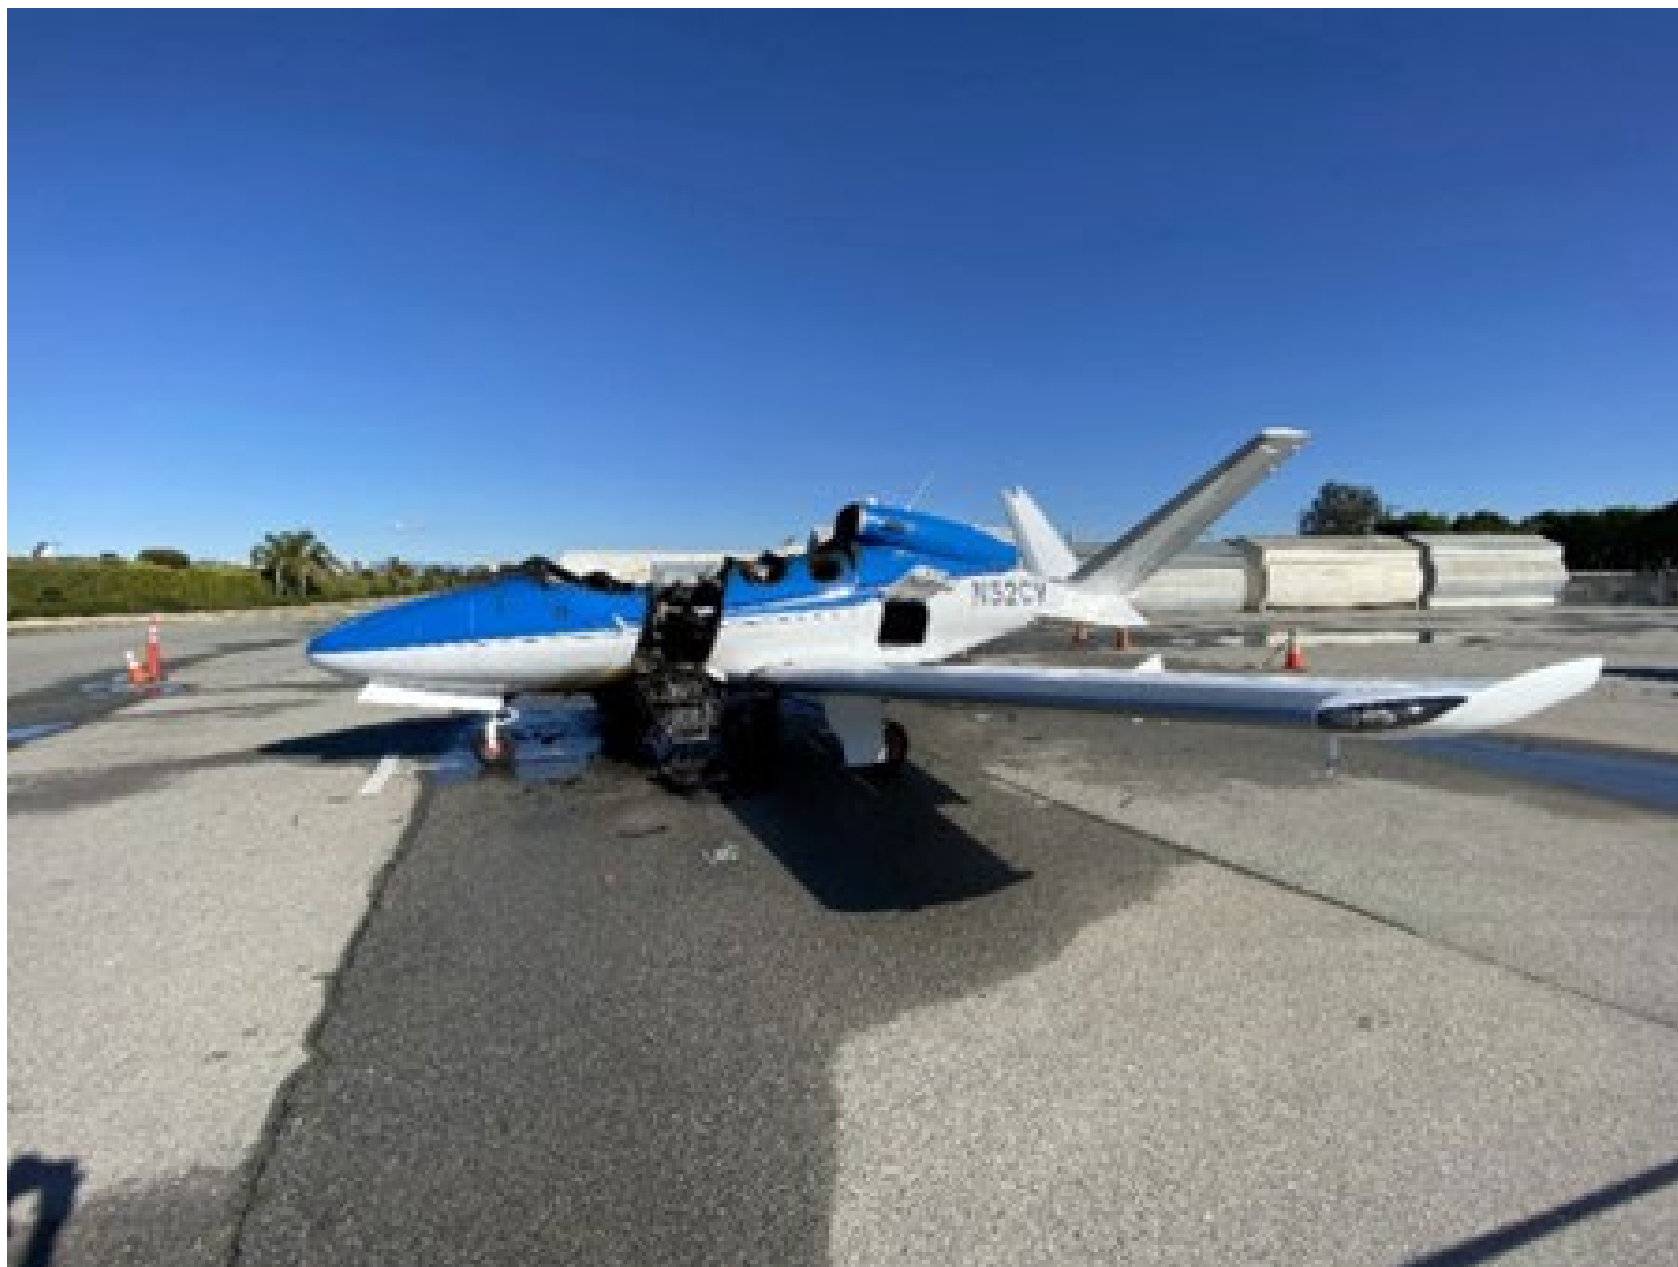
**Photo 5 - Accident airplane after fire was extinguished.**

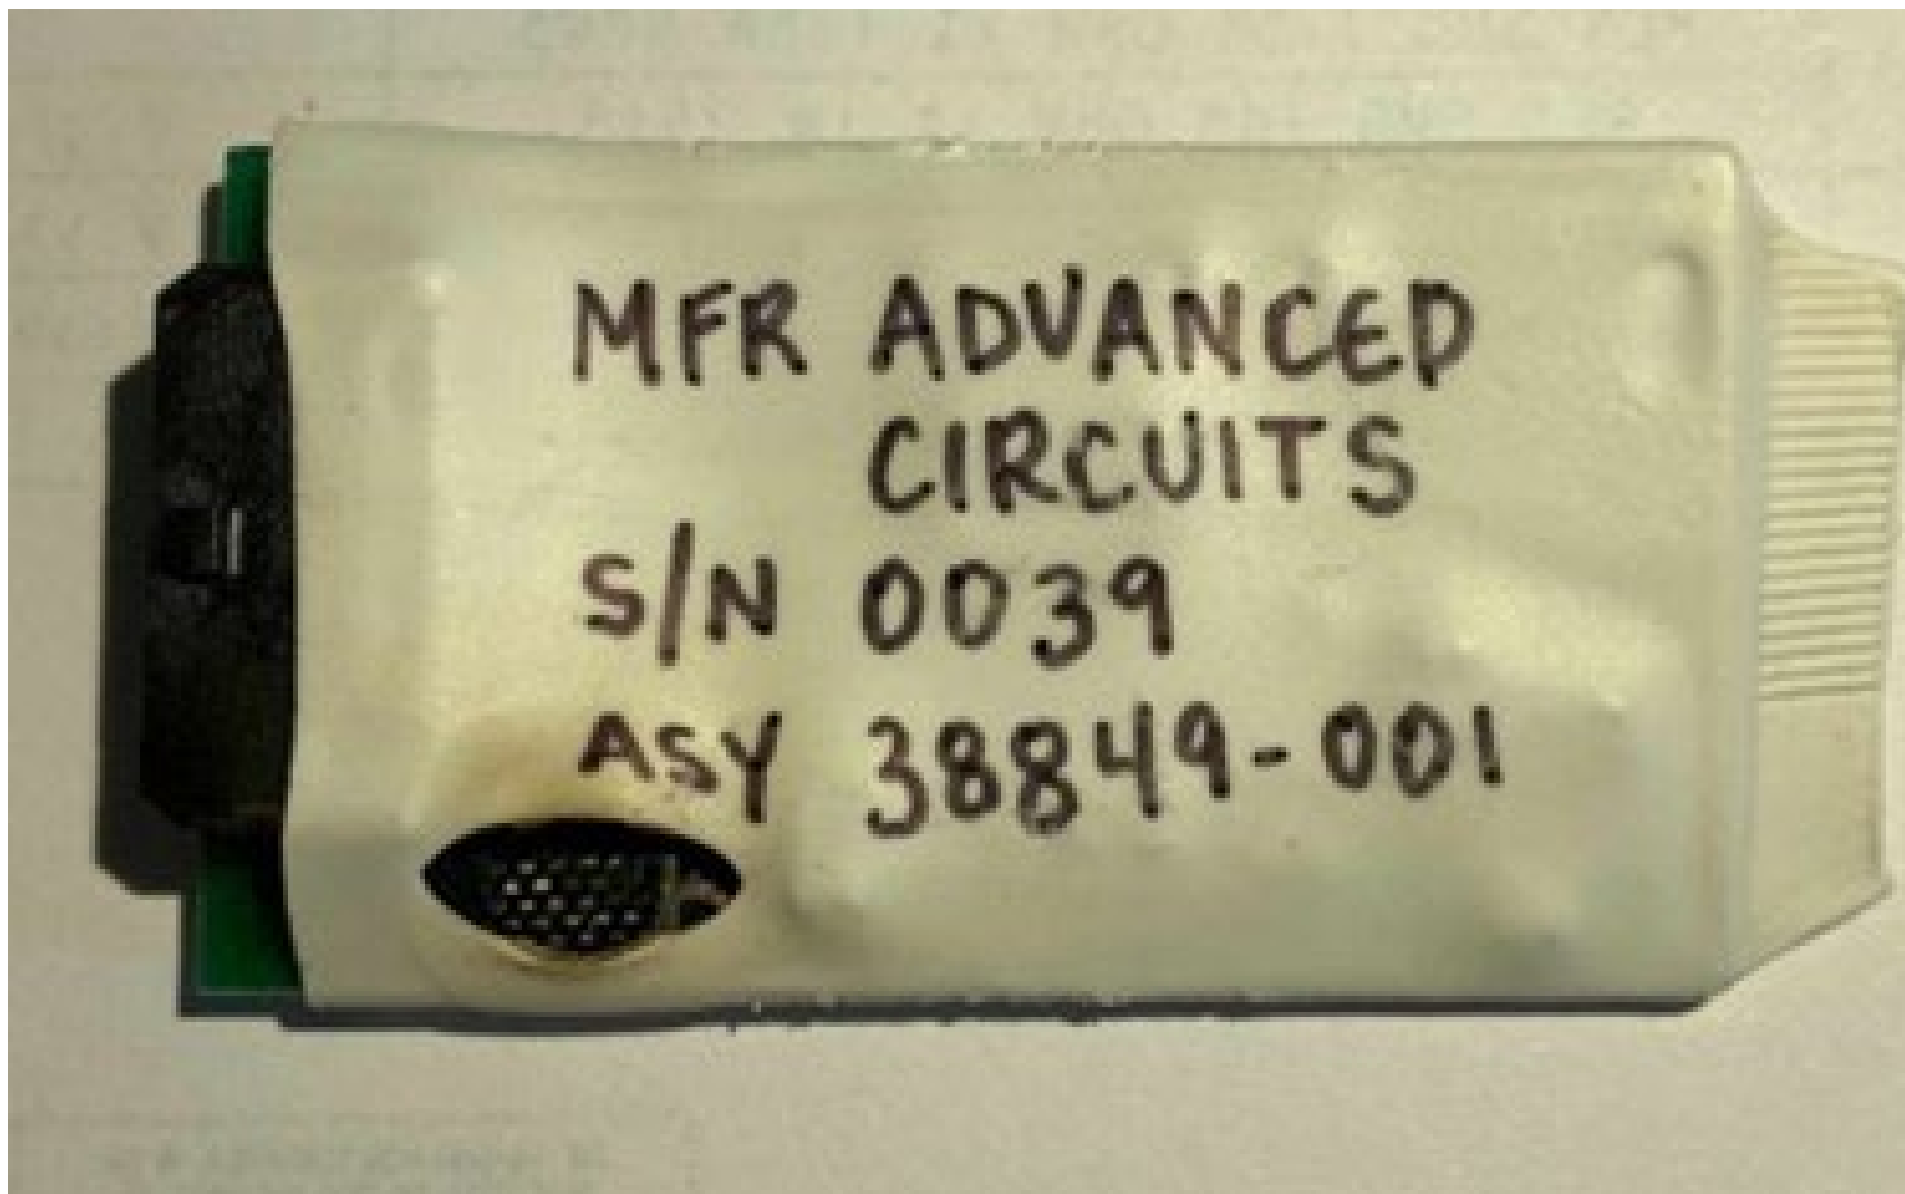
**Photo 6 - Audio card exhibiting burnt resistor (Source: Cirrus).**
