## **Memorandum for Record**

**NTSB Accident Number: WPR20LA135**  
**Aircraft Registration & Make/Model: N6521Y / Piper PA-23-250**  
**Accident Location: Hemet, CA**  
**Accident Date: April 30, 2020**

### **Accident Site Survey Report**

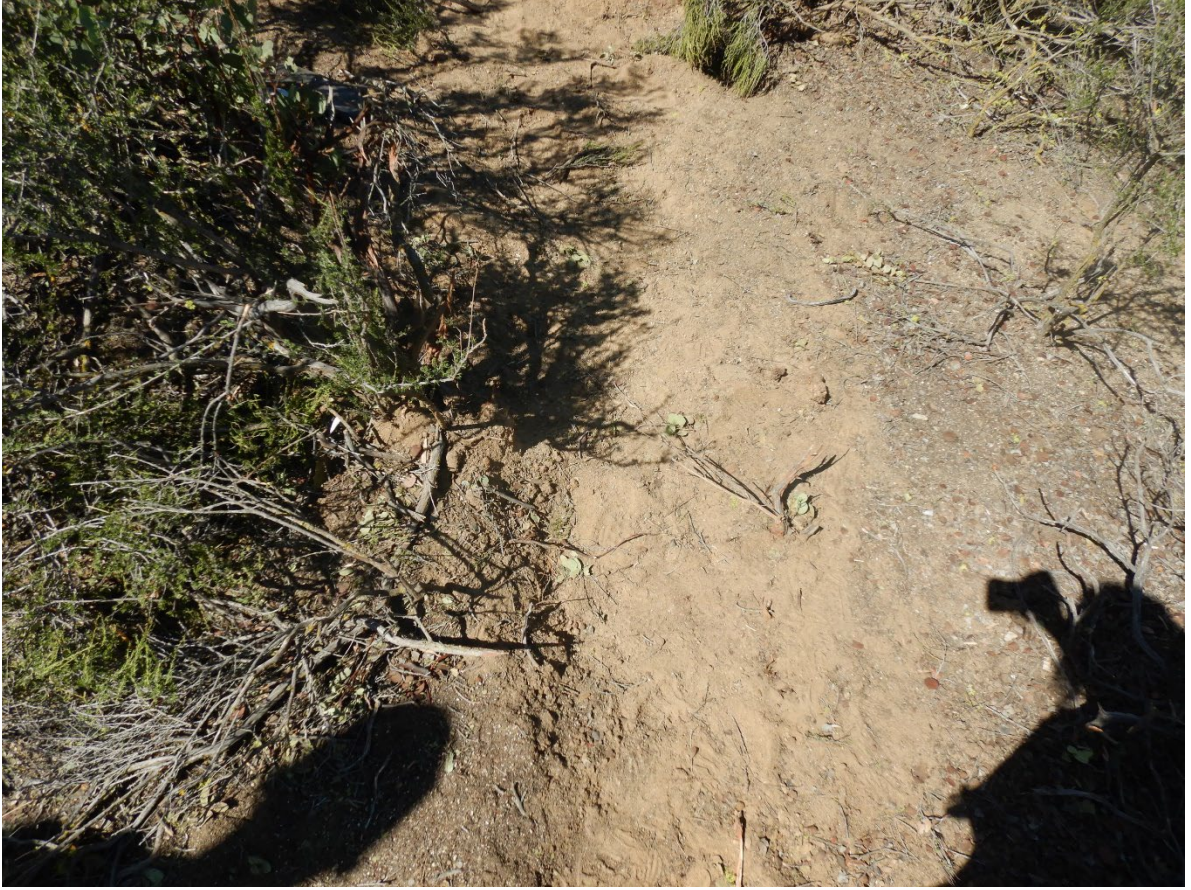
The first identified point of impact was a shallow indentation in sandy soil at the top of the ridgeline at an altitude of 3,606 ft MSL. The first 120 ft of the wreckage trail featured shallow scrapes in the soil and uprooted manzanita bushes with some fragments of wing skin distributed along the sides of the wreckage path. About 120 ft downhill from the beginning of the wreckage path, a shattered granite boulder was noted; downhill from the boulder, more fragments of the wreckage were present, and deep gouges were seen in the soil.

Figure 2. First point of probable impact.

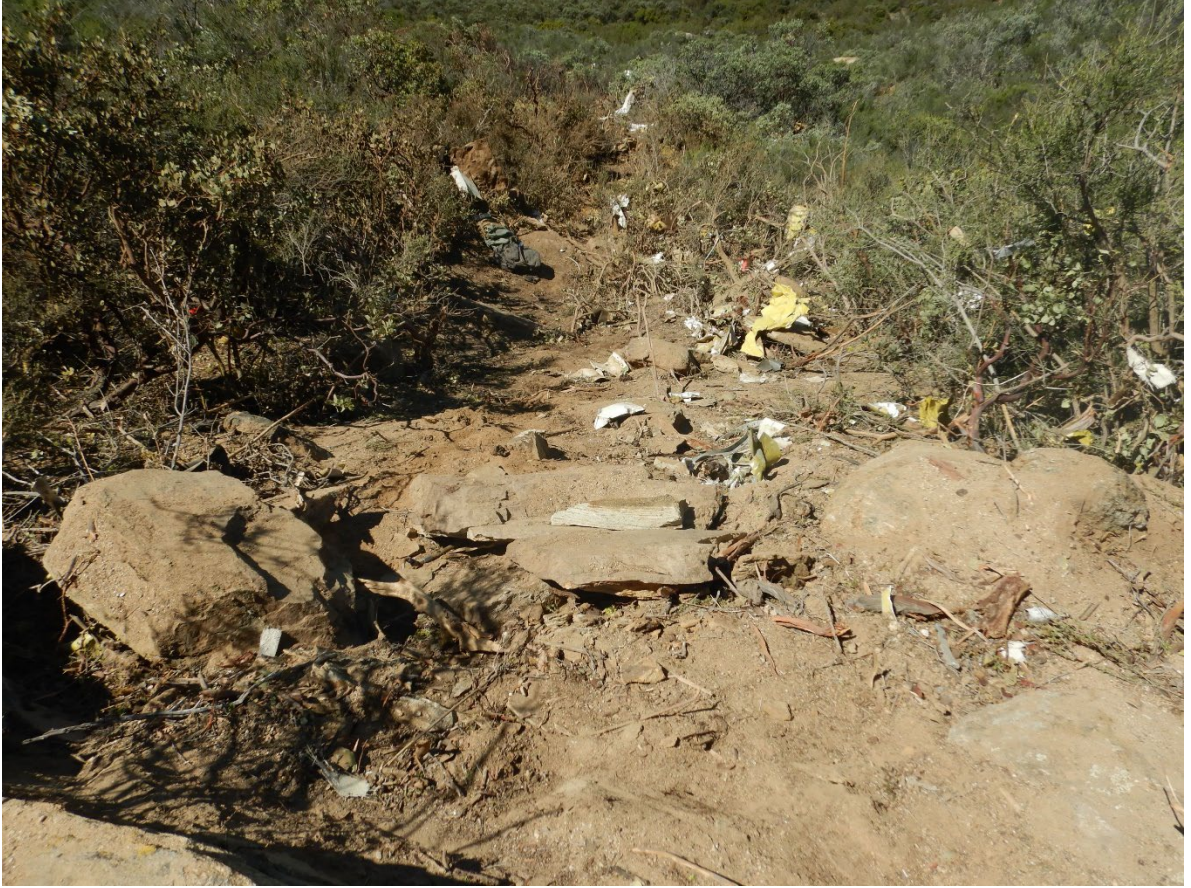
**Figure 3. Debris field running downhill, with large-shattered boulder in the foreground.**

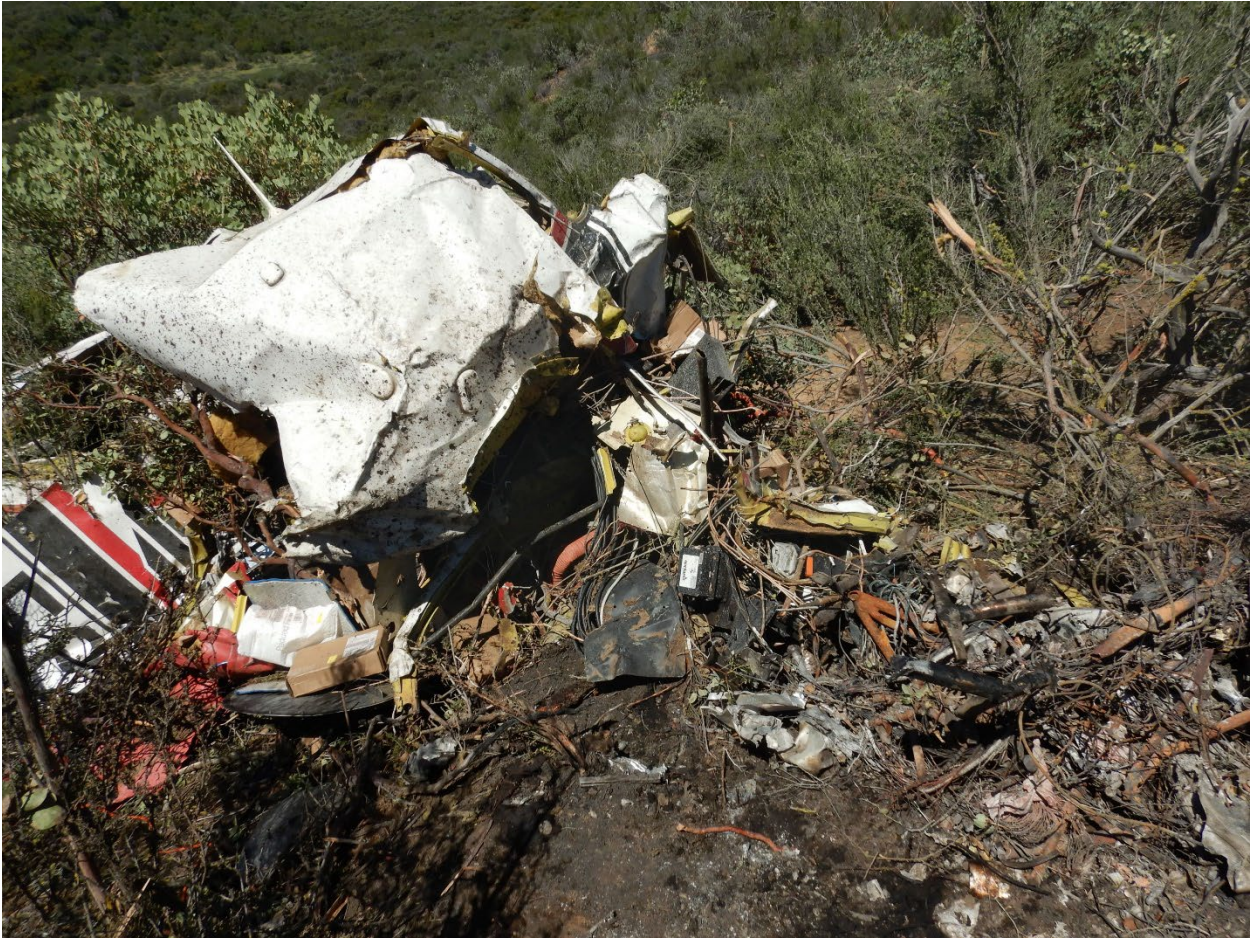
The main wreckage was comprised of the fractured fuselage and empennage. Both wings had separated from the fuselage, and both engine separated from the wings.

Figure 4. Main wreckage.

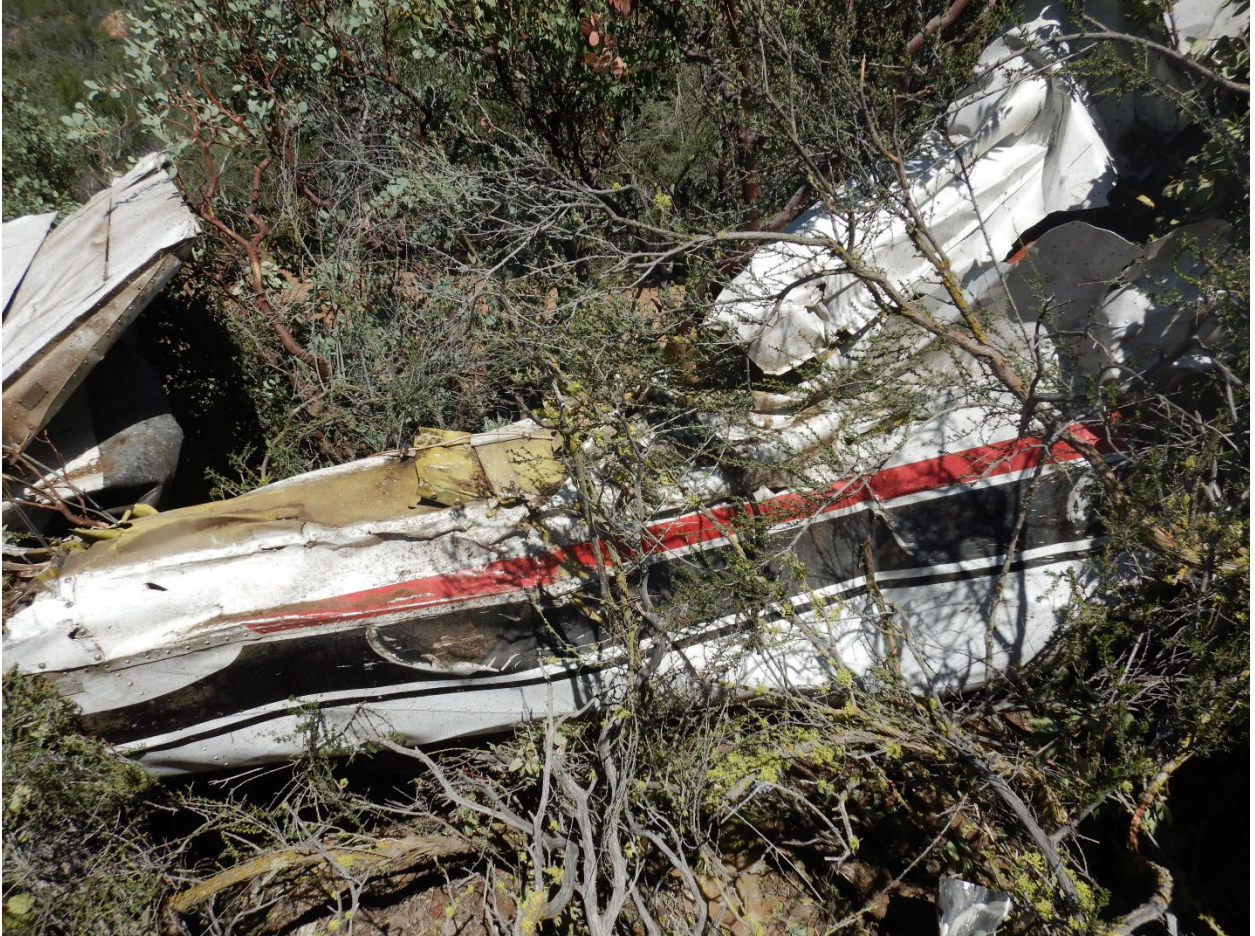
Figure 5. Aft fuselage.

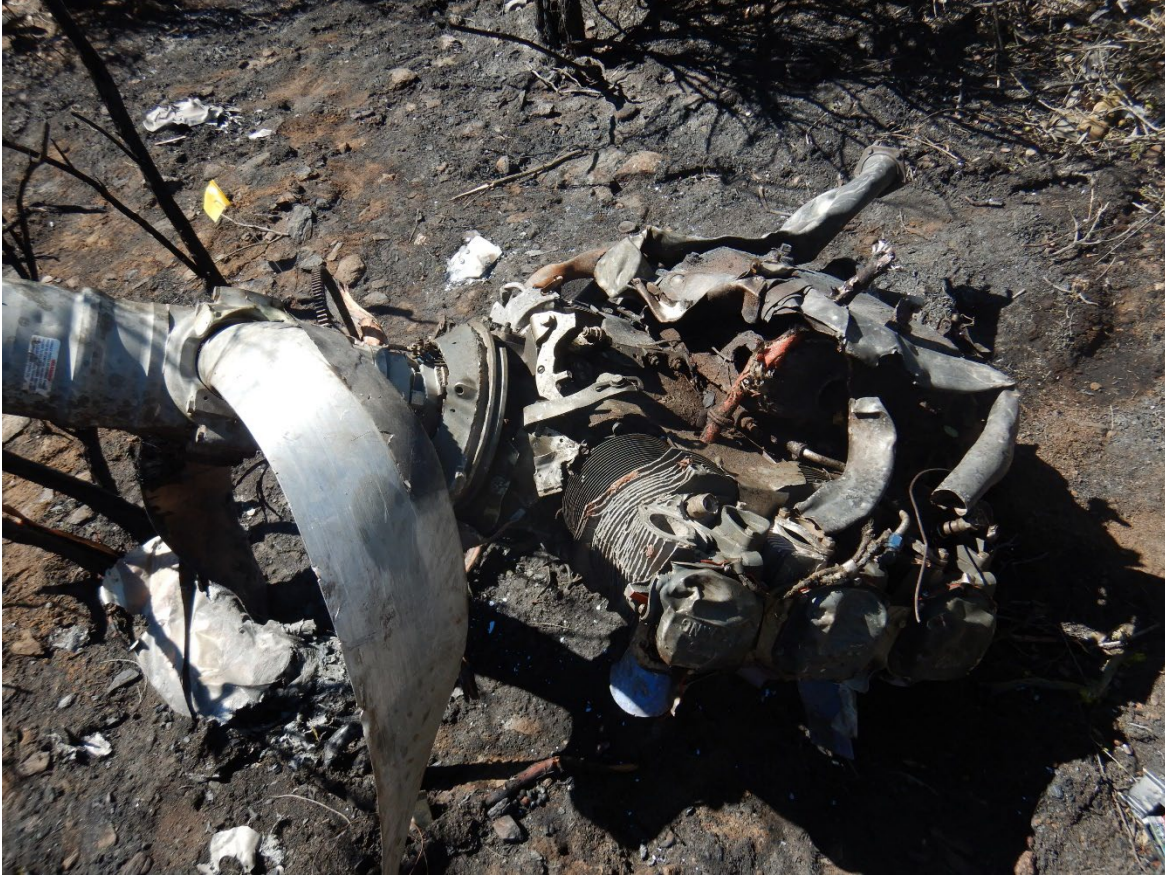
Figure 6. left engine with propeller.

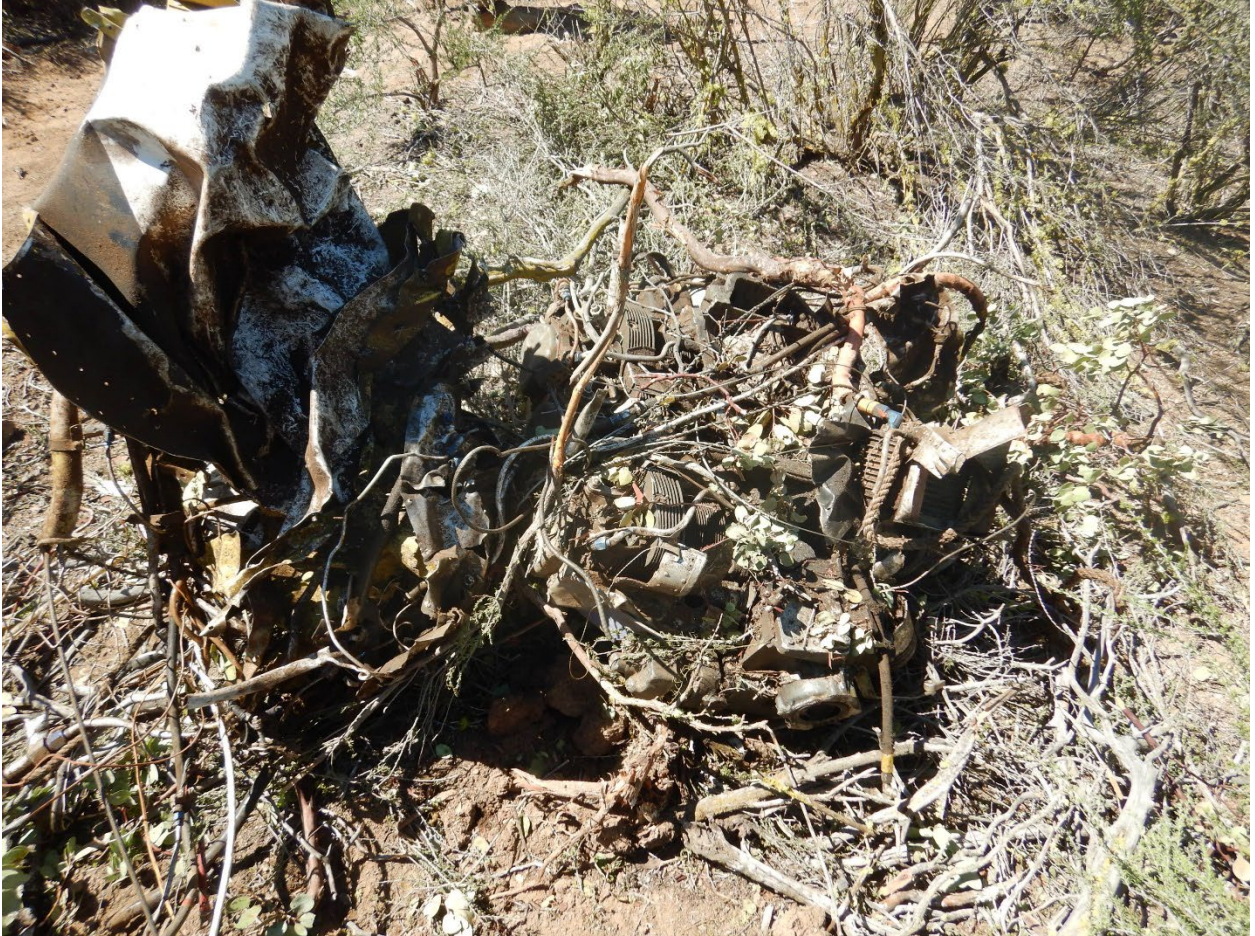
Figure 7. Right engine without propeller.
