**NATIONAL TRANSPORTATION SAFETY BOARD**  
Vehicle Recorder Division  
Washington, D.C. 20594

**Specialist's Factual Report**  
**By W. Deven Chen**

Location: Phoenix, Arizona  
Date: May 13, 2020  
Aircraft: Mooney M20J  
Registration: N201HH  
NTSB Number: WPR20LA144

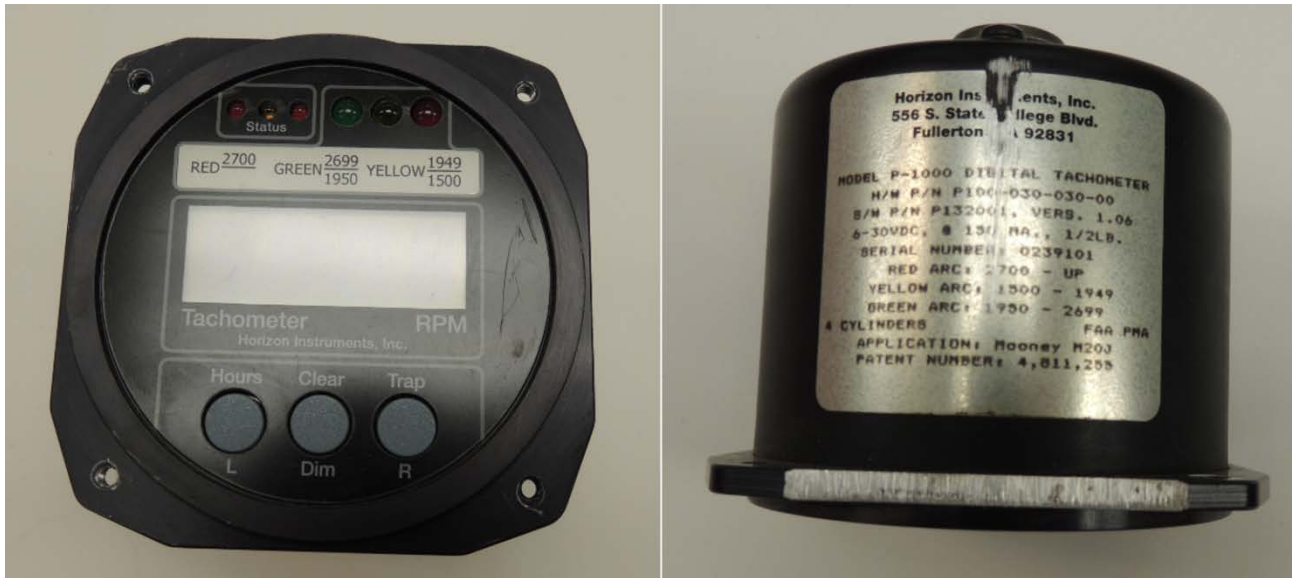
The device arrived undamaged at the Vehicle Recorder Division, as shown in Figure 1. The device only retains tach time and highest recorded RPM value. In an agreement with the investigator in charge (IIC), the pursuit of downloading the tach time was not attempted.

Figure 1: Horizon Instrument P-1000 as received.

The Horizon Instruments P-1000 is a digital tachometer which provides diagnostic and performance information about the aircraft's engine and ignition system. The system provides a means to electronically monitor engine rotational speed in a digital representation. The device also records aircraft engine hours. The device can store engine hour information and highest RPM achieved during a power cycle.

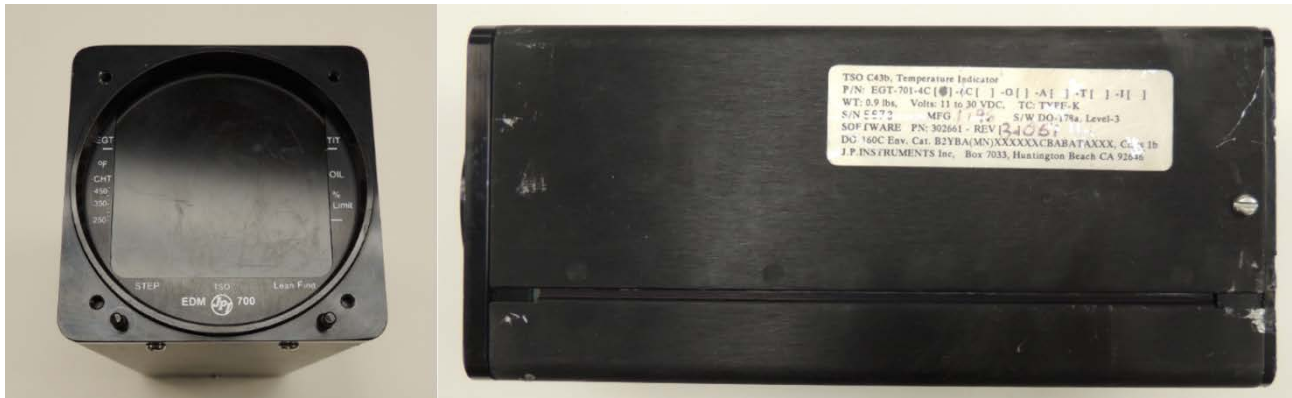
Upon arrival at the Vehicle Recorder Division, an exterior examination revealed the unit had no damage, as shown in Figure 2. The device powered up normally and data were downloaded using the manufacturer's software.

**Figure 2: JPI EDM 700 as received.**
