## HISTORY OF FLIGHT

On May 31, 2020 at 1759 Pacific daylight time, an experimental Cub Crafters CCK-1865, N303KP, was substantially damaged when it was involved in an accident near Valley Center, California. The pilot sustained fatal injuries and the passenger was seriously injured. The airplane was operated as a Title 14 Code of Federal Regulations Part 91 personal flight.

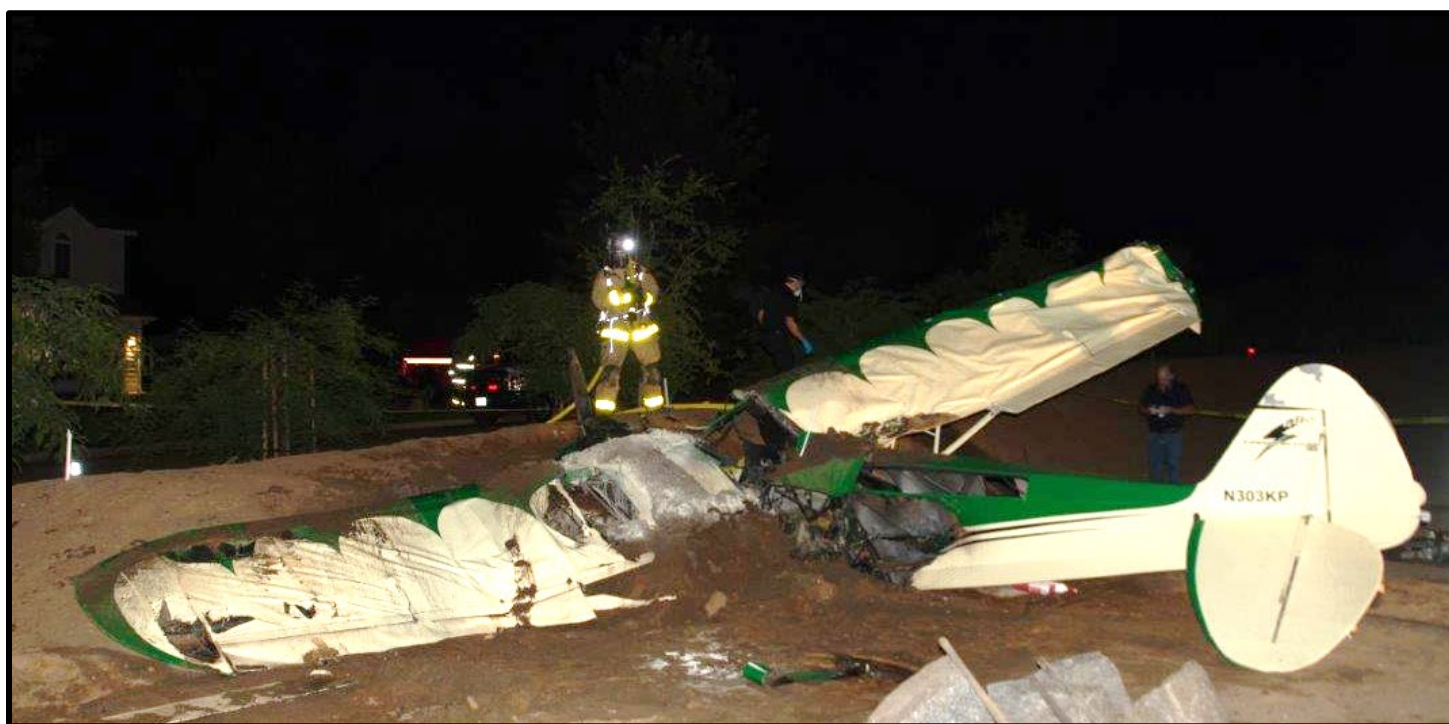
The accident site was located in soft dirt about 100 feet from the residence on Palomar Vista Dr., Valley Center, CA<sup>2</sup>. In character, the terrain was flat, and populated by scattered mature large bush. The main wreckage, consisting of the entire airplane, came to rest upright near tall brush and had burned the terrain in the surrounding 5 to 10 feet. The wreckage was subjected post-impact fire and burned. Control continuity was established onsite by the FAA inspectors.

Figure 9: Wreckage (picture proved by FAA inspector)
