## **NATIONAL TRANSPORTATION SAFETY BOARD**

### **Specialist's Factual Report**

# **METEOROLOGY**

WPR20LA211

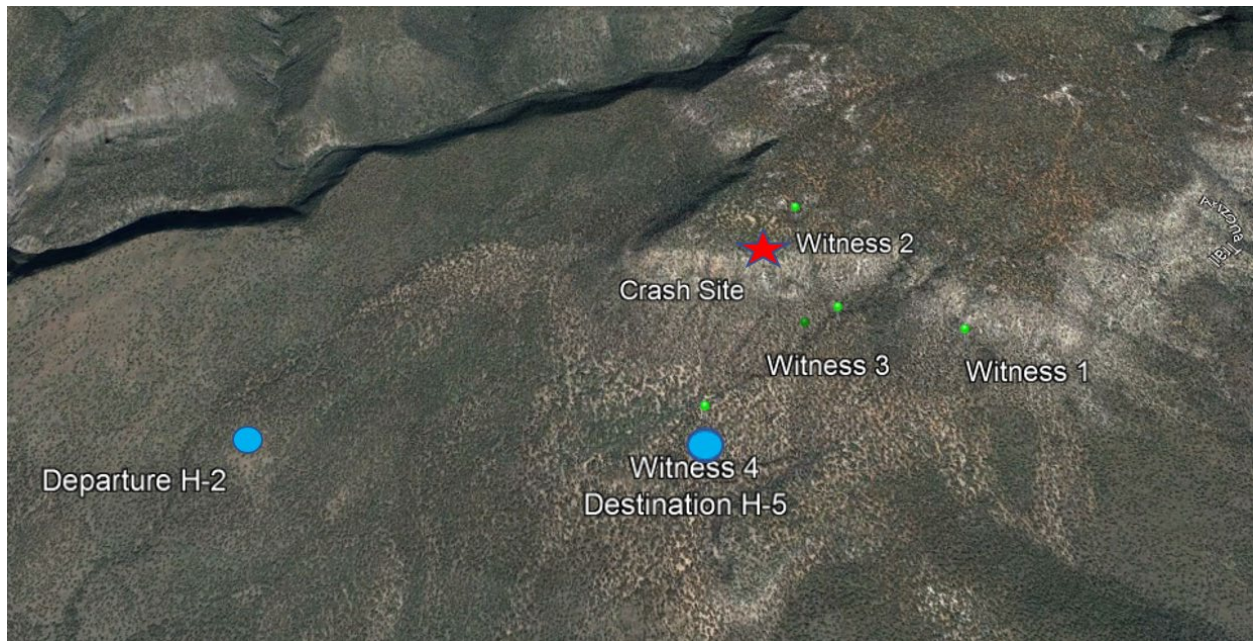
Several of the forest fire fighters who witnessed the accident provided statements regarding the wind and general weather conditions. Figure 7 presents the locations of the witnesses relative to the accident site, the Helispot 2 (H-2) departure point and the destination at Helispot 5 (H-5). All of the witnesses indicated that there were no clouds or thunderstorms in the area during the period. The full witness interviews are in the docket, and the general weather conditions reported by those witnesses are summarized below. In follow-up questions with the witnesses, two responded (witness 1 and 2) seeing dust devils<sup>11</sup> in the area the day prior, day of, and day after the accident.

**Figure 7 - Witness locations**

Witness 1 – was a Fire Line Safety Officer and was located east of the accident site. He indicated that the winds were 5 to 10 mph, with winds generally stronger in the afternoon with gusts, and indicated it was a little breezier on top of the mesa. He also indicated that on multiple days prior to the accident they would see huge dust devils, which would typically originate from within the burned area of the fire. He added that the dust devils were regular forming, a couple every hour. When asked if he observed any dust devils on the day of the accident, he indicated that he recalled seeing them but did not have a clear memory of where and at what time he observed them.

Witness 2 – was a Fire Lookout who was positioned at the top of the ridge immediately north-northeast of the accident site, indicated that the conditions at the time of the accident that the weather was still with light winds predominantly from the southwest, with no gusts. He indicated that the wind gusts came later in the afternoon. With regards to seeing any dust devils, he indicated seeing “ash whirls” in the area but could not remember the specifics of what days or times he witnessed them. He did indicate that the “ash whirls” developed in or near close proximity of the fire area of the Tonto north fire near Payson, and that they were very common in that area.

Witness 3 – was working a hot ash-pit on the north side of the Polles fire and was located approximately 200 yards southeast of the accident site. He was facing in the direction of the approaching helicopter, when he heard “weird rotor wash sound from a helicopter, looked up, and saw the helicopter become unstable in flight”. He didn’t notice any winds at the time.

Witness 4 – was located on the northwest edge of the fire and to the south of the accident site. He indicated that light winds from the southwest, with no gusts, with clear skies, and added he didn’t see any kind of cumulus clouds.

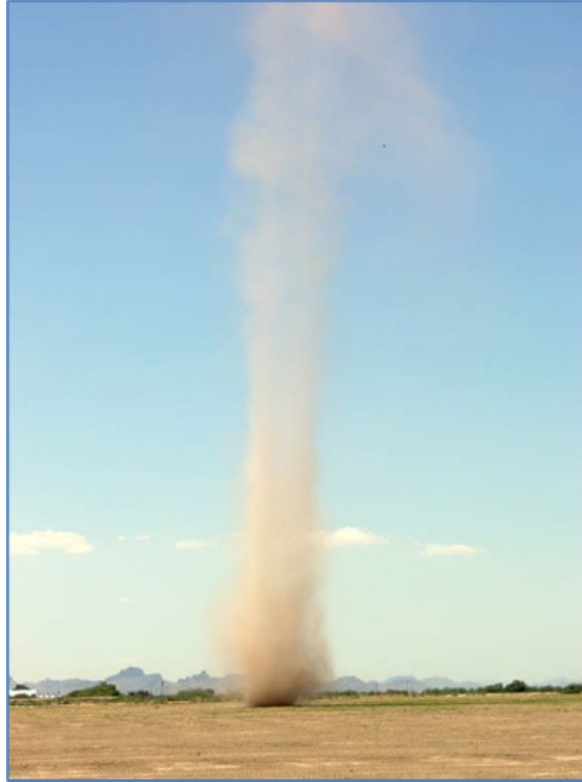
Figure 8 is a photograph of dust devil in Arizona, which had a diameter of 40 ft and extended several hundred feet in the vertical.

**Figure 8 - Dust devil observed over Arizona**
