# NATIONAL TRANSPORTATION SAFETY BOARD

## Onboard Image, Audio, and Data Recorder

### Specialist's Factual Report

| Aircraft: | Airbus Helicopters AS350B3, N755AE |

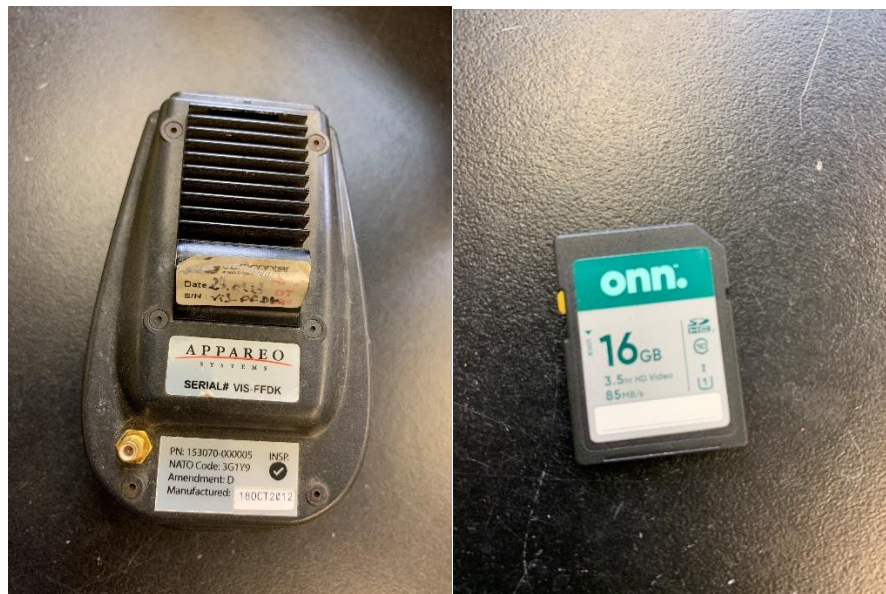
Initial inspection of the device indicated no obvious major component damage. The unit was shipped with an removable SD card, which was not congruent with the type of SD card that is shipped with the unit by the manufacturer (Appareo).

**Figure 1. The Appareo Vision 1000 device and the associated SD card, as received.**

The removable SD card associated with the accident device, pictured on the right of figure 1, was read with a PC. No obvious data was found on the removable SD card.

The accident SD card in figure 1 shows that it has a label that suggests it is a 16 GB capacity Class 10<sup>3</sup> SDHC U1<sup>4</sup> UHS I<sup>5</sup> SD card.

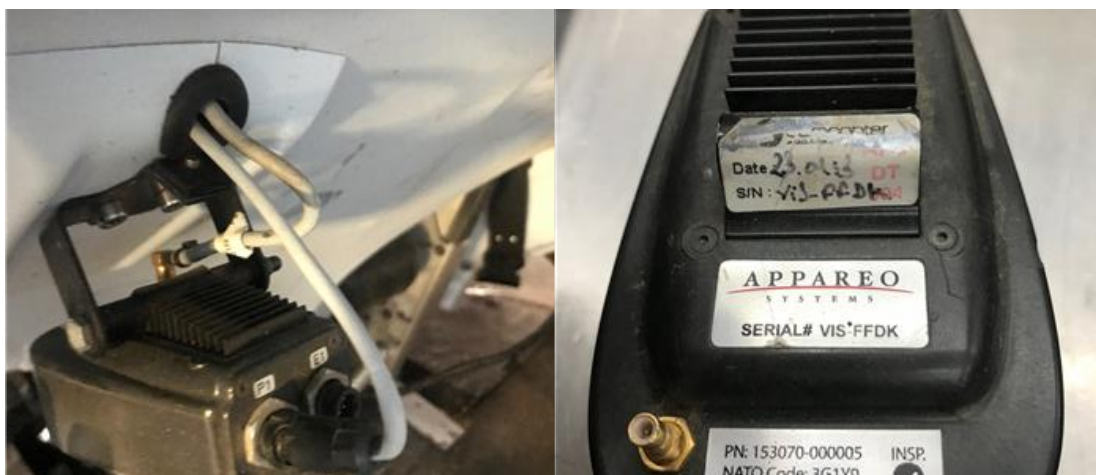
An investigator who had traveled to the accident site provided photos (figure 4) that showed the unit was found plugged in at the time of the accident.

**Figure 4. The accident unit, as noted in the wreckage, post-accident.**

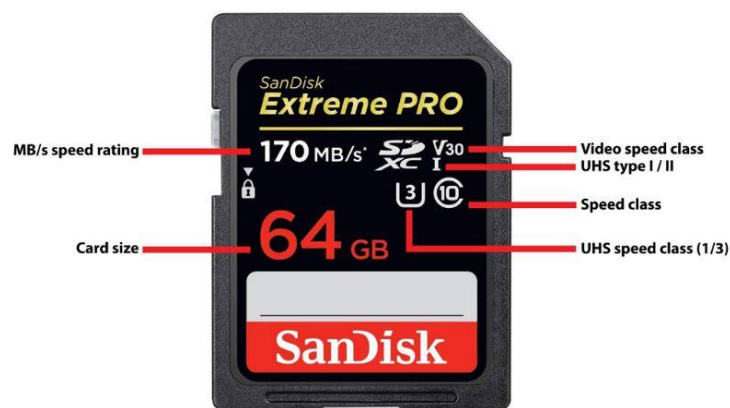
There are numerous speed ratings defined by the SD Association<sup>2</sup>. The SD Association also agrees upon a standard format for marking the specifications of memory devices. Capacity, bus speed and speed class are some of the defined components of the standardized specification markings of an SD device. Figure 5 is an annotated SD card showing the various definitions for the markings of an SD device, the definitions of which are found in the footnotes to this section.

**Figure 5.** Standardized performance markings on an SD device (source: <https://www.amateurphotographer.co.uk/>)

<sup>3</sup> Speed Class – Speed class symbol comprises of the letter “C” with a number inside. A “C10” symbol indicates a “class 10” card capable of reading and writing at 10 MB/sec.

<sup>4</sup> UHS Speed Class – Ultra High Speed. A “U1” symbolizes a UHS Speed Class 1 which should support a minimum of 10 MB/sec read/write speed. Typically, the UHS speed class refers to the minimum sustained read/write performance of the card.

<sup>5</sup> UHS Bus Speed – A roman numeral “I” indicates theoretical short-term maximum read and write speed, which is always higher than the UHS Speed Class rated speed.
