# SafranHE On Site Examination Report

| NTSB Reference: | <b>WPR20LA244</b> |
| Aircraft Type: | <b>Airbus H125</b> |
| Variant: | <b>Arriel 2D</b> |

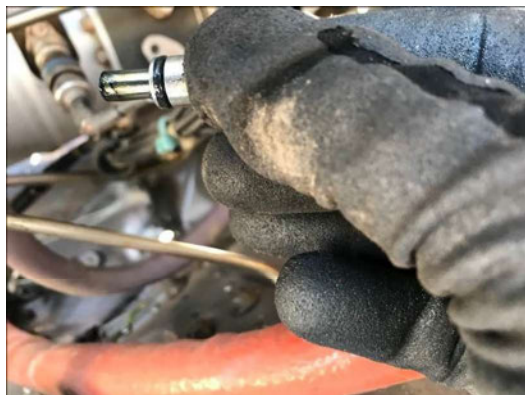
**Module 1 magnetic plug**

**The reduction gearbox and accessory gearbox chip detectors were found clean.**

| Equipment | Condition |
|---|---|
| MO1 Magnetic Plug | Clean |

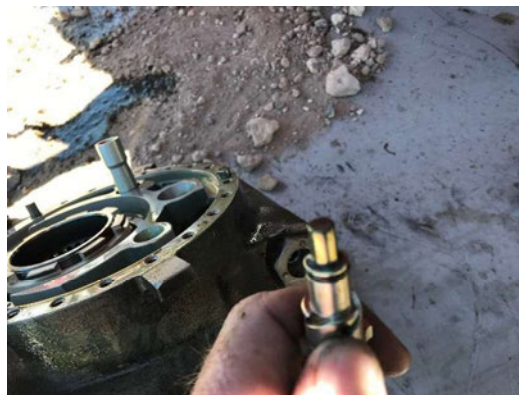
**Module 2 magnetic plug**

| Equipment | Condition |
|---|---|
| MO5 Magnetic Plug | Clean |

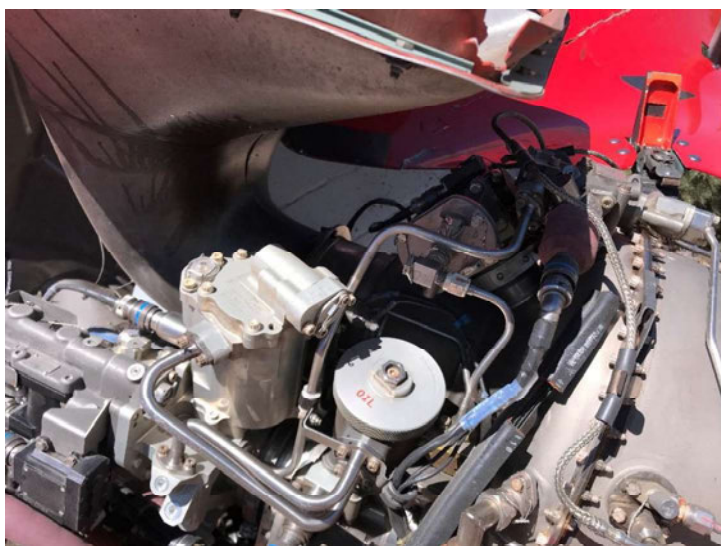
**Oil Filter**

| Equipment | Condition |
|---|---|
| Oil Filter | Not removed |

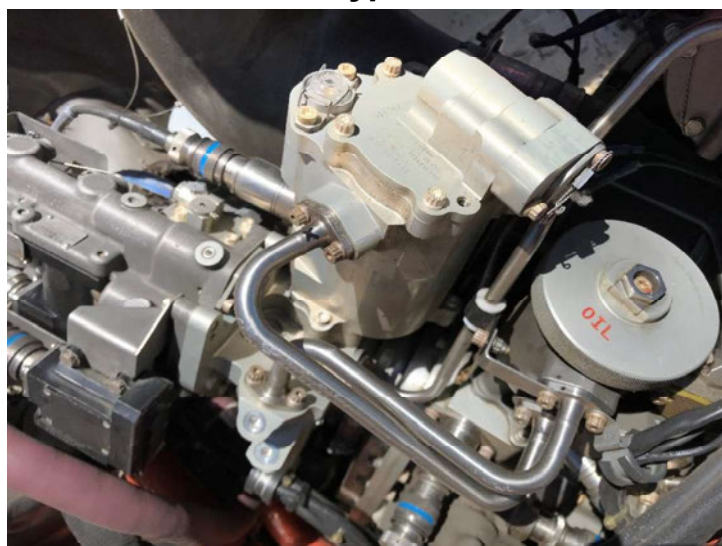
**FCU Fuel Filter no bypass**

| Equipment | Condition |
|---|---|
| FCU Fuel Filter | Not removed |

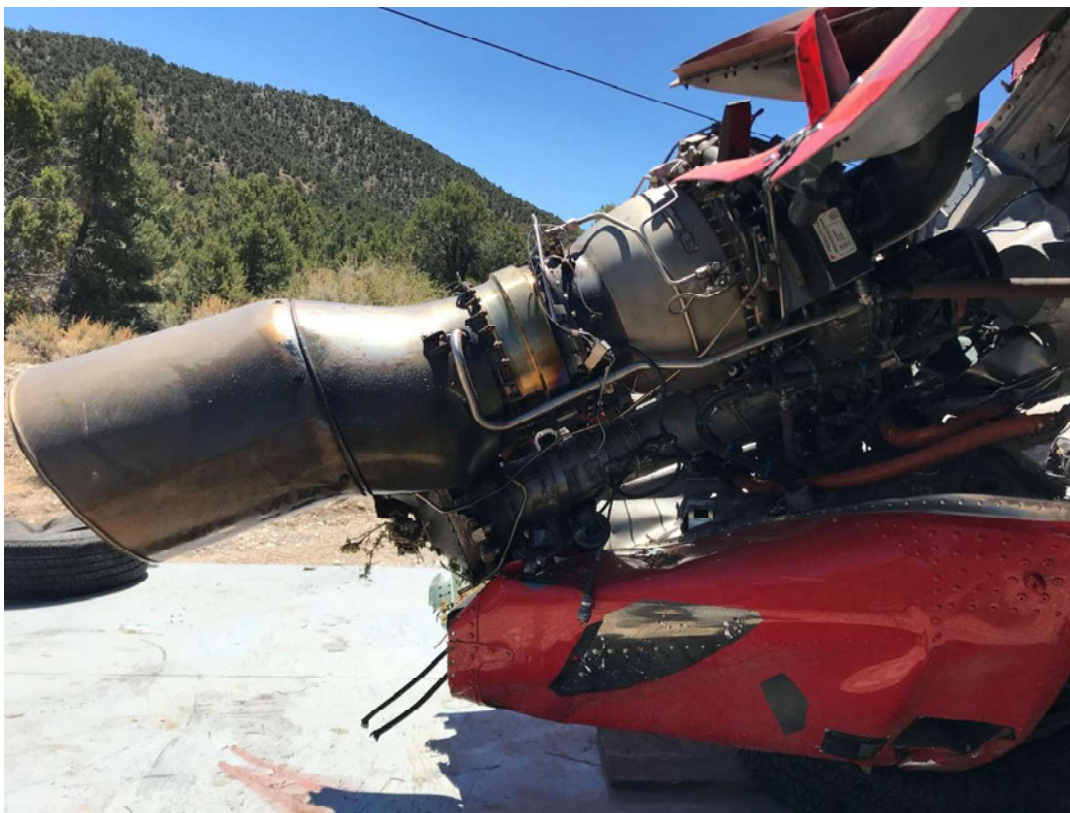
## Overall Engine

**As found the engine was still retained in the helicopter by the front and rear supports. Visually, there was very little external damage to the engine. Oil spray was evident on the bottom of the bellmouth consistent with engine operation after inversion and oil being expelled from the bleed valve. All fuel, oil, air, and electrical connections were intact and appeared to be correctly saftied. The aircraft was recovered to a trailer for the remainder of the exam.**

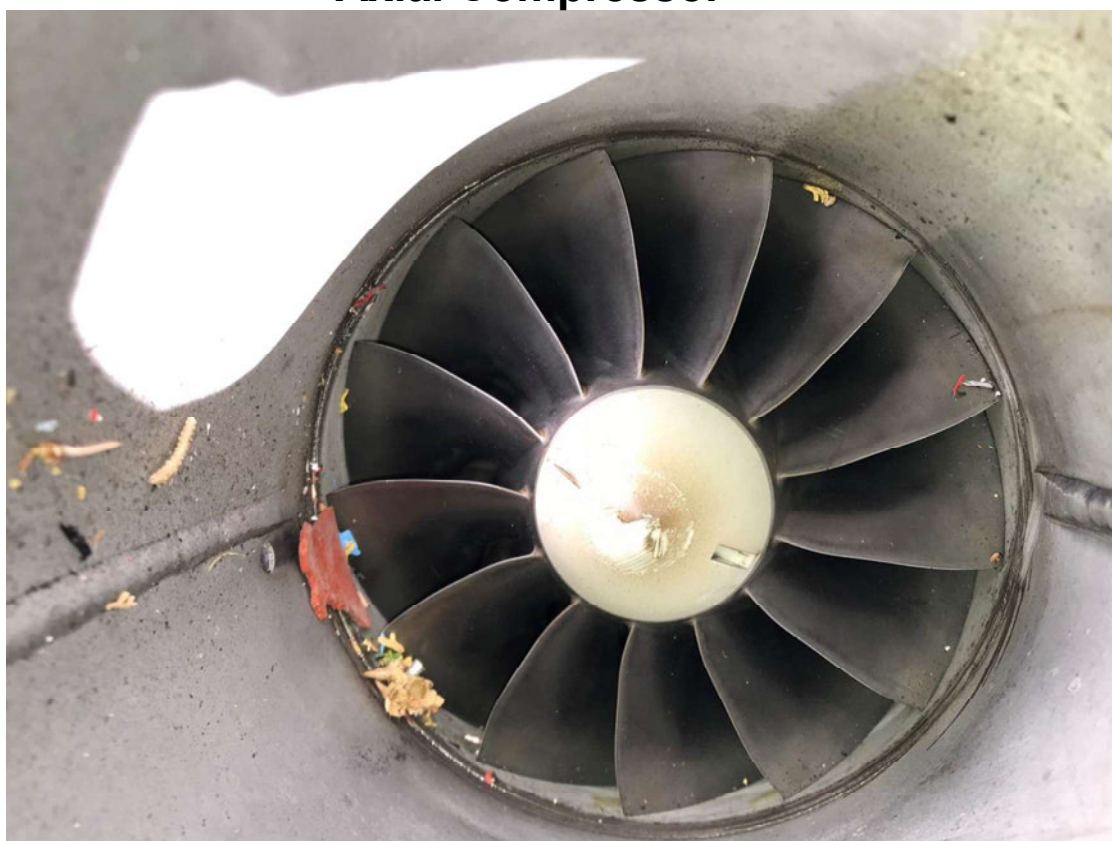
## Axial Compressor

**The gas generator and free turbine could both be turned freely by hand. There was minor FOD damage on the axial compressor. Oil was present inside the exhaust pipe a well, again consistent with the engine running while inverted.**

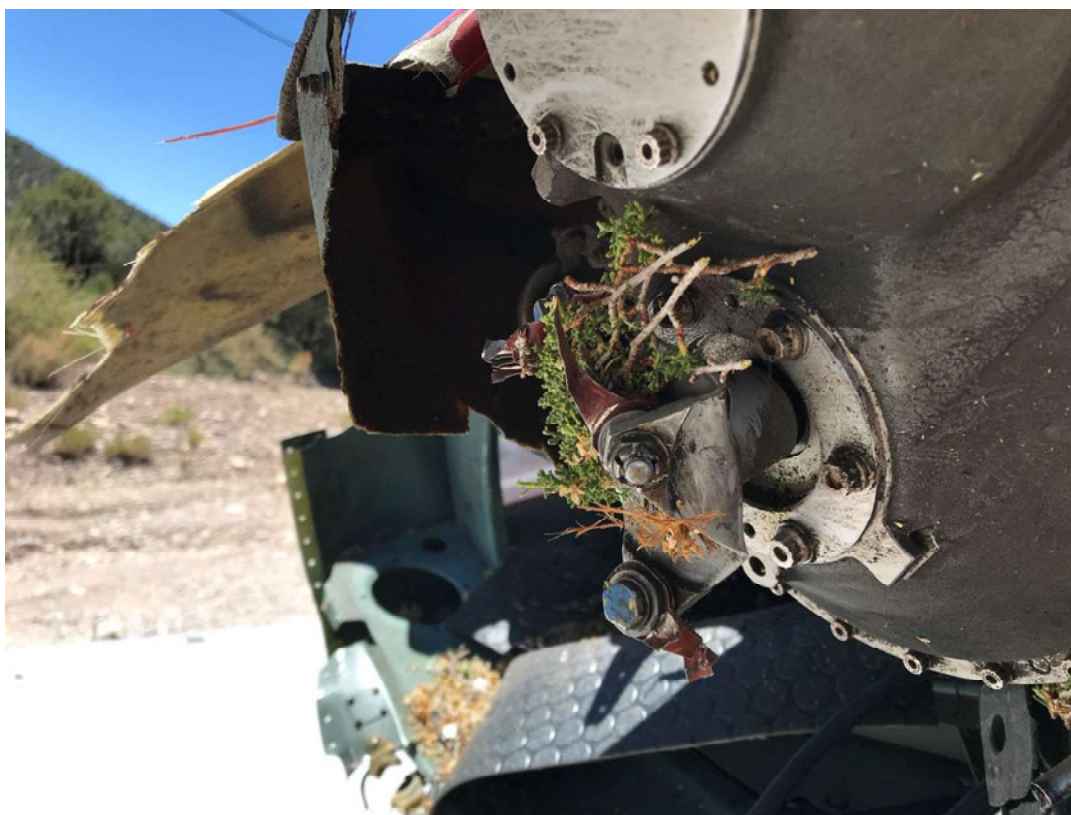
## Tail Rotor Drive Coupling

**Proper freewheel operation was confirmed. The rear tail rotor drive short shaft had separated from the drive flange on the freewheel shaft. The flector group connecting the two was torsionally splayed.**

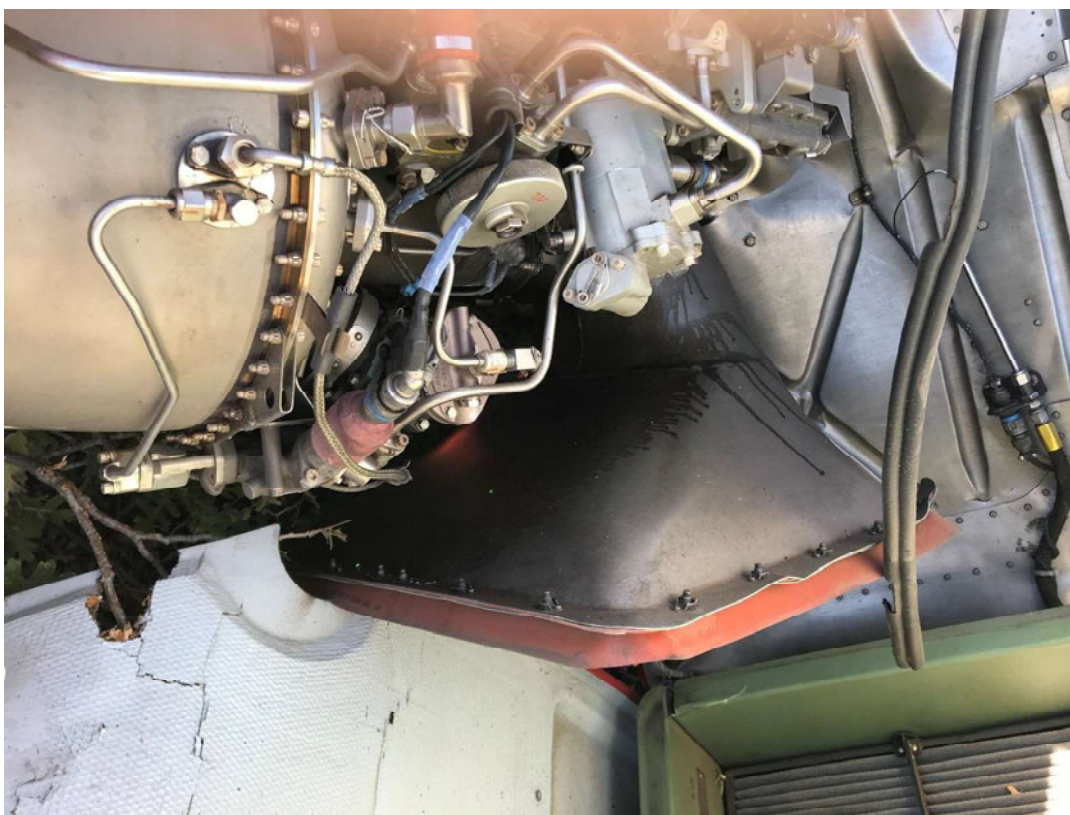
## Oil sprayed from bleed valve on bellmouth

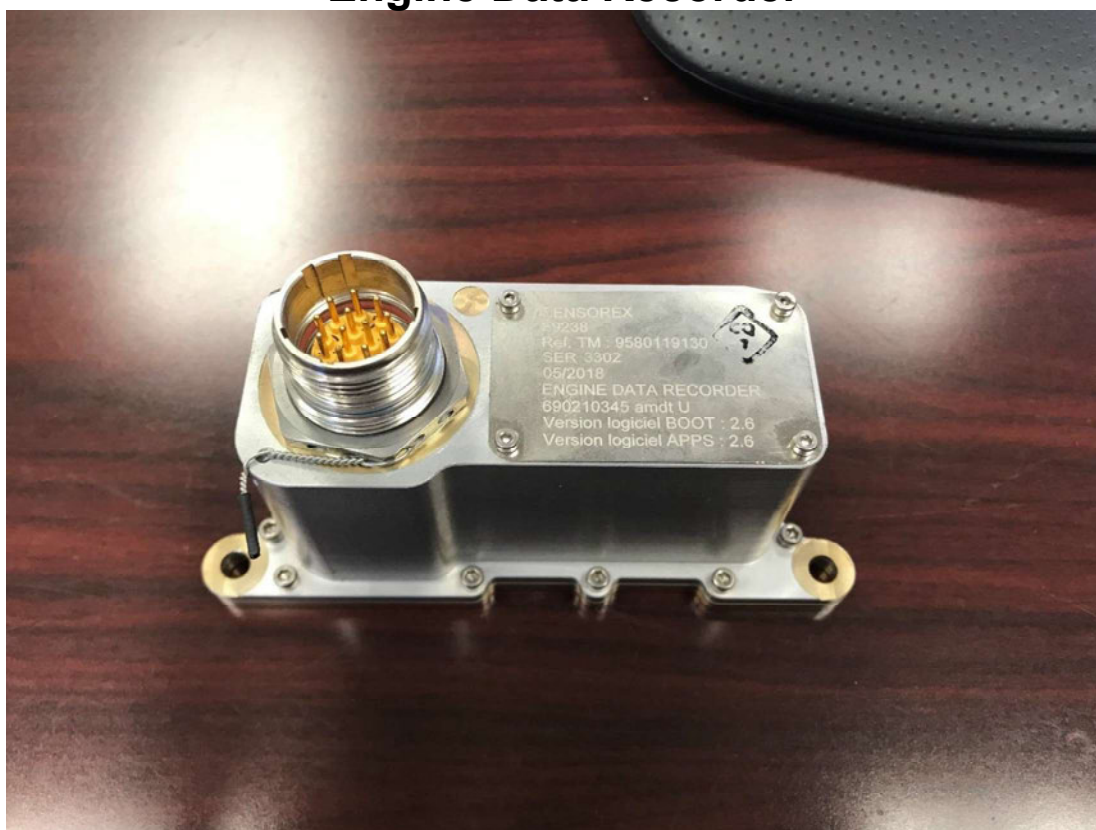
## Engine Data Recorder

**The EDR was removed from the helicopter and downloaded at the factory. The final flight shows that during the accident the pilot placed the engine in idle then back to flight and then back to idle near the end of the recording. The EDR also shows that the during this sequence the NR drops below the necessary RPM to maintain lift.**
