# NATIONAL TRANSPORTATION SAFETY BOARD

## MATERIALS LABORATORY FACTUAL REPORT

Report No. 20-059

Place : San Jose, California  
Date : August 2, 2020  
Vehicle : Cessna 172S, N55231  
NTSB No. : WPR20LA256  
Investigator : James Bledsoe, AS-WPR

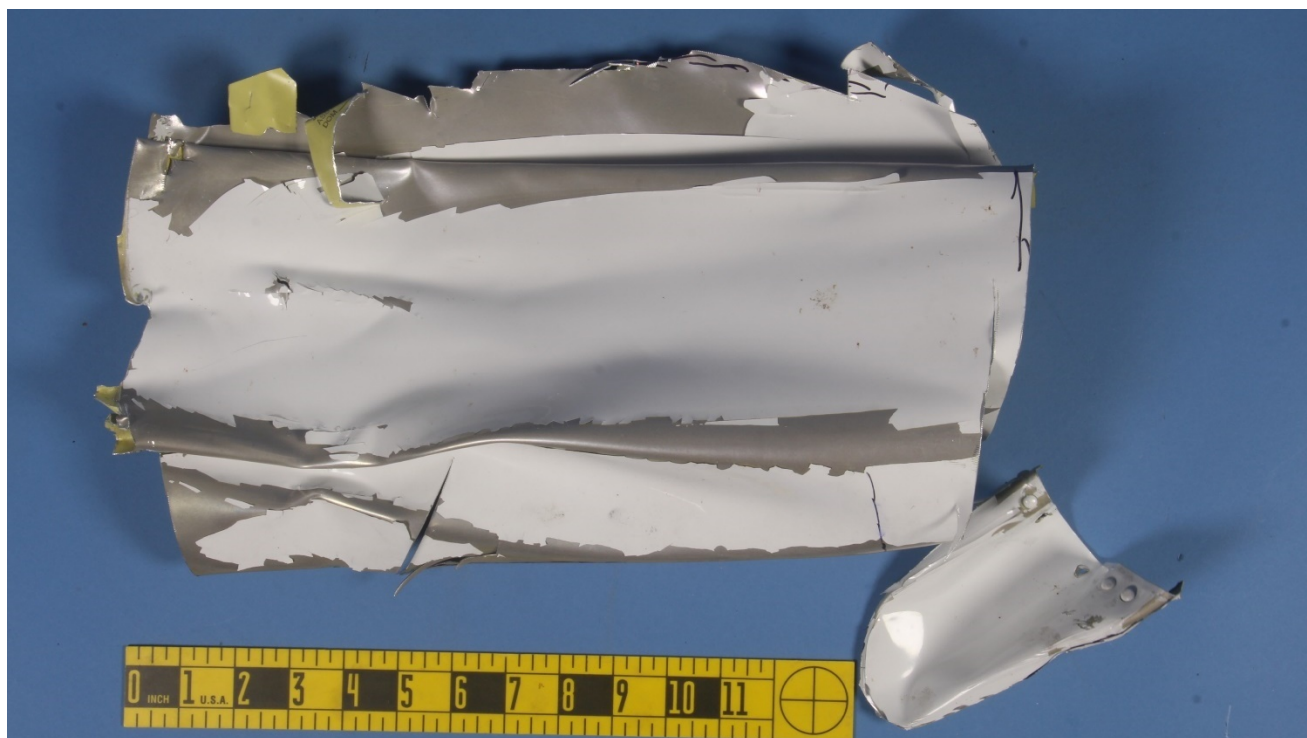
The Materials Laboratory received pieces of the wing skin as shown in Figure 1 and Figure 2 from the external and internal sides, respectively. The larger piece had buckled and crumpled in multiple locations, exhibiting spalling and loss of the external white paint layer. This paint loss was located parallel to the most deformed locations of the section. The periphery of the larger piece showed a jagged appearance, consistent with having been cut from the surrounding structure.

Figure 1 – Sections of the dented wing skin assembly, viewed from the exterior side, as received.

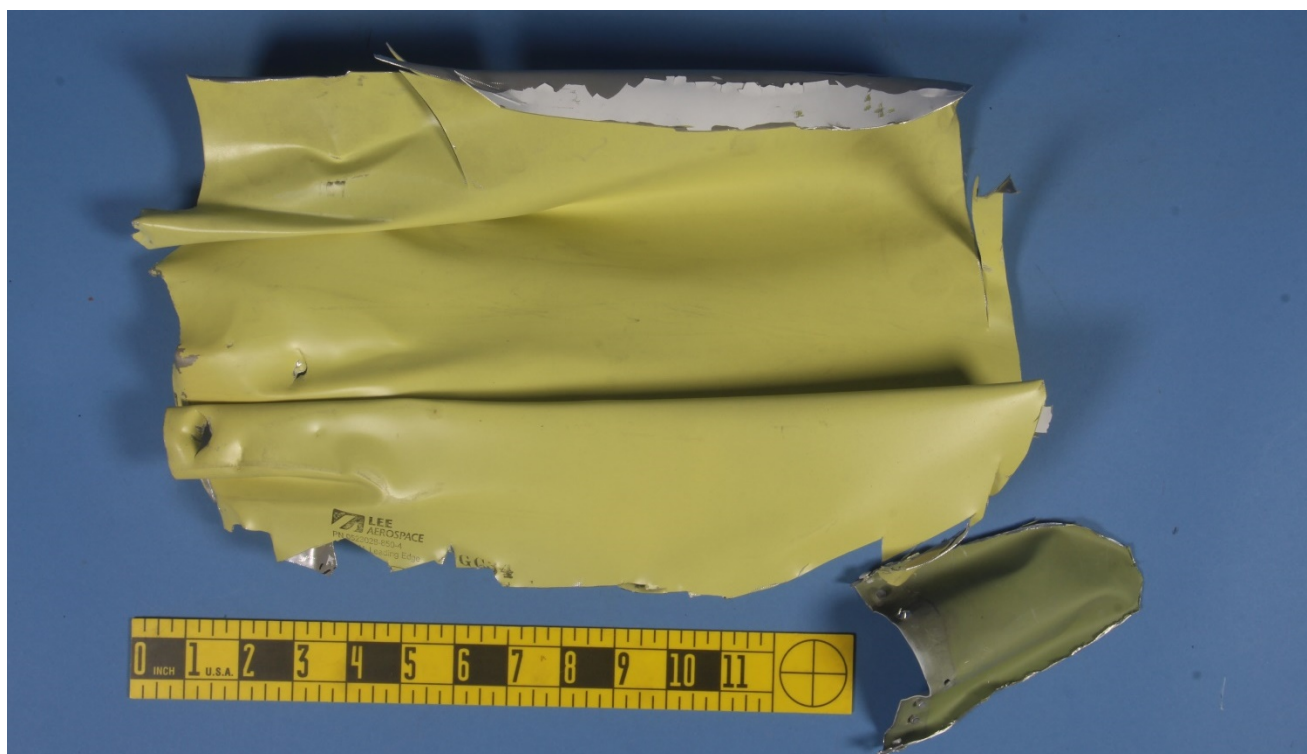
The smaller piece was in a rounded U-shape, shown in the lower right in the first two figures. This piece was also dented, and still contained the external heads of several rivets. Most of the paint on this piece was still adherent.

Figure 2 – Sections of the dented wing skin assembly, viewed from the interior side, as received.

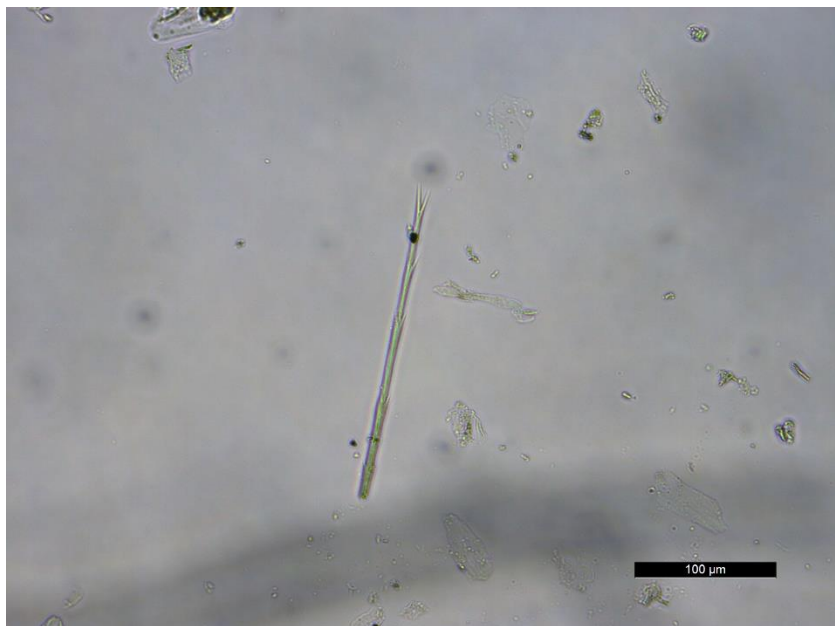
1. Golden Eagle (*Aquila chrysaetos*), microscopic feather sample removed from small piece of leading-edge (200925.14.1) of aircraft. Microstructure consistent with Golden Eagle (Photo 1).
2. Golden Eagle, microscopic sample removed from large piece of leading-edge (200925.14.2). Microstructure consistent with Golden Eagle.

Photo 1. Photomicrograph of partial feather barbule removed from a small piece of leading edge (200925.14.1). Microstructure is consistent with Golden Eagle.
