# Accident Investigation

## N711GH – UH-1H Super Huey

NTSB Investigation No. WPR20LA280

19 AUG 2020

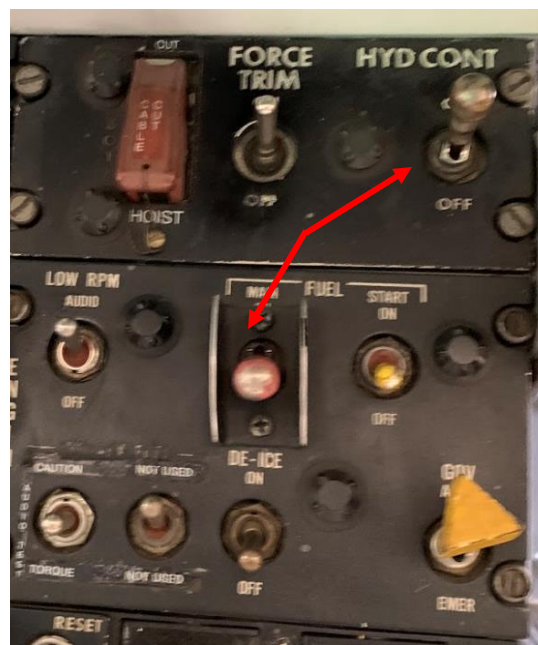
All witnesses stated that N711GH reported a hydraulic malfunction and was maneuvering in a left turn – which requires more torque. Case studies have shown that UH-1H pilots have accidentally secured fuel on the fuel management panel instead of hydraulics due to the close proximity of the switch locations. This is compounded by each panel utilizing a switch which is the same size and shape – pictured right. Note that CAL FIRE installed side guards on the main fuel shutoff switch which is not organic to the panel.

If fuel was secured in lieu of hydraulics, while maneuvering to the left, rotor decay would occur immediately after fuel starvation to the powerplant, possibly creating the loss of controlled flight. This theory cannot be reasonably confirmed at the accident scene without further analysis of the MA components.

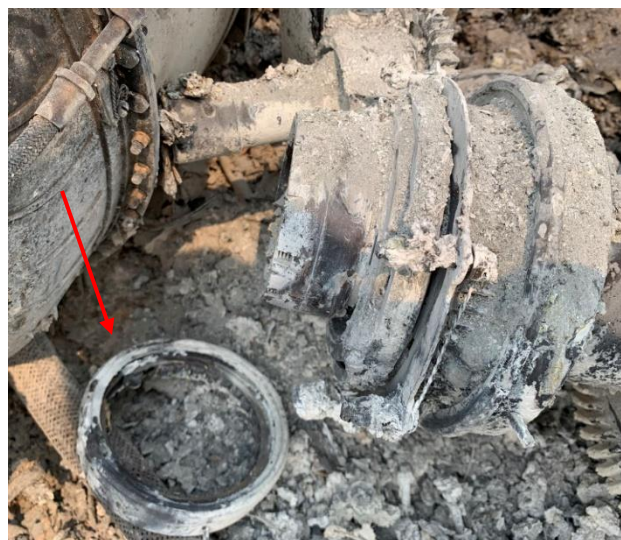
Another point of interest was a main transmission roller bearing that was found to have been missing several rollers (Pictured right). I am not confident in speculating if this could have seized the main transmission, however it may be of interest to the investigators.
