# NATIONAL TRANSPORTATION SAFETY BOARD

## Global Positioning System Devices

### Specialist's Factual Report

Location: Pine Grove, Oregon  
Date: August 24, 2020  
Aircraft: Kaman K1200  
Registration: N314  
Operator: Private  
NTSB Number: WPR20LA283

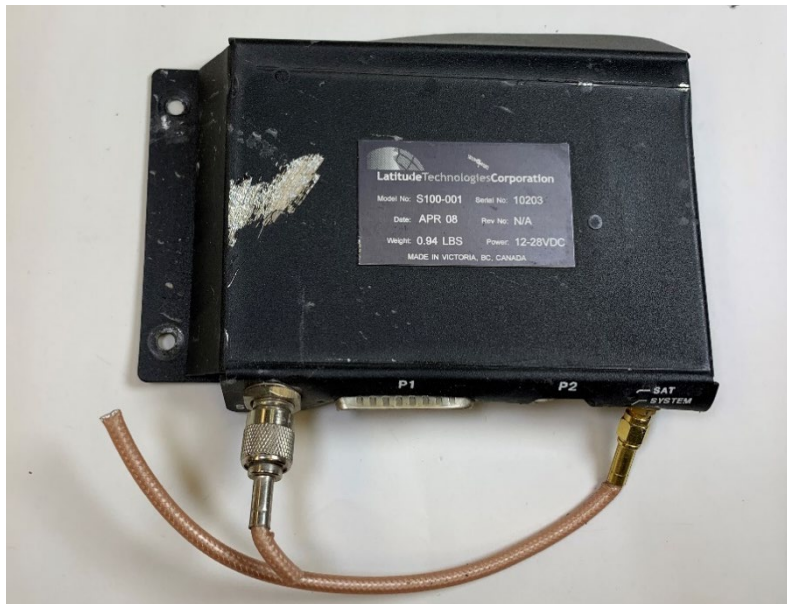
**Figure 1.** S100 as received.

Upon arrival at the Vehicle Recorder Laboratory, external examinations revealed the devices had sustained impact damage, as shown in Figures 1 and 2, rendering them inoperable. In discussions with the manufacturer and the Investigator-In-Charge (IIC), it was determined that the devices likely contained redundant data and the Skynode S100 would provide the most relevant data to the investigation. Thus, only the Skynode S100

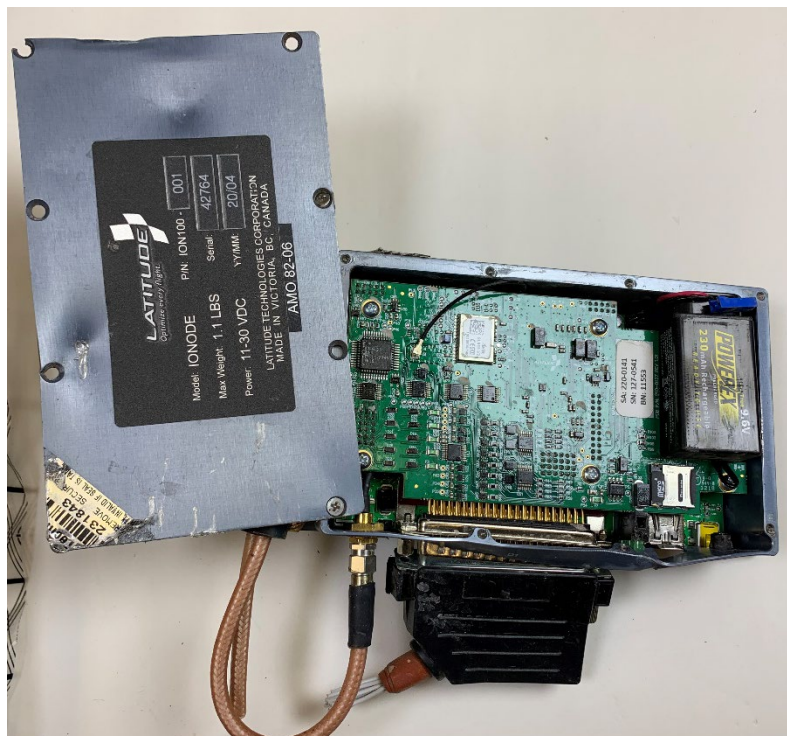
**Figure 2.** IONode as received.

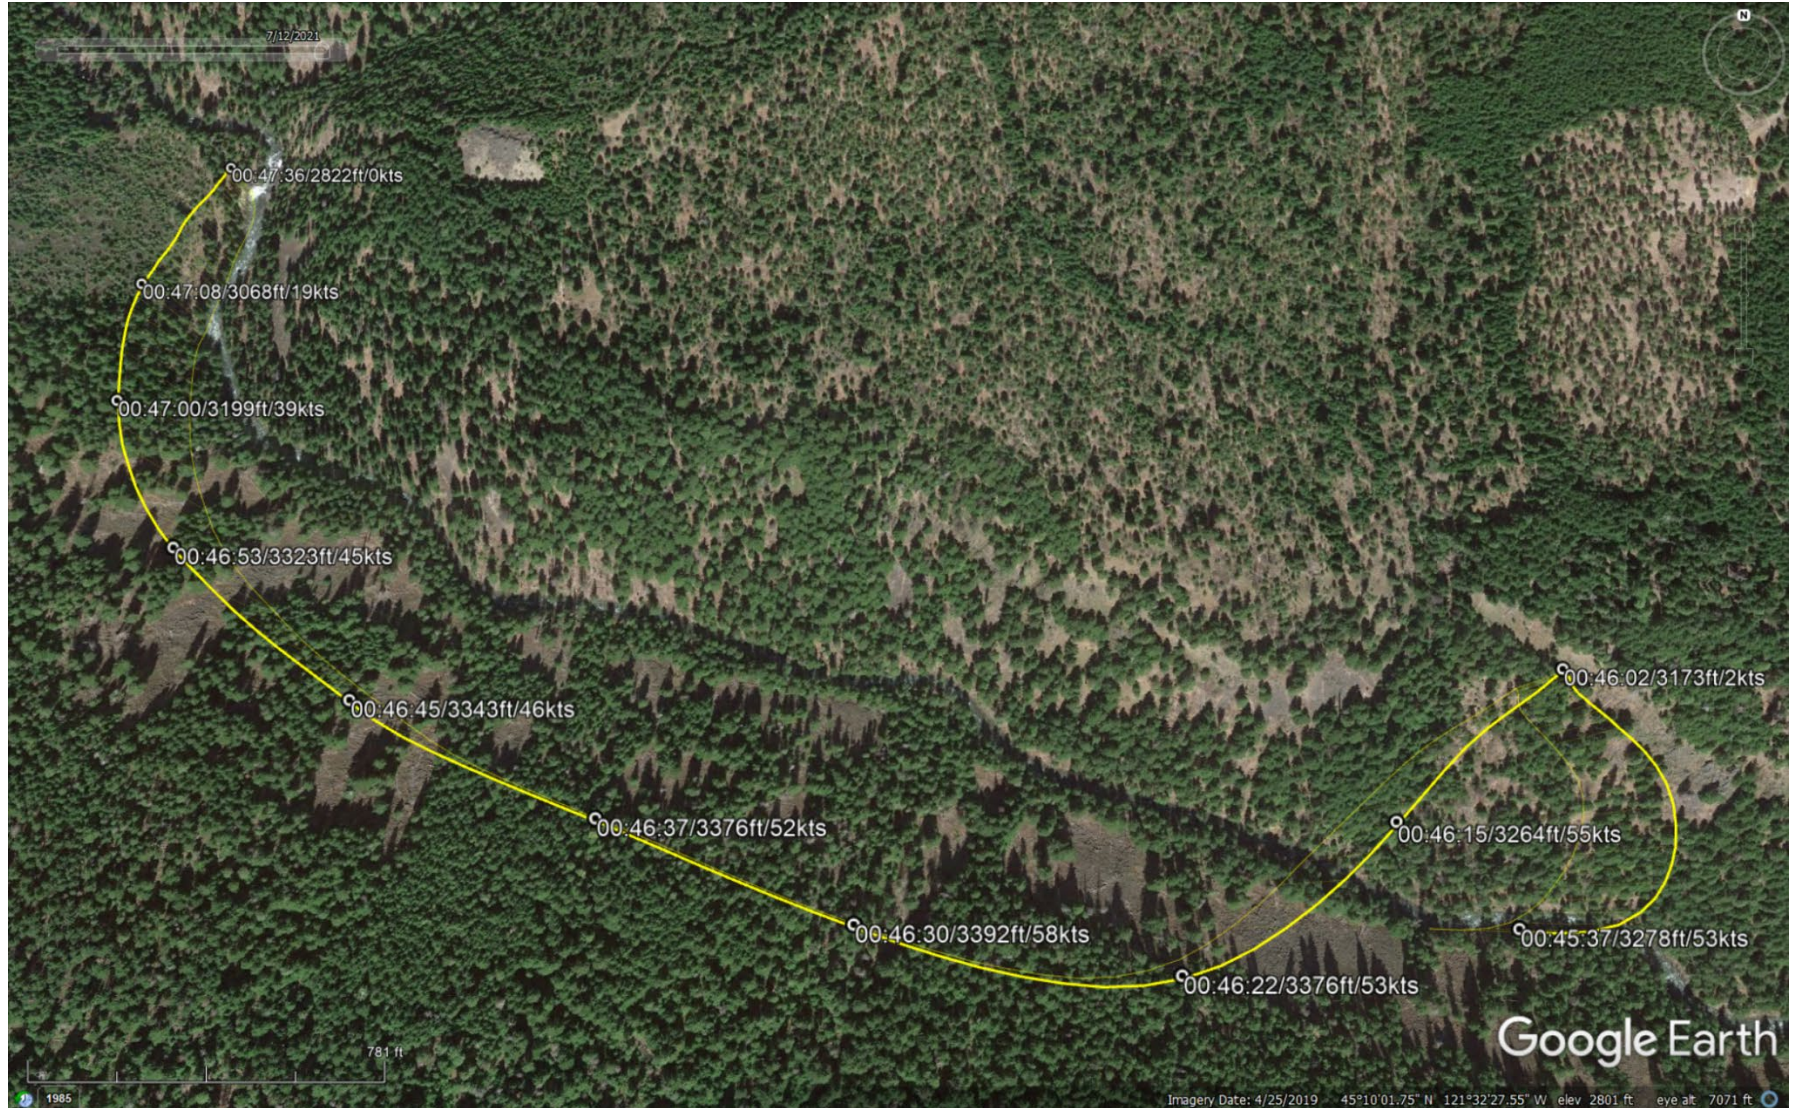
Figure 3 is a graphical overlay generated using Google Earth showing the recorded data from the Skynode S100. Weather and lighting conditions in Google Earth are not necessarily the weather and lighting conditions present at the time of the recording.

The first data point was recorded at 00:45:37 UTC and the final data point was recorded at 00:47:36 UTC on August 25, 2020.

**Figure 3.** Google Earth overlay of the flight data extracted from the SkyNode S100.

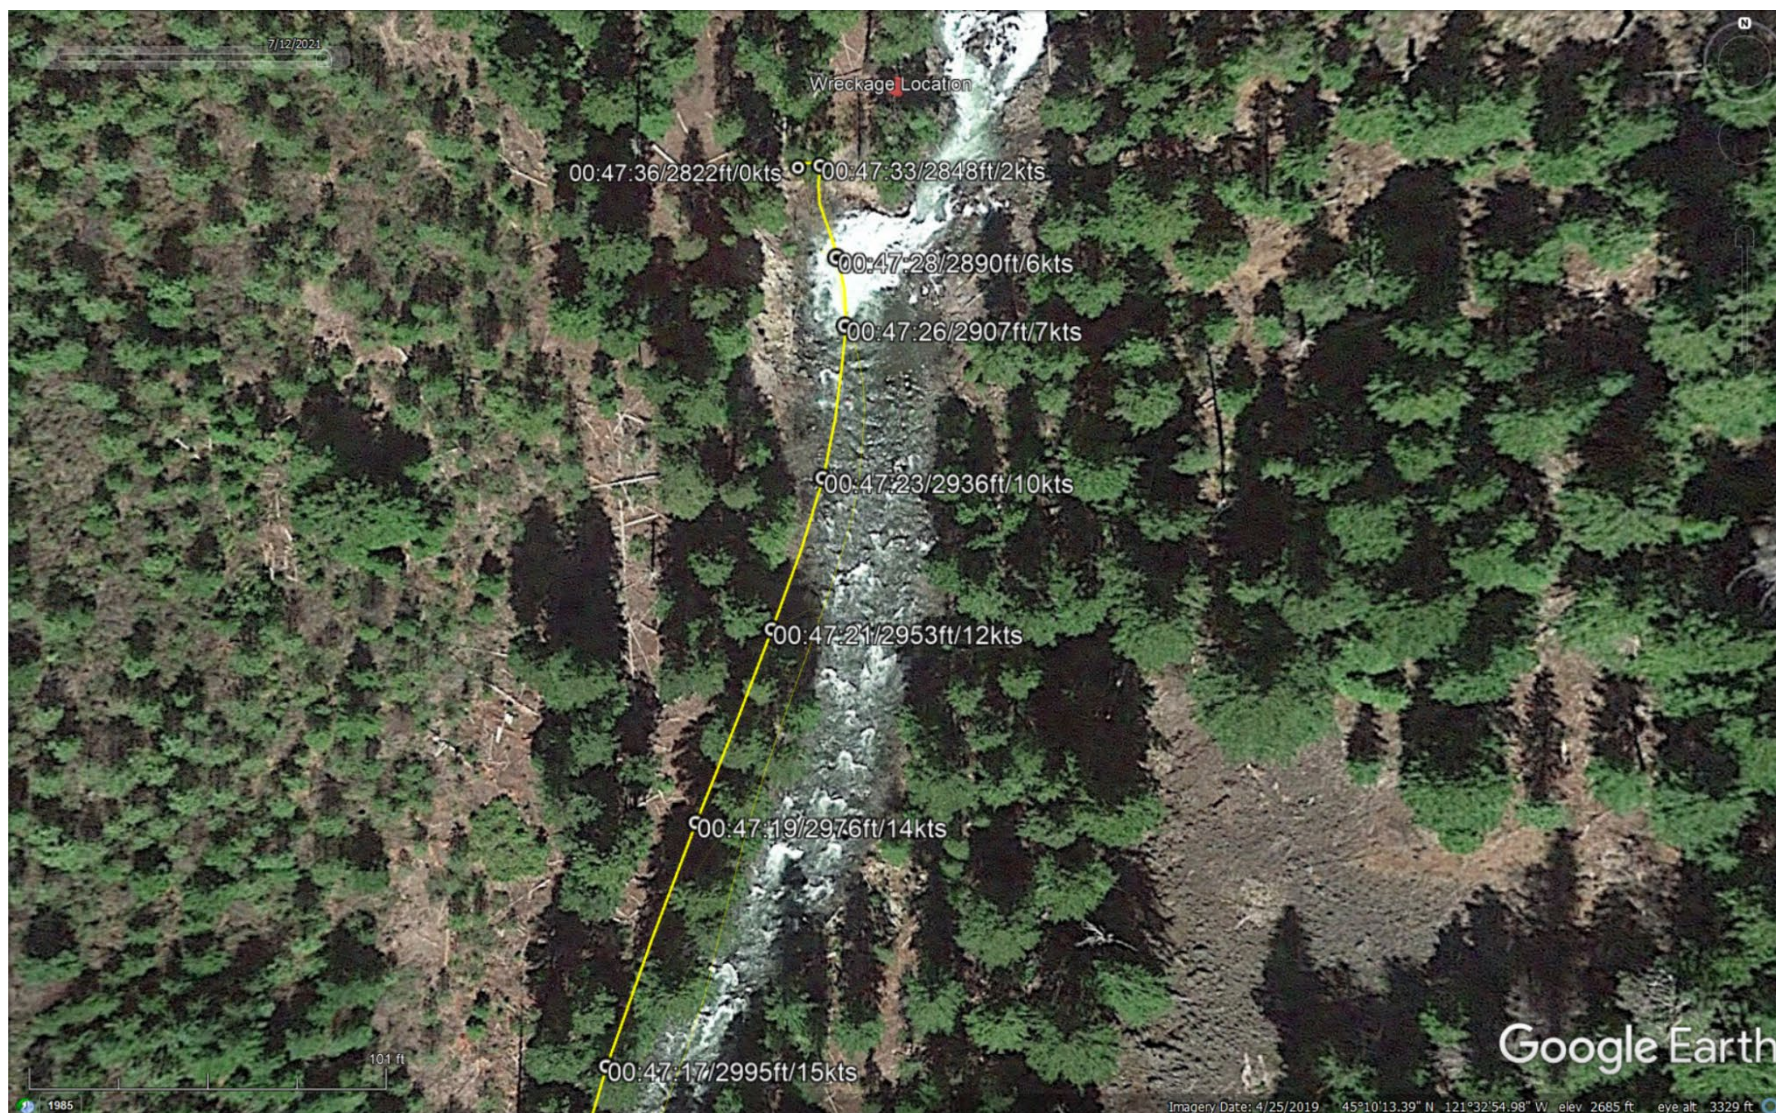
Figure 4 is a Google Earth overlay showing the end of the accident flight and the reported wreckage location.

**Figure 4.** Google Earth overlay of the end of the flight data extracted from the SkyNode S100 and the wreckage location.

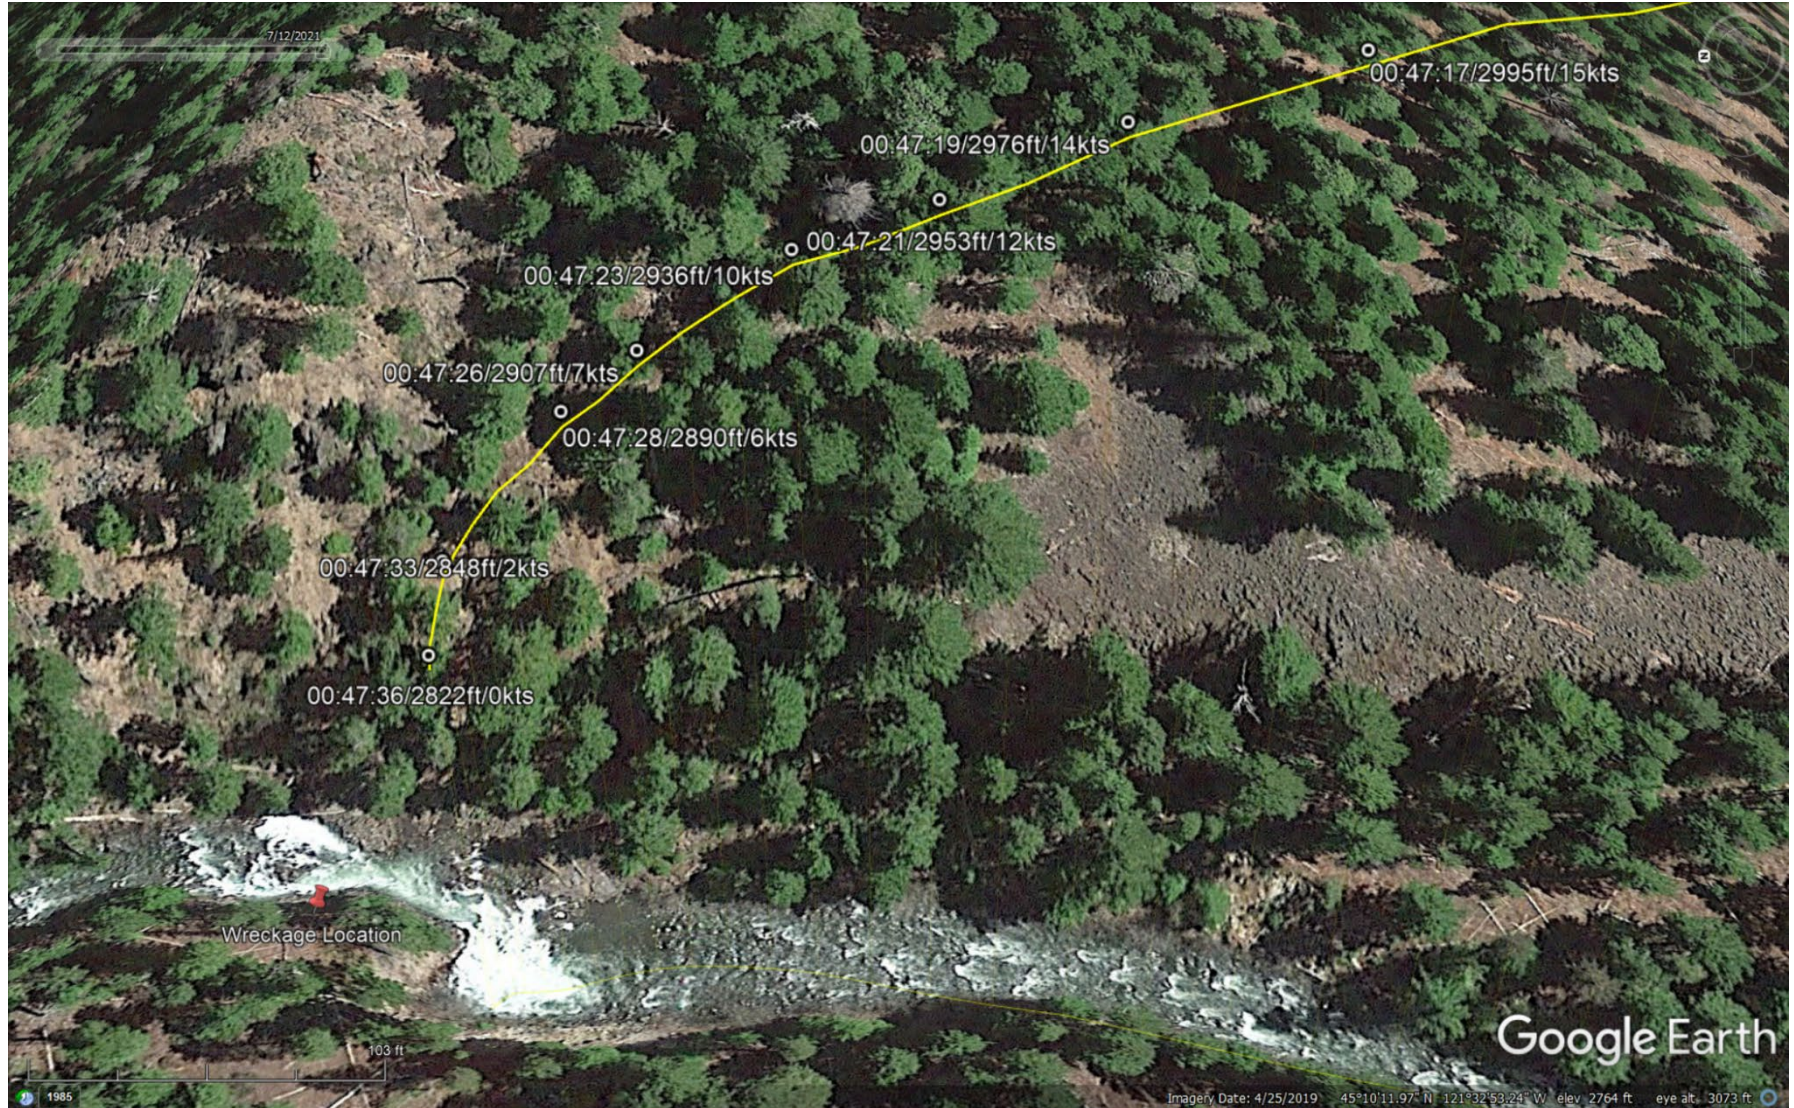
Figure 5 is a Google Earth overlay showing the end of the accident flight and the reported wreckage location from an alternate angle (sideview).

**Figure 5.** Google Earth overlay of the end of the flight data extracted from the SkyNode S100 and the wreckage location (sideview).
