# NATIONAL TRANSPORTATION SAFETY BOARD

## PILOT/OPERATOR AIRCRAFT ACCIDENT/INCIDENT REPORT

Registration Number: N386MA

Model: DA-40

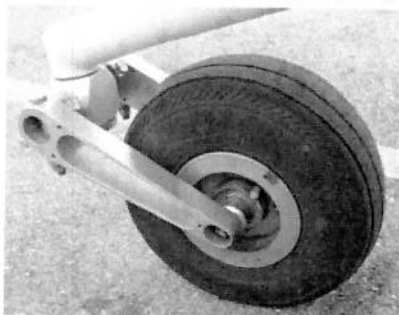
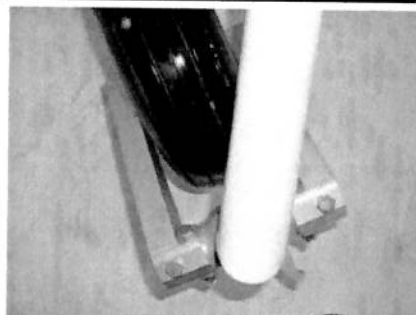
## Attachment 10

### Landing Gear

#### Nose Wheel

- Free castoring nose wheel ( $\pm 30^\circ$ )
- Sprung by elastomer package.
- Tire pressure 2.0 bar or 29 psi.

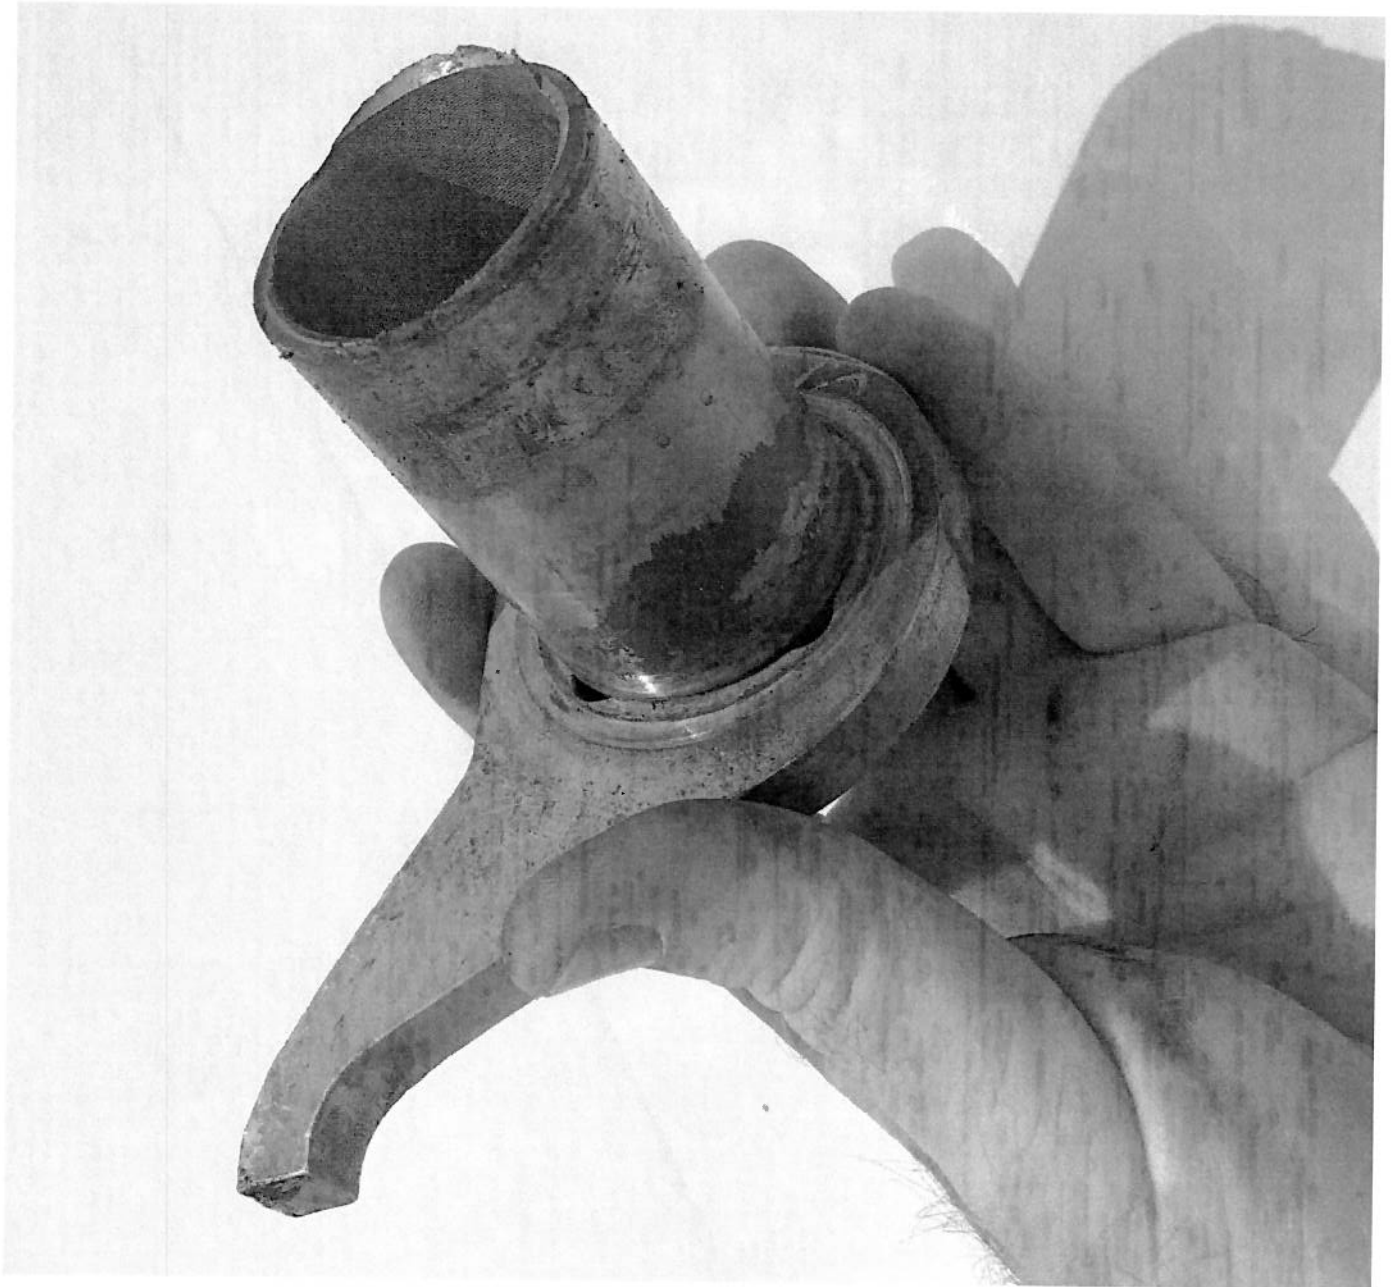
**Attachment 11**

Castor Stop & Pivot Axle

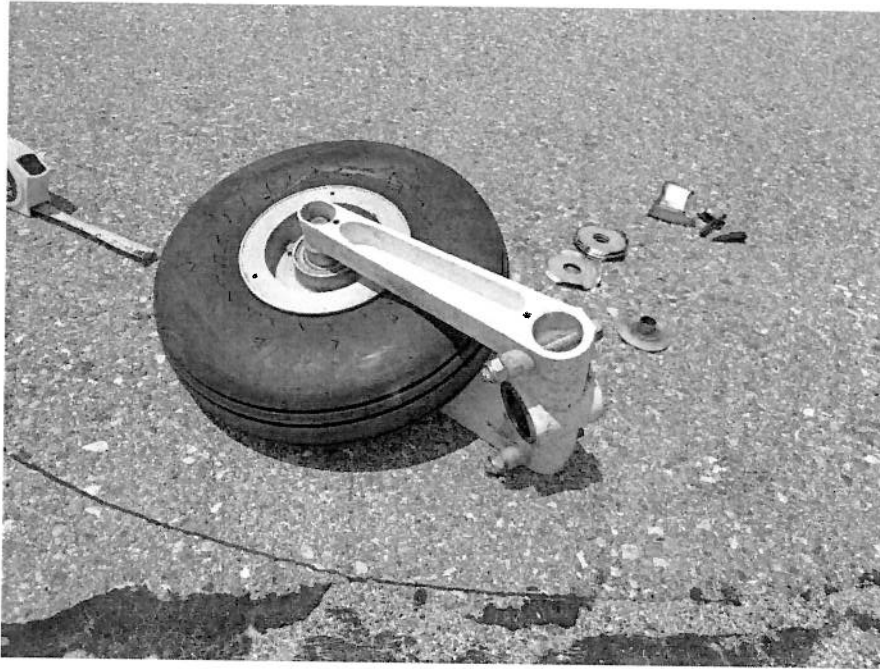
**Attachment 14**

Wheel & Fork Assembly

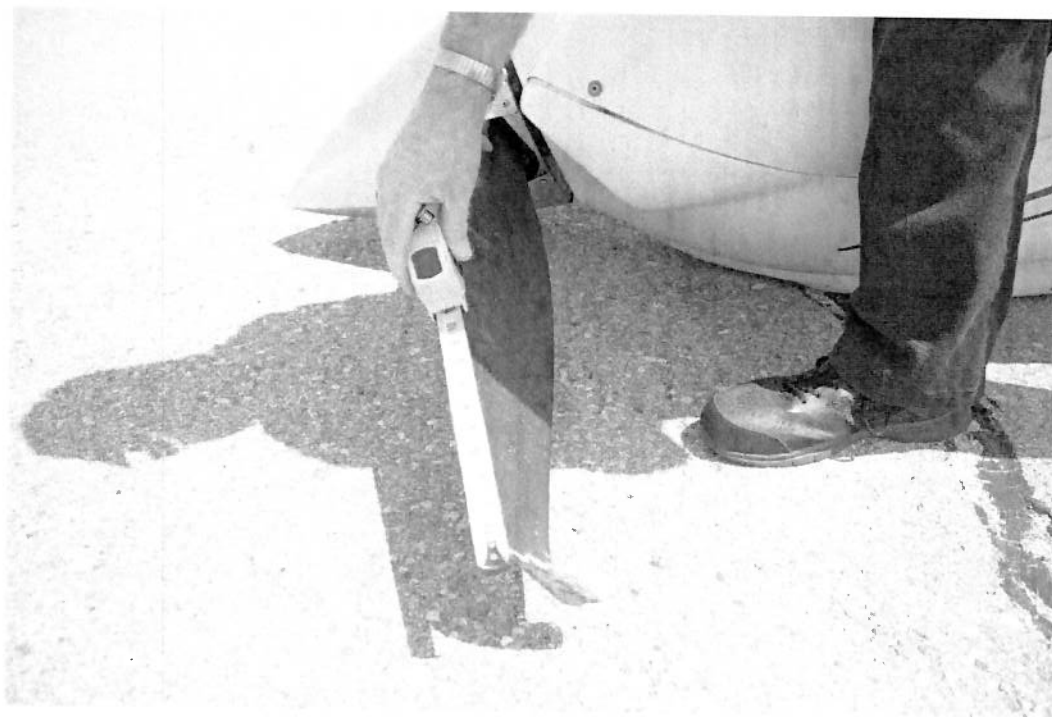
**Attachment 17**

Propeller Damage

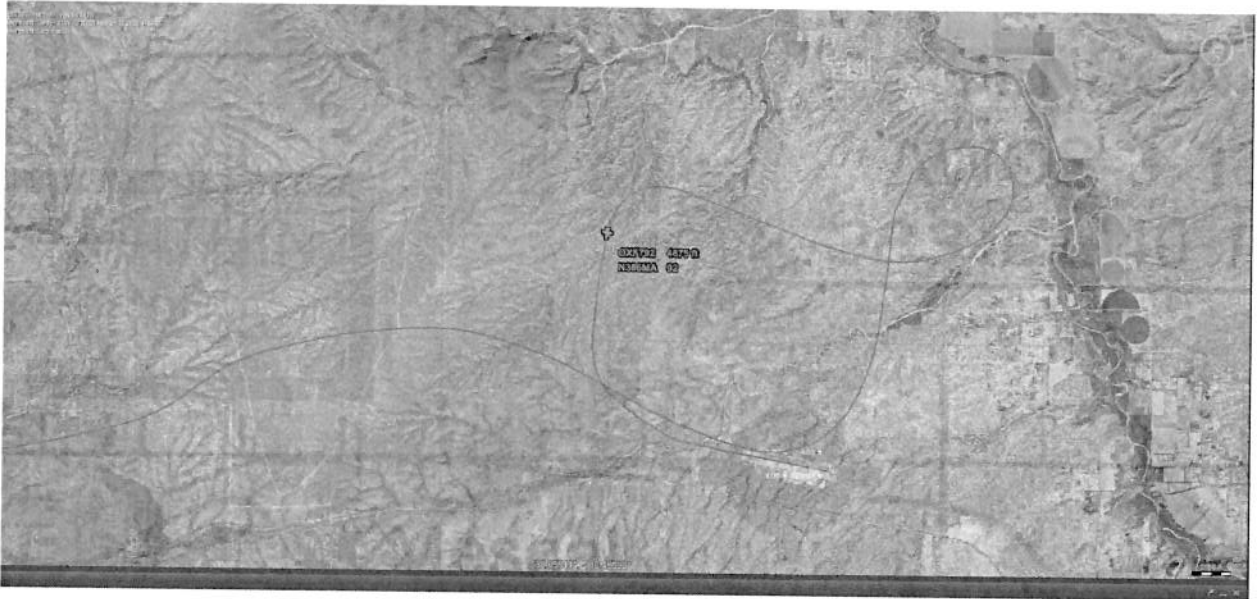
### **Attachment 18**

The aircraft was observed descending for a straight-in approach before climbing and executing a teardrop entry from overhead the airport. The teardrop turn was initiated 2.5 NM from the airport. The aircraft was still in a wide-arc Base-to-Final turn, well off of the centerline, when it descended through the 300 ft altitude above the runway touchdown elevation.

OpsVue Radar flight trail: approach & landing sequence overview. Speeds are groundspeeds and thus not as informative as airspeeds.

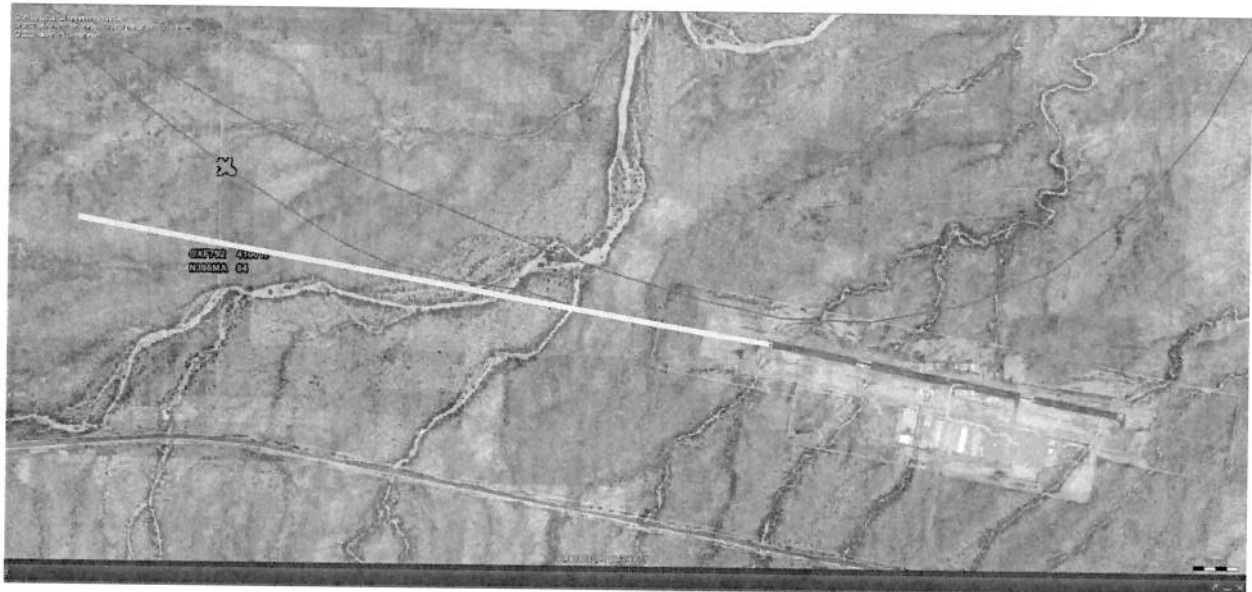
### **Attachment 19**

OpsVue Radar flight trail: note misalignment with runway centerline.

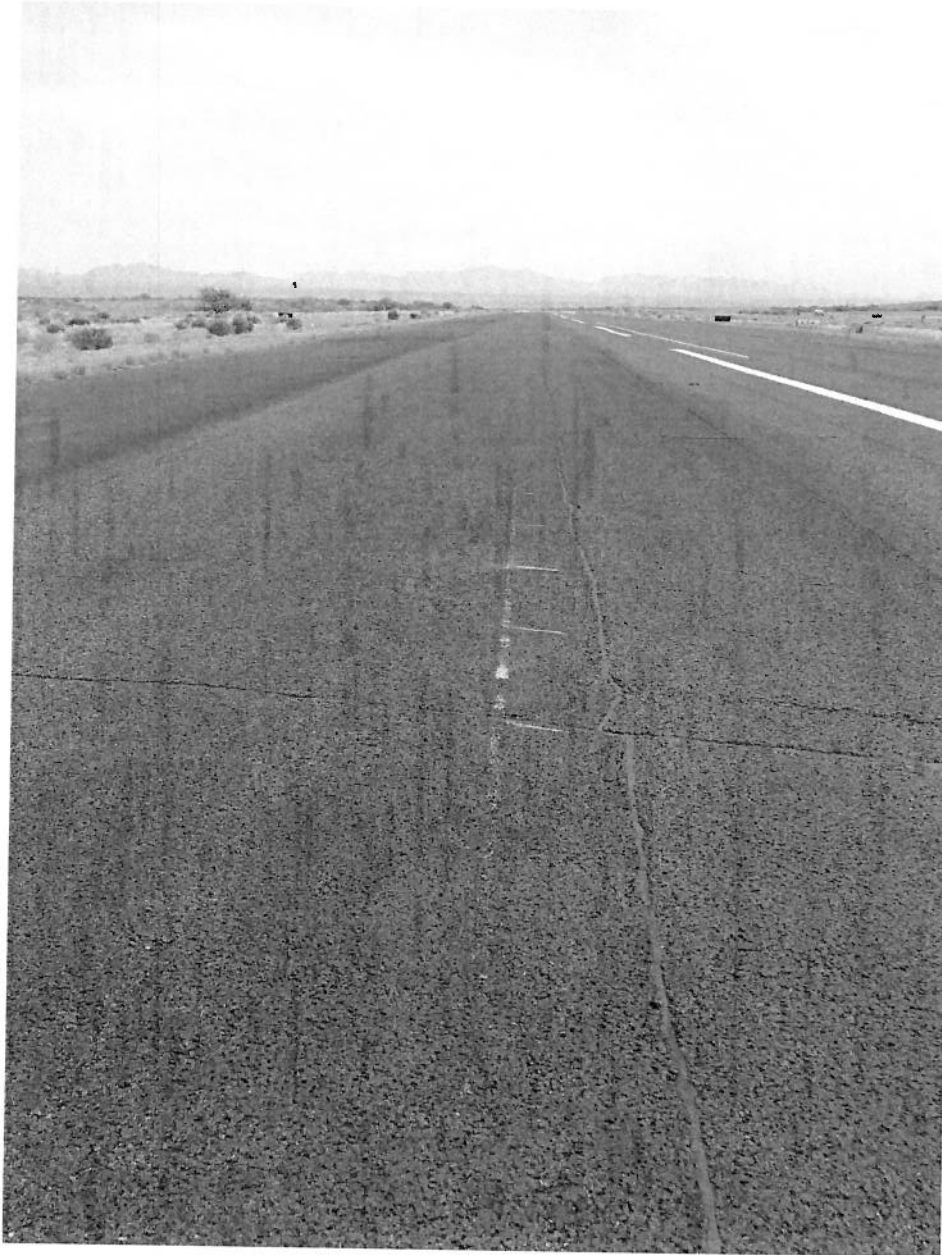
**Attachment 24**

The location of the flare and touchdown cannot be determined with accuracy. The runway surface was inspected and photographed (see attachments.) The path depicted along the ground by OpsVue is consistent with the markings made on the surface by the propeller and nosegear leg tubular strut. The nosegear fork and tire assembly was recovered from the scene by the airport manager, and the precise location where it was found is unknown. We are thus unable to determine where the nosegear tire first set down onto the runway. The first runway contact by the strut & propeller occurred approximately 1715 feet from the threshold. The second strike sequence began approximately 1970 feet from the threshold. The aircraft came to rest 2275 feet from the threshold. OpsVue also captured the sequence where the aircraft was moved by the FBO to the apron, but this is not deemed relevant to the investigation.

First set of Prop Strikes and Nose Leg Strut markings. Looking down RWU 10 to the east.

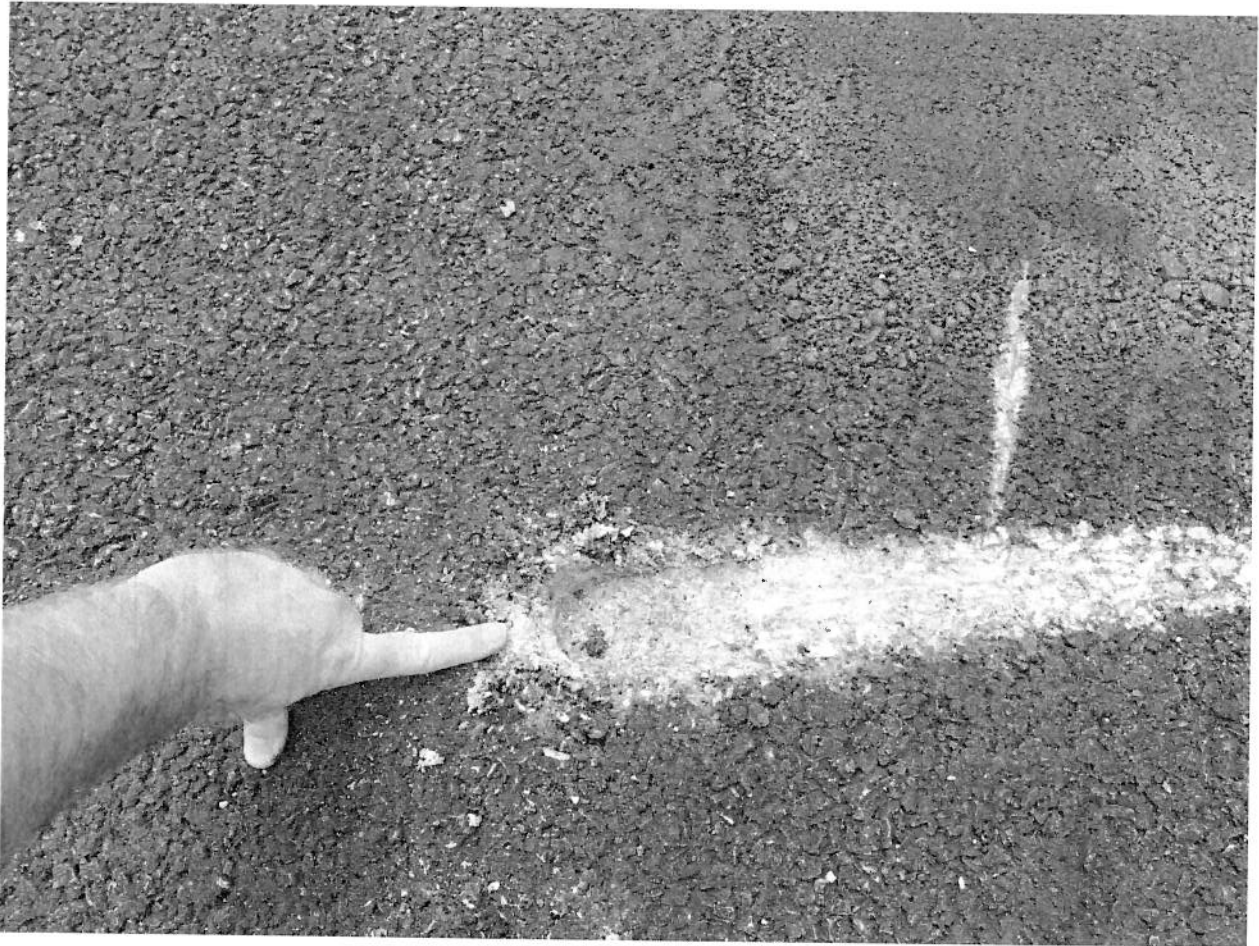
**Attachment 26**

Leg Strut divot

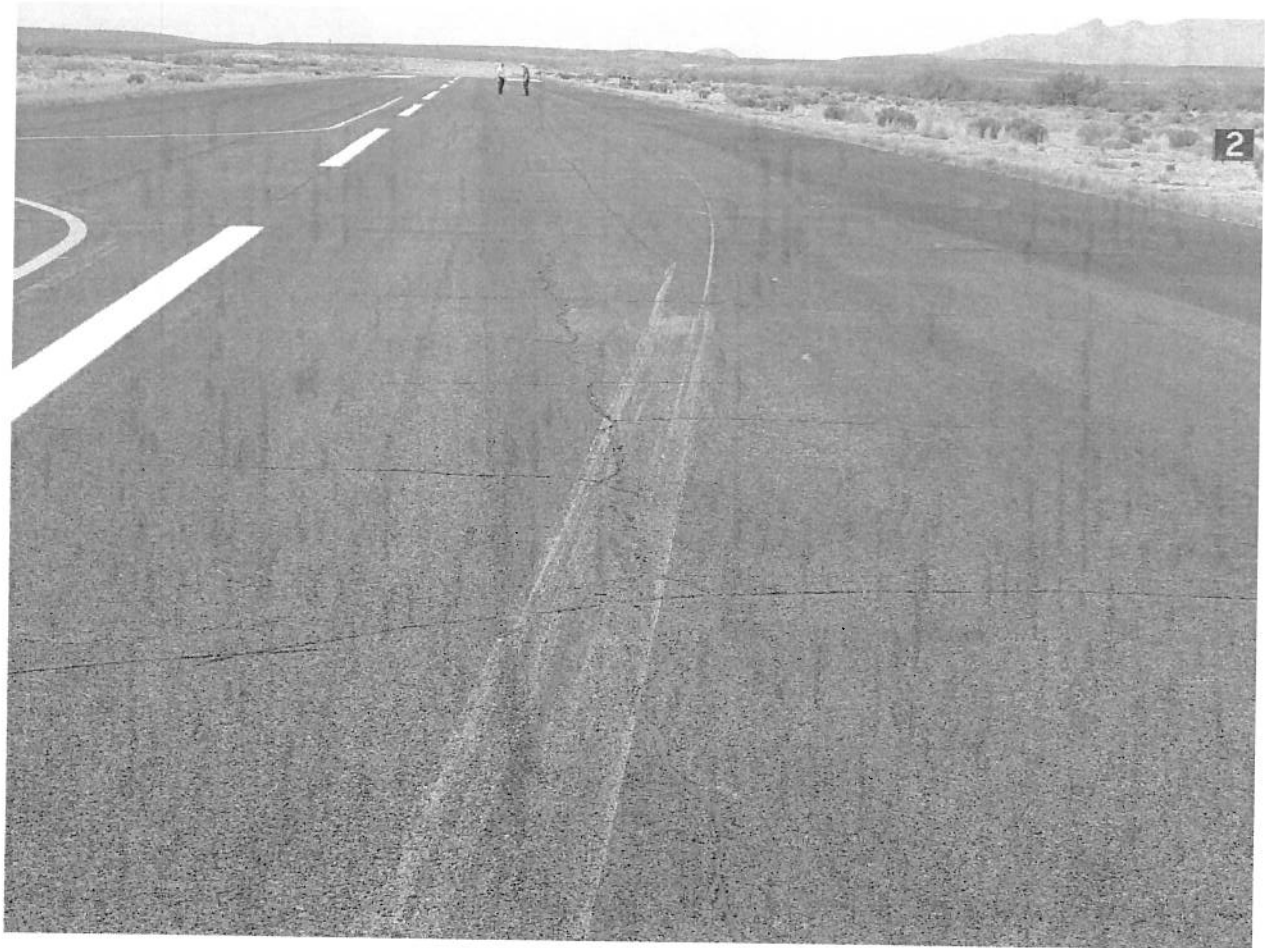
**Attachment 27**

Final Slide-Out On Lower Cowling. Looking up RWU 10 to the west.

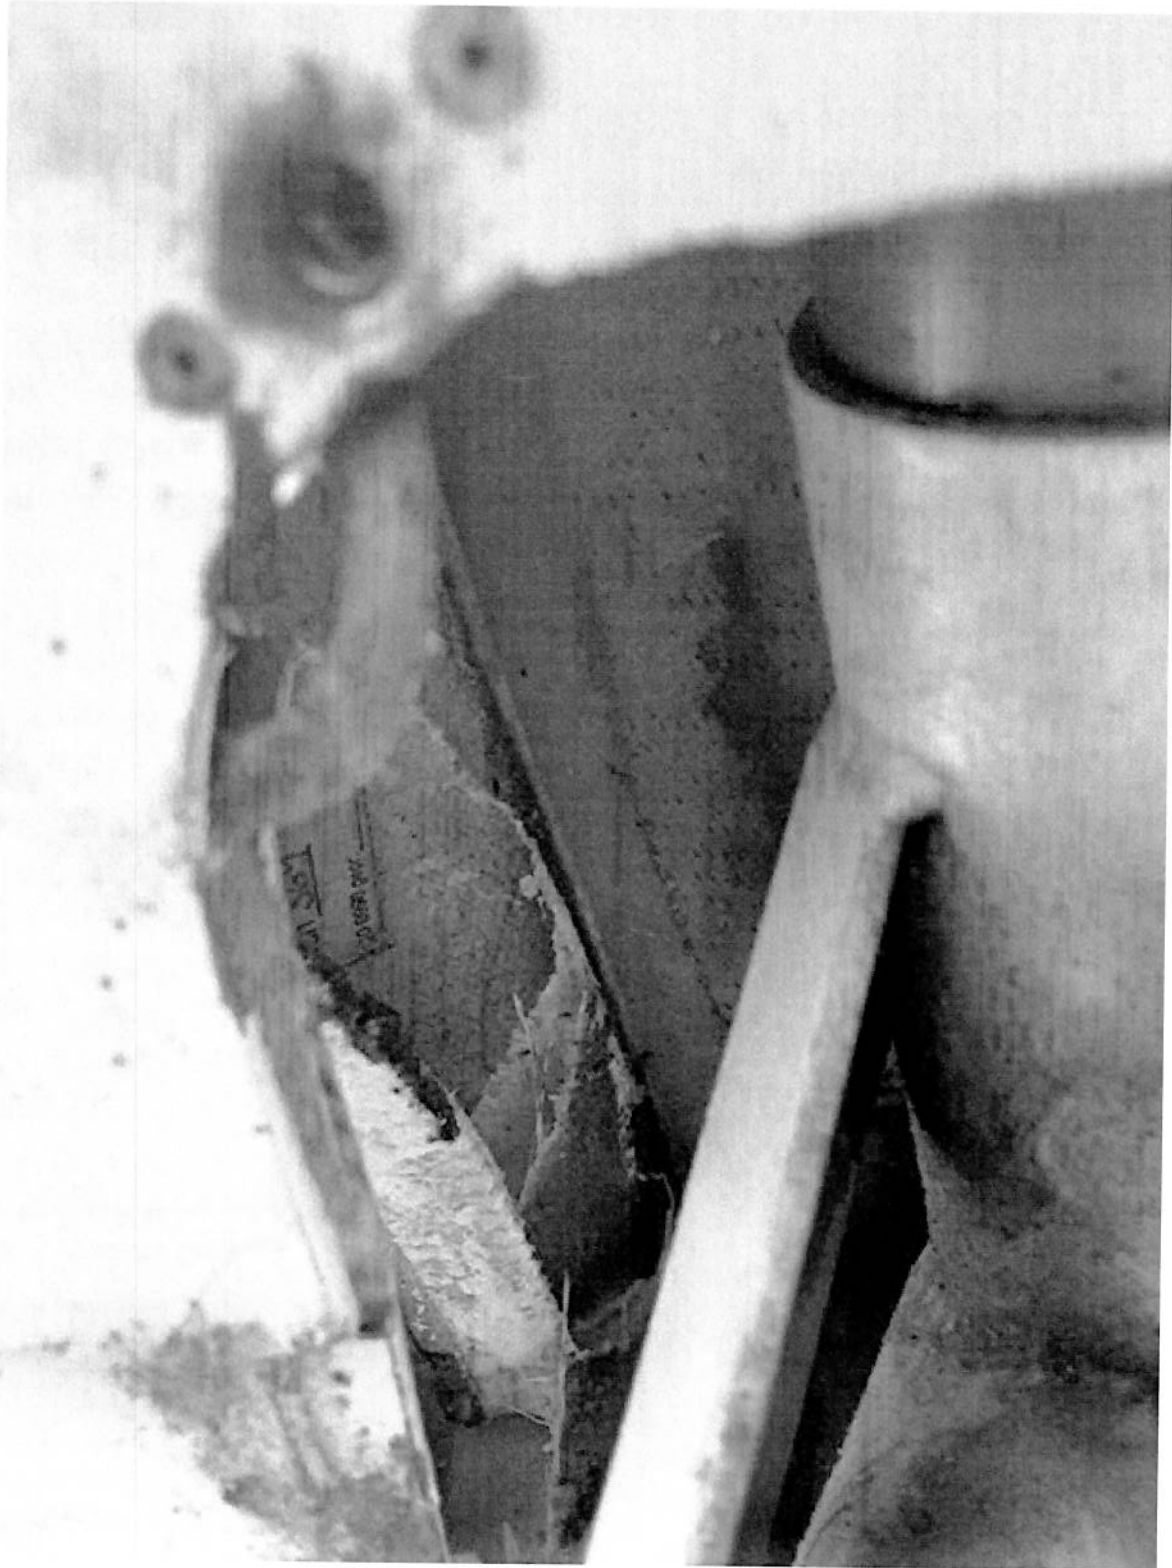
**Attachment 28**

Maintenance Supervisor, A&P-IA wrote regarding the hidden damage inspection: "[u]pon inspection of Diamond DA40 N386MA S/N 40.449 located at Benson, AZ E95. Attached photos show the nose gear collapsed and folded to the aft underneath the airplane. The firewall has no sign of damage as well as the engine cradle. The exhaust collector, airbox, propeller, fuel pump panel, nose gear panel, and lower cowling are significantly damaged. The damper rod is broken, and the gear leg is broken above the fork and gear leg tube. Bottom section removed to aid in inspection all parts accounted for and in aircraft. The gear leg has torn the belly skin aft of the nose gear to the edge of the fuel pump access panel. The bulkhead between the nose gear compartment and the fuel pump compartment has been crushed. All other structure within the fuel pump access appears to be sound. The only damage to the upper hat profile is where the bolt holding the spanner tube in the nose gear has over rotated and the nut tore a hole above it that appears to go all the way through."

Documented damage from Hidden Damage Inspection

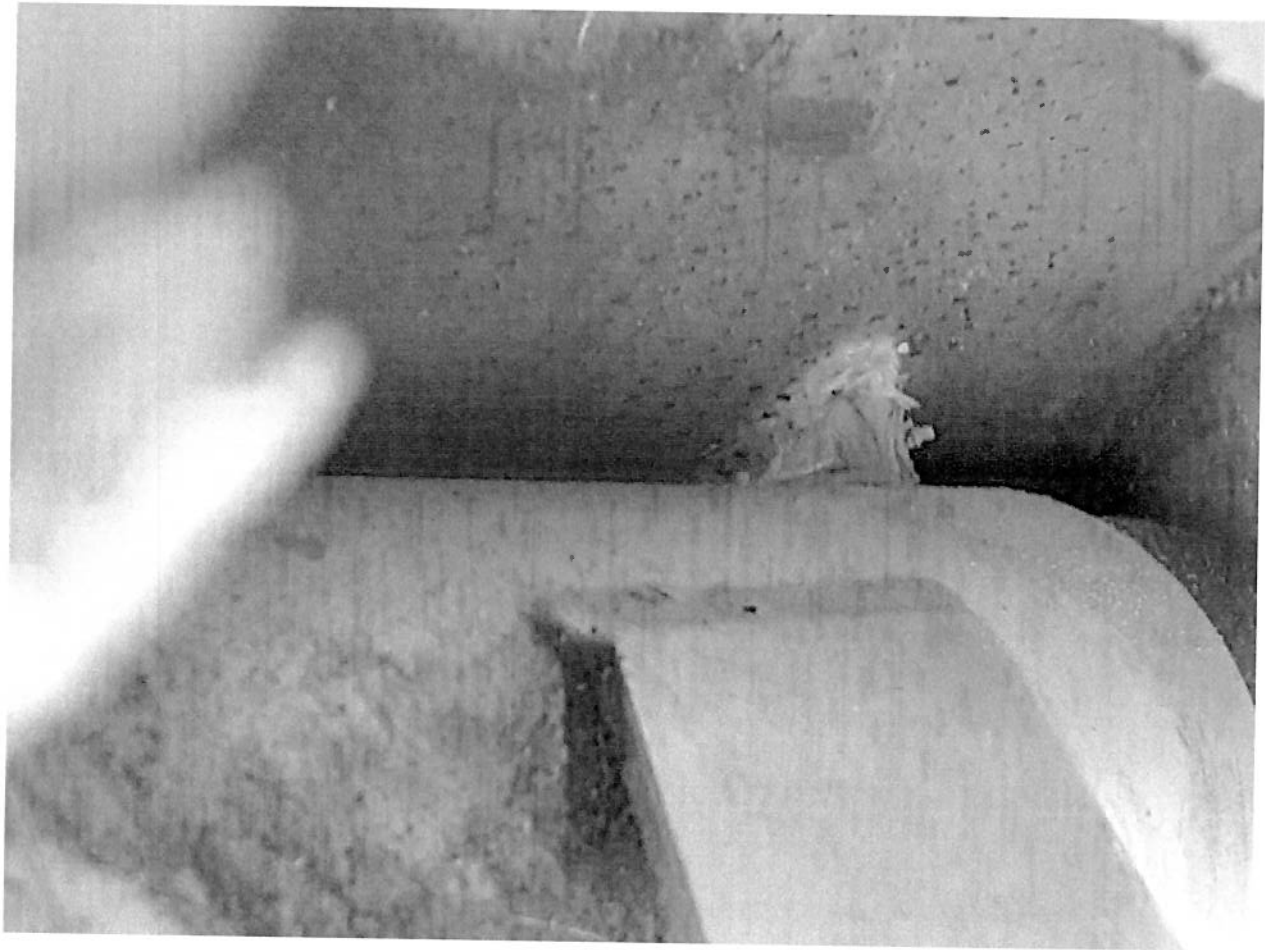
**Attachment 31**

Documented damage from Hidden Damage Inspection
