## **NATIONAL TRANSPORTATION SAFETY BOARD**

### **Specialist's Factual Report**

# **METEOROLOGY**

WPR20LA295

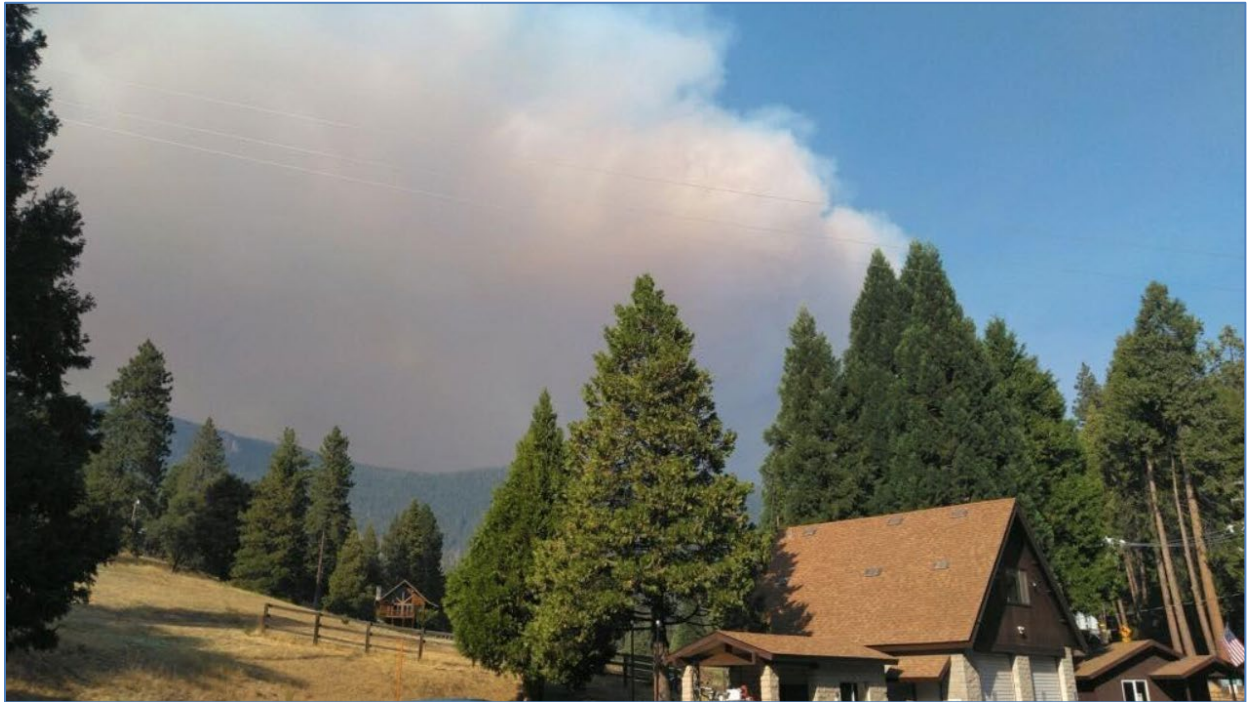
Figure 15 and 16 are photographs from the Tulare Fire Department, Tulare, California, which were taken from a located approximately 7 miles south of KVIS looking east towards the SQF Fire complex on September 4, 2020 at an unknown time. The images show an extensive smoke plume drifting northward up the Sacramento Valley. Figure 17 is the Rattlesnake fire looking northward on the same day, as smoke obscures the higher terrain.

**Figure 15 - Photograph of Tulare Fire Station and the SQF Fire on September 4, 2020 looking east**

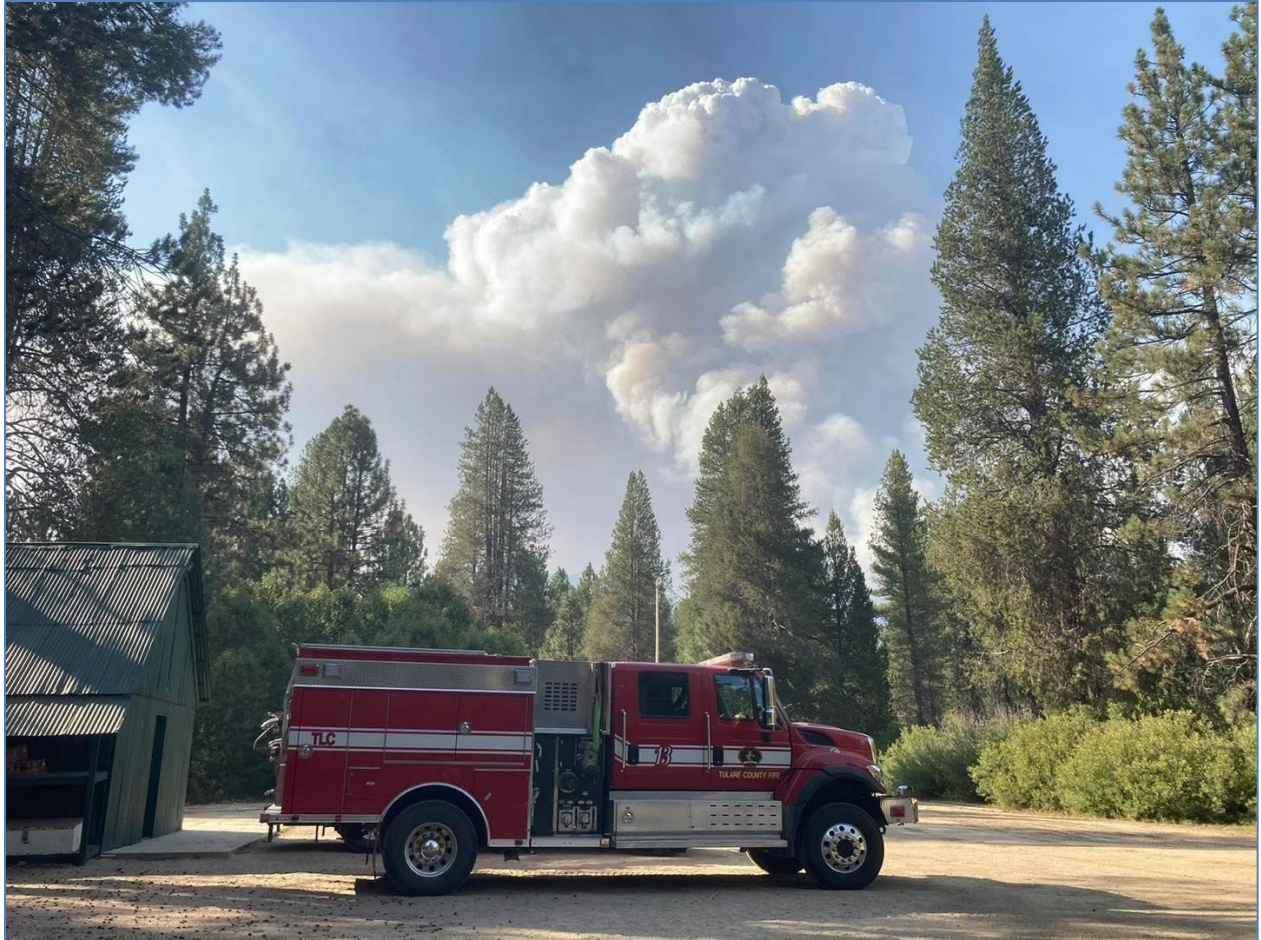
**Figure 16 - Photograph of the SQF Fire complex looking east from Tulare Fire Department**

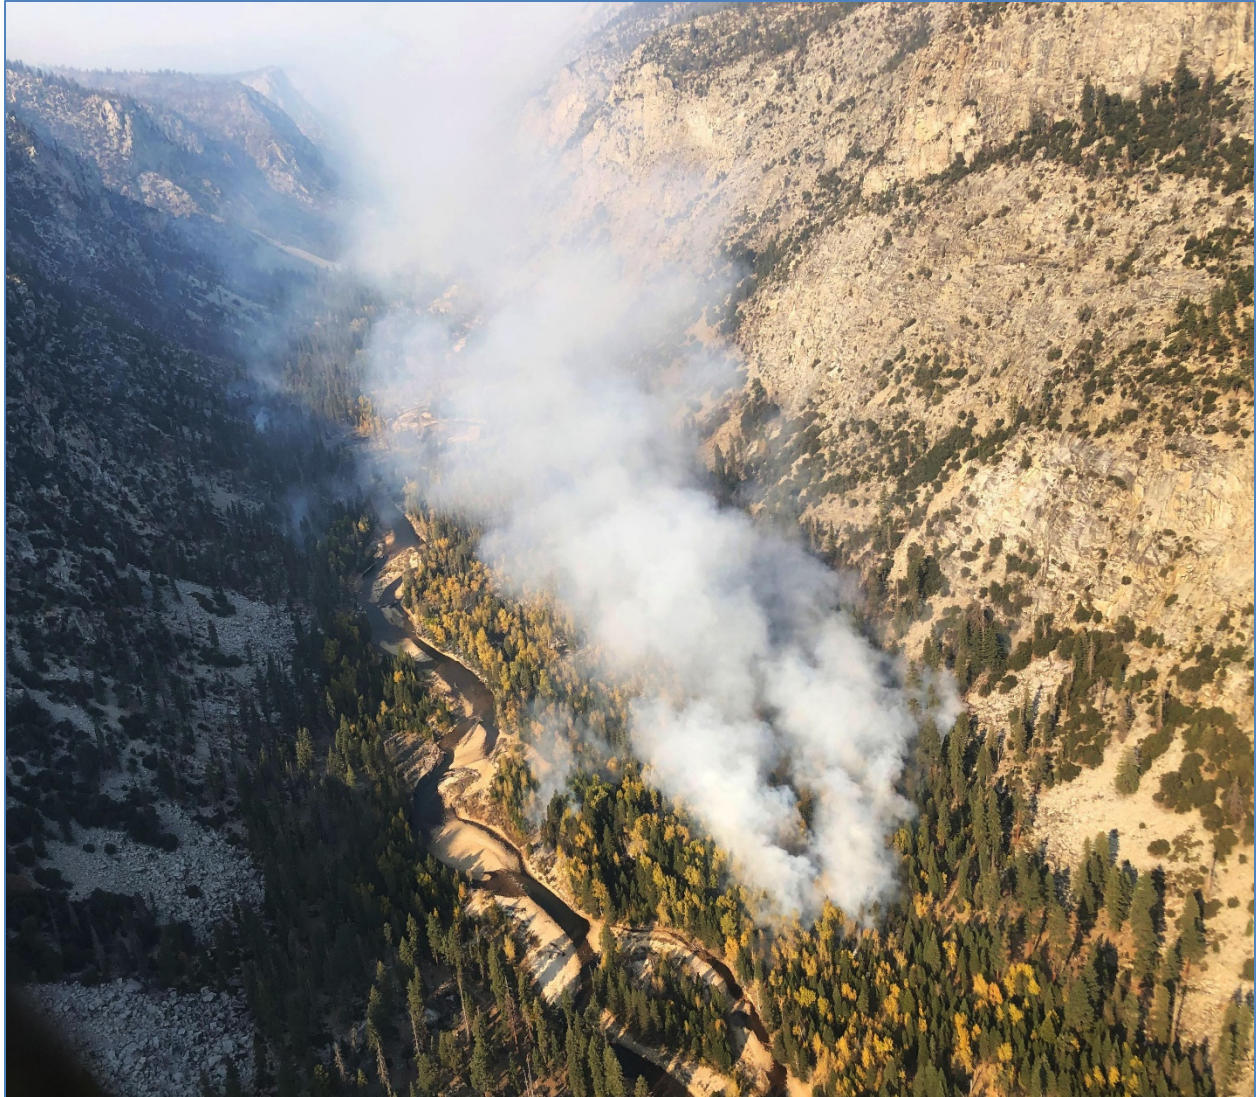
**Figure 17 - Rattlesnake fire on September 4, 2020 looking northward**
