## **NATIONAL TRANSPORTATION SAFETY BOARD**

### **Specialist's Factual Report**

# **METEOROLOGY**

WPR20LA304

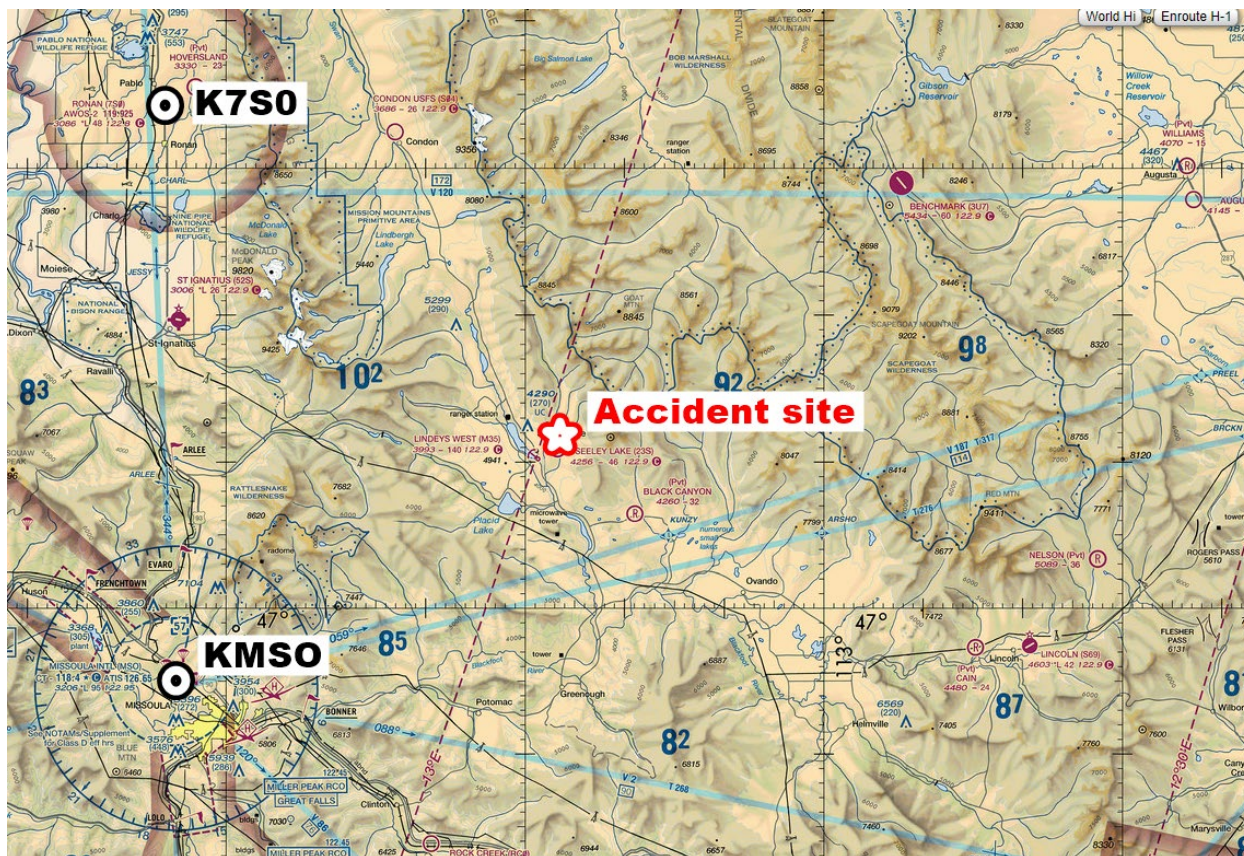
**Figure 5 – Sectional map of the accident area with the location of the accident site and surface observation sites**

The area surrounding the accident site was documented using official Meteorological Aerodrome Reports (METARs) and Specials (SPECIs). The following observations were taken from standard code and are provided in plain language. Figure 5 is a local sectional chart with the accident site and the closest weather reporting locations marked.
