**NATIONAL TRANSPORTATION SAFETY BOARD**  
Vehicle Recorder Division  
Washington, D.C. 20594

## **Data Recording Devices**

**Specialist's Factual Report**  
**By W. Deven Chen**

Location: Emmett, Idaho  
Date: September 22, 2020  
Aircraft: Air Tractor AT-802A  
Registration: N836MM  
Operator: Aero Seat Inc  
NTSB Number: WPR2OLA315

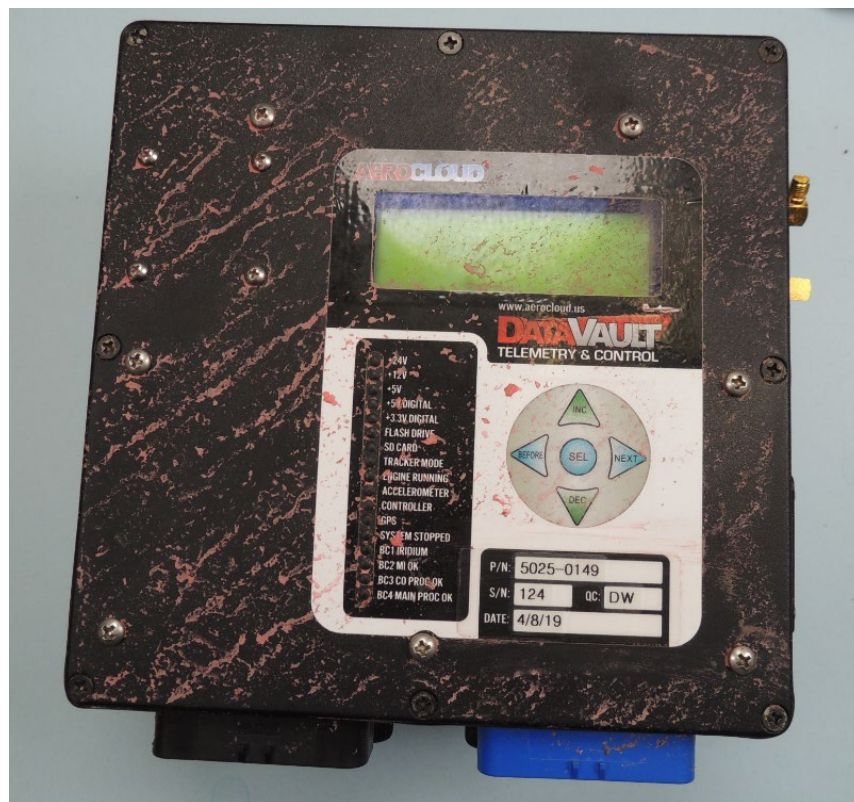
Upon arrival at the Vehicle Recorder Division, the device did not have obvious physical damage except having been covered by pink fire retardant, as shown in Figure 1. A microSD card was removed from the device, however, only configuration data and some test files were present. According to Trotter Controls, the seller of the device, reasons for flight data not being stored on the microSD card could be that the microSD card was not properly inserted or as a result of a technical issues of the device itself. Trotter Controls further explained that the DataVault contained only a small amount of non-volatile memory (32 kilobytes) internally for storage of configuration data only. Thus, no accident related data recovered from the device.

**Figure 1: Aero Cloud DataVault as received.**

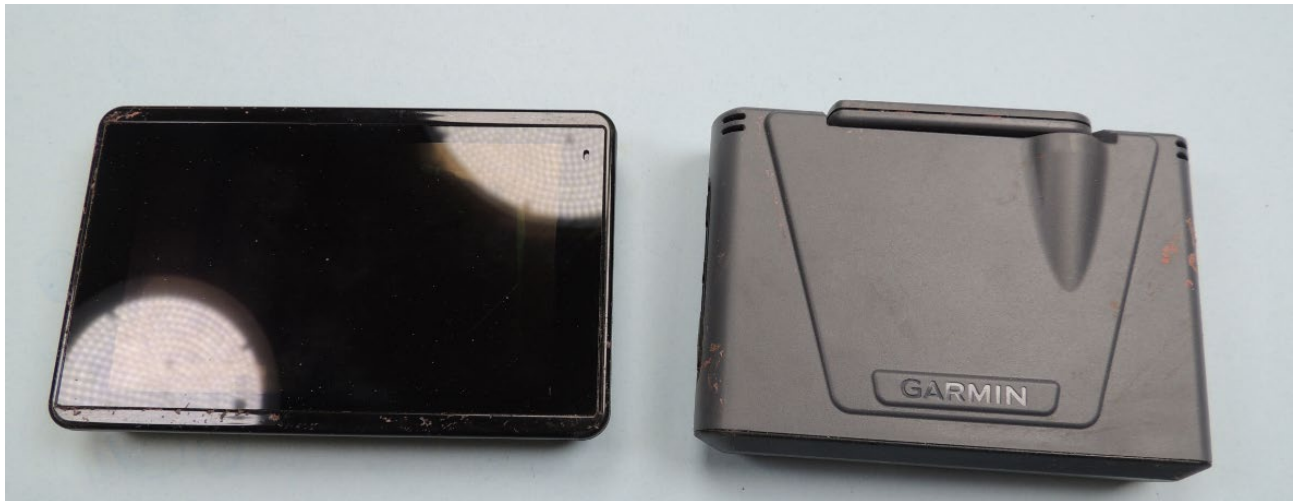
Both devices did not have obvious physical damage upon arrival at the Vehicle Recorder Division, as shown in Figure 2. The Garmin GDL 52 that worked as a transceiver did not store any flight data. The Garmin Aera 660 that worked as a display powered up normally and data were extracted and converted to engineering units using laboratory tools.

**Figure 2: Garmin Aera 660 (left) and Garmin GDL 52 (right) as received.**

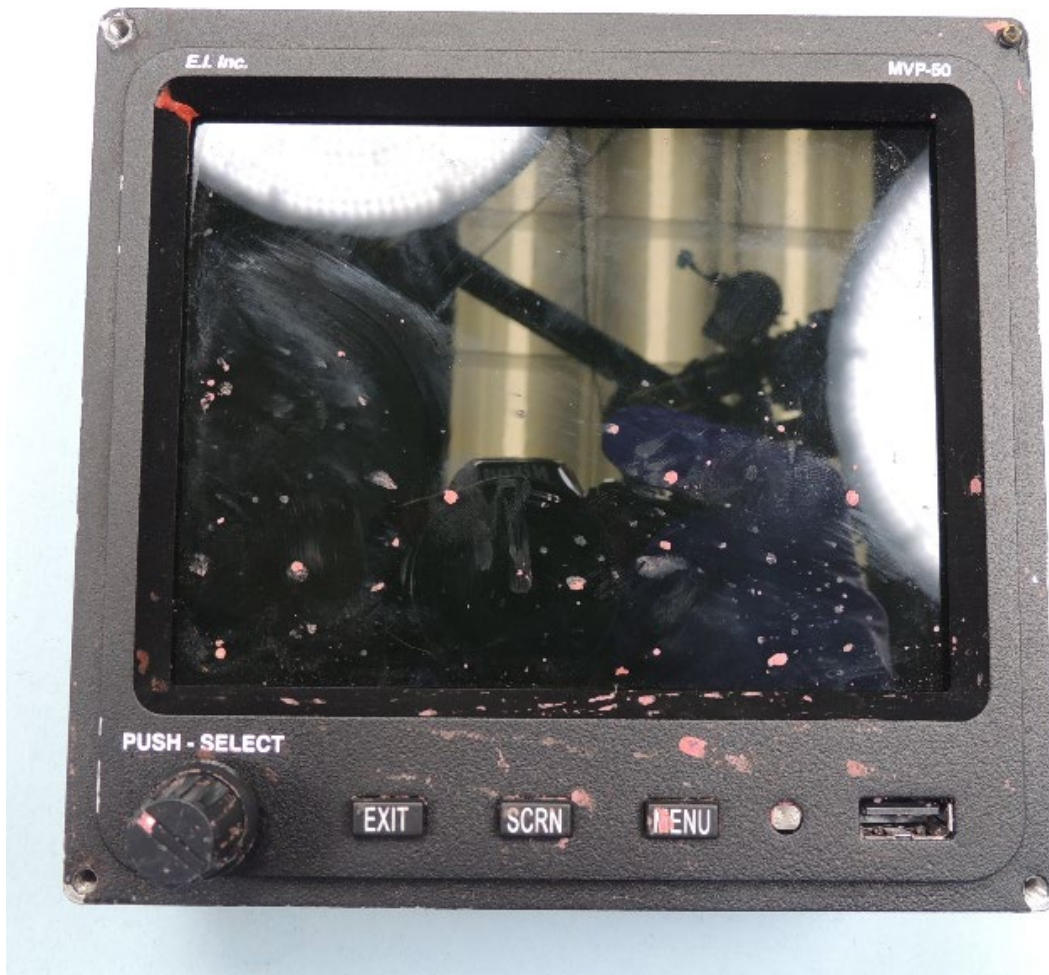
Upon arrival at the Vehicle Recorder Division, an external examination revealed the device did not have obvious physical damage, as shown in Figure 3. The device powered up normally and data were downloaded using an USB stick.

**Figure 3: Electronics International MVP-50T as received.**

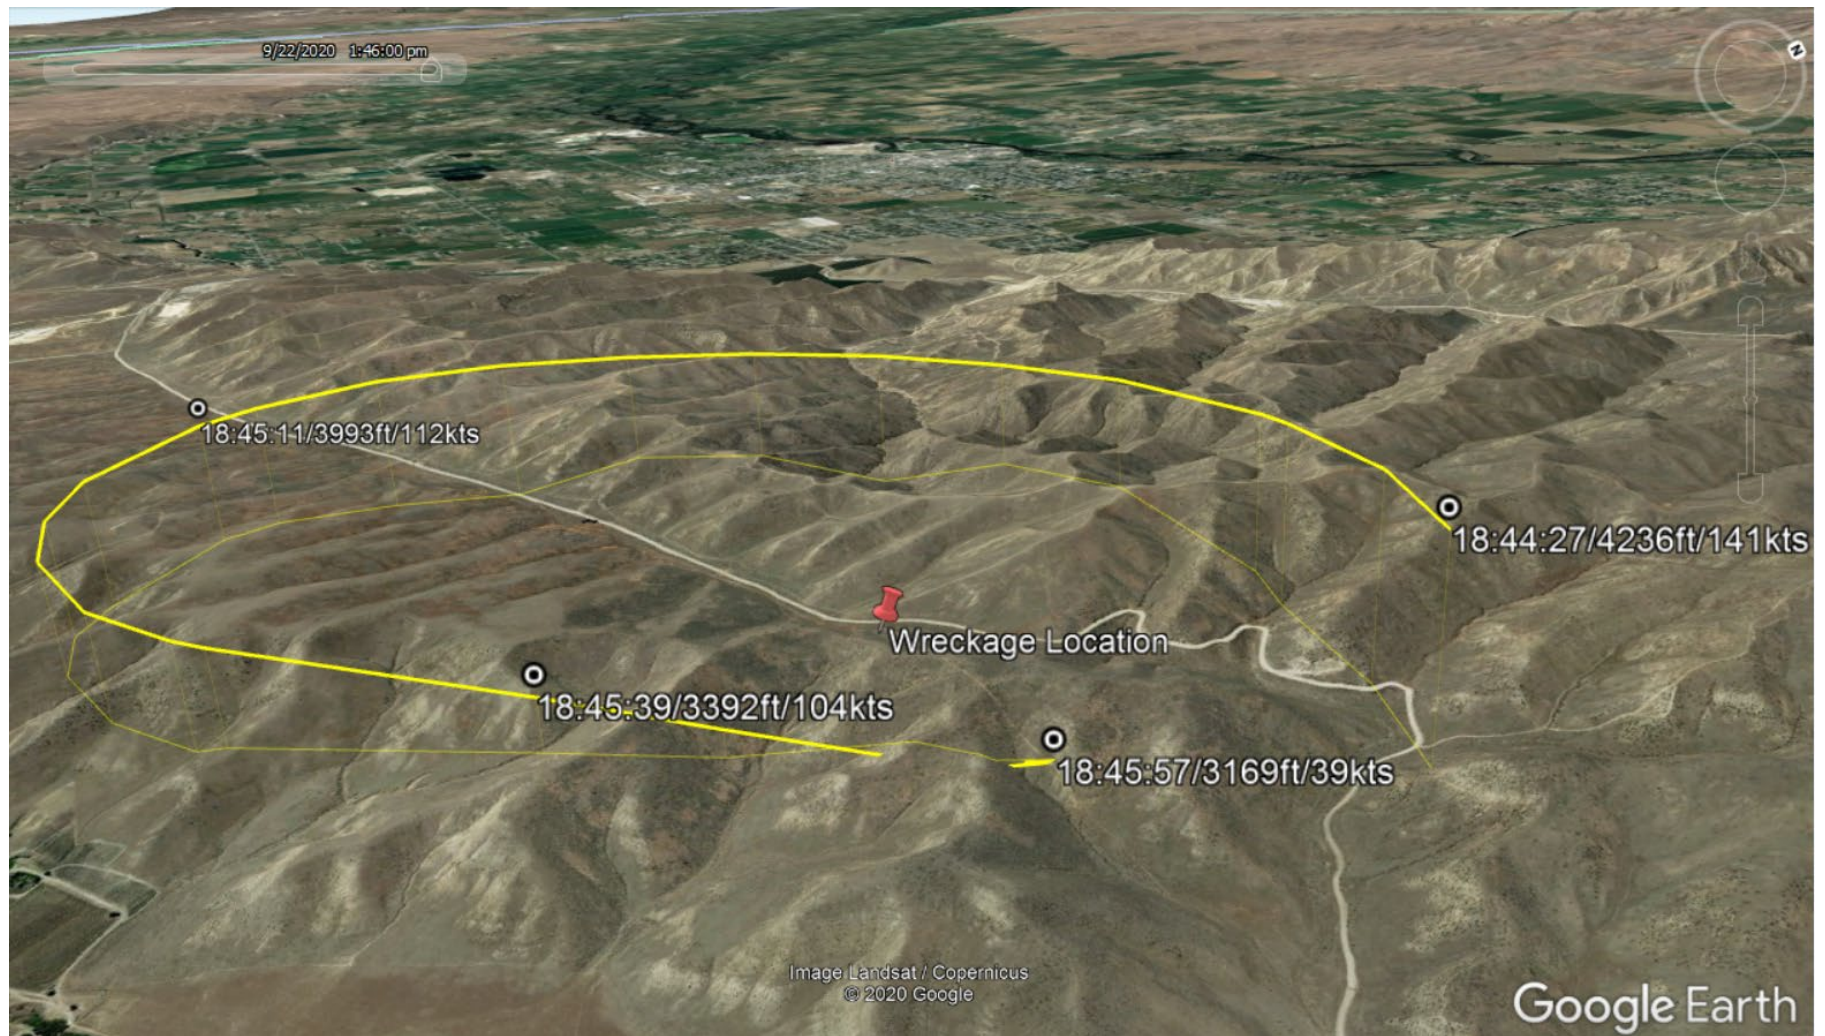
Figure 10 is a Google Earth overlay of the final portion of the accident flight. The reported wreckage location is shown with a red pin.

**Figure 10: Google Earth overlay of the final portion of the accident flight.**
