## **NATIONAL TRANSPORTATION SAFETY BOARD**

### **Specialist's Report**

# **METEOROLOGY**

WPR20LA319

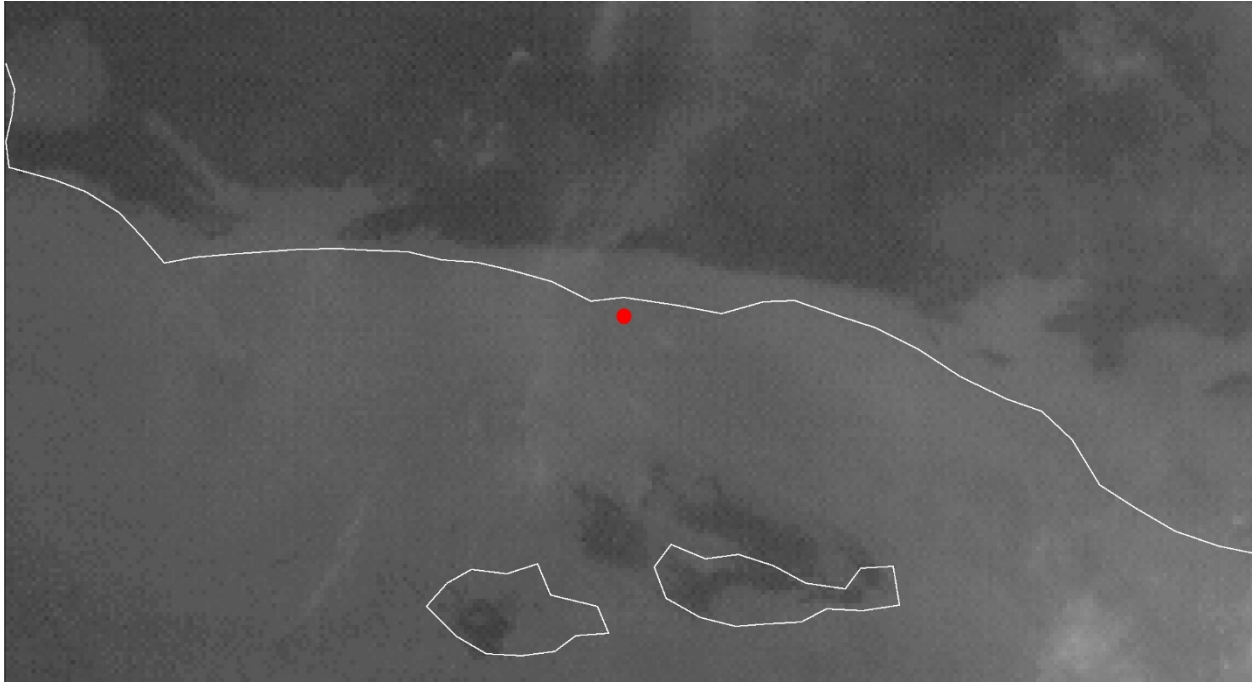
**Figure 1** – GOES-17 visible imagery (contrast enhanced) from 0701 PDT. Accident location denoted by red dot. This image has not been corrected for any parallax error.

Geostationary Operational Environmental Satellite (GOES)-17 visible (0.64µm) and infrared (10.3µm) data were obtained from an archive at the Space Science Engineering Center at the University of Wisconsin-Madison. Imagery from 0701 PDT are presented in figures 1 and 2. The GOES-17 visible imagery (which has been contrast enhanced) depicted cloudy conditions over the accident site along the California coast. Infrared cloud-top temperatures over the accident site were 15°C, which, when considering the 0700 PDT HRRR sounding (see Section 4.0), corresponded to cloud top heights of either about 10,000 feet or in a range of heights between about 1,500 feet and the surface (due to the near-isothermal temperature profile of the troposphere below about 1,500 feet).
