# NATIONAL TRANSPORTATION SAFETY BOARD

## Cockpit Display – Recorded Flight Data

### Specialist's Factual Report

Location: Cordes Lakes, Arizona  
Date: October 24, 2020  
Aircraft: Lancair 235  
Registration: N25NL  
Operator: Private  
NTSB Number: WPR21FA025

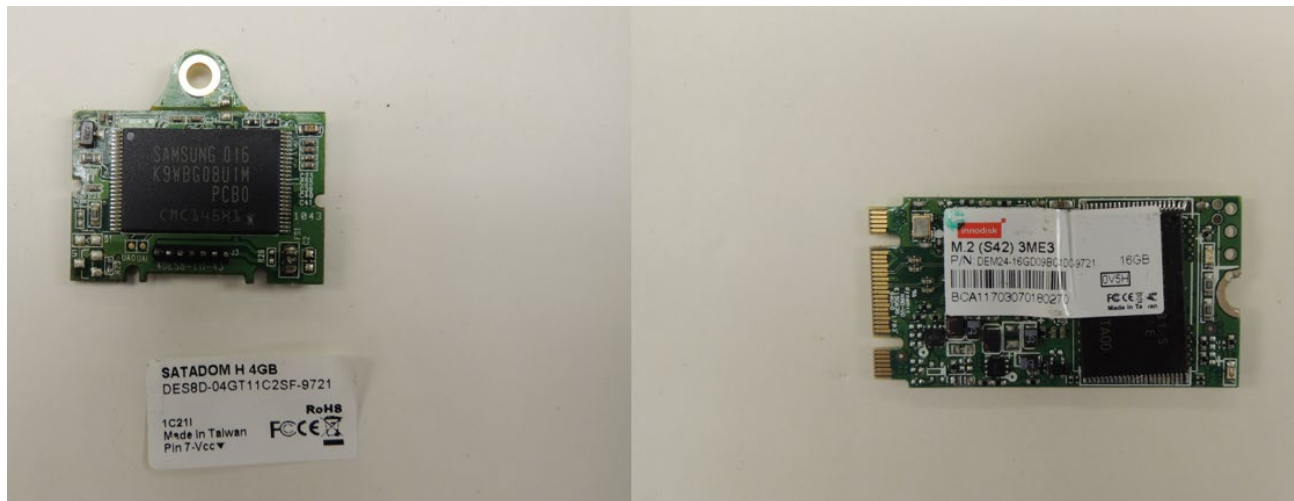
Figure 3: Memory modules from SV D700 (left) and SV HDX (right).

The Dynon SV D700 and HDX sustained severe impact damage upon arrival at the Vehicle Recorder Division, as shown in Figures 1 and 2. The memory modules of each device were removed from the devices, as shown in Figure 3. Both memory modules were unreadable due to damage. A support request was sent to the device manufacturer, and the response was that the level of damage precluded their recovery ability. A subsequent support request was sent to the memory module manufacturer – Innodisk based in California, USA. Innodisk recovered data from the damaged memory modules.

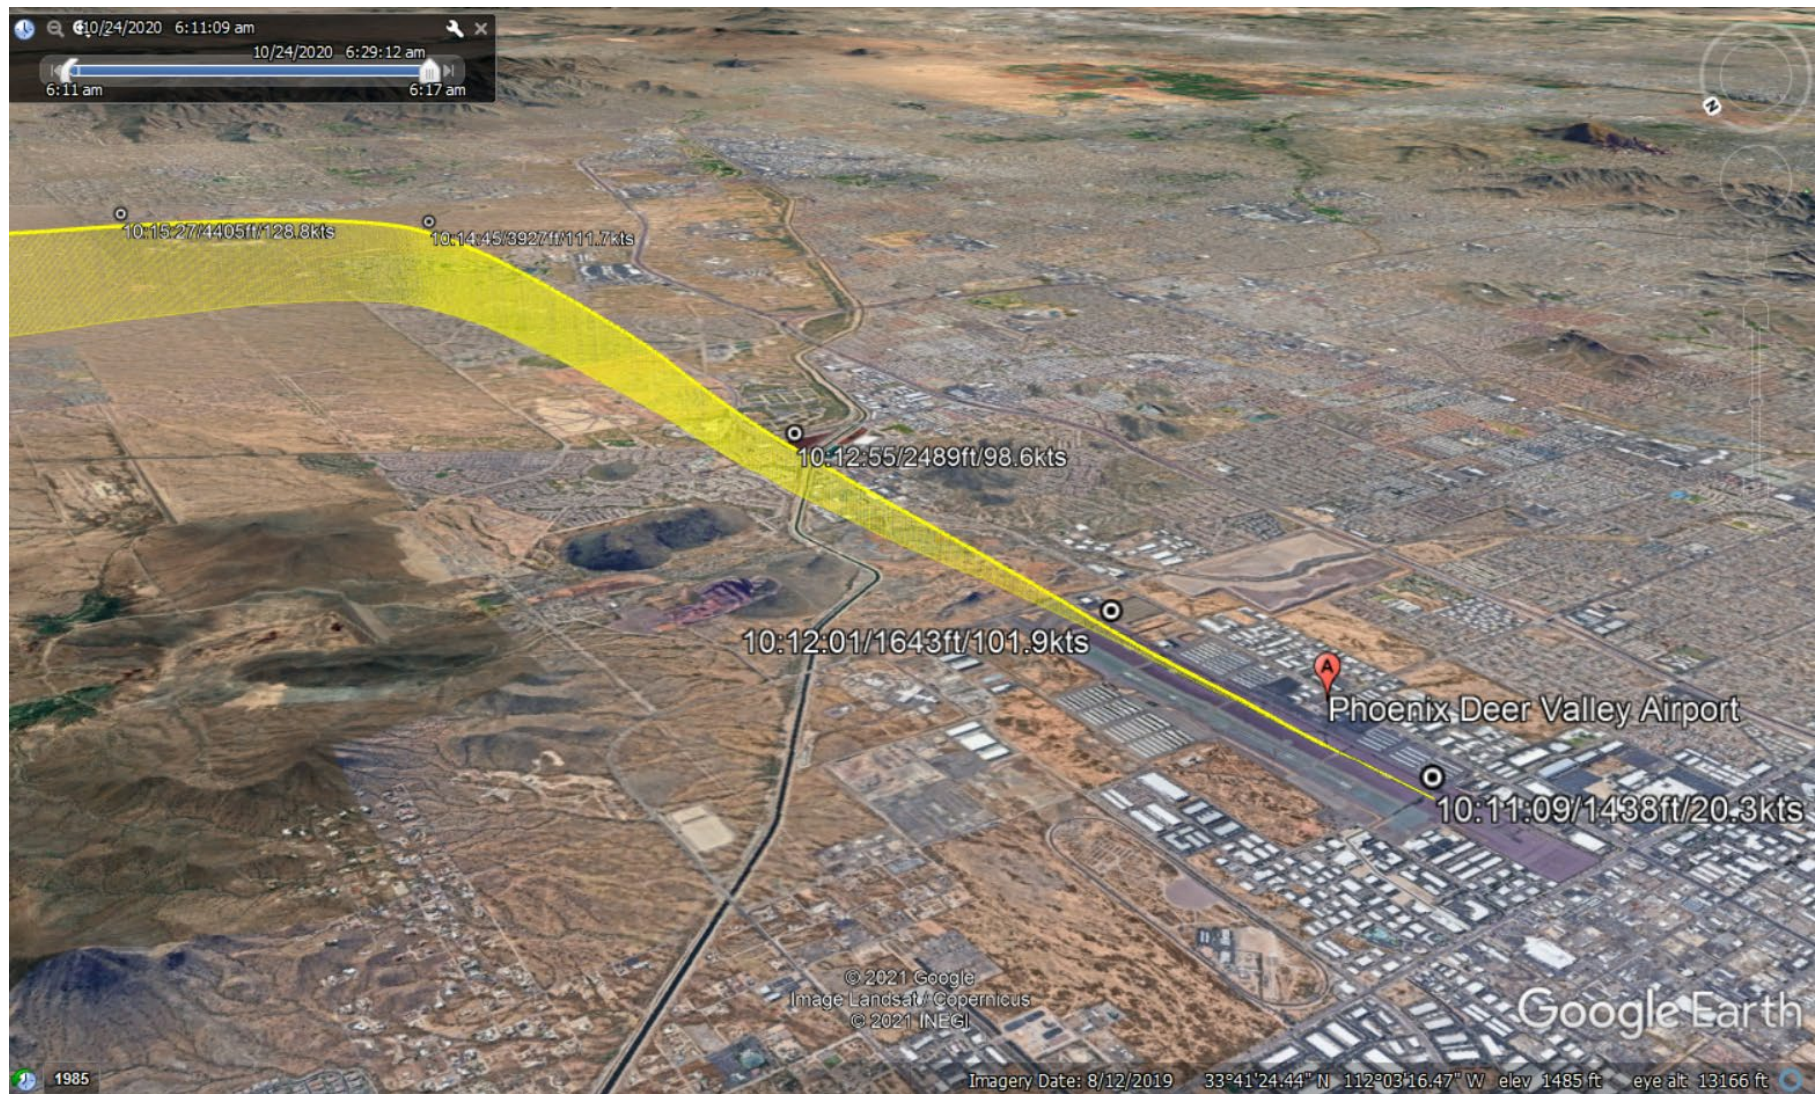
Figure 9 is a Google Earth overlay of the beginning of the accident flight. It shows the aircraft took off at Phoenix Deer Valley Airport around 10:11:09 MST.

Figure 9: Google Earth overlay of the beginning of the accident flight.
