## **NATIONAL TRANSPORTATION SAFETY BOARD**

### **Specialist's Factual Report**

# **METEOROLOGY**

WPR21FA286

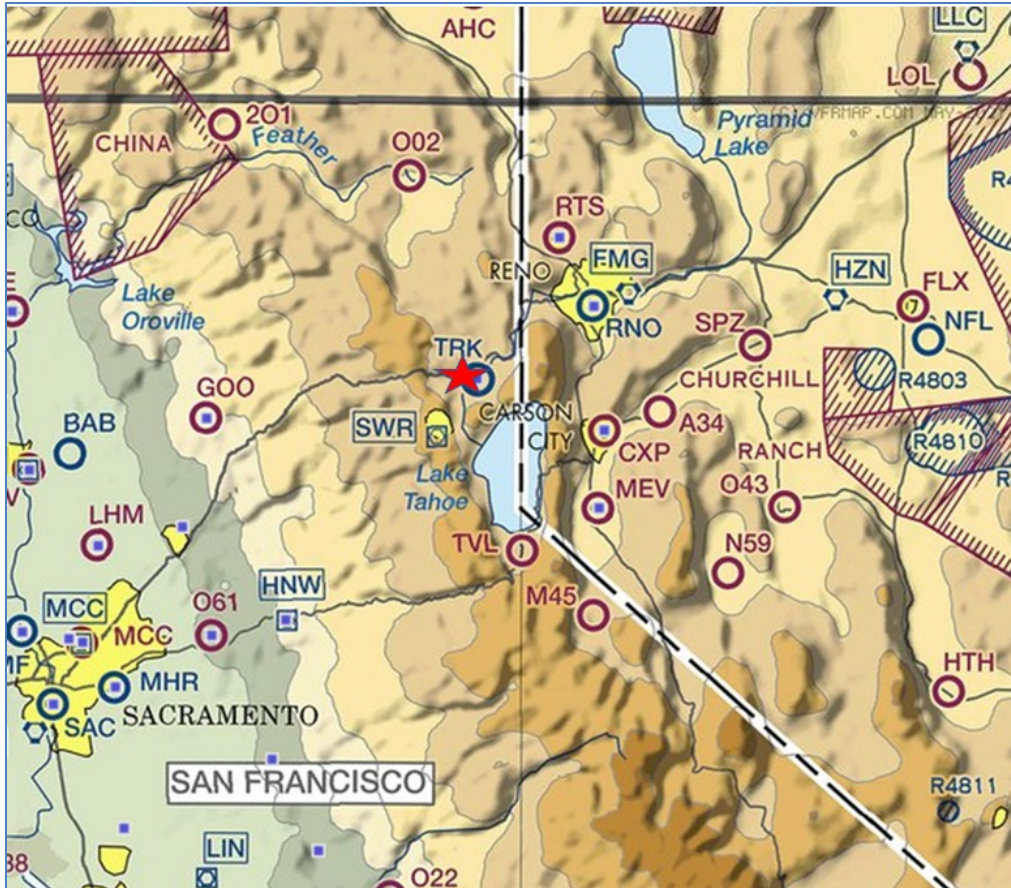
Figure 3 - Depiction of the closest weather reporting locations and the accident site.

The official observations issued surrounding the accident site were documented using standard Aviation Routine Weather Reports (METAR<sup>7</sup>) and Aviation Select Special Weather Reports (SPECIs). Cloud heights are reported above ground level (agl) in the following section, and the magnetic variation was estimated at 13° east based on the latest sectional chart for the area. Figure 3 is a World Aeronautical Chart (WAC) depiction of the area with the closest airports and those with weather reporting capability (labelled in blue) and the general topography of the area. The accident site was located immediately west of TRK and is documented below.
