# **NATIONAL TRANSPORTATION SAFETY BOARD**

## **Video Study**

**NTSB Case Number:  
WPR21LA011**

Location: Spirit Lake, Idaho  
Date: October 6, 2020  
Time: 1533 Pacific Daylight Time (PDT)  
Aircraft: Rans S-7 Courier Amphibious Airplane

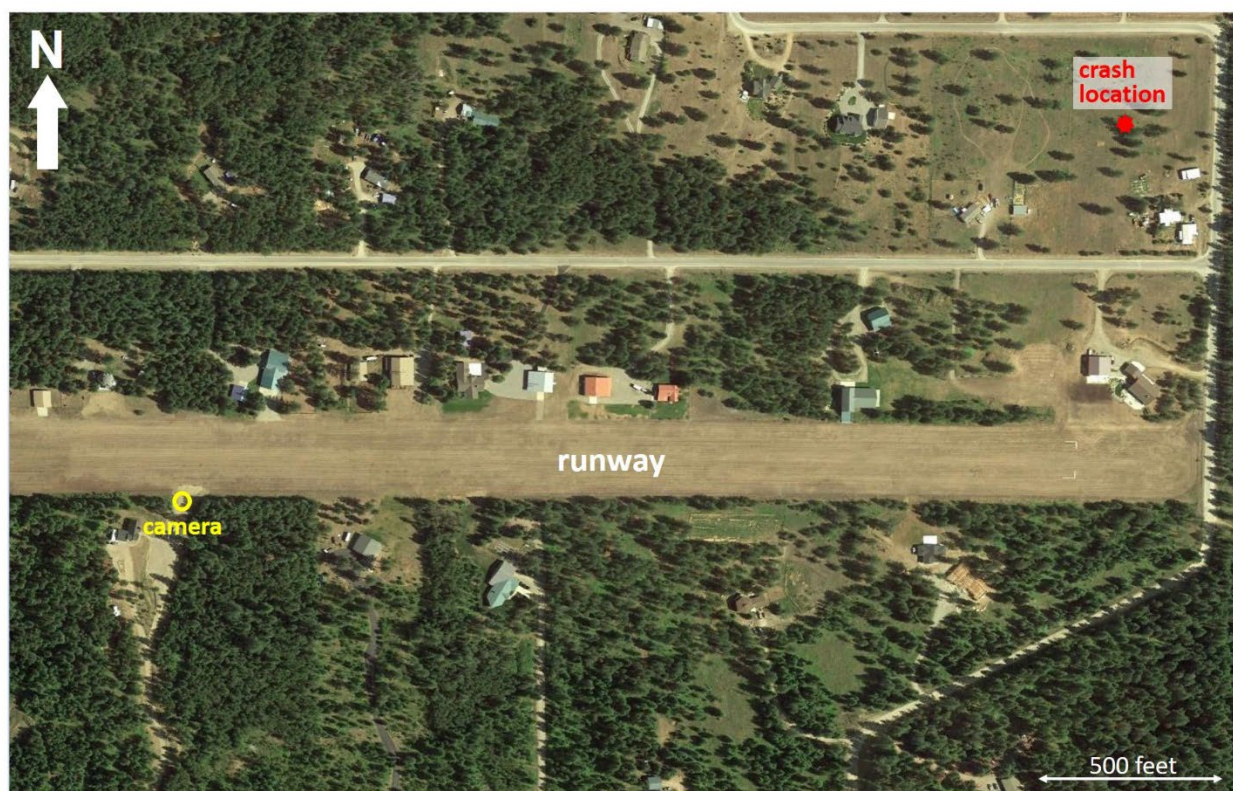
**Figure 1. Aerial Image of the Accident Area**

The goal of this investigation was estimating the ground track, ground speed, altitude, orientation angles and engine speed of the airplane based on a video recorded by a viewer on the ground. The iPhone XS video was about 37 seconds long, it had 1920x1080 resolution and frame rate of 30 fps. It recorded sound at the rate of 44,100 samples/second. The location of the camera is shown in Figure 1 that displays an aerial view of the accident area. The figure also shows the crash location.

The estimation was based on references that were visible both in aerial images such as Figure 1 and in video frames such as the one in Figure 2. The references were the buildings located north of the runway. A computer program that simulates camera optics was used to project the references onto a frame from the video in an iterative process in which the four unknown angles were varied so as to align the projected references with their images. When the projected references were aligned optimally with their images in the frame, values of the four angles were the optimal estimates of these parameters. At that point, the model of the camera optics was calibrated.

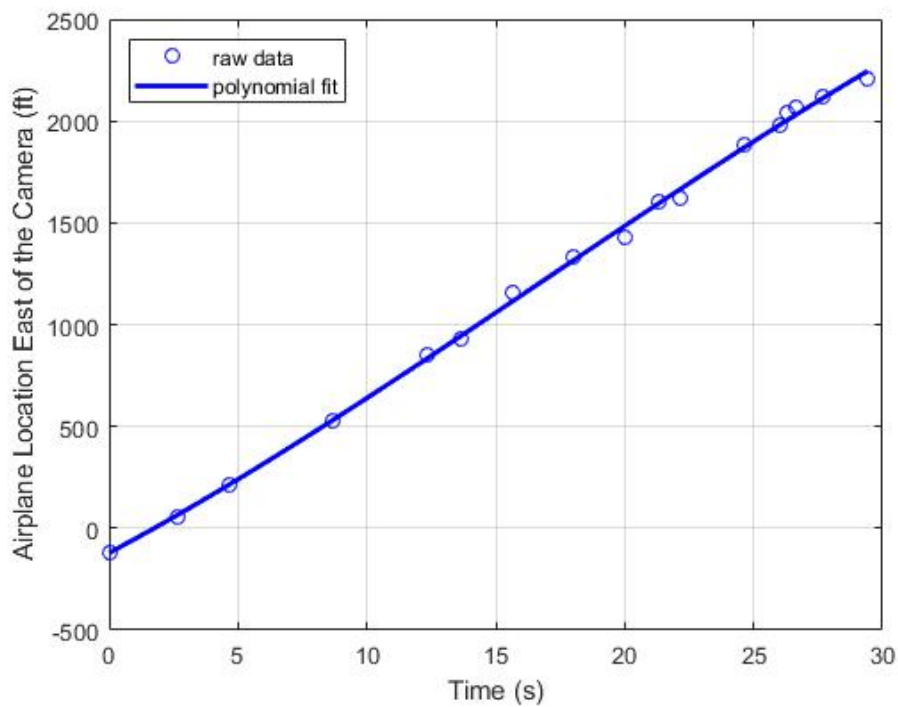
**Figure 3. Estimated Airplane Location East of the Camera**

Figure 3 shows the estimated location of the airplane along the runway that is oriented in the west-to-east direction. The airplane was moving west-to-east. The location of the camera was set to 0 feet in the figure. Time was set to zero when the first video frame was analyzed, which was 5.33 seconds after the video started. Figure 4 shows the location of the airplane north of the camera. The location of the camera was

set to 0 feet in the figure. The blue lines in Figure 3 and Figure 4 are 3<sup>rd</sup> order polynomial fits to the 17 raw data points.

Figure 5 shows the estimated airplane ground track. The solid blue line is based on the polynomial location fits in Figure 3 and Figure 4. The dotted line connects the last airplane location that could be estimated with the known crash location.

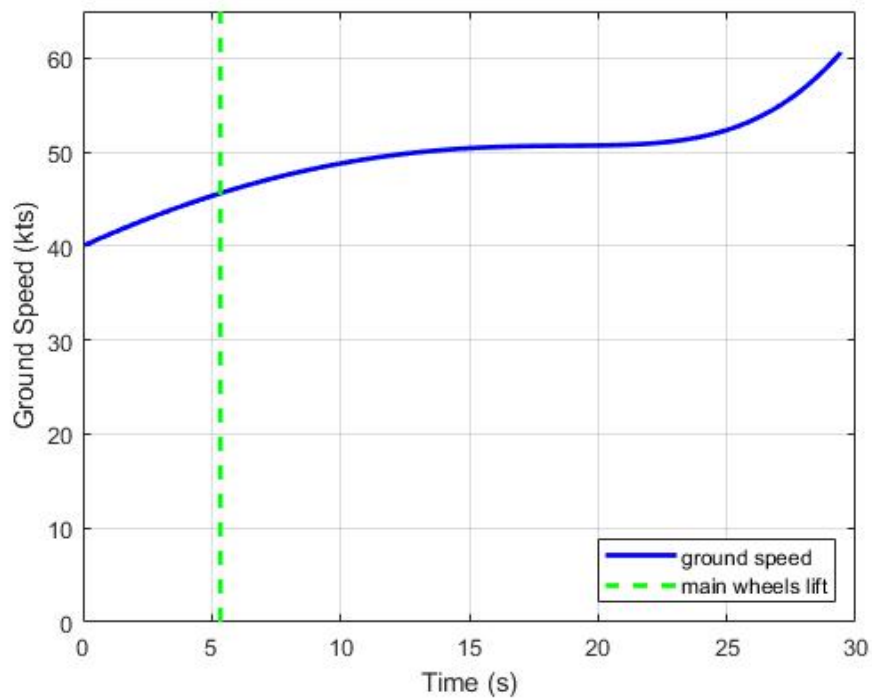
**Figure 6. Estimated Ground Speed**

Figure 6 shows the estimated ground speed of the airplane. The airplane had four wheels mounted on the amphibious floats. The vertical broken line marks the time when the two main (rear) wheels lifted, at about time 5.3 seconds. The airplane was airborne past that time.

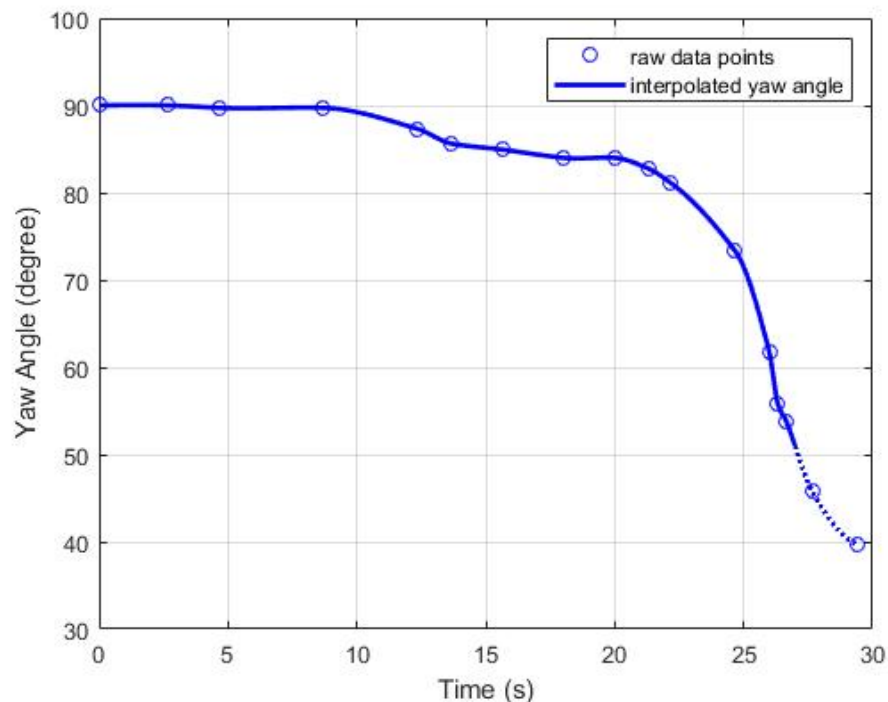
**Figure 7. Estimated Yaw Angle of the Airplane**

Figure 7 shows the yaw orientation of the airplane. Yaw angle is zero when airplane nose points to north and it increases clockwise. At time zero, the yaw angle was  $90^\circ$  because the airplane nose was pointed to the east. Past time 27 seconds, the angle is represented by a dotted line to indicate reduced accuracy because of reduced visibility of the airplane in the video.

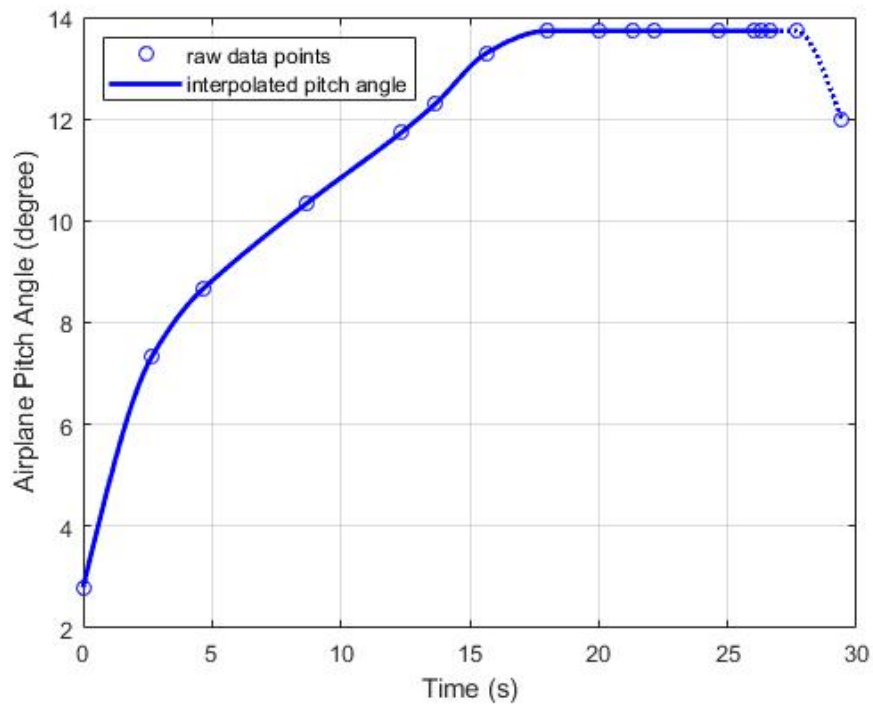
**Figure 8. Estimated Pitch Angle of the Airplane**

Figure 8 shows the estimated pitch angle of the airplane. The angle is defined as zero when the longitudinal axis of the airplane is horizontal. The angle increases as the nose starts pointing up. The dotted line segment indicates reduced angle estimation accuracy.

The wing incidence angle, i.e., the angle between the wing airfoil chord and the longitudinal axis of the airplane was estimated as about  $4^\circ$  based on the images of the airplane in the video. Figure 9 shows the estimated pitch angle of the wings. It is  $4^\circ$  higher than the pitch angle of the airplane shown in Figure 8.

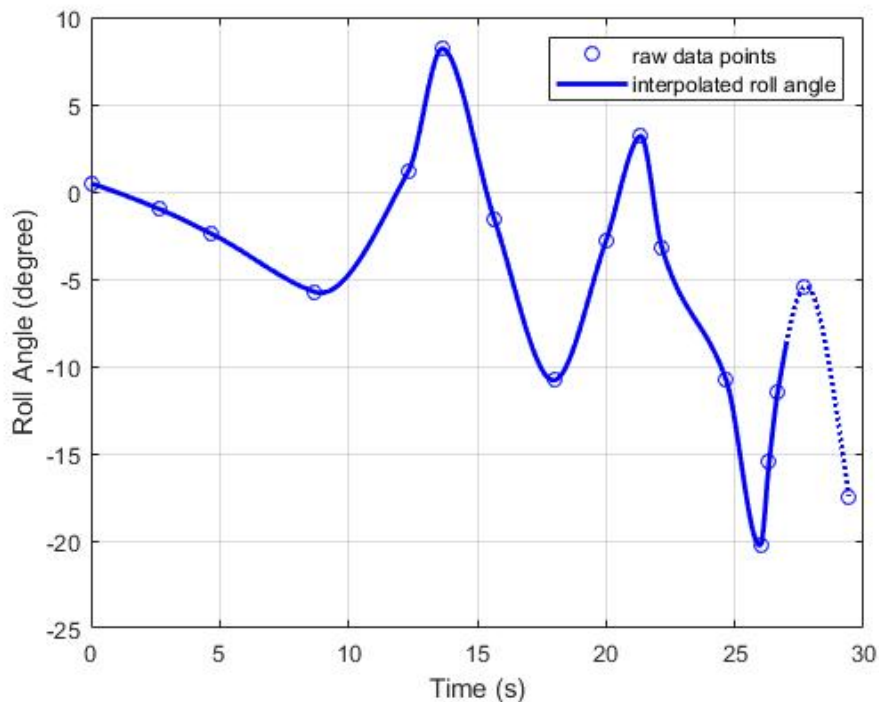
**Figure 10. Estimated Roll Angle of the Airplane**

Figure 10 shows the estimated roll angle of the airplane. Positive roll corresponds to right wing down. The figure shows large roll angle swings past time 10 seconds. Between time 13.67 seconds and time 18 seconds, roll angle decreased by  $19^\circ$ , going from  $+8.2^\circ$  to  $-10.8^\circ$ . The angle then increased to  $+3.2^\circ$  at time 21.33 seconds and then decreased to  $-20.2^\circ$  at time 26 seconds.

Figure 12 shows that past time 12 seconds, the wing angle of attack continued climbing dangerously close to the stall angle of attack of the Rans S-7 NACA 2412 wing airfoil. It is possible that wing stall actually occurred near time 15 seconds and it caused the large  $19^\circ$  roll angle change between time 13.67 seconds and time 18 seconds seen in Figure 10. Figure 12 shows that the wing angle of attack decreased to about  $12^\circ$  by time 20 seconds but then increased toward stall values.

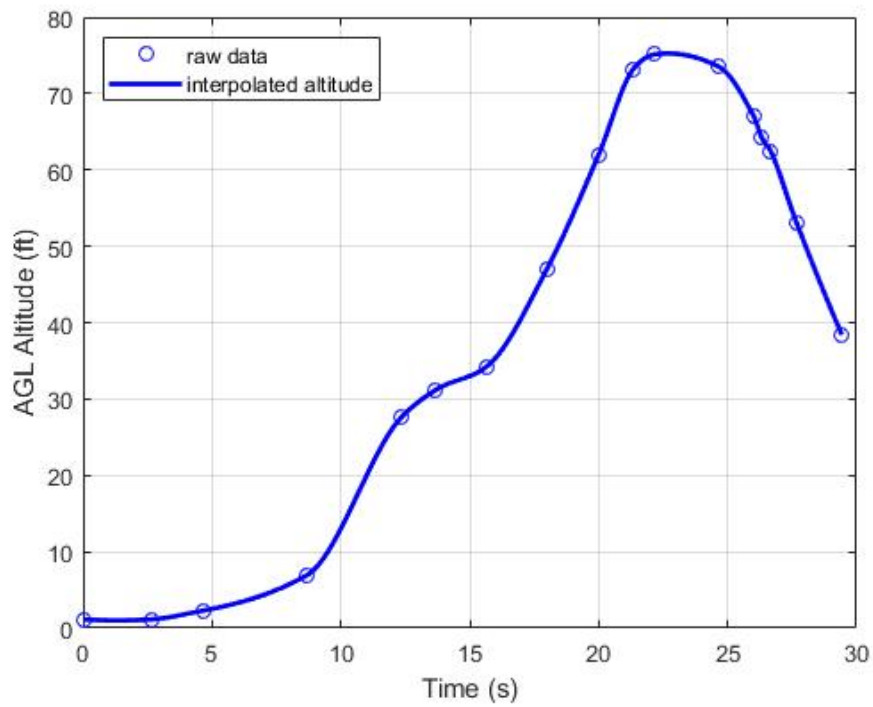
**Figure 11. Estimated AGL Altitude of the Airplane**

Figure 11 shows the estimated AGL altitude of the airplane. Altitude is set to zero when all four airplane wheels are on the runway. The figure shows the altitude of the nose of the airplane above the altitude where the nose was when all four wheels were on the runway. The maximum altitude that the airplane reached was about 75 feet above the runway, at about time 22 seconds. The airplane was losing altitude past that time.

The estimated vertical speed of the airplane is the slope of the estimated altitude of the airplane shown in Figure 11. The flight path angle (or climb angle) of the airplane is the angle between the velocity vector of the airplane and the horizon. It is computed by  $\tan^{-1}(\text{vertical speed} / \text{ground speed})$ .

At time 25 seconds, the estimated wing angle of attack was  $20^\circ$ , above the wing airfoil stall angle of attack. Figure 11 shows that past time 25 seconds, the airplane was losing altitude. It impacted the ground about 650 feet from the ground location corresponding to the last altitude data point in Figure 11.

Figure 13 shows that the engine and the propeller were operating properly in the time window between 26.5 seconds and 28 seconds. Figure 11 shows that the airplane started losing altitude at about time 25 seconds. This indicates that the engine and the propeller were not the cause of the altitude loss.

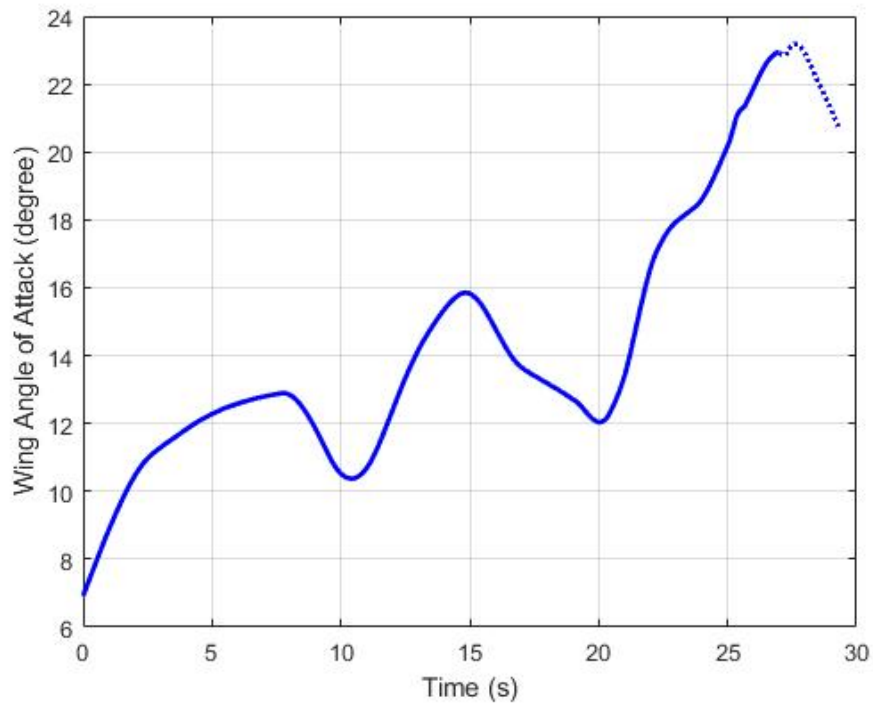
**Figure 12. Estimated Wing Angle of Attack**

The angle of attack of the wings is given by the difference between the wing pitch angle shown in Figure 9 and the flight path angle. Wind direction and speed also affect the angle of attack, but since they were not known, they were not taken into account. Figure 12 shows the estimated wing angle of attack. The accuracy of the estimate is about  $\pm 1.5^\circ$ . The airplane angle of attack is smaller by  $4^\circ$  than the wing angle of attack.

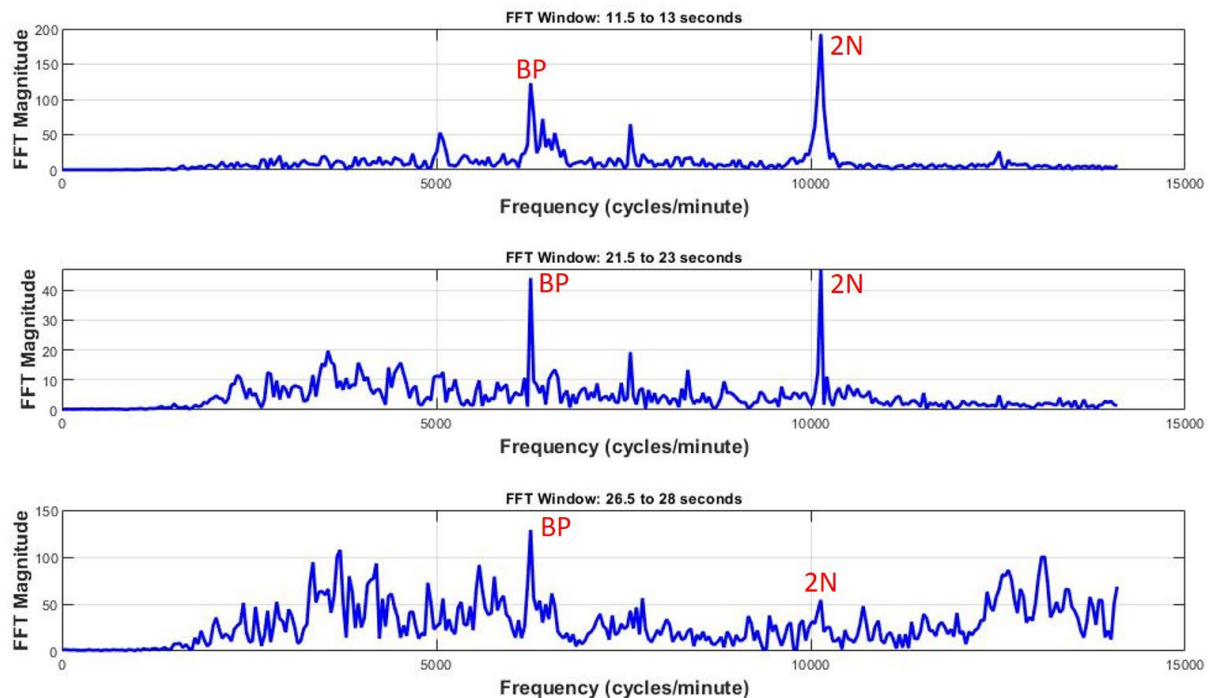
**Figure 13. Spectrum of the Recorded Sound**

Figure 13 shows the spectra of the recorded sound at three analysis times. The spectra were computed in 1.5-second wide windows with a 65536-point Fast Fourier Transform (FFT) algorithm, resulting in 40.4 cycle/minute resolution. The analysis windows started at times 11.5 seconds, 21.5 seconds and 26.5 seconds. Two peaks are marked in each plot. BP marks the blade passage frequency and  $2N$  marks the second harmonic of the engine speed. At all three times, these frequencies were BP=6258 cycles per minute (cpm) and  $2N=10130$  cpm. The frequency ratio was  $10130/6258=1.62$ , indicating that the engine reduction gearbox and the propeller were intact.

The airplane was moving away from the camera at about 50 knots at the three times when the spectrum was computed, resulting in the recorded frequencies being about 93% of the emitted frequencies due to the Doppler effect. Therefore, the estimated engine speed was  $(10130/2)/0.93=5446$  rpm, about 94% of the rated engine speed of 5800 rpm.
