## **NATIONAL TRANSPORTATION SAFETY BOARD**

### **Specialist's Factual Report**

# **METEOROLOGY**

WPR21LA032

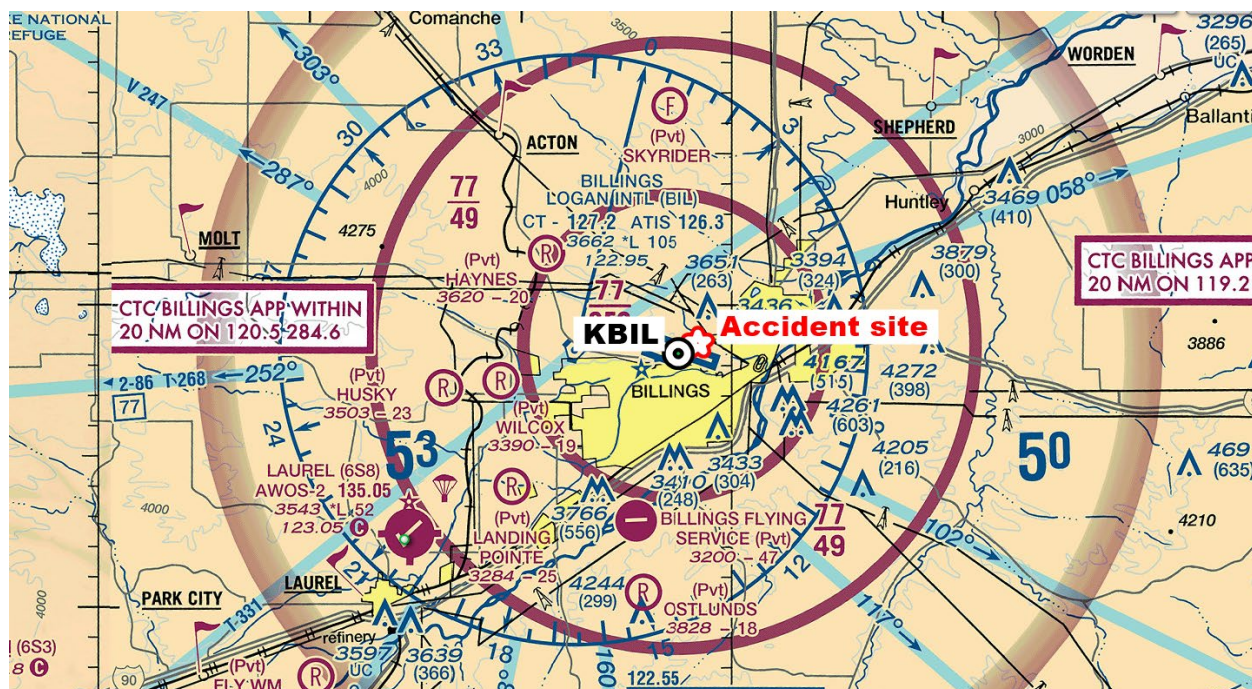
**Figure 6 – Sectional map of the accident area with the location of the accident site and surface observation site**

The Billings area surrounding the accident site was documented using official Meteorological Aerodrome Reports (METARs) and Specials (SPECIs). The following observations were taken from standard code and are provided in plain language. Figure 6 is a local sectional chart with the accident site and the closest weather reporting location marked.

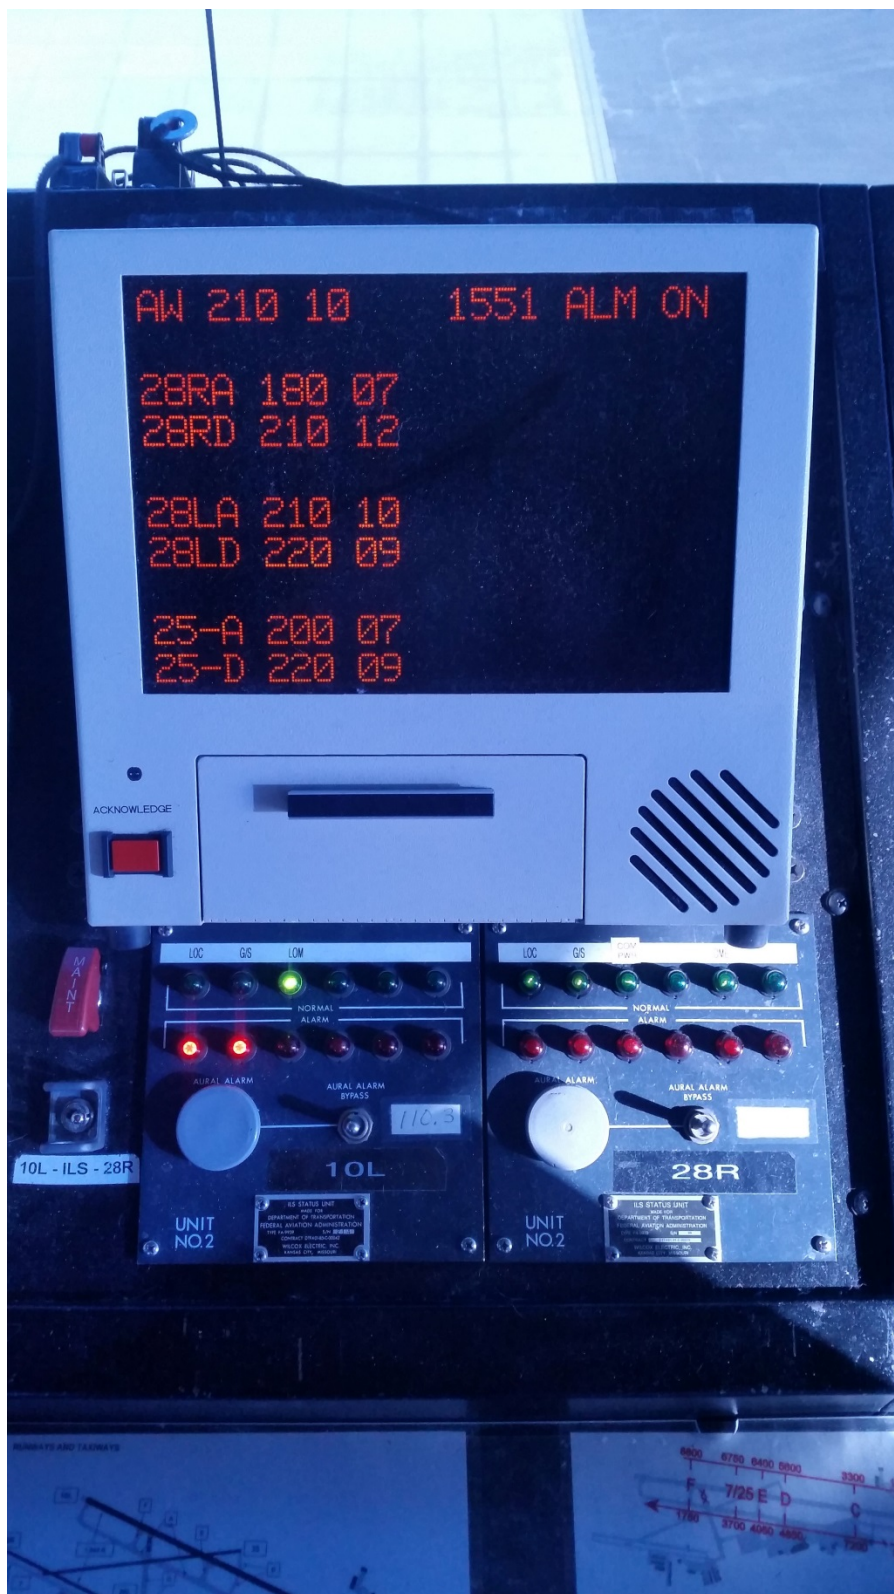
**Figure 11 – Example of the LLWAS display for the Billings ATC**
