**Continental TSIO-520-M(7)**  
**ENGINE EXAM: WPR21LA059 (N878AH)**  
**DATE: 03MAR2021**

LOCATION: SouthWest Aircraft Recovery & Transport

| <b>A/C MK/MDL</b> | Cessna TU206G |
| <b>Accident Location</b> | Twentynine Palms Airport (KTNP) |

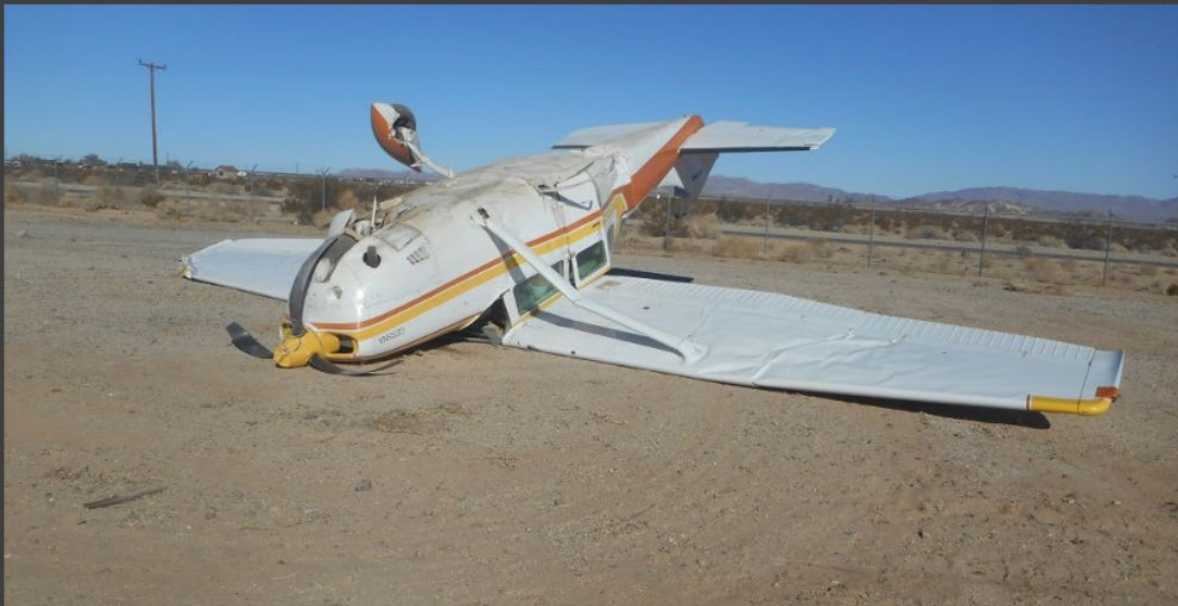
**Figure 1:** View of propeller damage which occurred upon impact with terrain

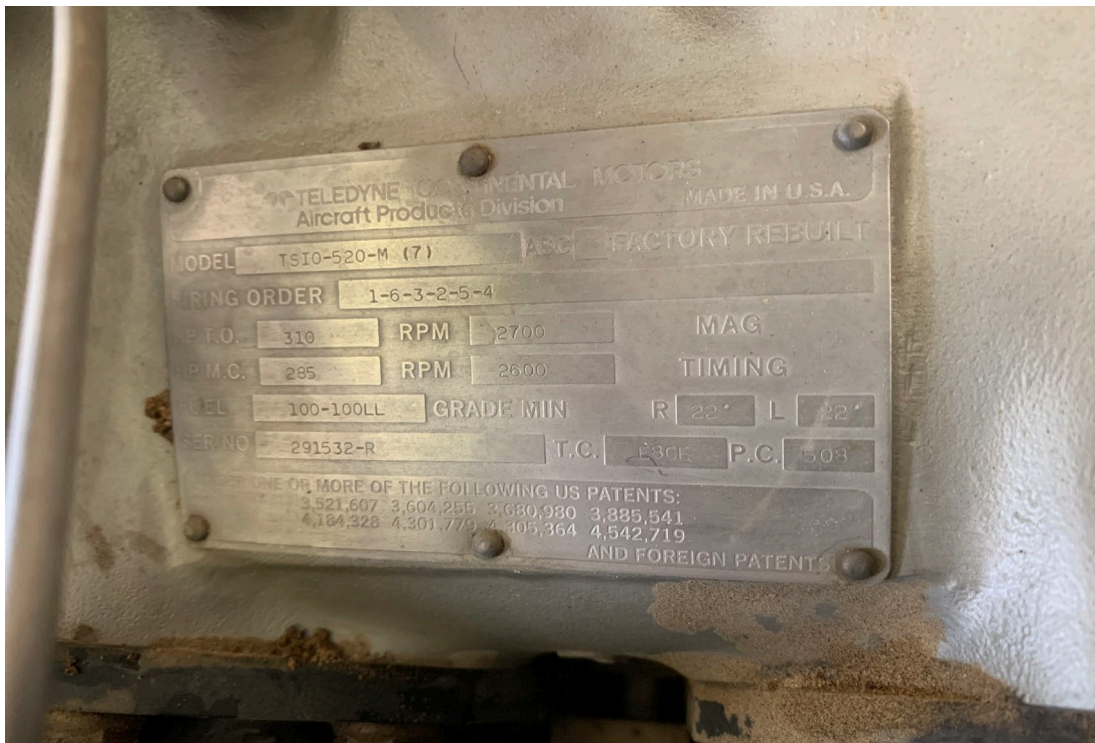
**Figure 2:** View of N878AH Engine Data Plate

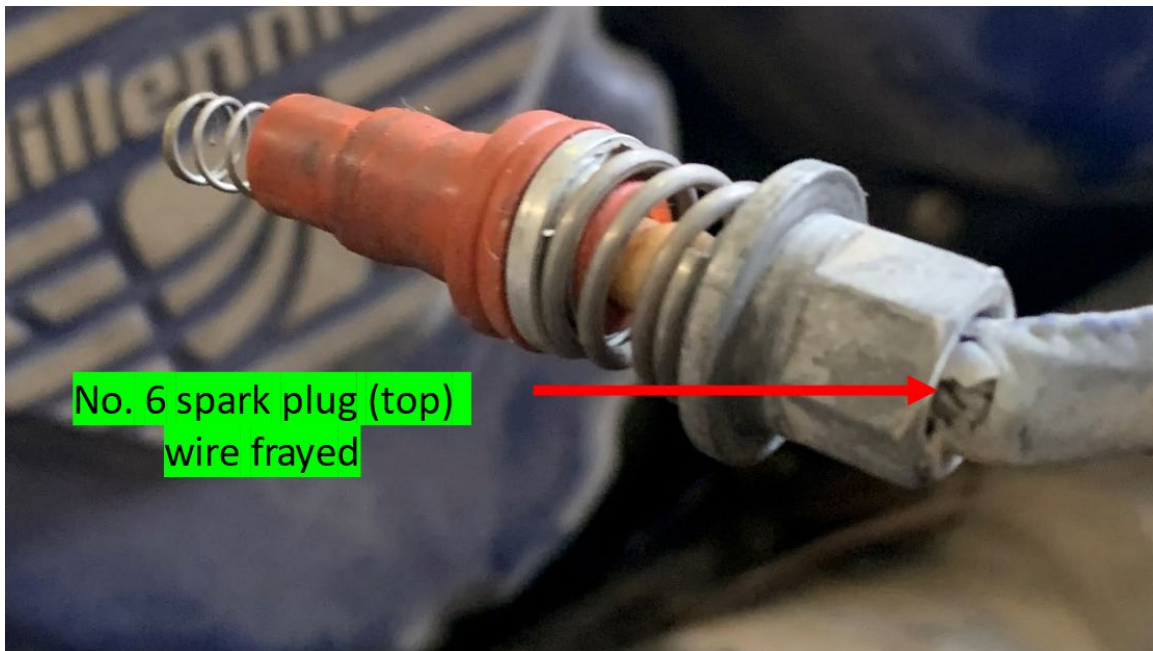
- No. 1 and No. 5 bottom spark plugs were torqued in excess of 25-inch-lbs.
- No. 6 spark plug (top) ignition cable wires exposed at ferrule.

**Figure 3:** View of frayed spark plug wire (No. 6 top plug)

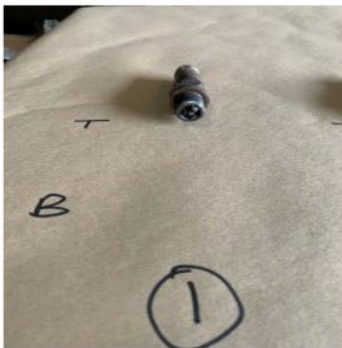
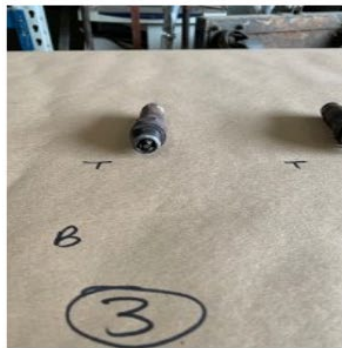
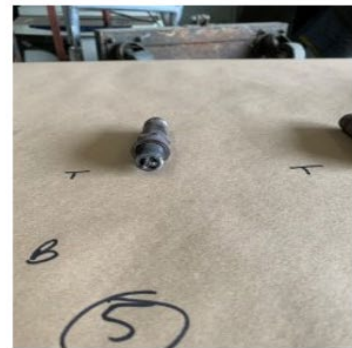
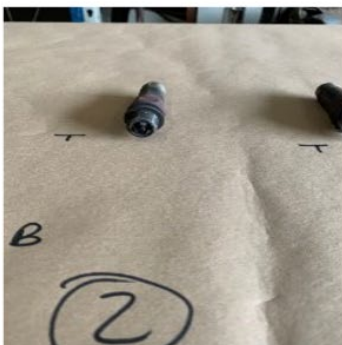
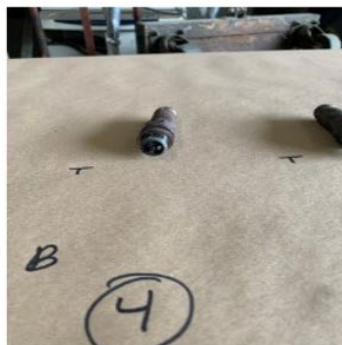
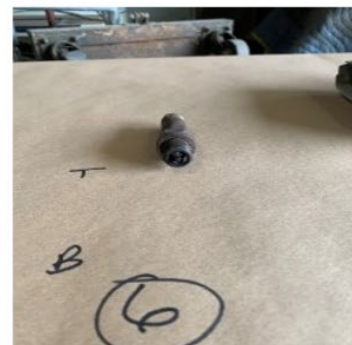
**GAPS SIMILAR** ☐ All yes ☒ NO \_\_ No. 1 gap is wide, No. 2 is wide, No. 5 top and bottom missing electrodes and points, No. 6 wide

**MECHANICALLY DAMAGED** ☐ None ☒ 1 ☒ 2 ☐ 3 ☐ 4 ☒ 5 ☒ 6

**Figure 4:** View of top spark plugs from cylinders 1-6

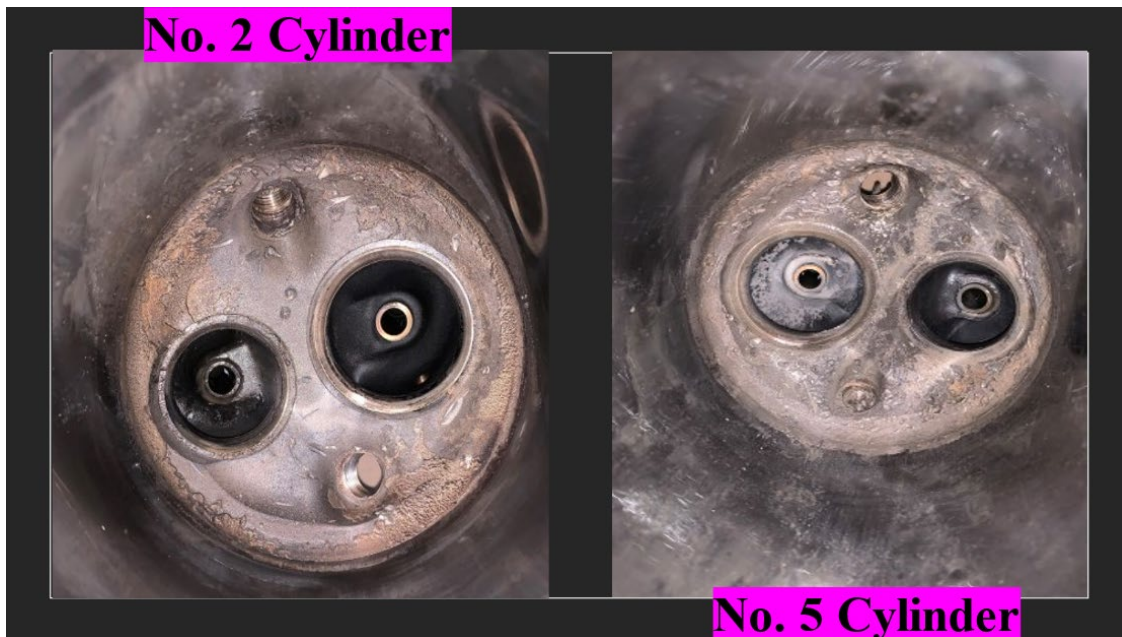
-Prop damage prevented engine test running. Borescope of cylinders indicated #2 exhaust valve head failure. #5 piston, cylinder head, top and bottom spark plug damage.

**Figure 5:** View of damage to No. 2 and No. 5 Cylinders

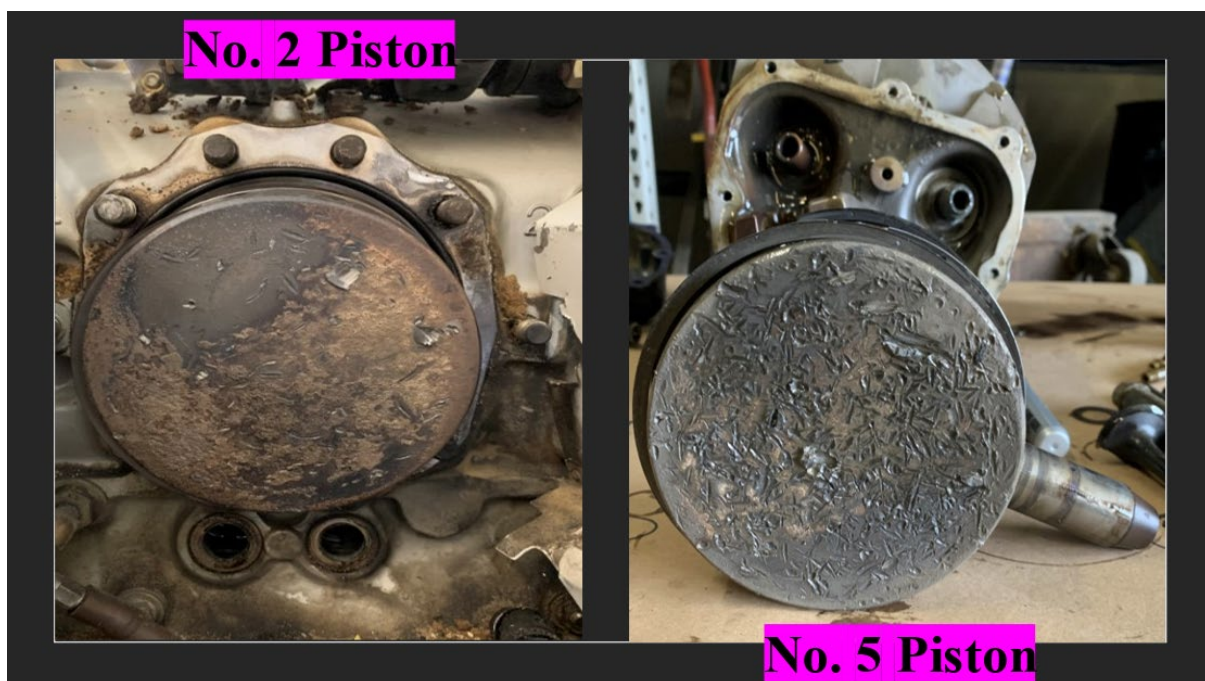
☐ NONE ☒ YES \_Damage to No. 2 and 5. piston heads from foreign object contact. No. 2 and No. 5 cylinders were unremarkable

**Figure 6:** View of damage to No. 2 and No. 5 Pistons

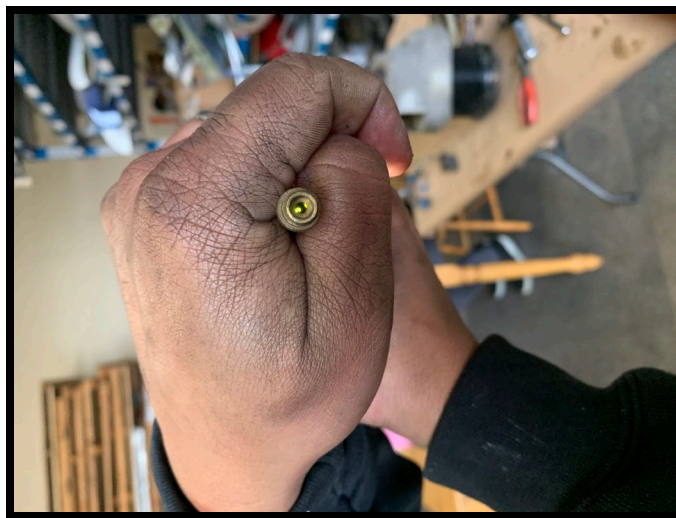
**Figure 7:** The No. 2 injector nozzle contained a greenish-yellowish foreign substance

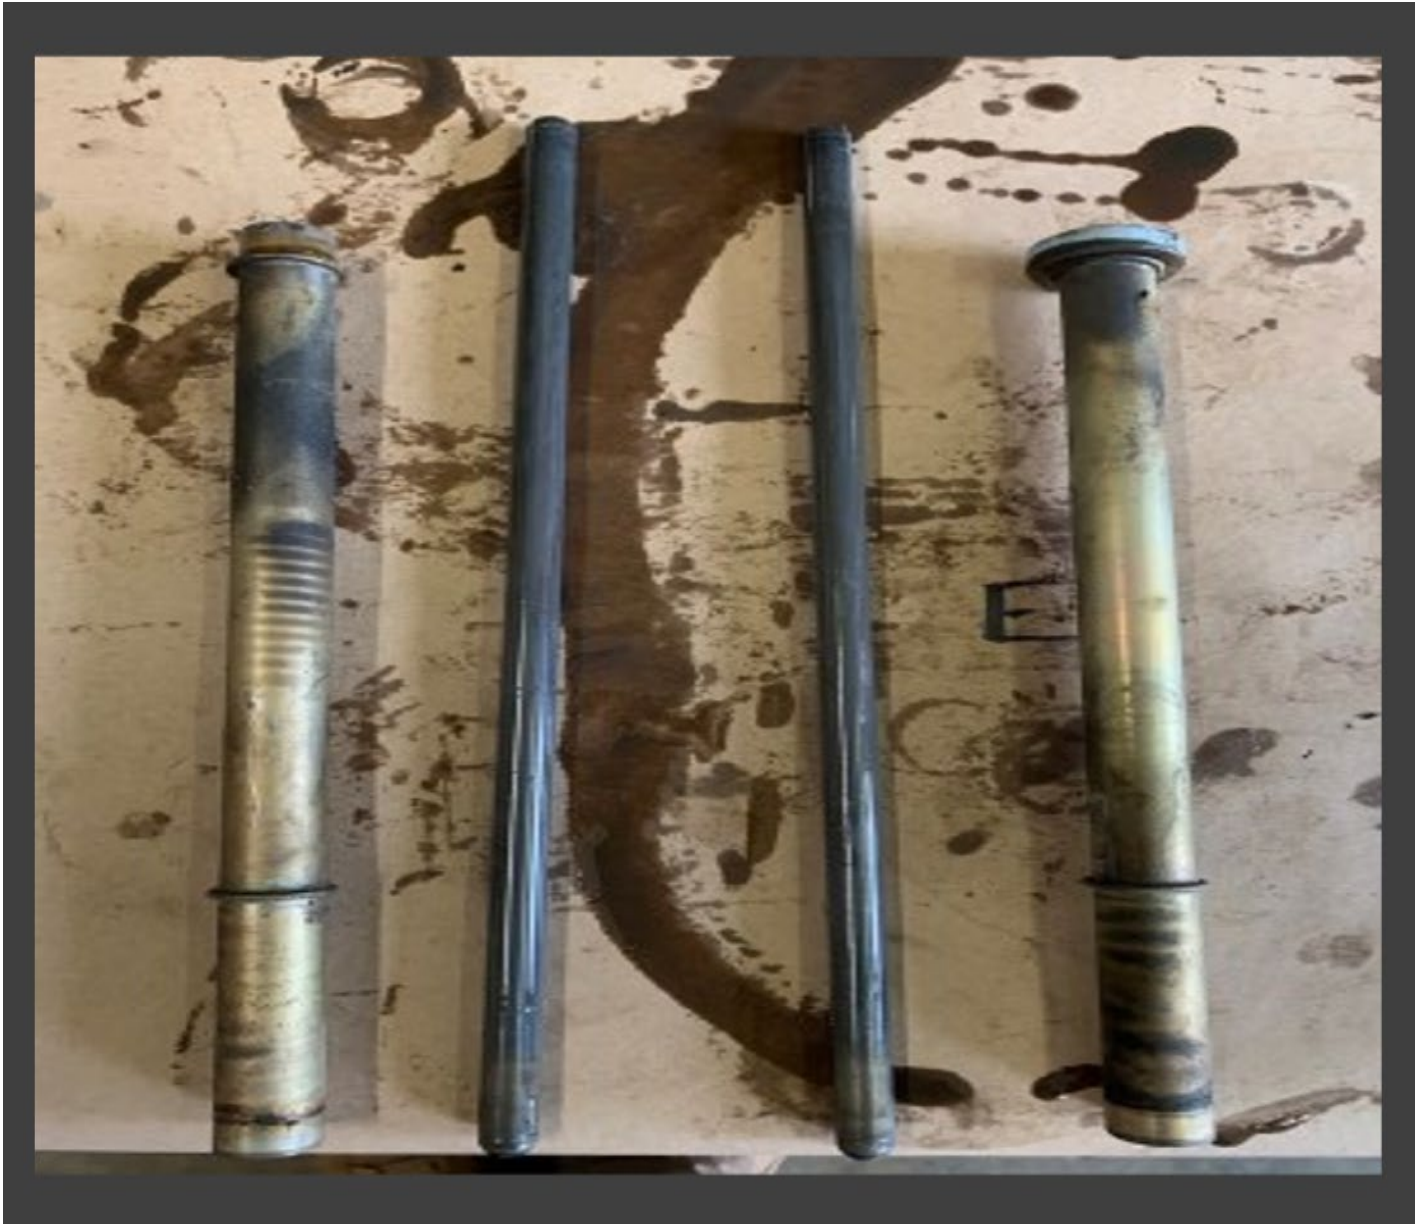
**Figure 8:** View of No. 2 push rods and housings

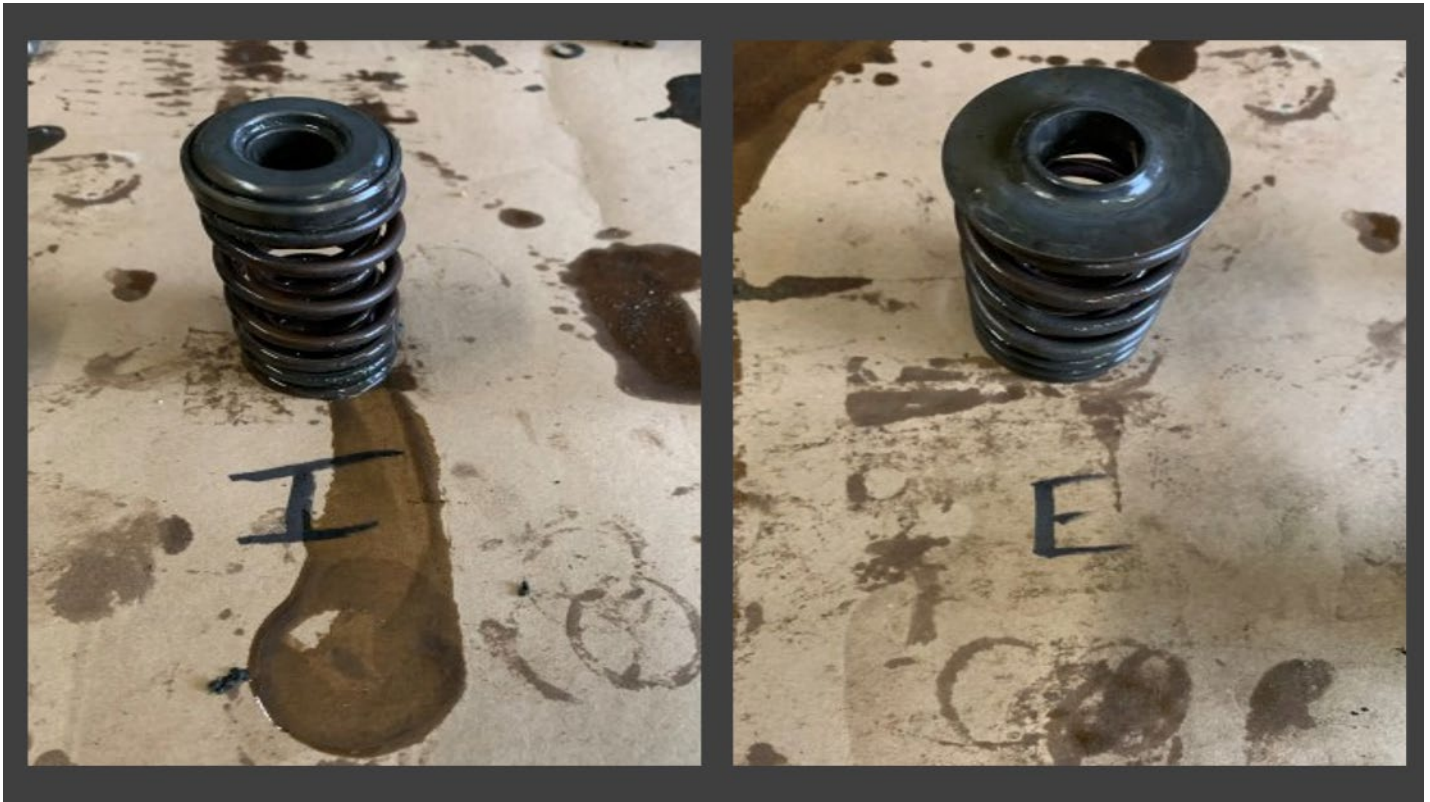
- Exhaust valve keepers normal. Exhaust valve missing about 45% of the head. Exhaust valve head exhibited extreme dishing and stretched.
- Intake valve: Exhibited extreme dishing & about .014 stretched.
- Intake/exhaust springs normal. Spring retainer for intake and exhaust normal. No. 2 valve guide severely worn.

**Figure 9:** View of No. 2 intake & exhaust springs with seats

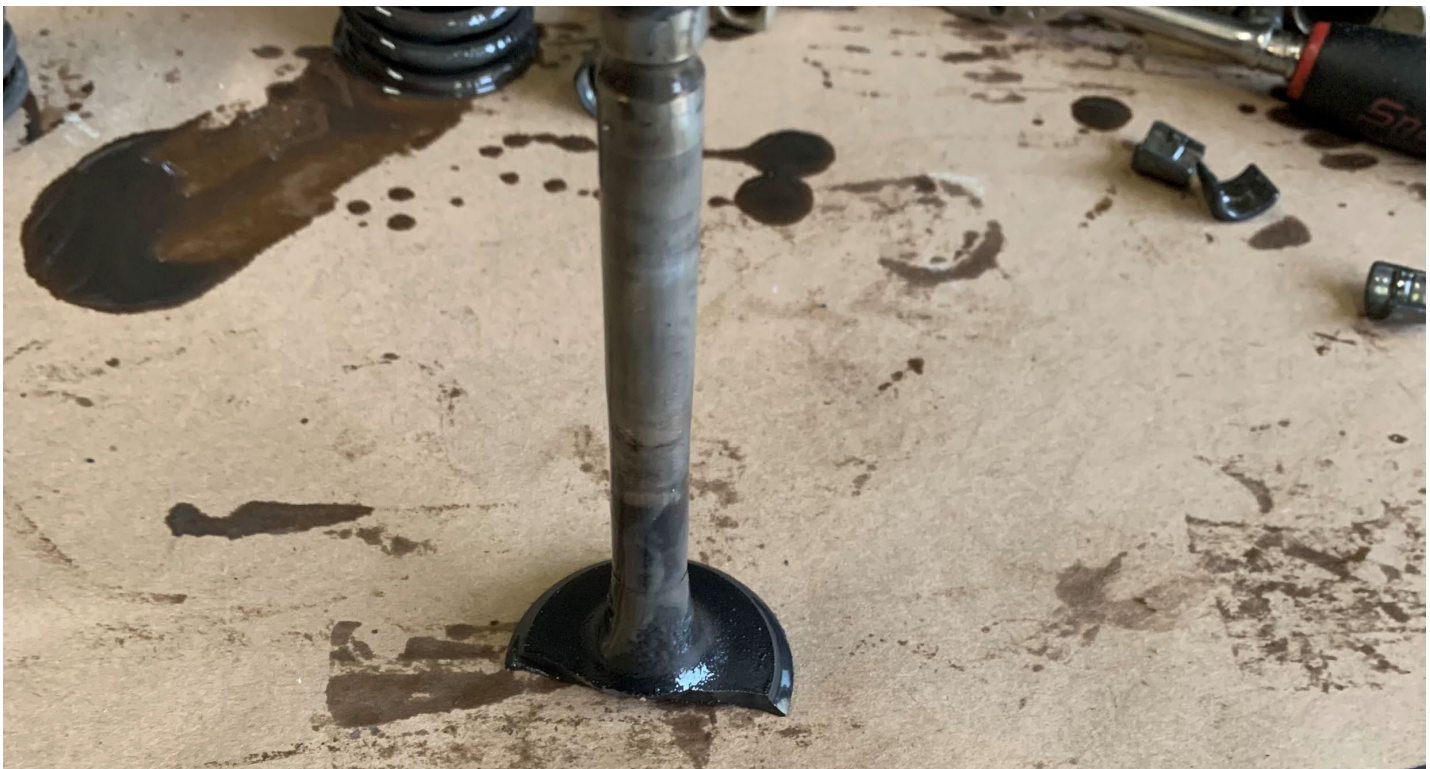
**Figure 10:** Top/Down view of No. 2 exhaust valve

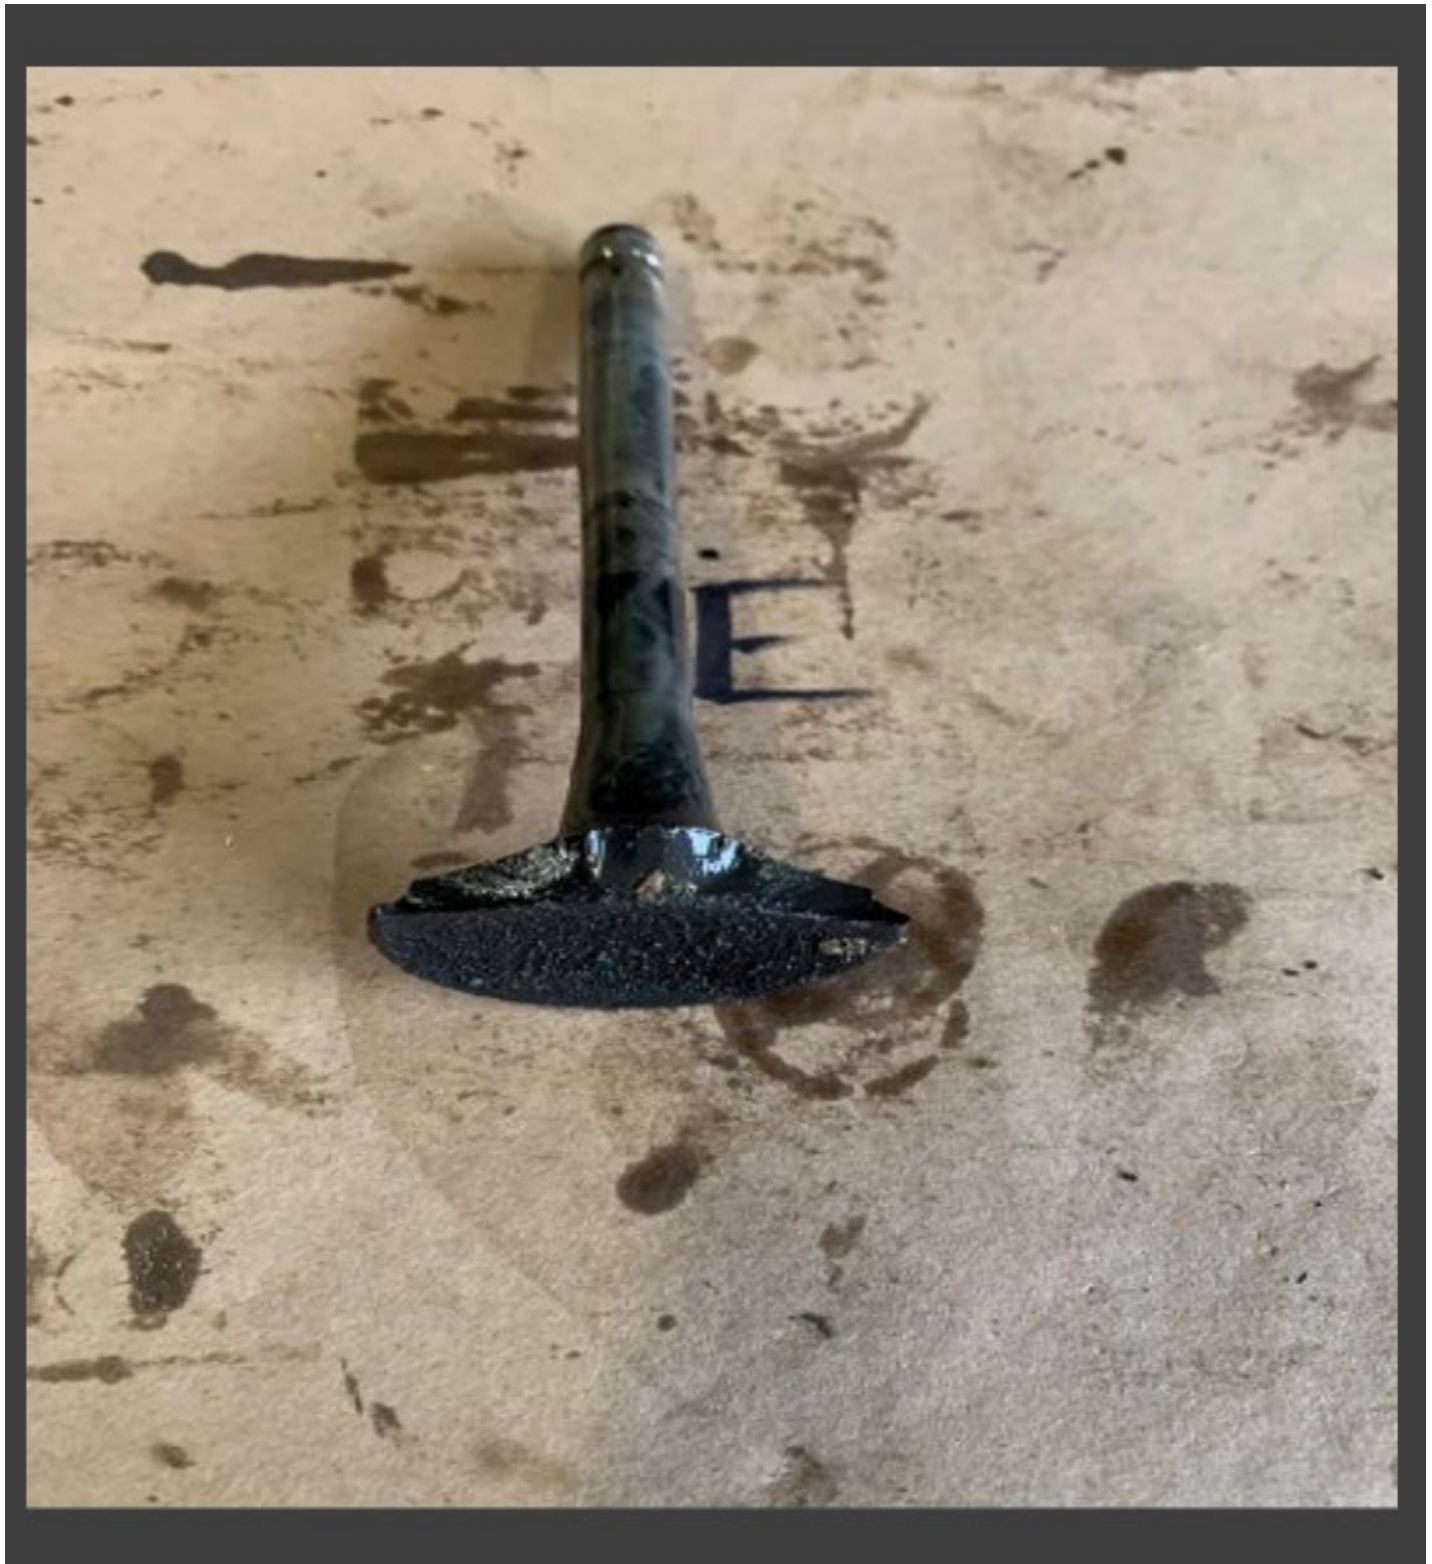
**Figure 11:** Profile view of No. 2 exhaust valve

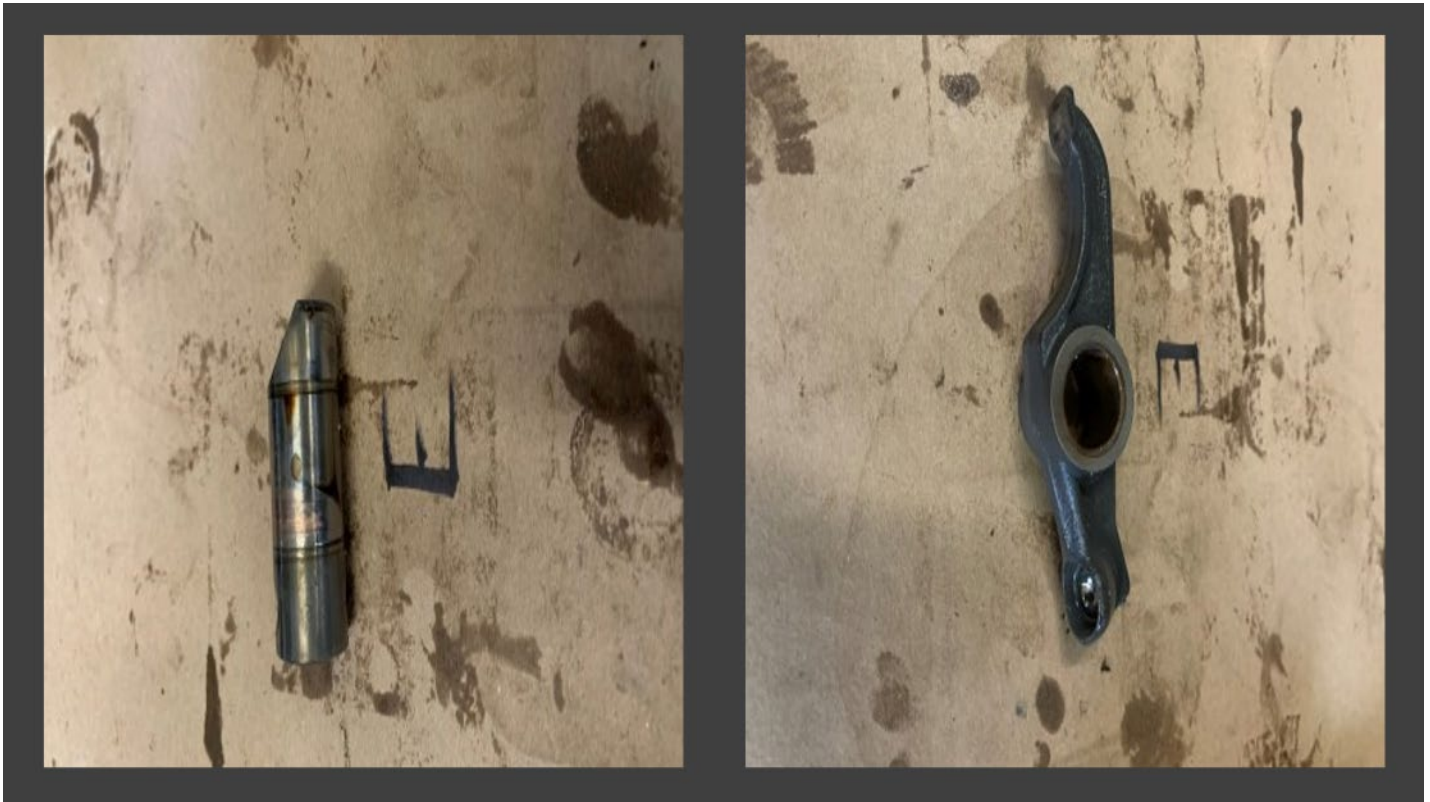
-No. 2 rocker arm severely worn, and rocker arm shaft severely worn.

**Figure 12:** View of No. 2 cylinder exhaust rocker arm & shaft

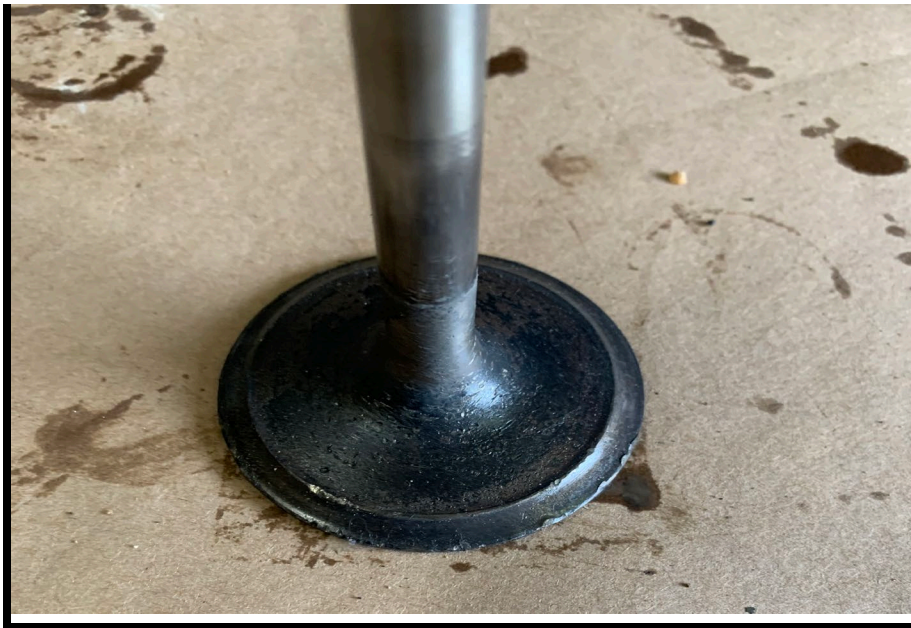
-Intake Valve exhibited dishing about the head. Intake valve also shows compression damage to the head. Exhaust valve stretched .007.

**Figure 13:** View of Cylinder #5 Intake Valve damage

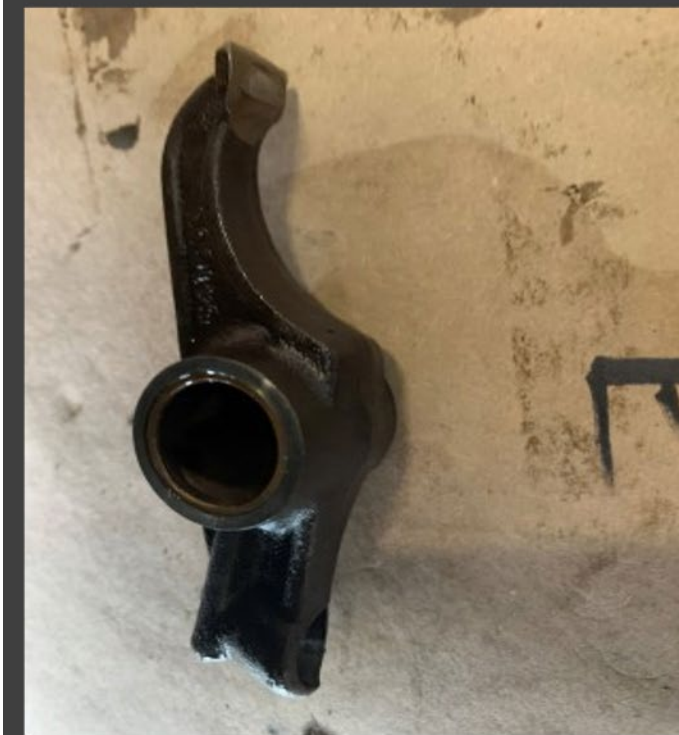
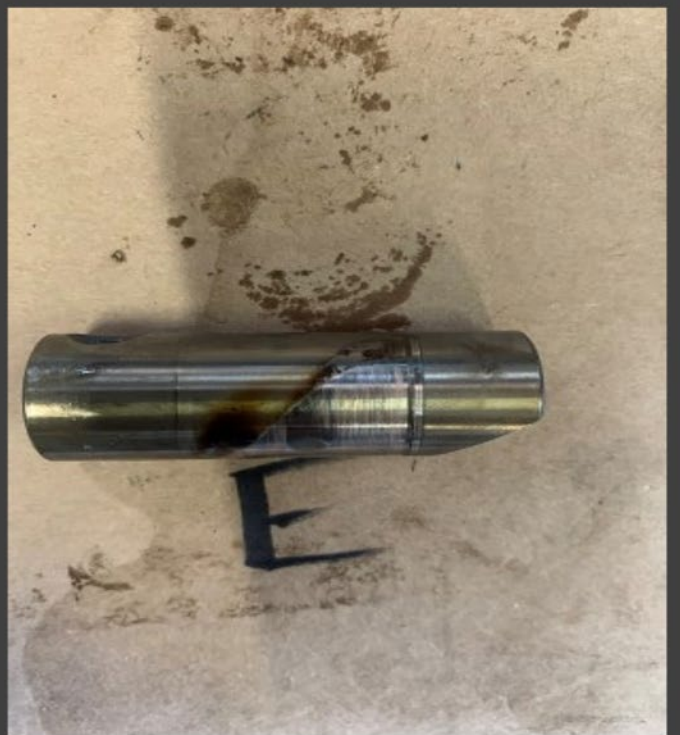
- Intake and exhaust rocker arms severely worn. Both intake rocker arm shafts severely worn.
- Exhaust rocker arm shaft worn .005

**Figure 14:** No. 5 exhaust rocker arm & shaft
