## **NATIONAL TRANSPORTATION SAFETY BOARD**

### **Specialist's Factual Report**

# **METEOROLOGY**

WPR21LA111

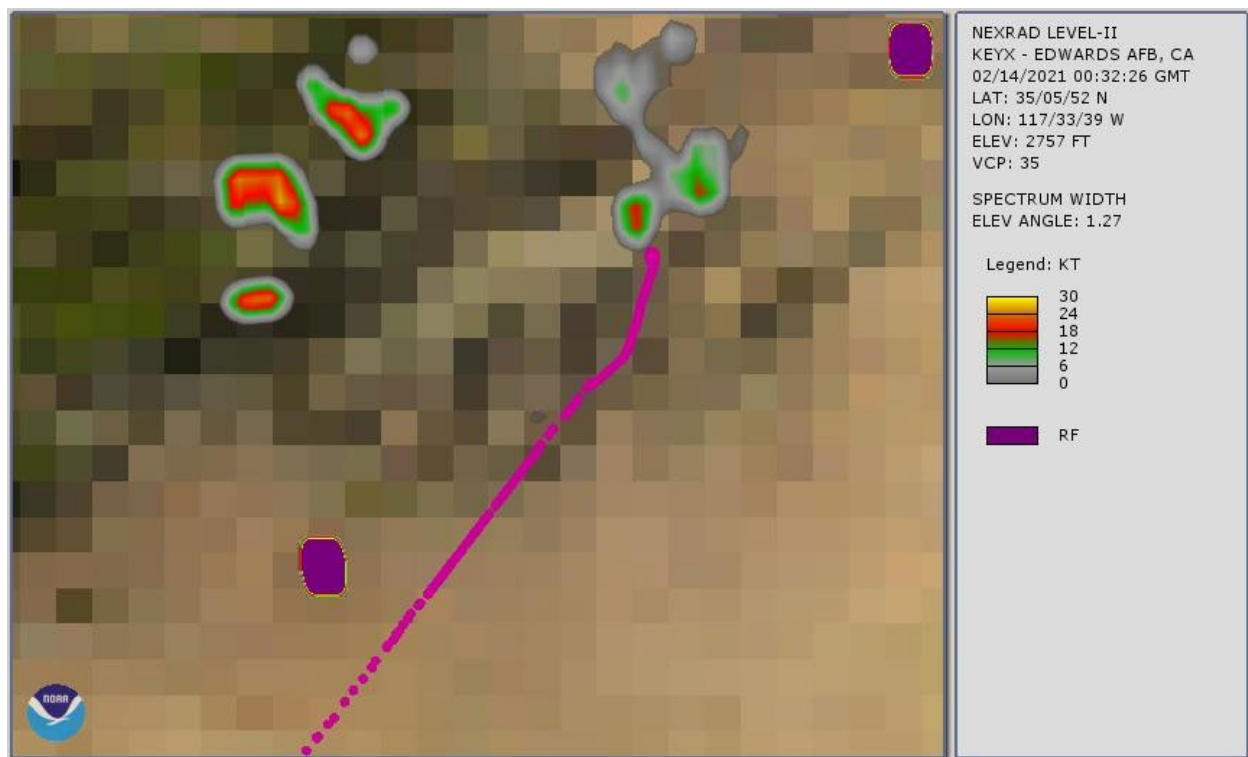
Figure 15 is the KEYX WSR-88D 1.27° spectrum width<sup>26</sup> image for 1632 PST, which showed strong shears in the echoes in the vicinity of the accident site, with shears between 18 and 24 knots.

Figure 15 - KEYX WSR-88D 1.27° spectrum width product for 1632 PST with the flight track
