**NATIONAL TRANSPORTATION SAFETY BOARD**

## **Non-Volatile Memory (NVM) Device**

### **Specialist's Factual Report**

Location: Edwards, CA  
Date: March 5, 2021  
Aircraft: Aermacchi Impala MB-326M  
Registration: N155TP  
Operator: Flight Research Inc  
NTSB Number: WPR21LA123

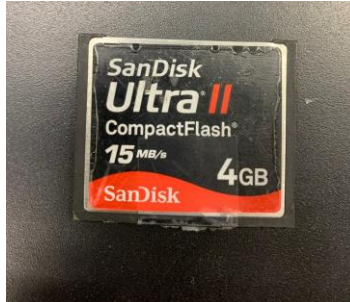
Upon arrival at the Vehicle Recorder Laboratory, an examination revealed the unit had sustained light impact damage. The device is shown in figure 1, as received. The device's plastic outer casing showed signs of heavy use. The outer casing was carefully opened, and the card's internal board was revealed to be slightly bent (figure 2).

**Figure 1.** Photo of CF card as received.

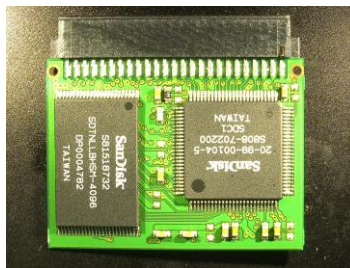
**Figure 2.** Photo of internal components.

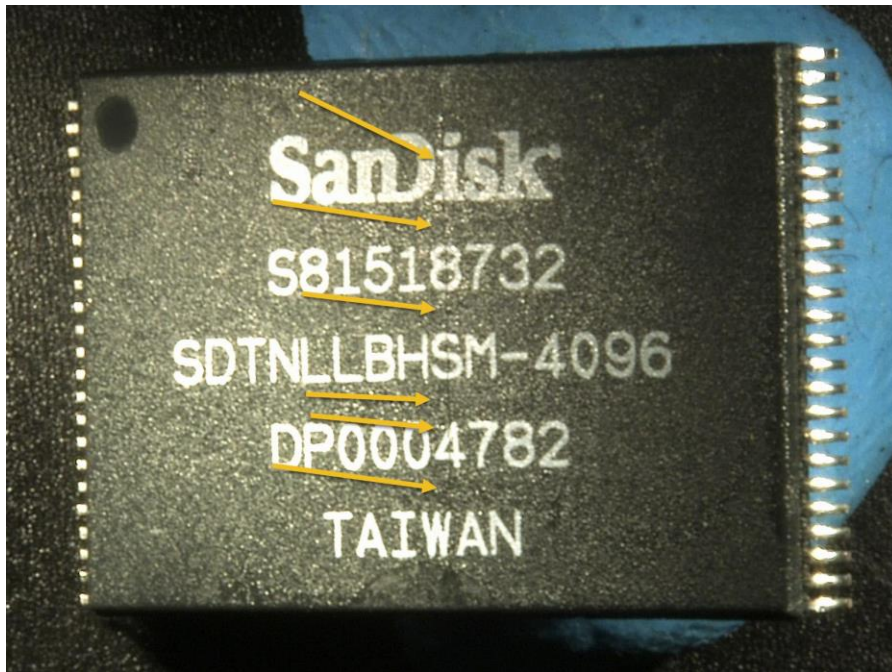
The NTSB received the card from the third-party lab on May 15, 2021. The CF card was subsequently re-examined. The 48-pin memory component was removed and inspected under a digital stereoscope. Figure 3 is a stereoscopic microscopy photo of the device taken on June 2, 2021. The device exhibited a crack along the face of the device when oriented in a manner to exploit external lighting. The crack is annotated in figure 3.

**Figure 3.** Stereoscopic microscopy photo of 48-pin memory component exhibiting a crack. The crack is annotated.

Cracks to an NVM component's external packaging often cause damage to the internal silicon die. If the internal silicon die is damaged, there are no known repair methods and results in a data loss situation. X-ray imagery of this type of damage are insufficient to image the damage, as the silicon die is too lightweight to image with an x-ray device. Instead of x-raying the device, a Confocal Scanning Acoustic Microscope (C-SAM) can be used to image the internal silicon die. A C-SAM evaluation of this component was not available for this investigation.

In lieu of a C-SAM evaluation, the 48-pin memory component was removed from the device and was attempted to be read with a specialized 48 pin reader designed specifically for this chip. Communication was unable to be established with the 48-pin memory component, the silicon die was assumed to be damaged, and no data was recovered.

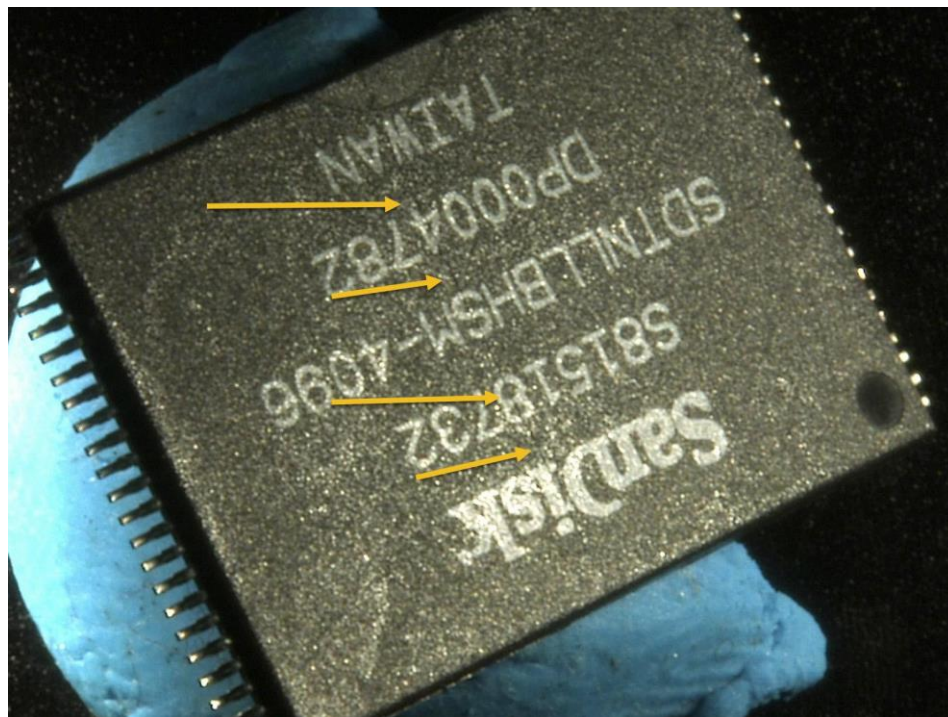
Figure 4 is an alternate view of the same crack, with external lighting used in such a way to highlight the crack.

**Figure 4.** Alternate stereoscopic microscopy photo of 48-pin memory component exhibiting a crack. The crack is annotated.

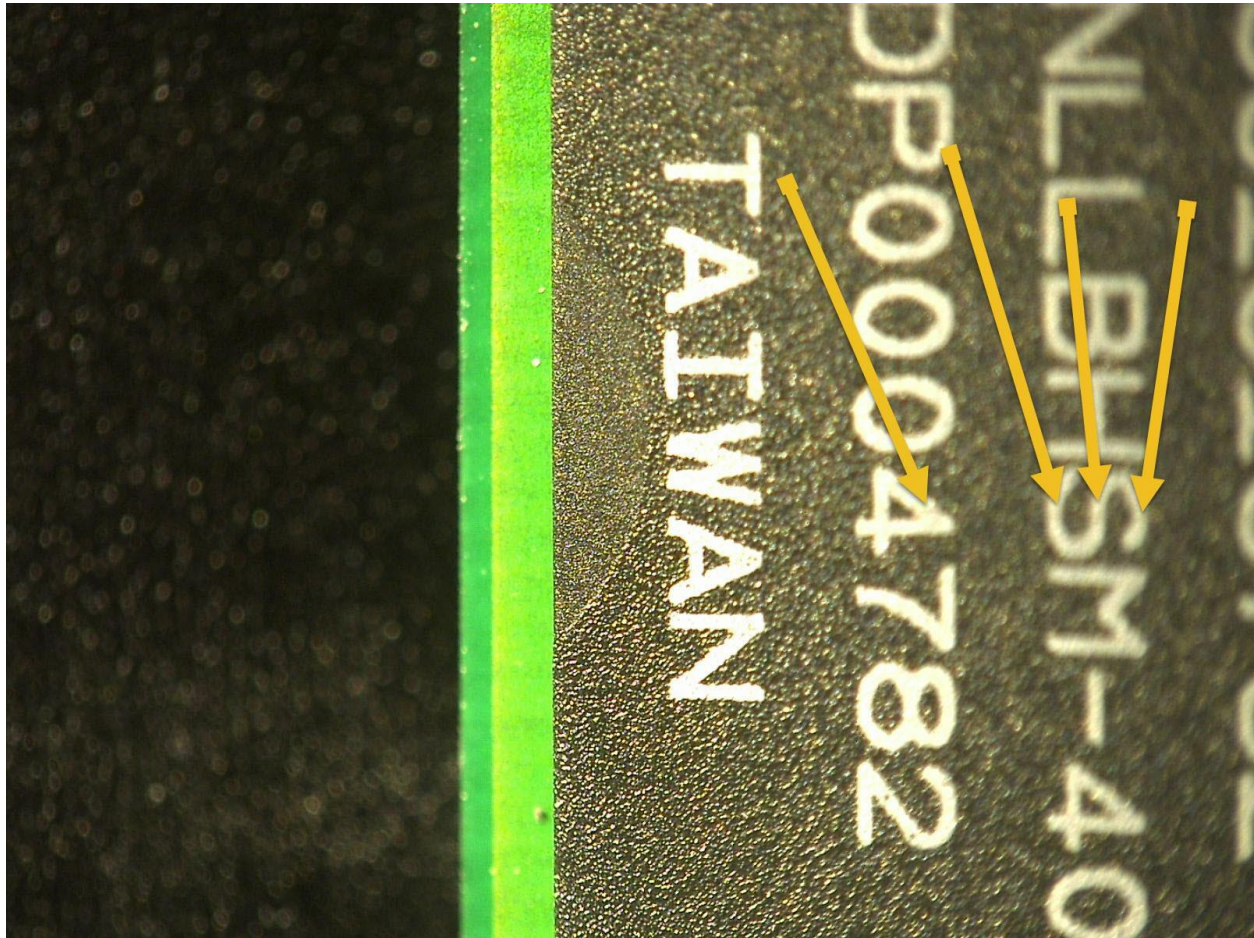
Older photos of the device, prior to being sent to the third-party lab, were then re-evaluated for evidence of the crack prior to shipment. Figure 5 is a photo taken on April 25, 2021, prior to shipment and third-party evaluation. The figure is annotated to show evidence of the potentially cracked area, congruent with the location of the crack later discovered in figures 3 and 4, above.

**Figure 5.** Re-evaluation of initial stereoscopic microscopy taken on April 25, 2021 at the NTSB lab.
