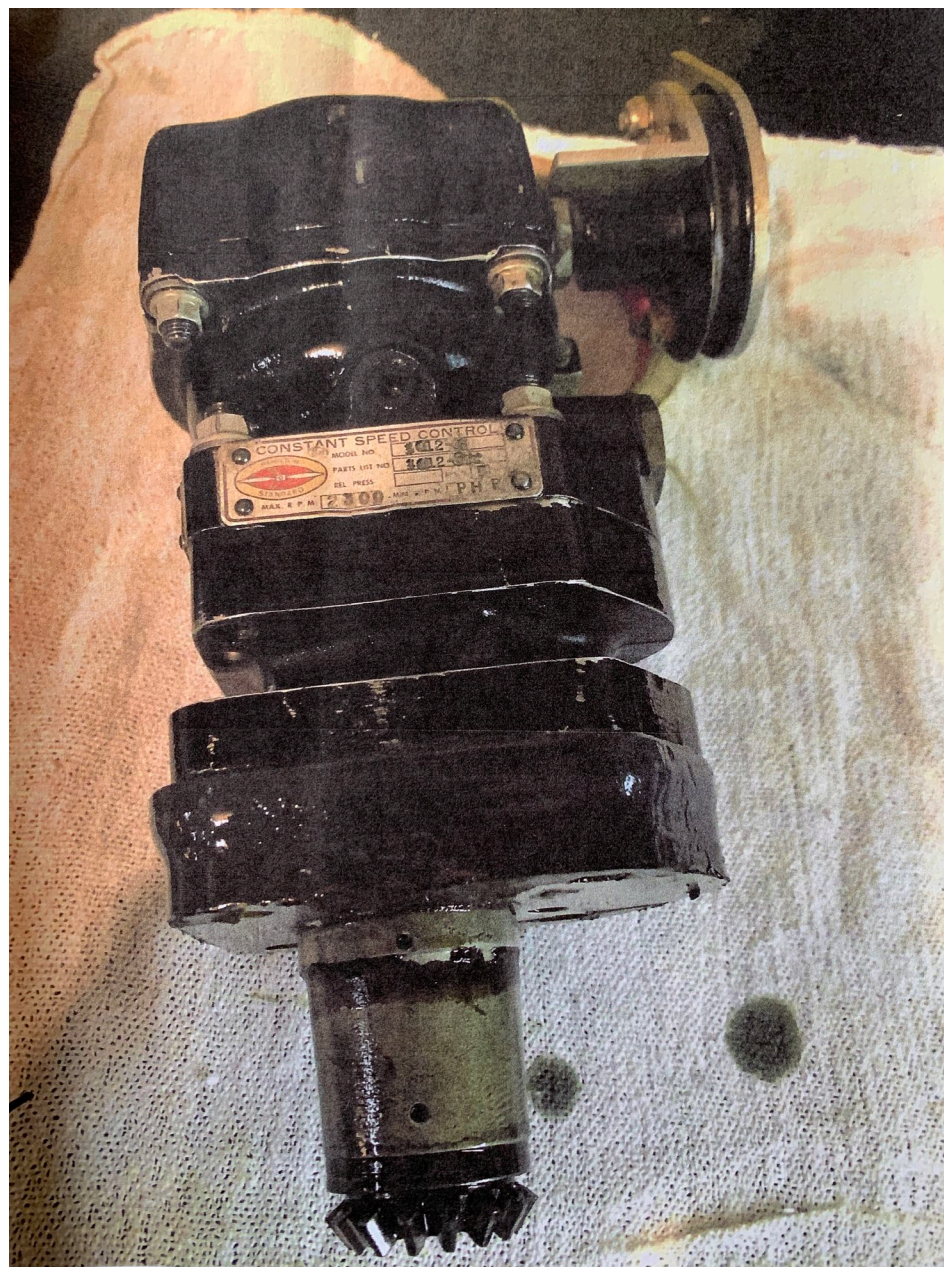
**Photo 1 – View of removed propeller governor (View of propeller governor gasket (courtesy of Wings West Exchange & Overhaul, Inc)**

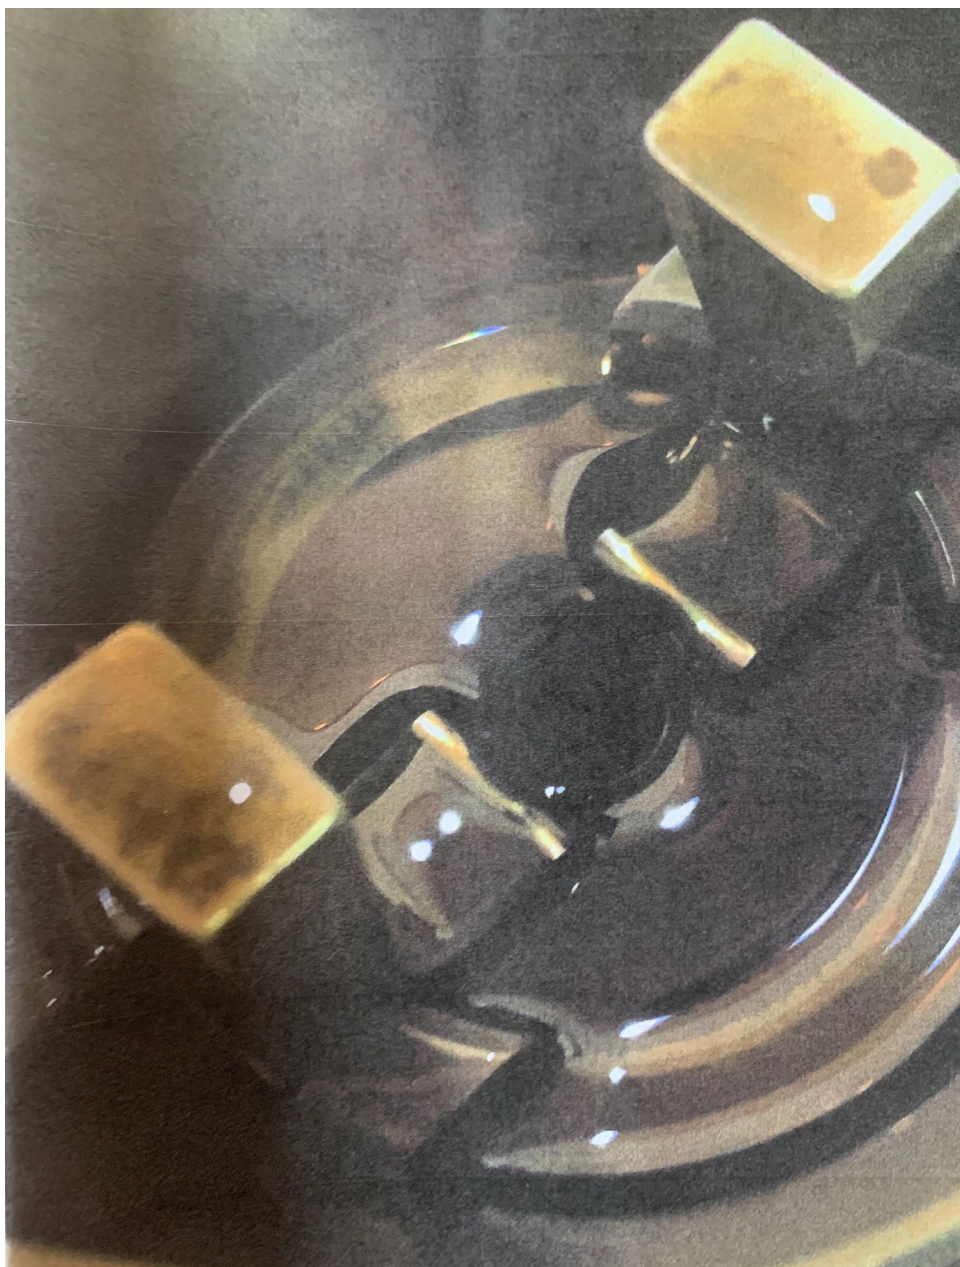
**Photo 2 – View of propeller governor fly weights (courtesy of Wings West Exchange & Overhaul, Inc)**

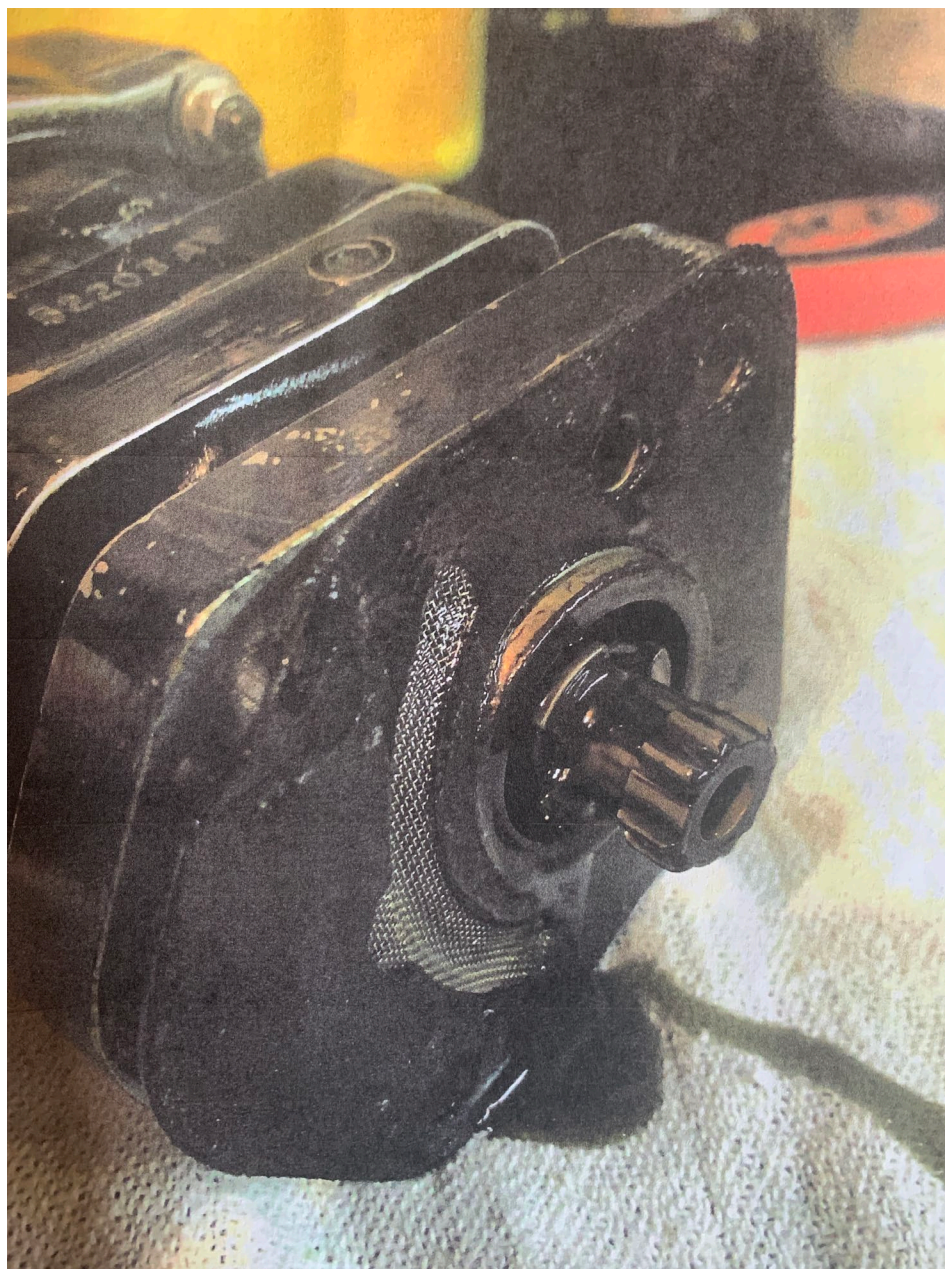
**Photo 3 – View of propeller governor drive gear (View of propeller governor gasket (courtesy of Wings West Exchange & Overhaul, Inc))**

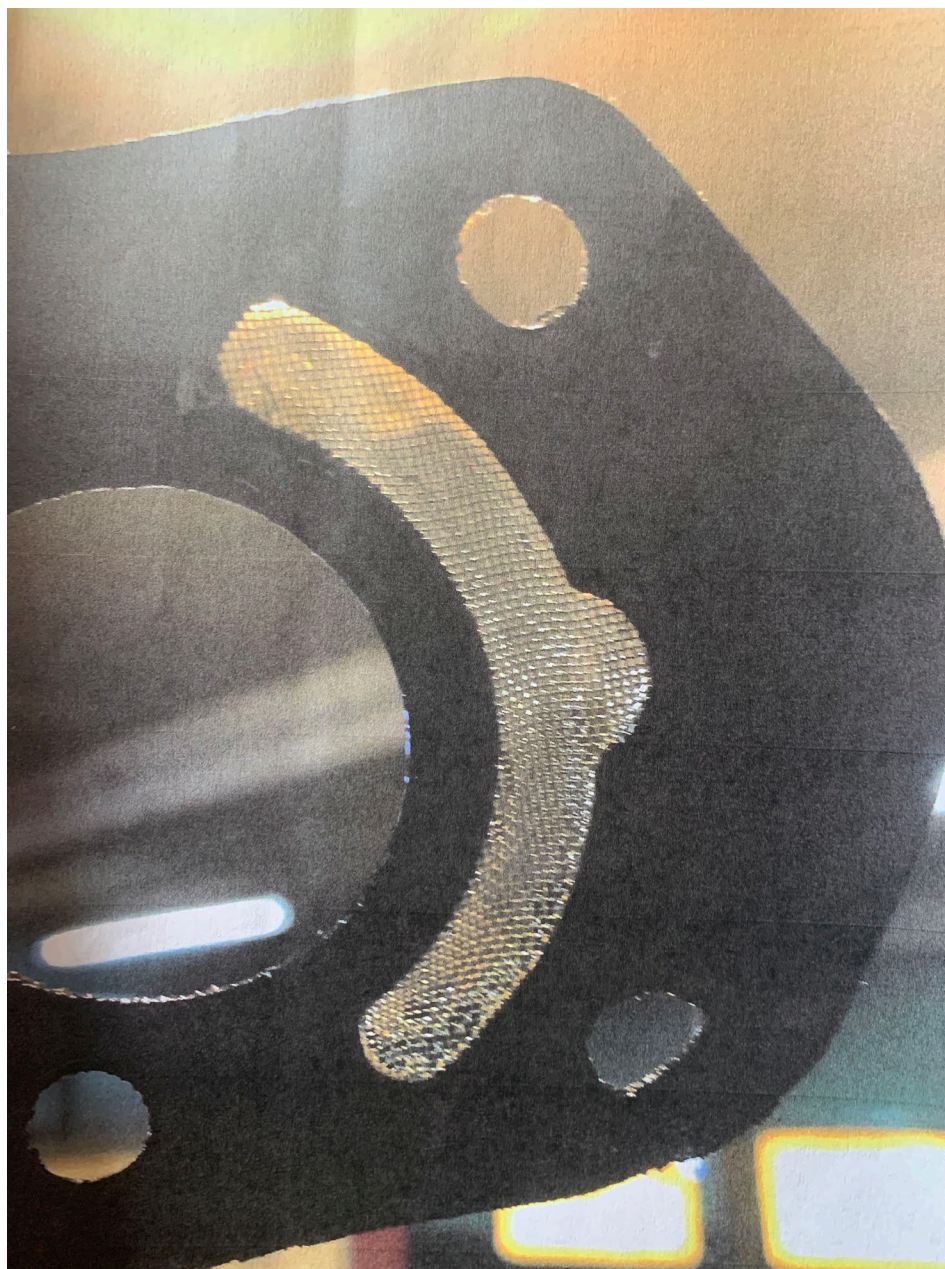
**Photo 4 – View of propeller governor mounting gasket (courtesy of Wings West Exchange & Overhaul, Inc)**

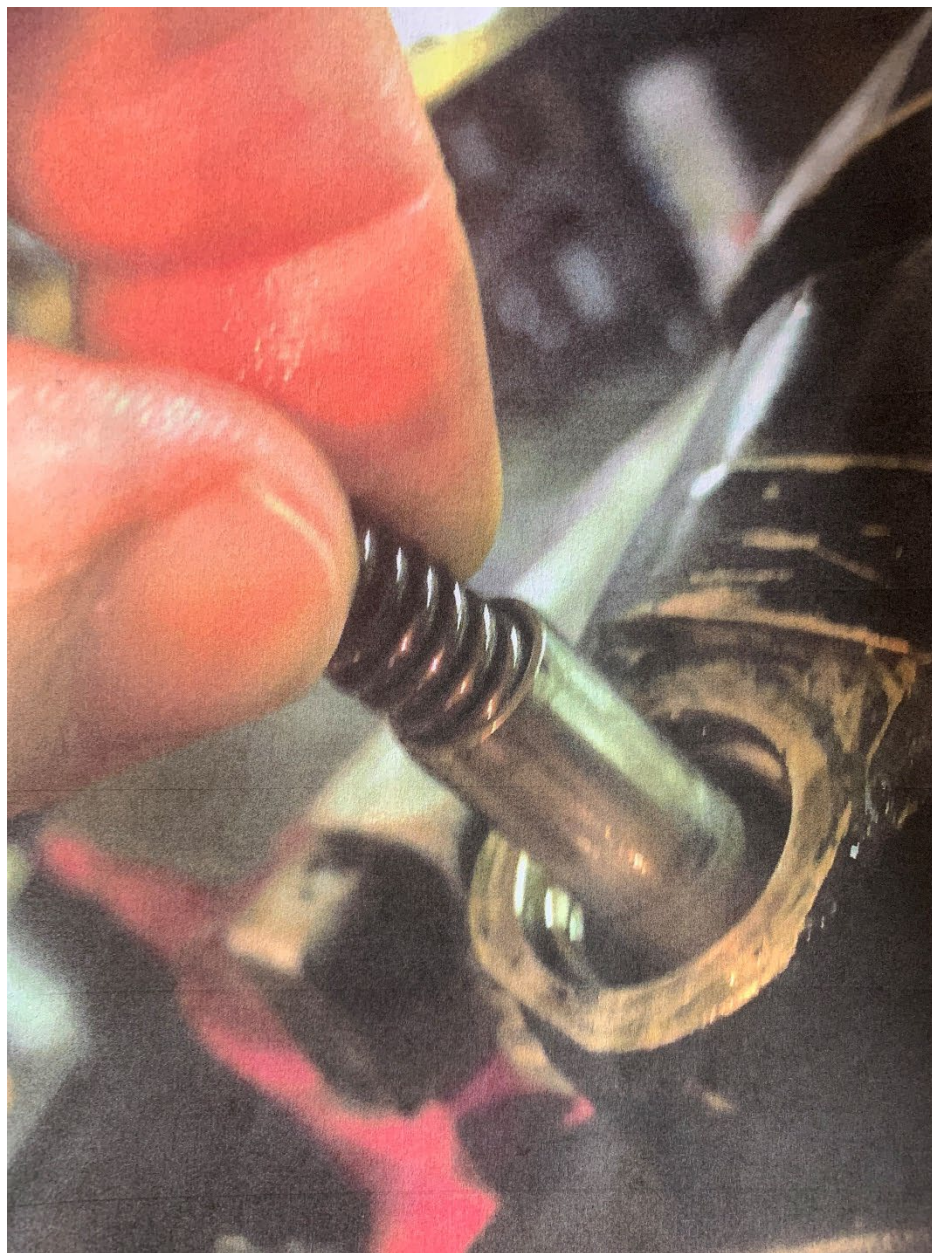
**Photo 5 – View of relief valve spring removed from relief valve plunger (courtesy of Wings West Exchange & Overhaul, Inc)**

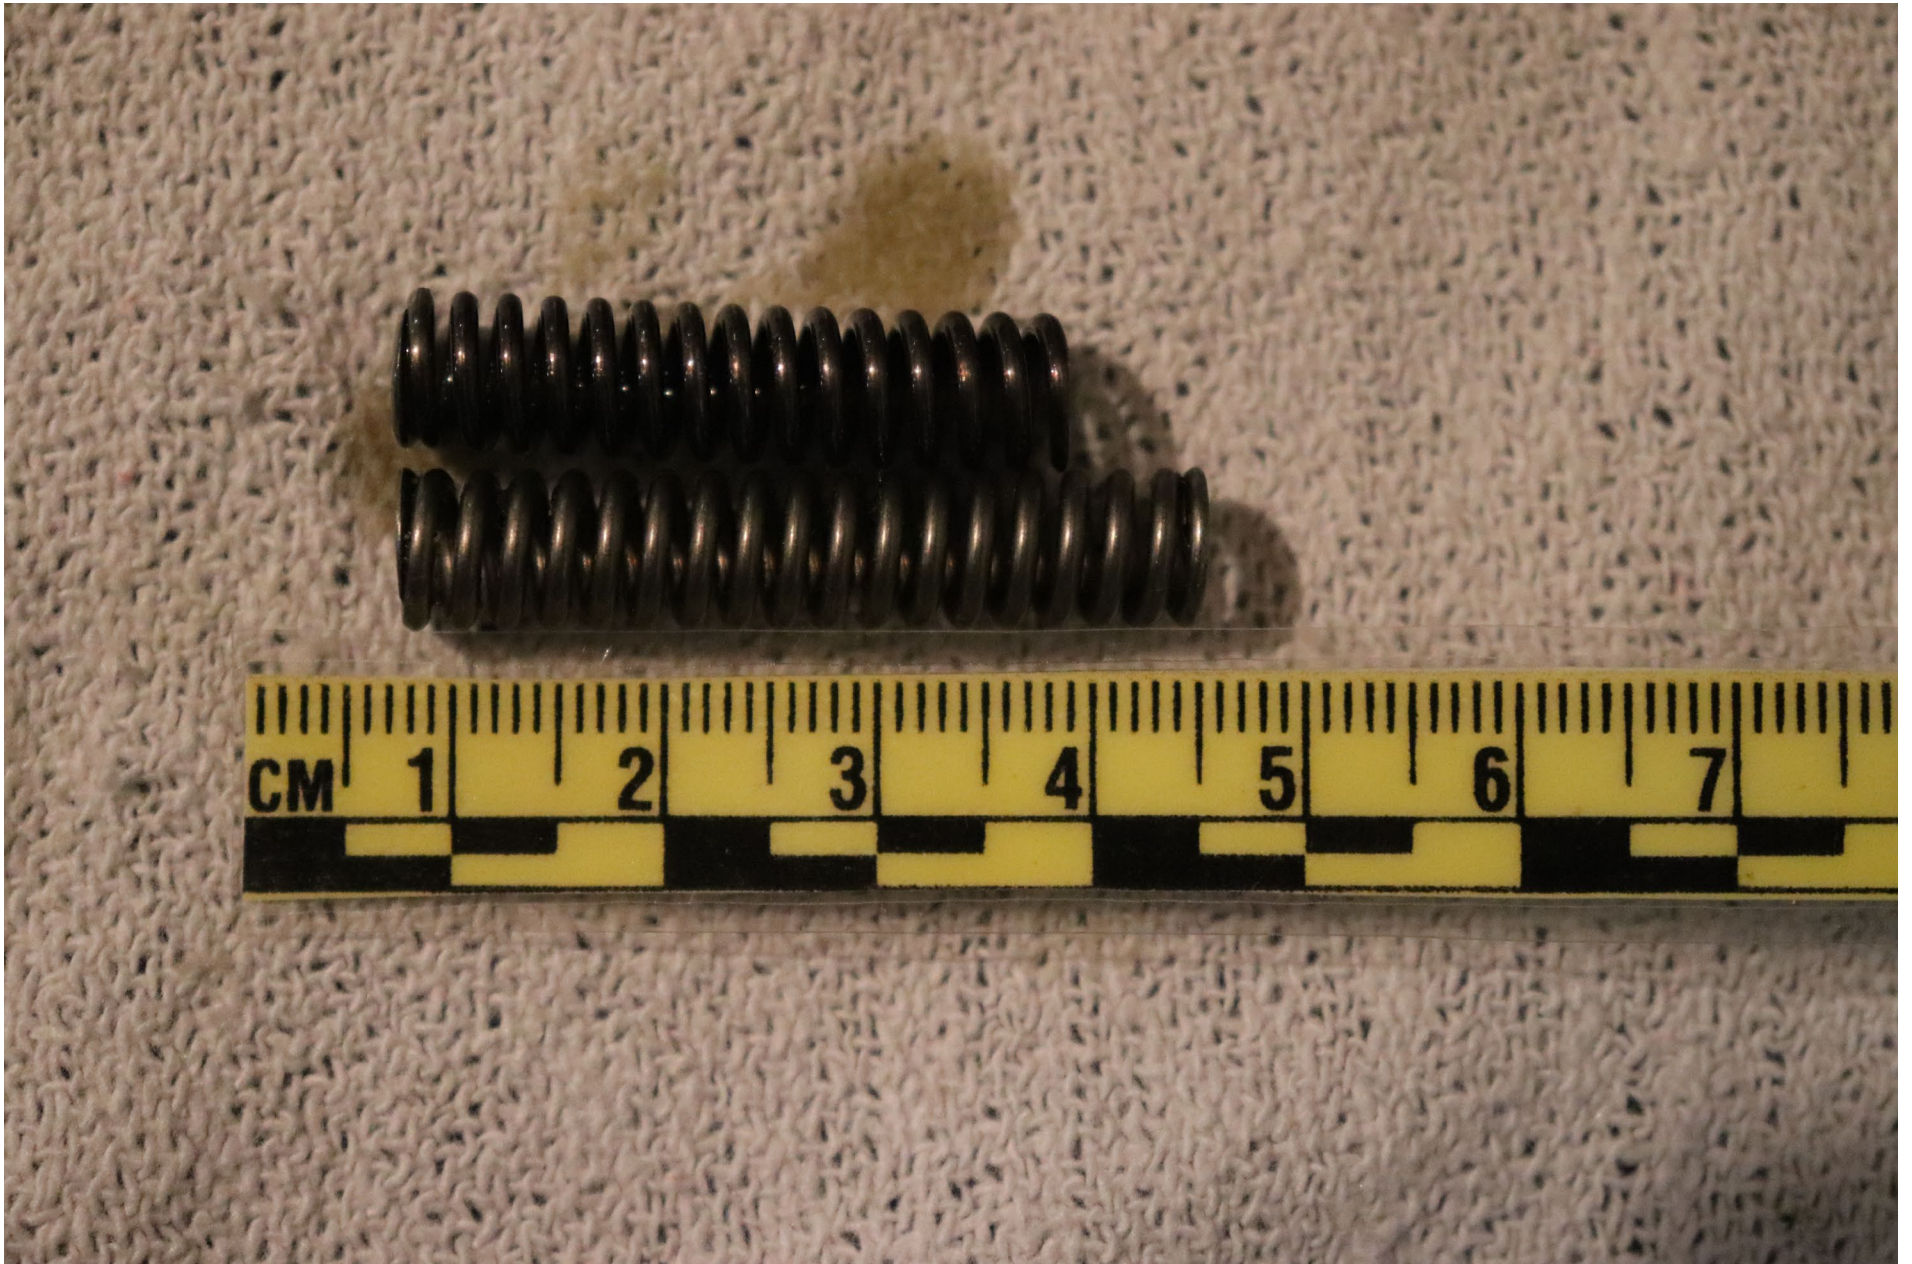
**Photo 6 – Comparison in length of relief valve springs. Upper spring is the removed spring, and the lower spring is an exemplar spring (courtesy of Wings West Exchange & Overhaul, Inc)**

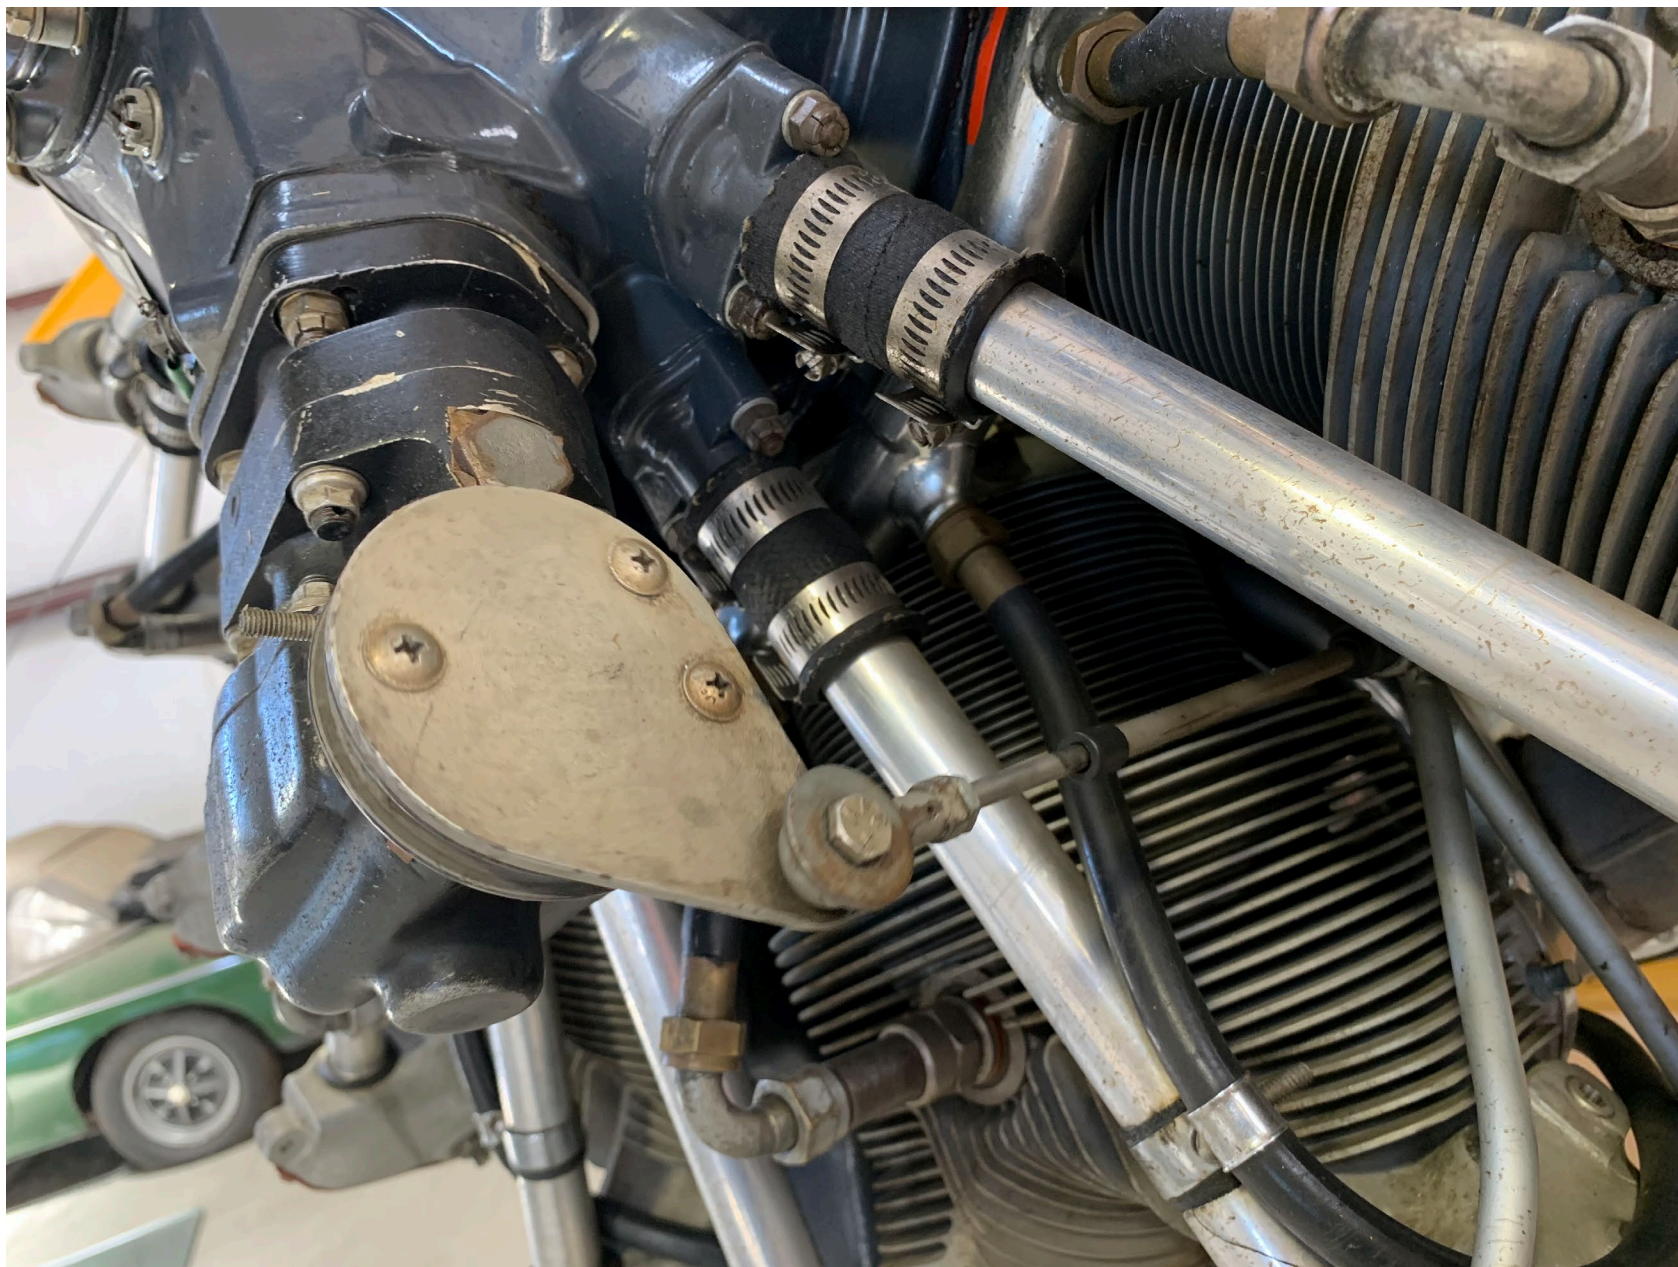
**Photo 7 – View of Propeller Governor installed on accident engine (photo courtesy of FAA)**
