**Subject:** WPR21LA344

The attached is a summary of airplane damage provided to Inspector Ruconich by the pilot on August 26, 2021.

### **N3186Y Fork, Firewall & Wing Inspection – 8/25/2021**

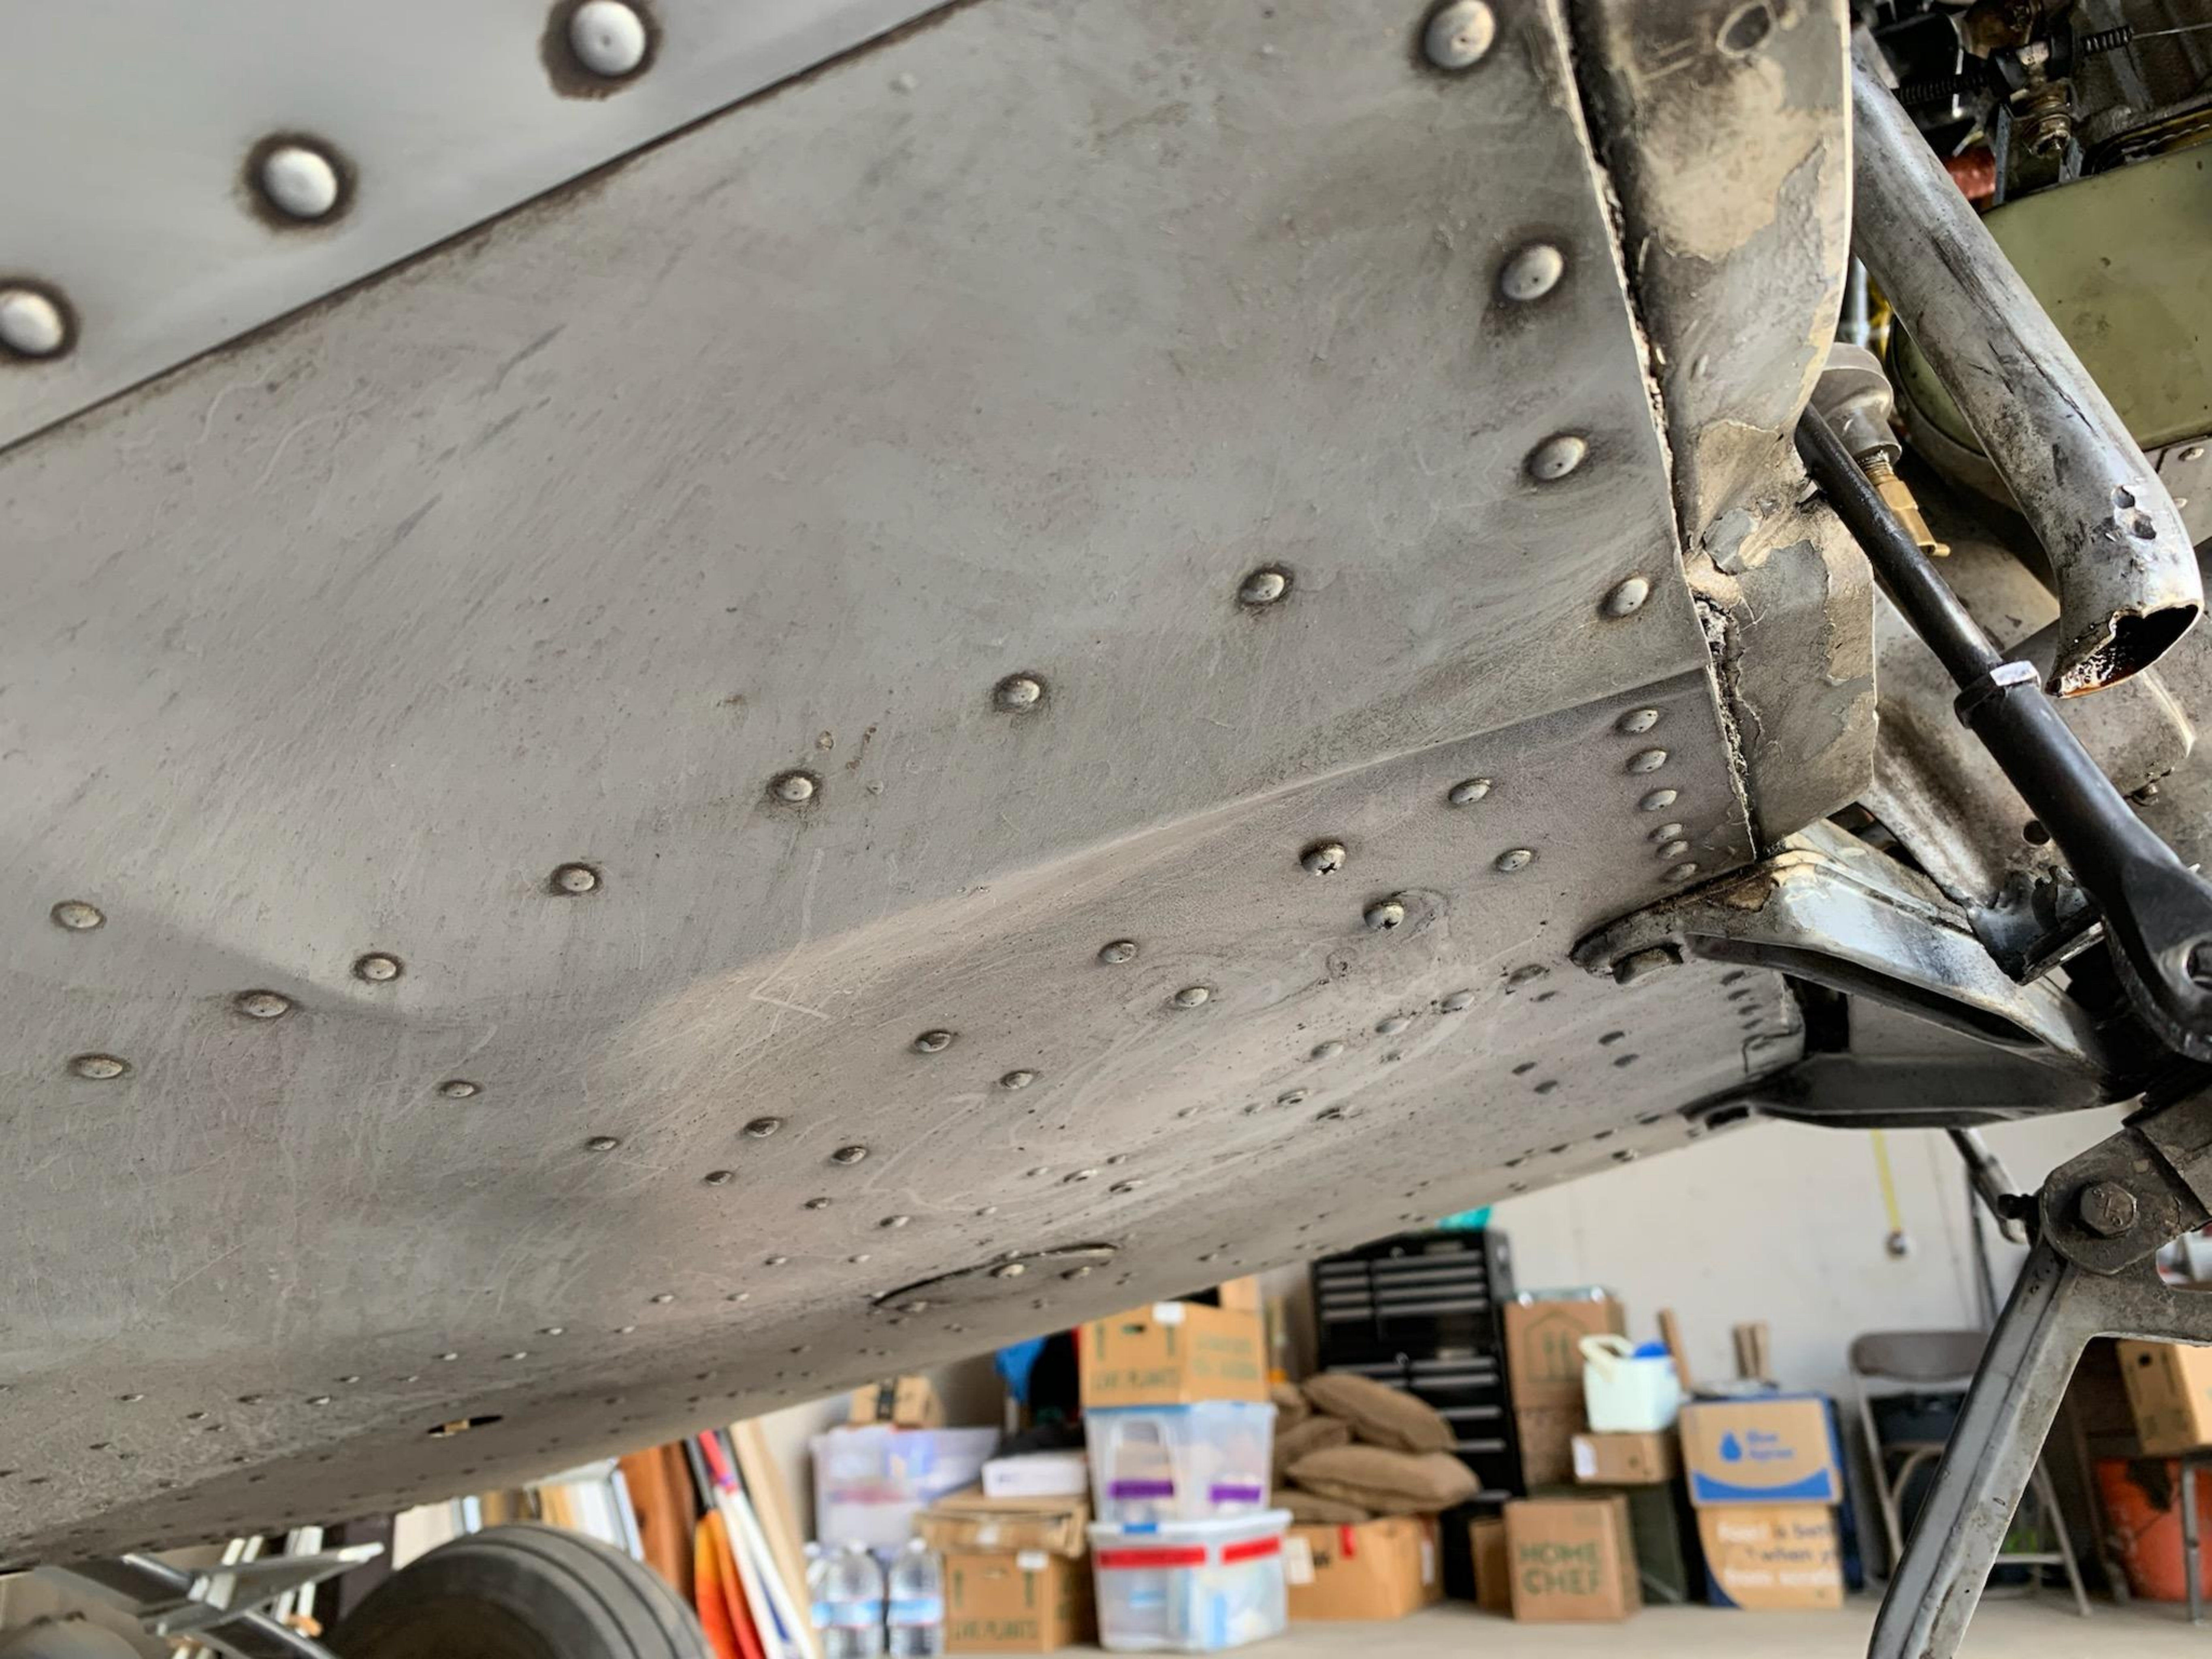
1. Fuselage belly, right side. Wrinkles at first two bays aft of firewall.
2. Fuselage belly. Wrinkles first two bays back from firewall.
3. Wrinkles just above nose gear upper mount and on right side of lower firewall.

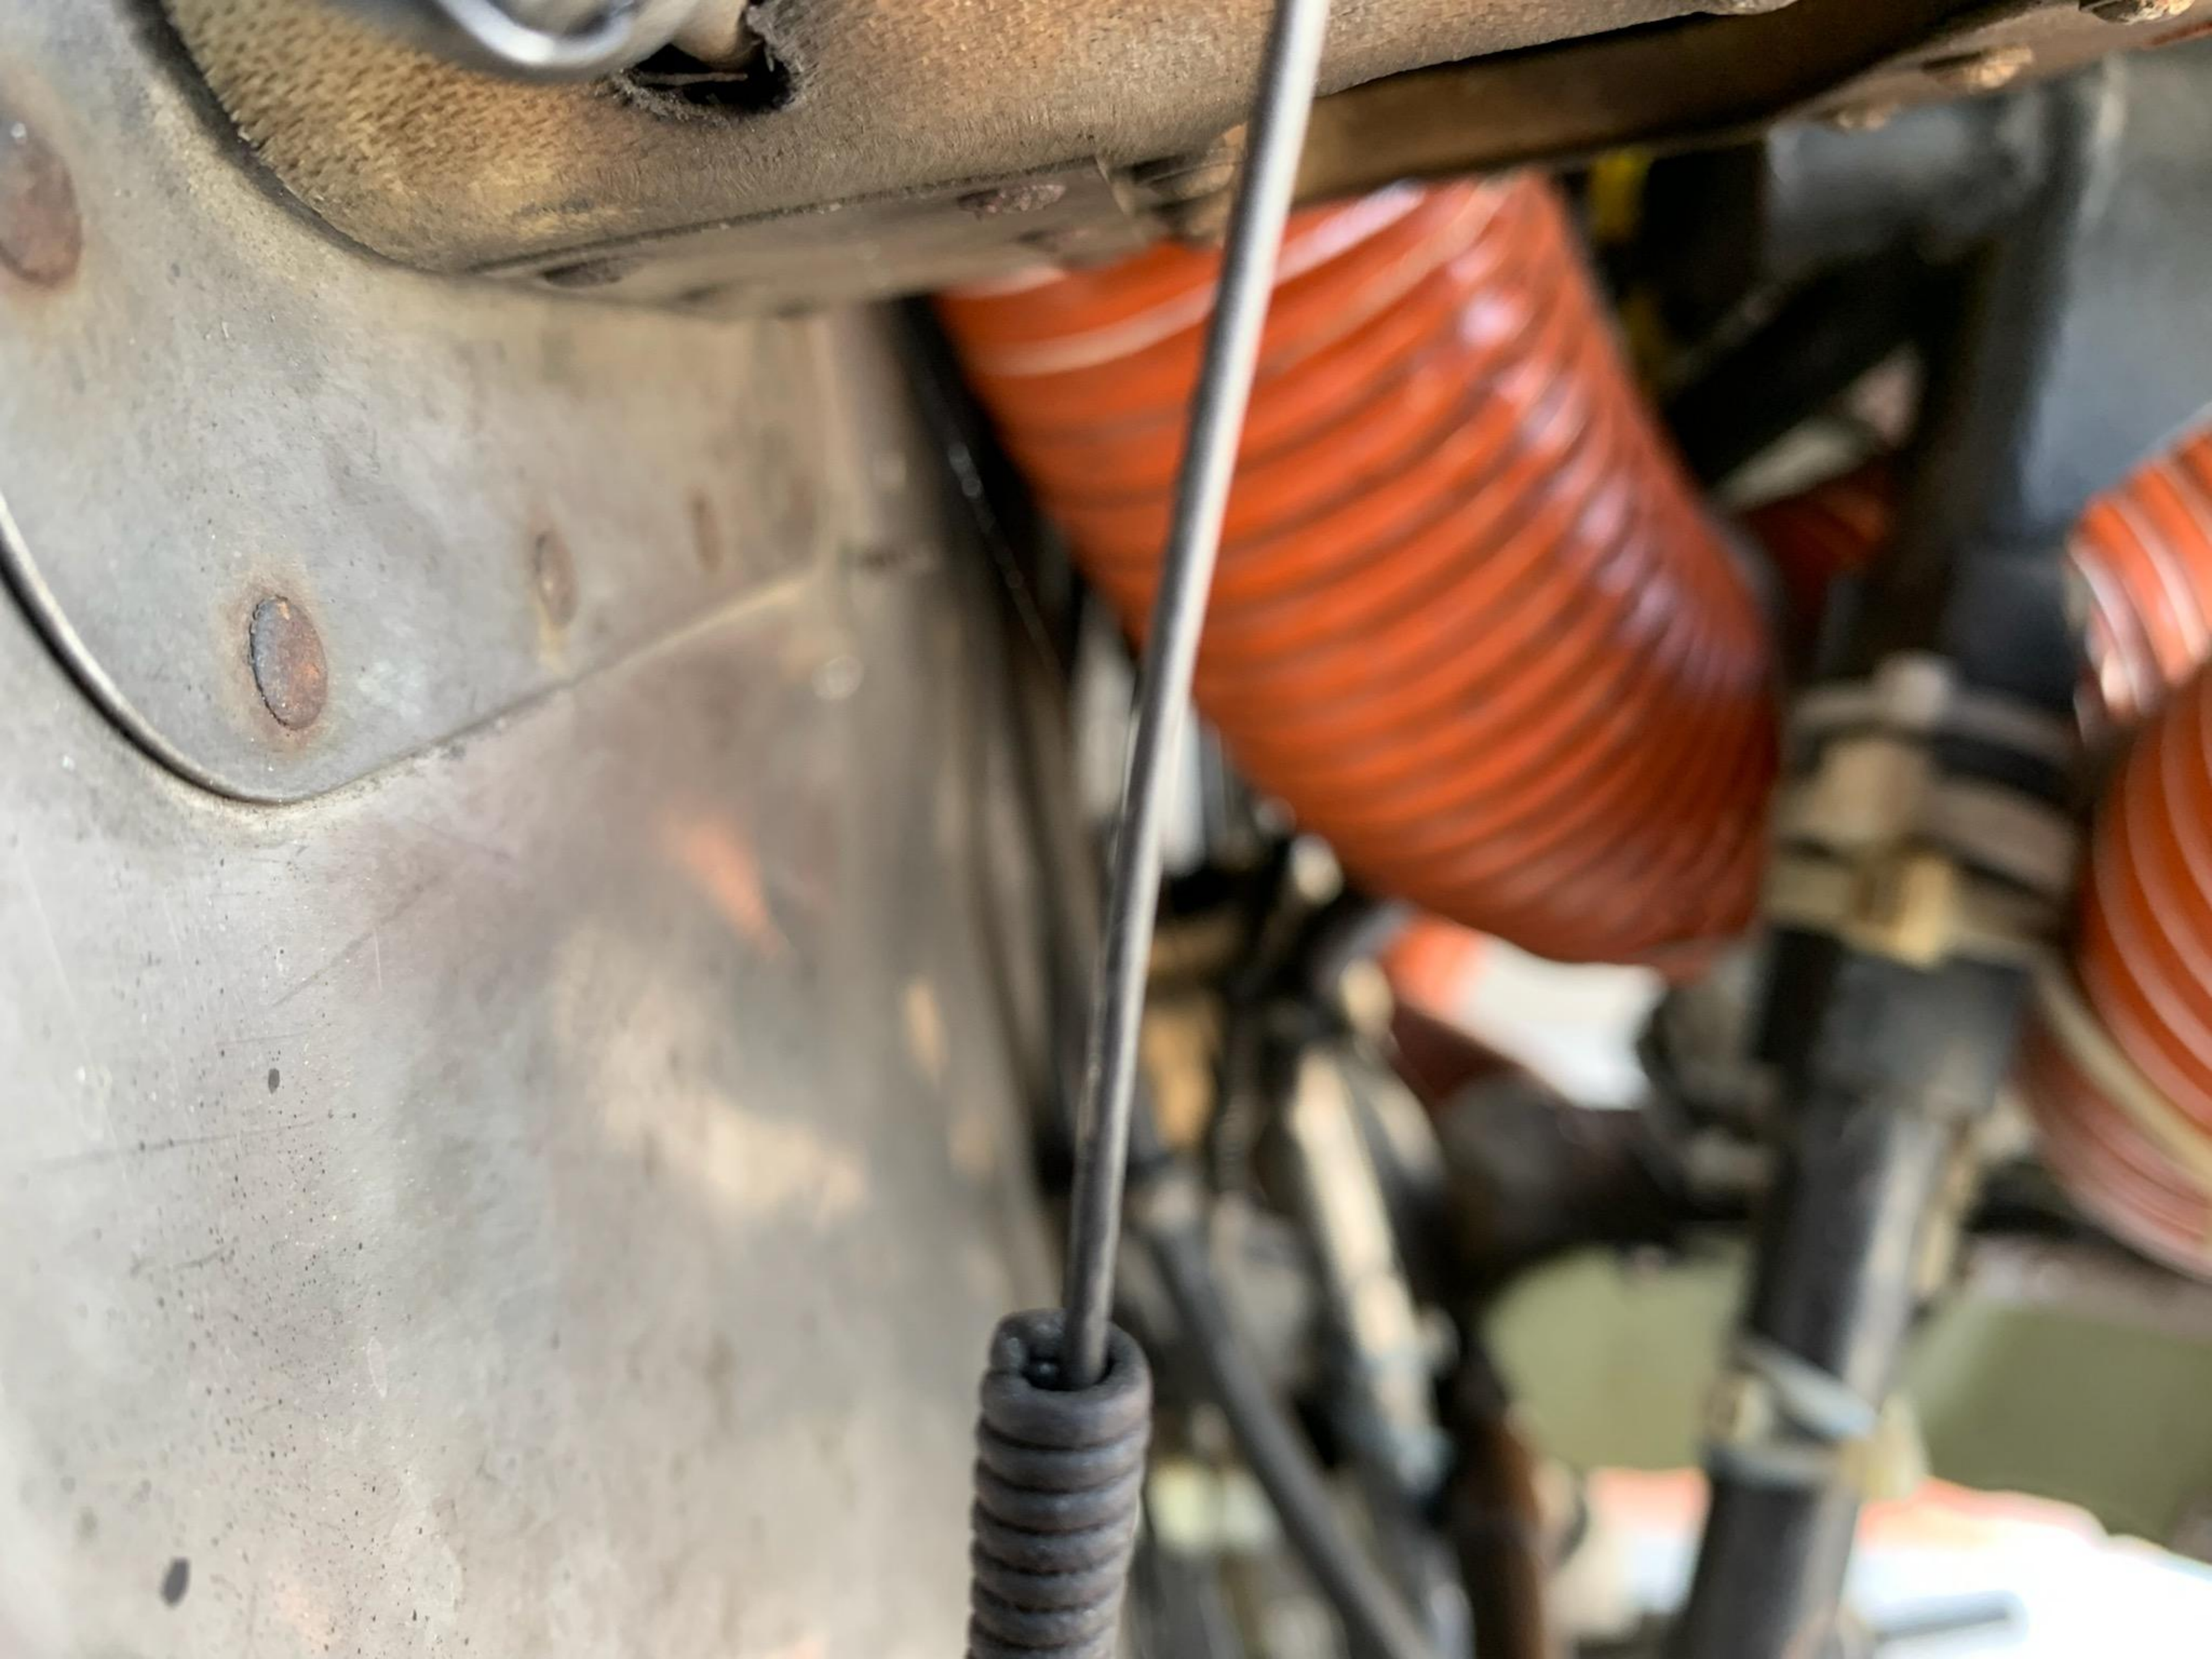
11. This is the left side looking to the right, referencing the rivet row, from previous photo. Notice the upper strut mount also for reference.
12. Left side of upper strut mount.

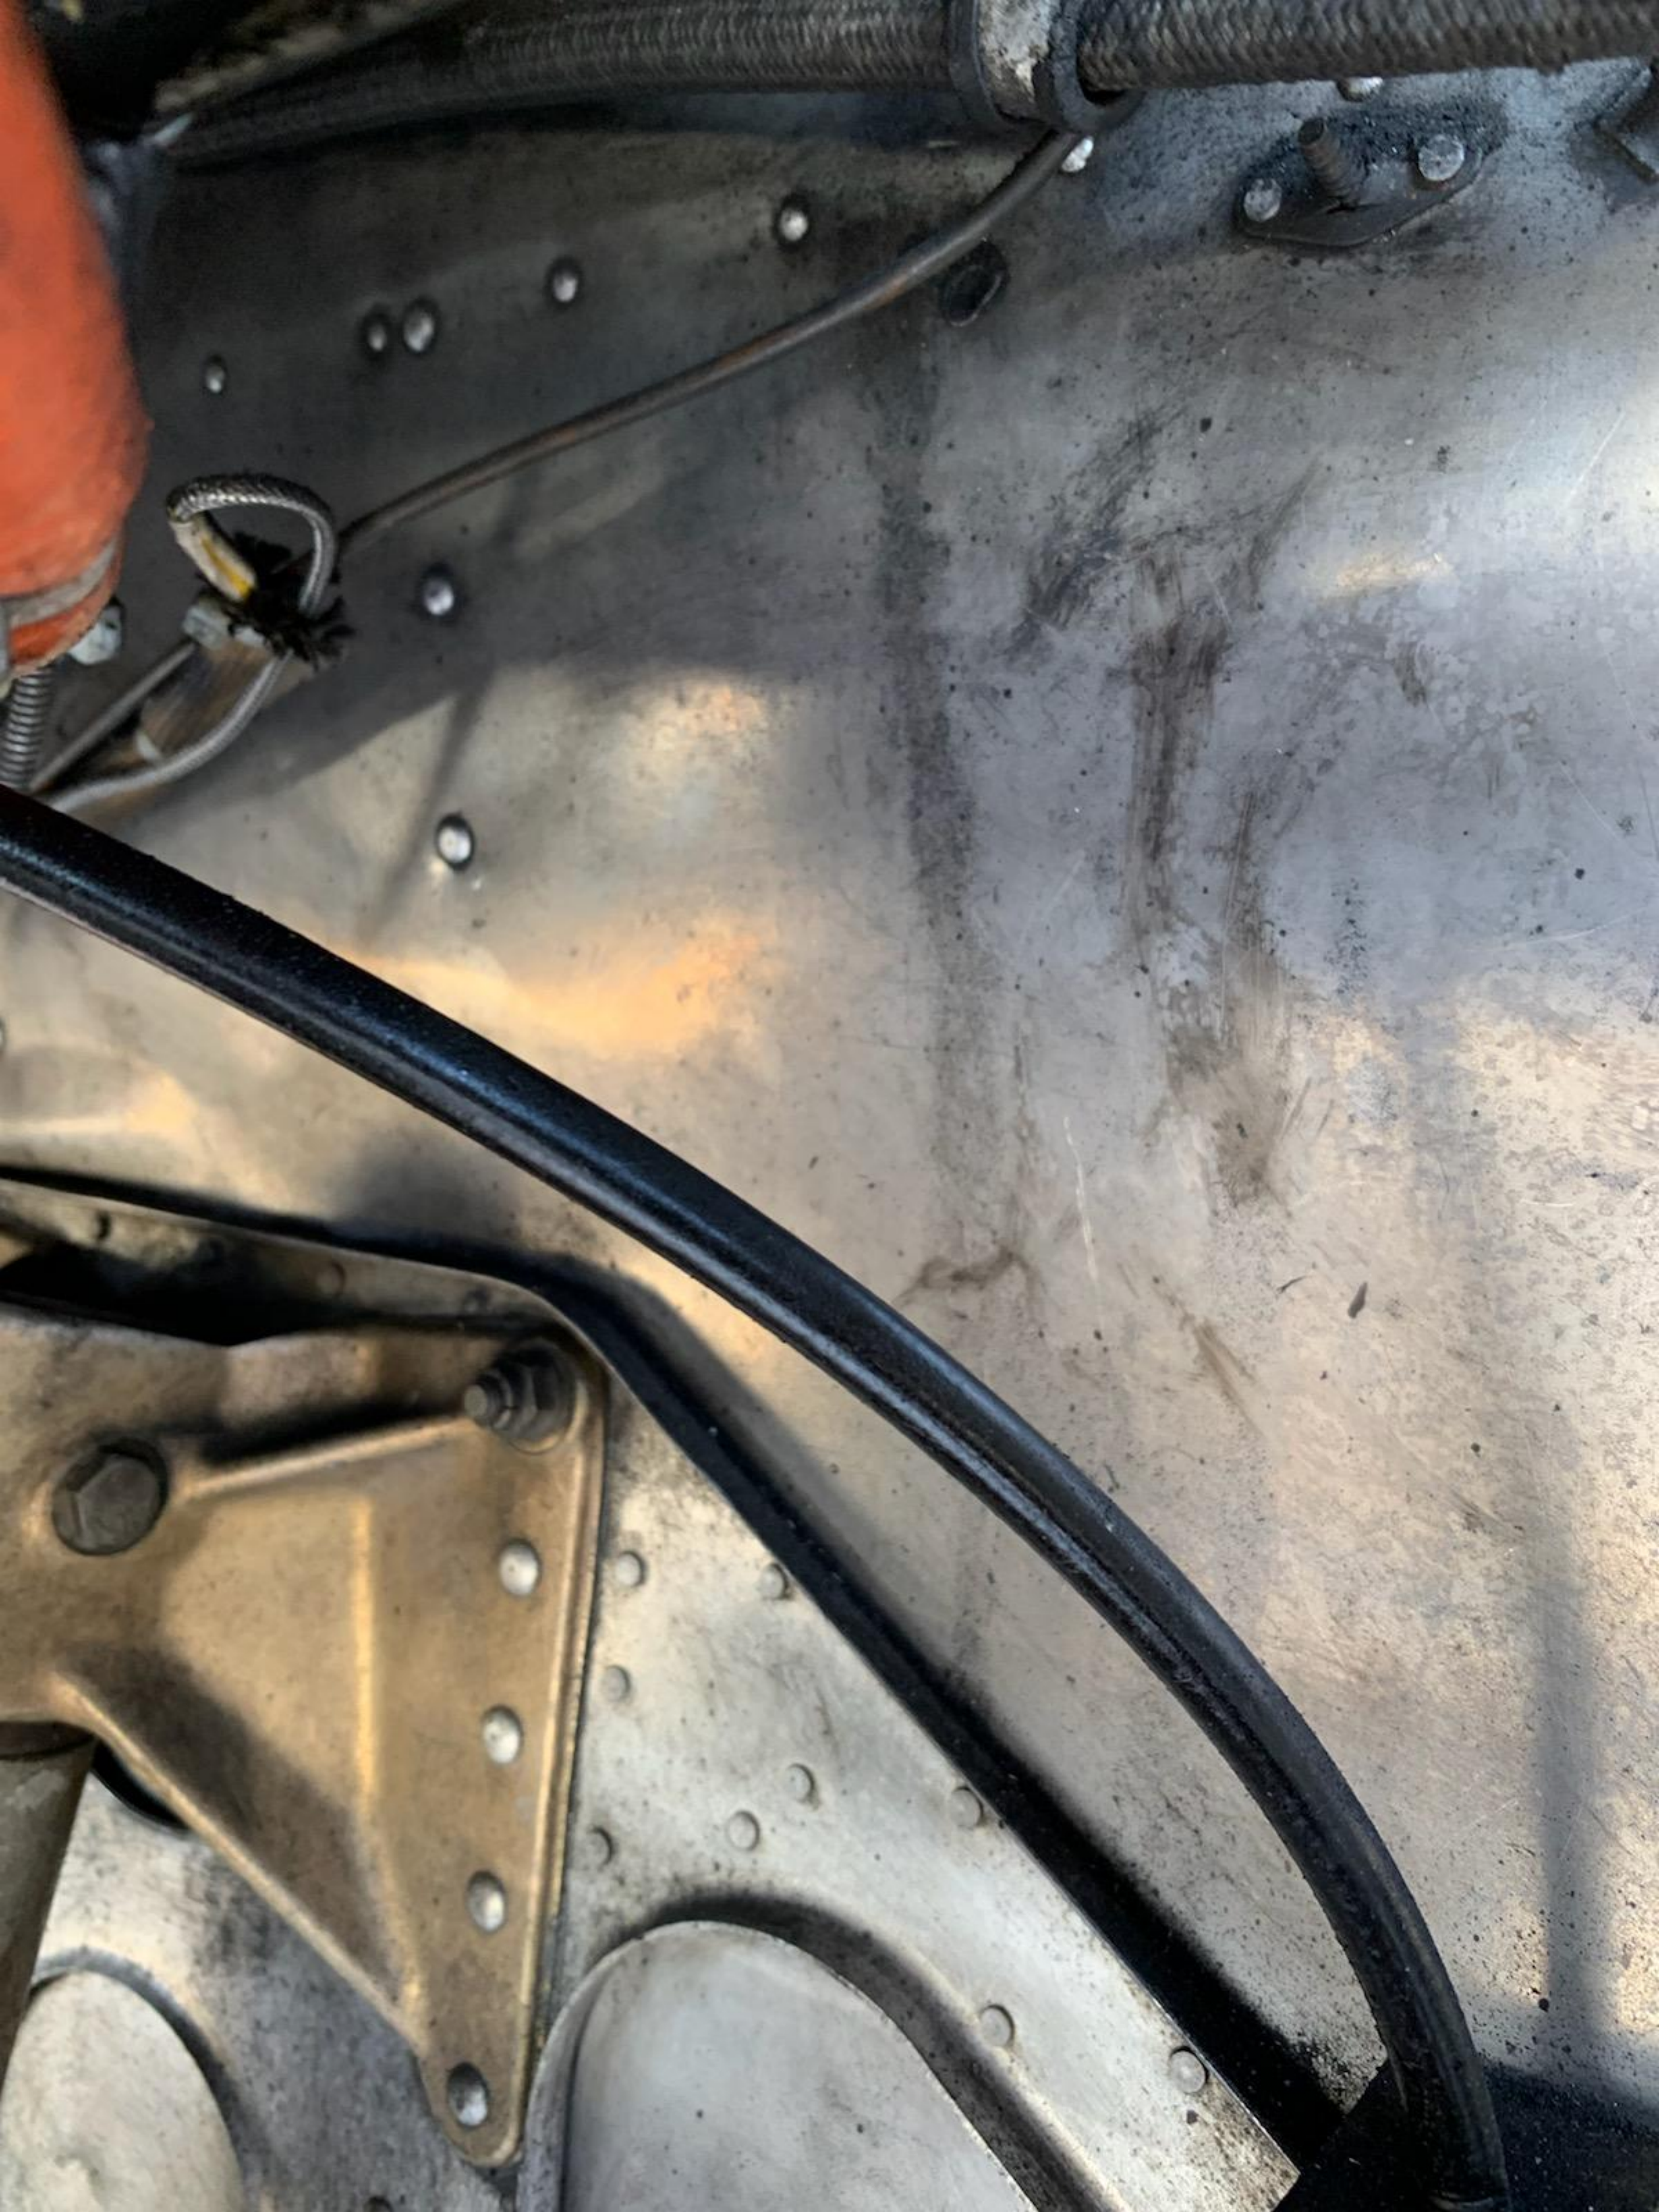
13. Reference rivet row at the top of photo. From this row down is where the initial inspection shows the damage to the firewall.
14. Another view of wrinkled fuselage belly skin.

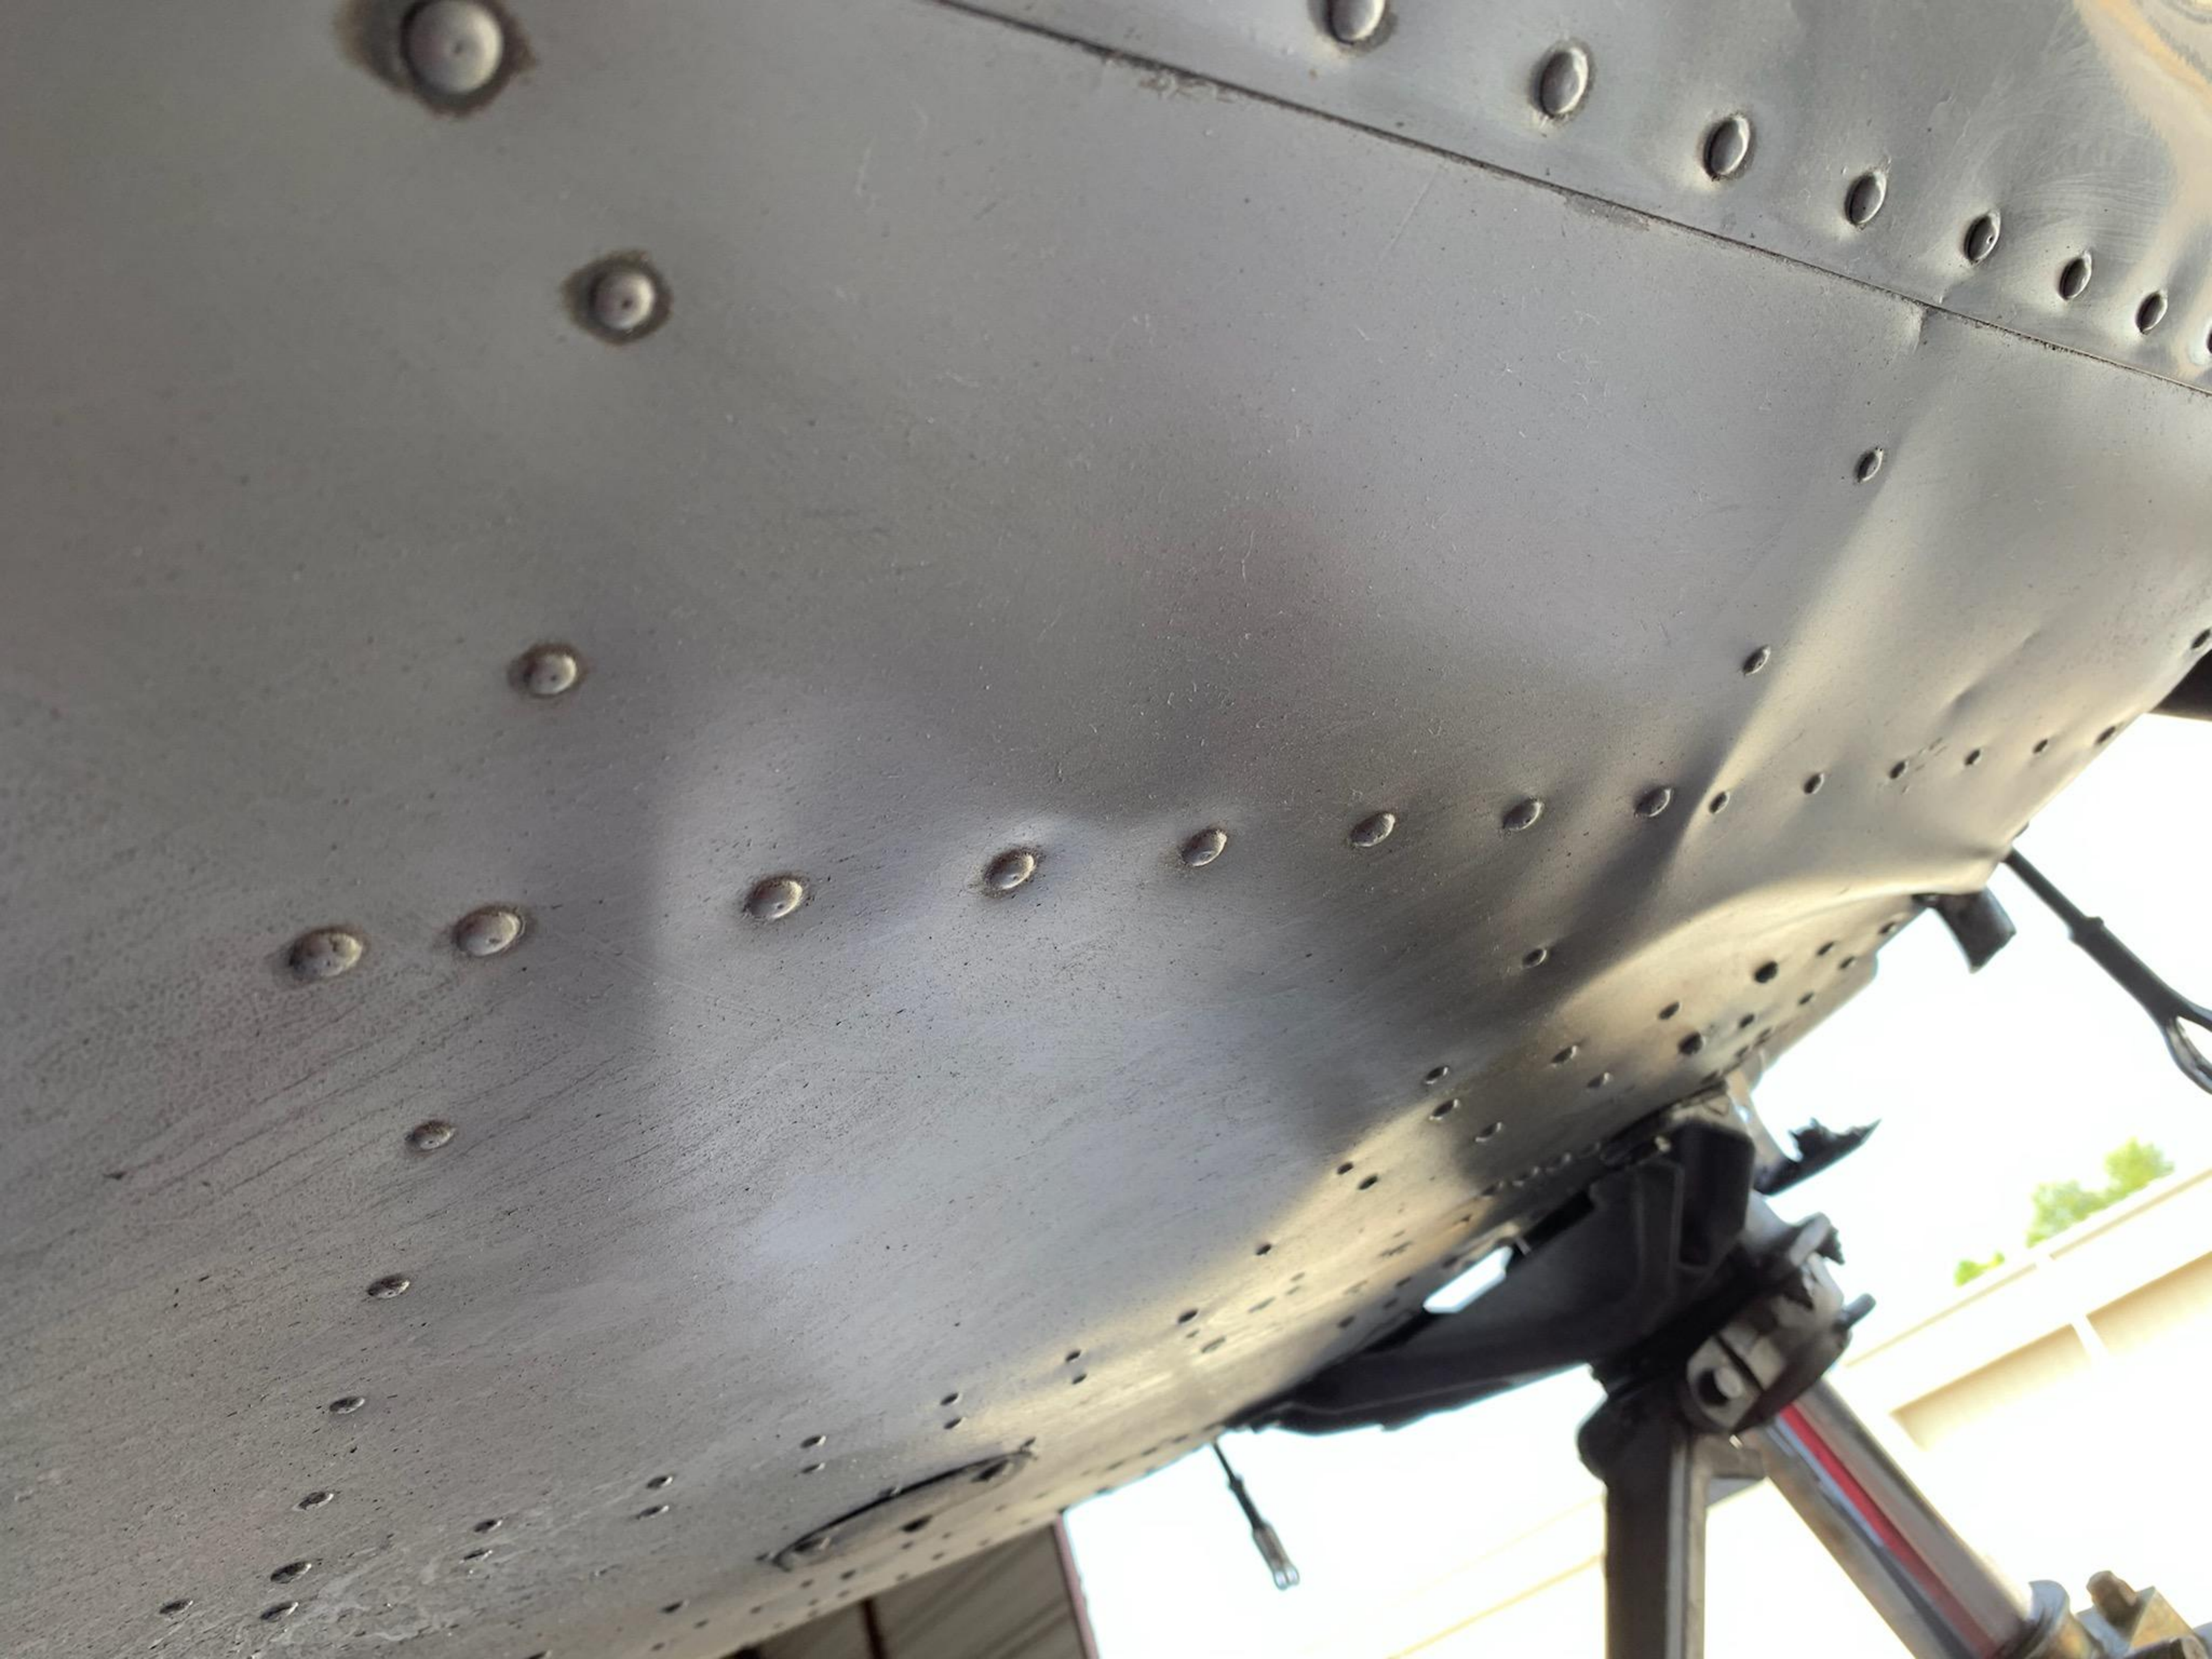
15. Fuselage belly, same wrinkles, different angle.
16. This airplane.
17. Right wing.
18. Right wing.
19. Right wing.
20. Right wing.

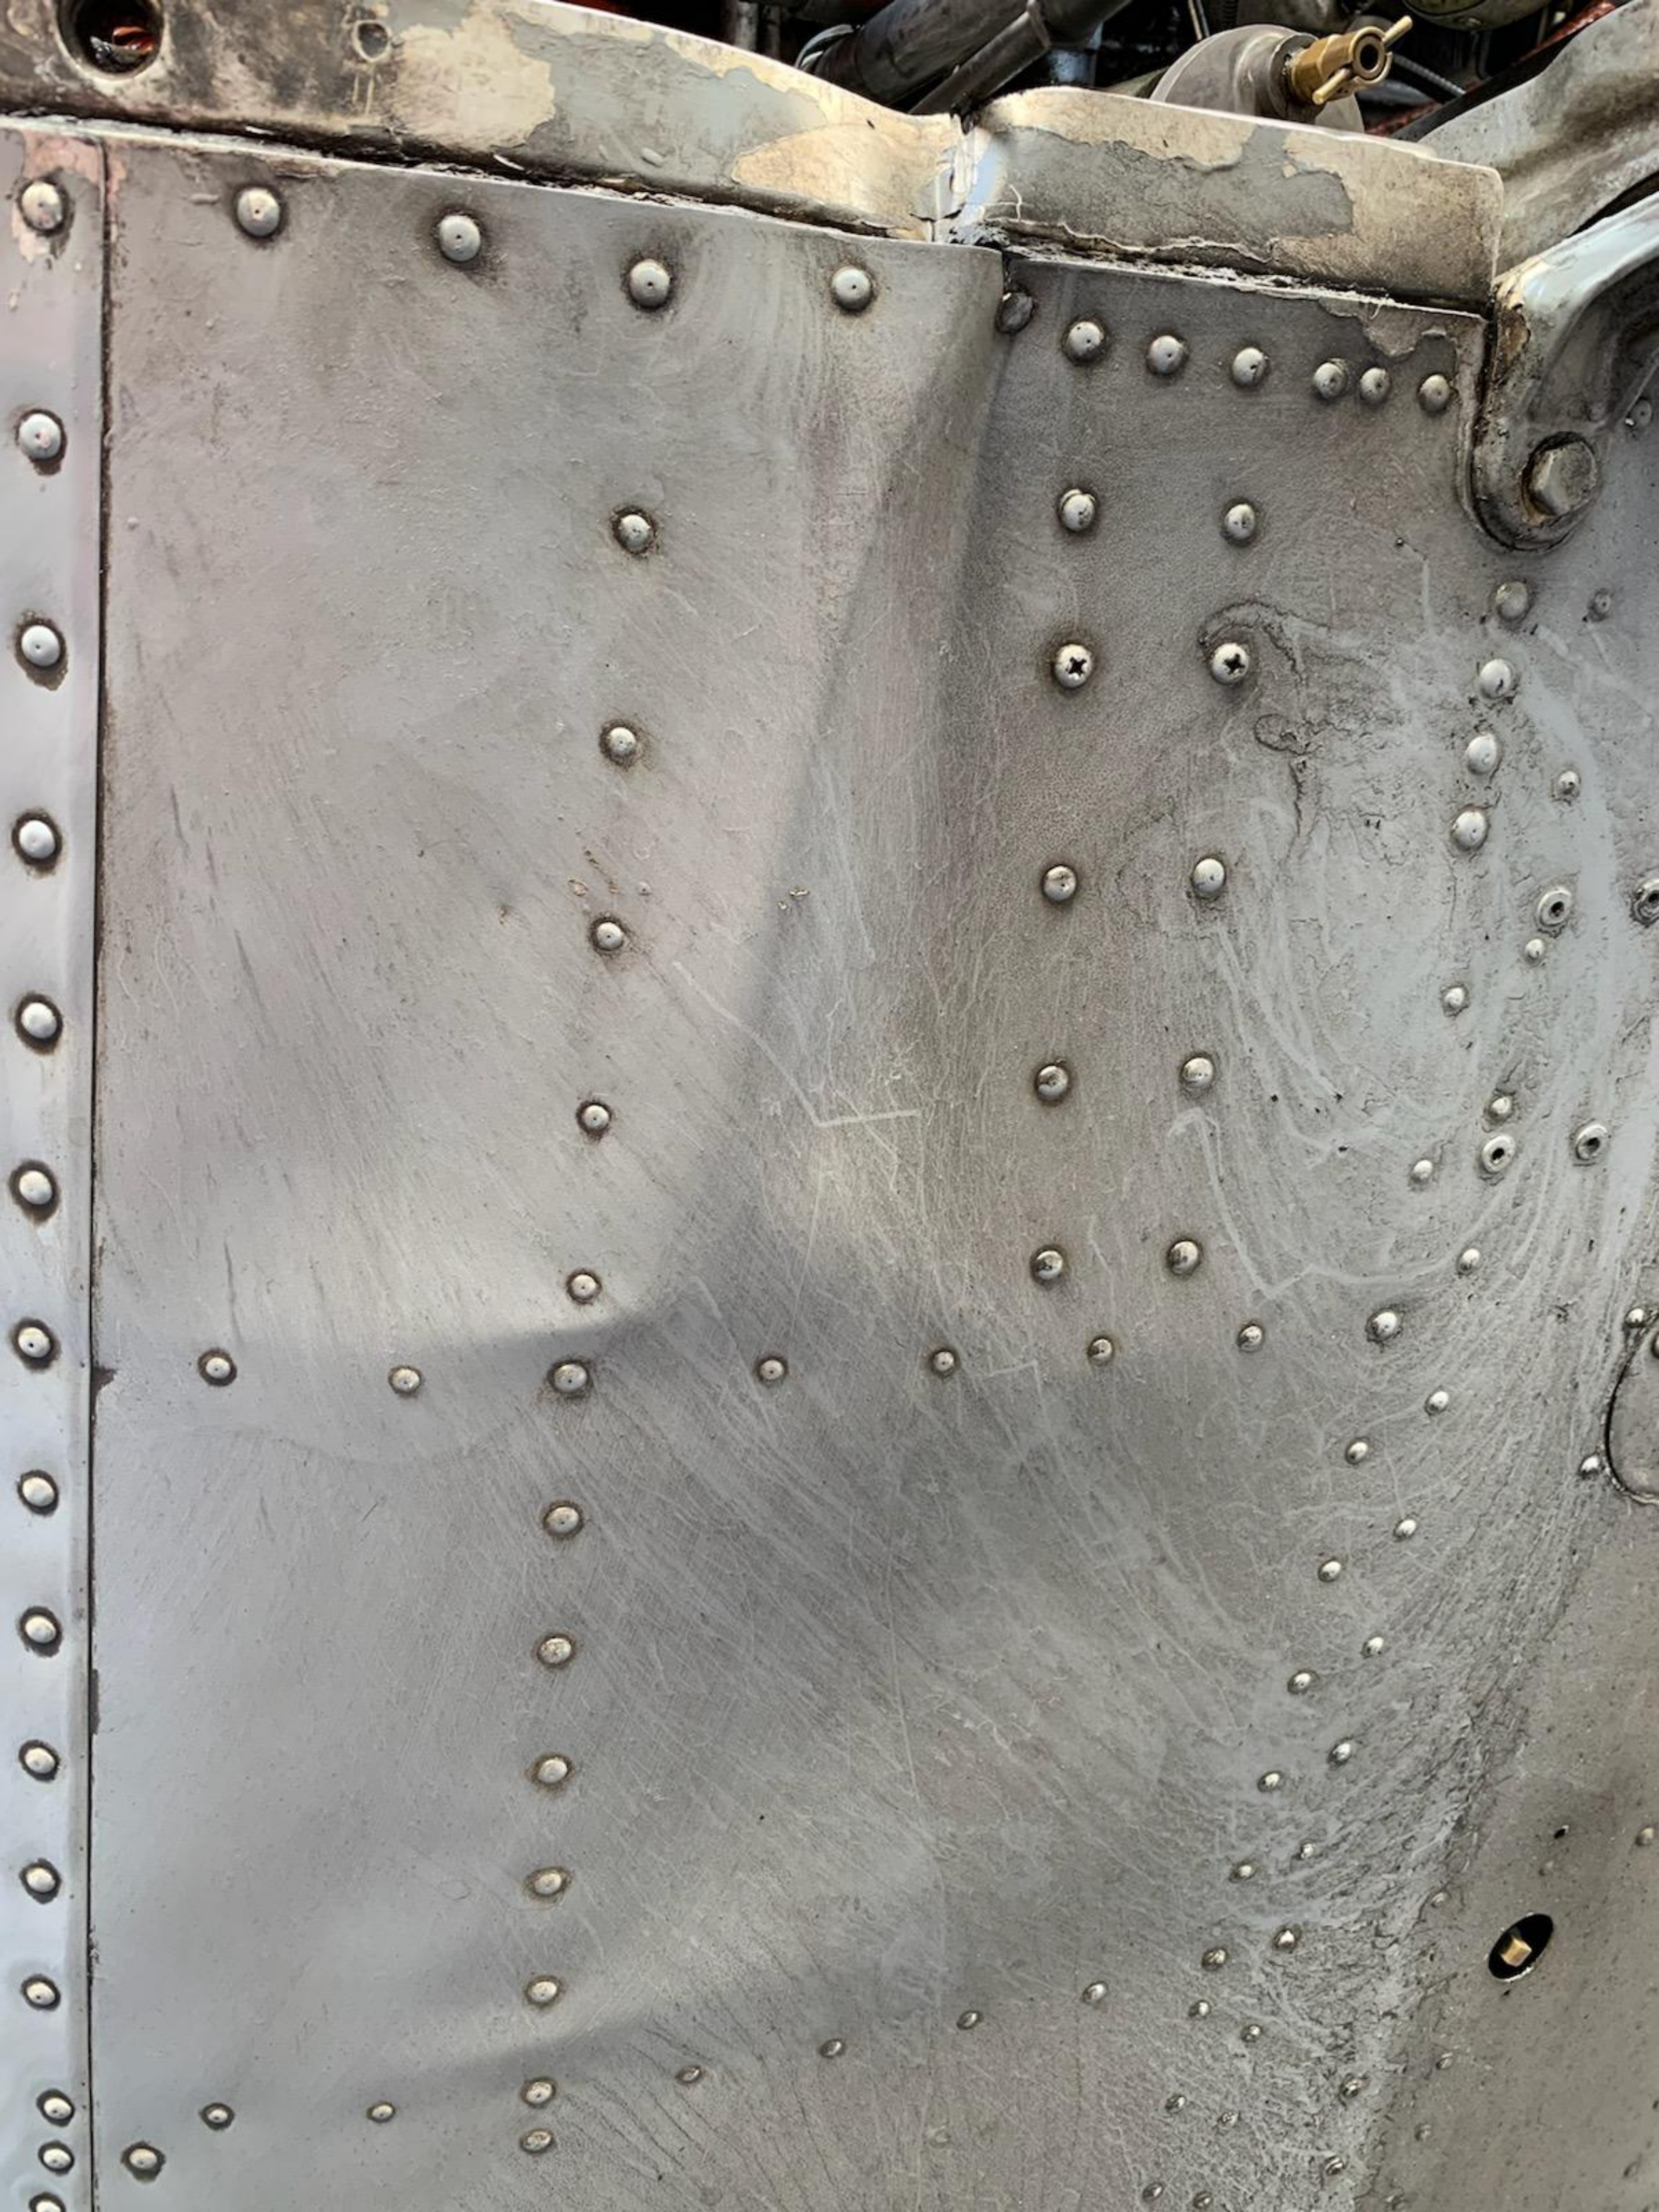
8. Firewall wave extends to left of nose gear, lower part.
9. Right lower side.
10. From the initial inspection, damage looks to be confined to the lower half of firewall from this rivet row down and the next photo showing the same rivet row on the left side.
