# NATIONAL TRANSPORTATION SAFETY BOARD

## Global Positioning System Device

### Specialist's Factual Report

Location: Buckeye, AZ  
Date: September 18, 2021  
Aircraft: Swearingen SX300  
Registration: N5SX  
Operator: Private  
NTSB Number: WPR21LA357

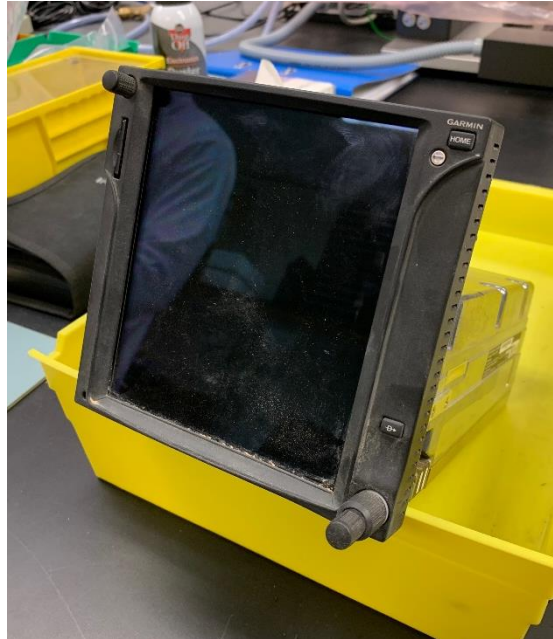
**Figure 1.** Photo of the Garmin GTN-750 device.

The device appeared largely undamaged. The device was booted in a desktop power station designed for Garmin devices. Through the unit's menus, an operation was selected that dumps flight logs from the device's internally mounted SD memory card was transferred to an externally accessible SD memory card on the front face of the unit. Flight logs were converted by the unit to comma separated value (.CSV) format.

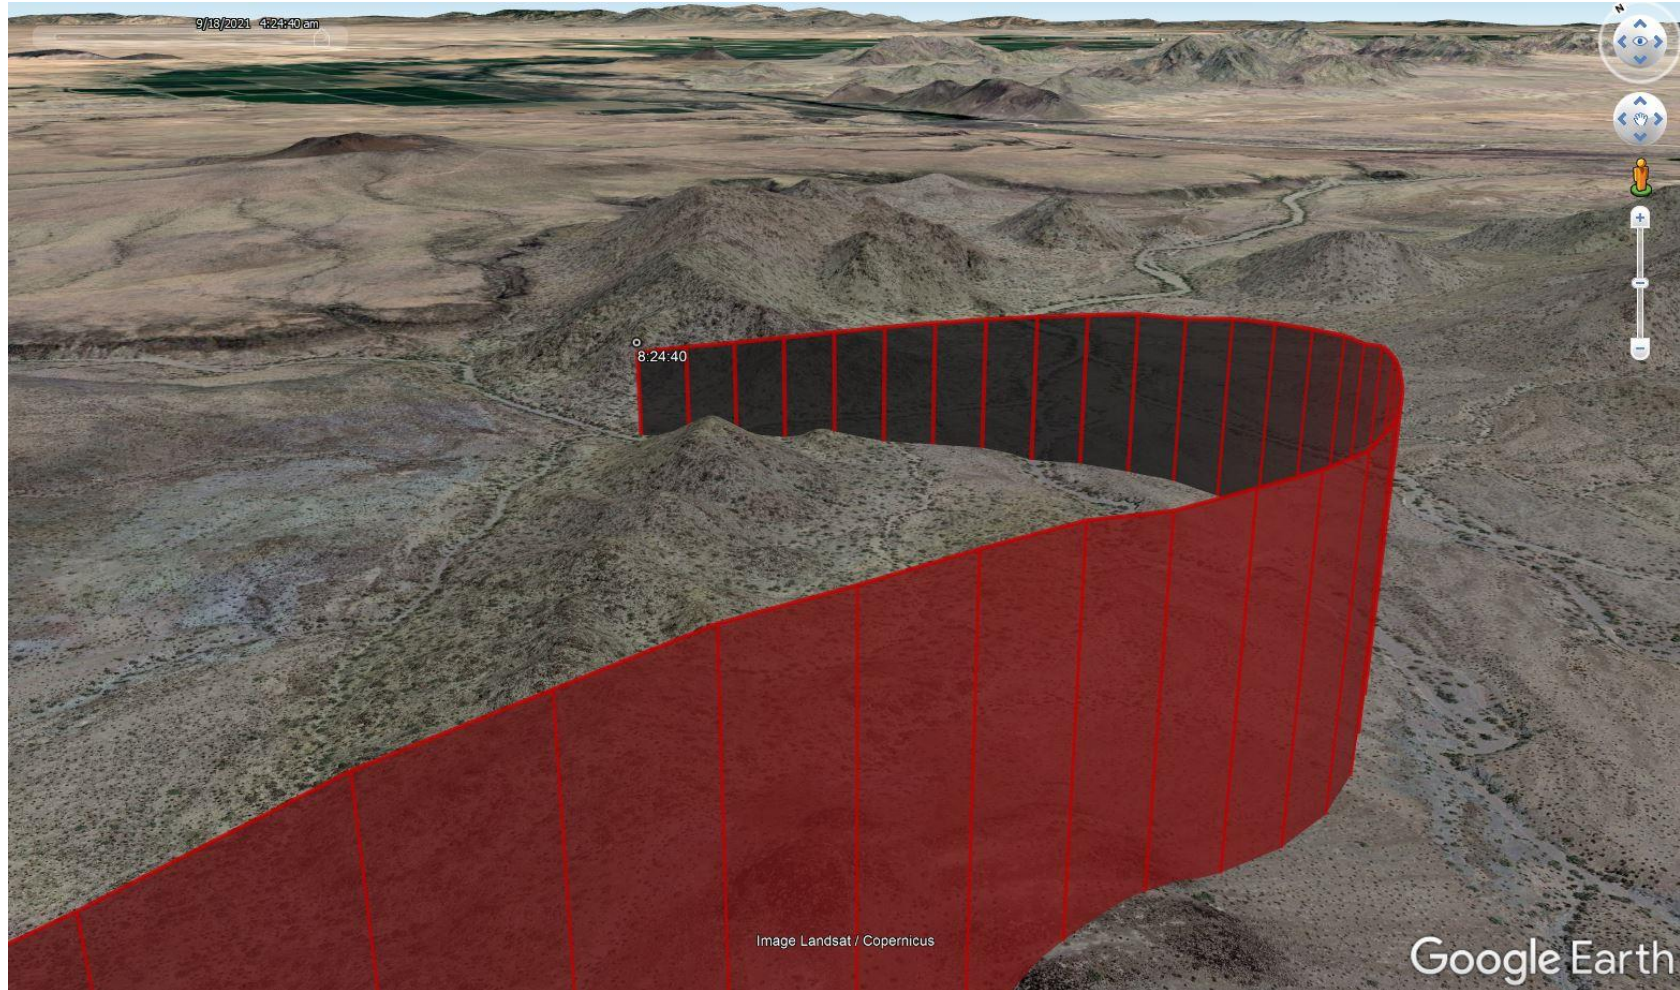
Figure 6 is a graphical overlay generated using Google Earth highlighting the aircraft's final tracklog as recorded by the Garmin device. The last recorded data point was at 8:24:40 LCL with a derived groundspeed of about 98 knots and a recorded MSL altitude of 1,143 feet.

**Figure 6.** Google Earth overlay showing the final tracklog points of the aircraft's position in proximity to mountainous terrain and a road.
