WPR22FA068

Attachment 7

Circling Approach Safety Alert

# Circling Approaches: Know the Risks!

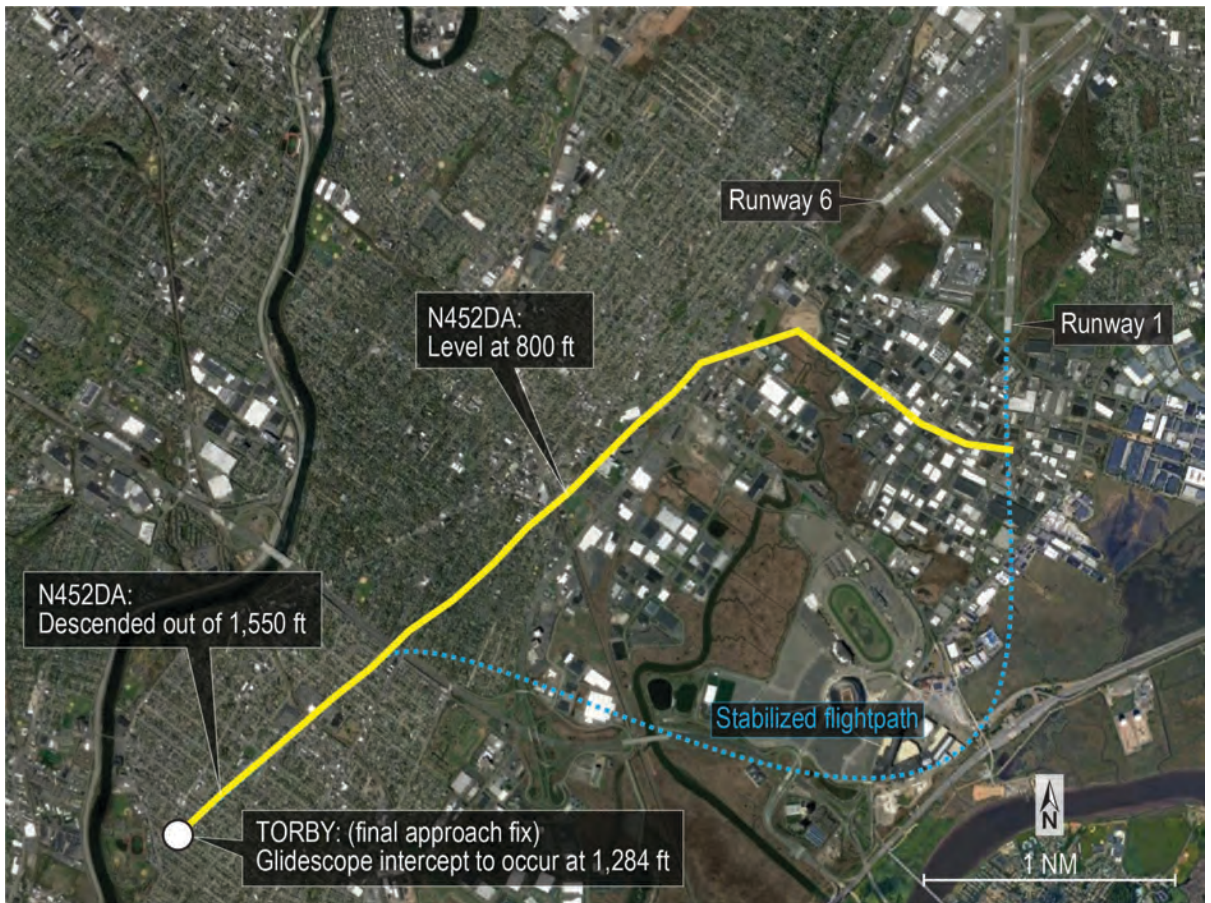
- During a Part 135 flight, a Learjet 35A departed controlled flight and impacted a commercial building while on a circling approach during day visual conditions. Four minutes before the accident, the visibility was reported as 10 statute miles or more, scattered clouds were reported at 5,500 ft above ground level (agl), and wind was from 330° at 19 kts gusting to 29 kts. The flight crew had been cleared by air traffic control (ATC) for the instrument landing system (ILS) runway 6 approach, circle to runway 1 (see figure 1). They were cleared for the approach more than 50 miles from the airport and had plenty of time to adequately prepare and brief the approach. However, the flight crew never briefed the approach and had difficulty becoming established on the ILS runway 6 approach because of a series of procedural deviations and errors. The airplane crossed the final approach fix (FAF) hundreds of feet above the altitude specified by the approach procedure, despite ATC reminding the flight crew twice about the minimum altitude for the FAF. The flight crew continued toward runway 6 (at an altitude higher than required for the approach) instead of initiating the circling approach at the FAF. Consequently, by the time they initiated the circling approach, the airplane was about 1 mile from the runway 6 threshold and could not be maneuvered to line up with the landing runway. The flight crew continued with the approach, the airspeed decreased during the turn, and the airplane stalled and crashed less than a mile from the runway 1 threshold. The pilot and co-pilot were fatally injured during the accident. **The flight crew had multiple opportunities to recognize and discontinue the unstabilized approach, most notably during the circling segment of the approach. Their lack of situational awareness could have been prevented by briefing the approach and following ATC instructions to become established on the approach and safely maneuvering to land.**

**Figure 1.** Overhead image showing a stabilized flightpath to runway 1 (in blue) compared with the accident airplane’s flightpath (in yellow) ([NTSB/AAR-19/02](#)).

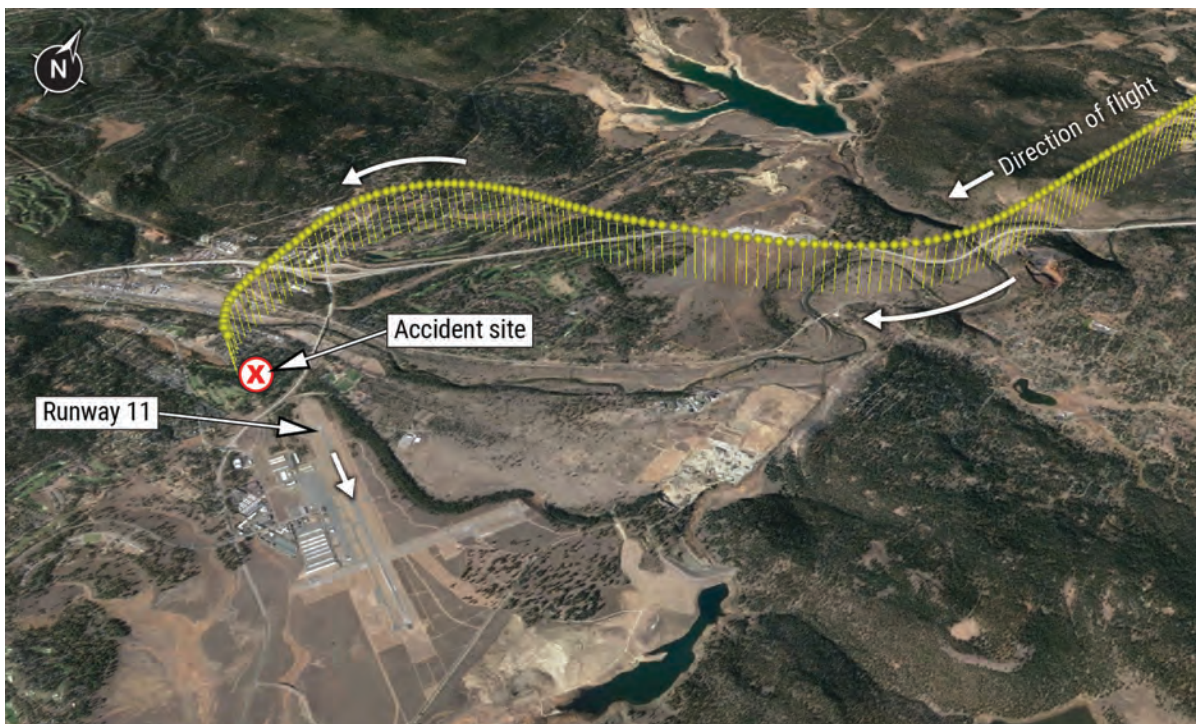
- A Bombardier CL-600-2B16 impacted terrain following a loss of control during a circling approach. Weather reported near the accident site included 4 statute miles visibility, a broken cloud layer at 2,300 ft agl, and wind from 280° at 11 knots, gusting to 16 kts. The flight crew initially planned for a straight-in RNAV approach to runway 11 (see figure 2). However, as the airplane neared the airport, ATC advised the flight crew to expect the RNAV runway 20 approach. The flight crew accepted the approach; however, they subsequently requested to circle to runway 11 because runway 20 was too short to meet their landing distance

requirement. After the airplane was established on the RNAV runway 20 approach, ATC offered the flight crew the option of entering the left downwind leg for runway 11 or crossing over the airport and entering a left downwind for runway 29. The flight crew maneuvered the airplane to enter the traffic pattern for runway 11. They continued circling past the runway 11 extended centerline and entered a nose down attitude and steep left turn, as it maneuvered close to the ground. The pilot, co-pilot, and four passengers were fatally injured. **The flight crew had many options available to them that would have increased the likelihood of executing a stabilized approach and successful landing, such as: requesting the approach they originally planned for, briefing the approach they accepted, or performing a missed approach procedure.**

**Figure 2.** Flightpath of the airplane with curved arrows indicating the initiation of the circling approach to runway 11 ([WPR21FA286](#)).

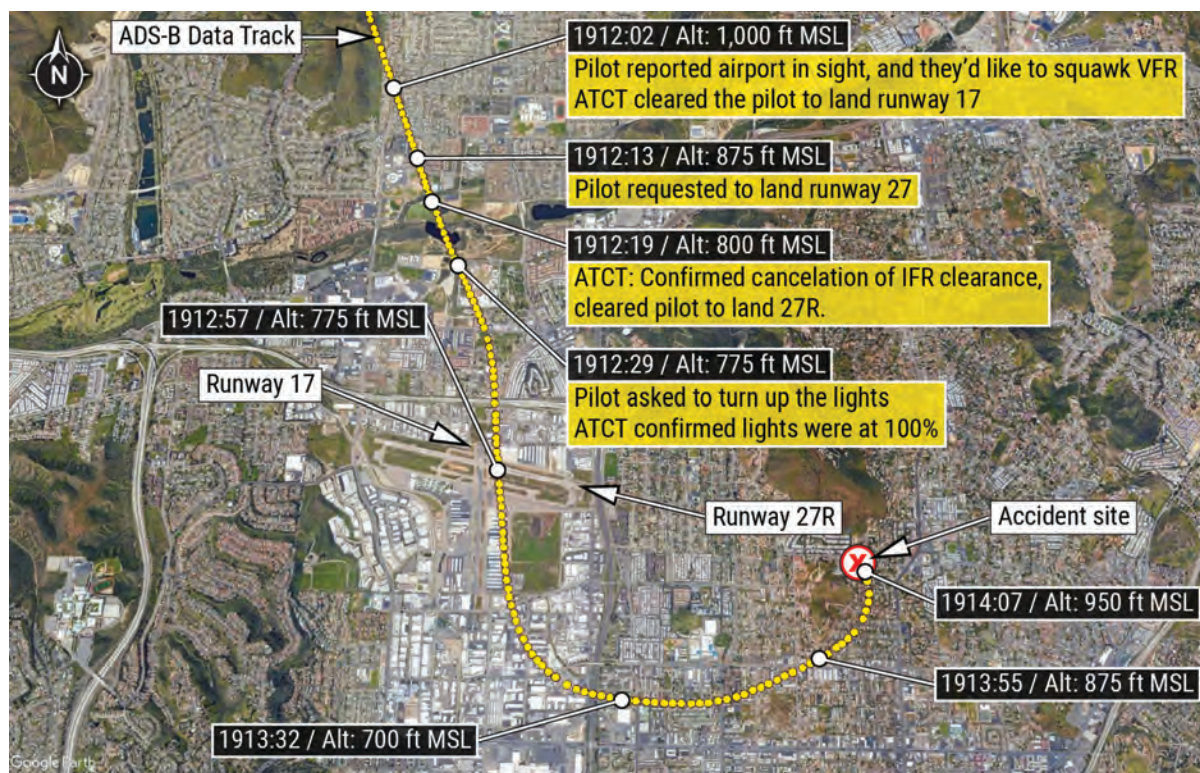
- A Learjet 35A struck power lines while performing a circling approach to the runway at night in deteriorating weather conditions. The flight crew initiated the GPS runway 17 approach and were cleared to land by ATC. About 4 minutes later, the pilot requested to land on runway 27. The controller instructed the pilot to overfly the airport and enter left traffic for runway 27R and subsequently cleared him to land. Shortly after, the pilot requested that the runway lights be increased; the controller responded they were already at 100 percent. Preliminary automatic dependent surveillance-broadcast data indicated the airplane overflow the airport at an altitude of 407 ft above ground level and then began a climbing turn to align with runway 27R. The airplane struck power lines and impacted the ground about a mile from the approach end of runway 27R, resulting in fatal injuries to the two pilots and two flight nurses. Recorded weather data indicated the visibility was 3 statute miles at the time of the accident and there was a broken cloud layer at 2,000 ft agl. **Instead of attempting a landing from an unstabilized approach in poor visibility, the flight crew could have initiated a missed approach procedure and attempted a landing to a different runway or diverted to another airport due to the weather.**

**Figure 3.** Overhead image of the airplane's flightpath toward runway 27R ([WPR22FA068](#)).
