WPR22FA098

## **SATLOC G4 AERIAL APPLICATOR GUIDANCE SYSTEM**

Specialist's Factual Report

Location: Coalinga CA  
Date: February 16, 2022  
Time: 21:30 (PST)  
Helicopter: Bell UH-1H N72297

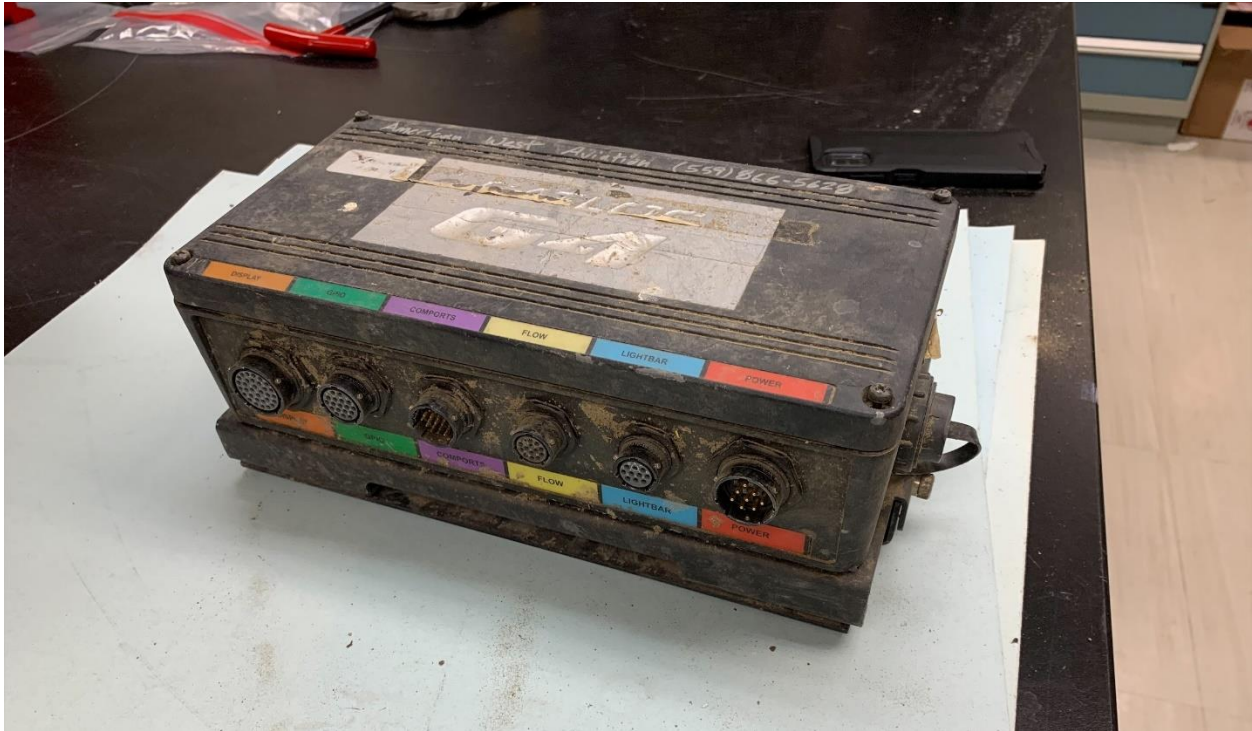
**Figure 1.** Satloc G4 CPU Module

The Satloc G4 was in good condition (see figure 1) and the data were downloaded using the manufacturer's procedure.
