WPR22FA151

## **OPERATIONAL FACTORS**

Specialist's Factual Report - Attachment 12

FAA AATD Observation

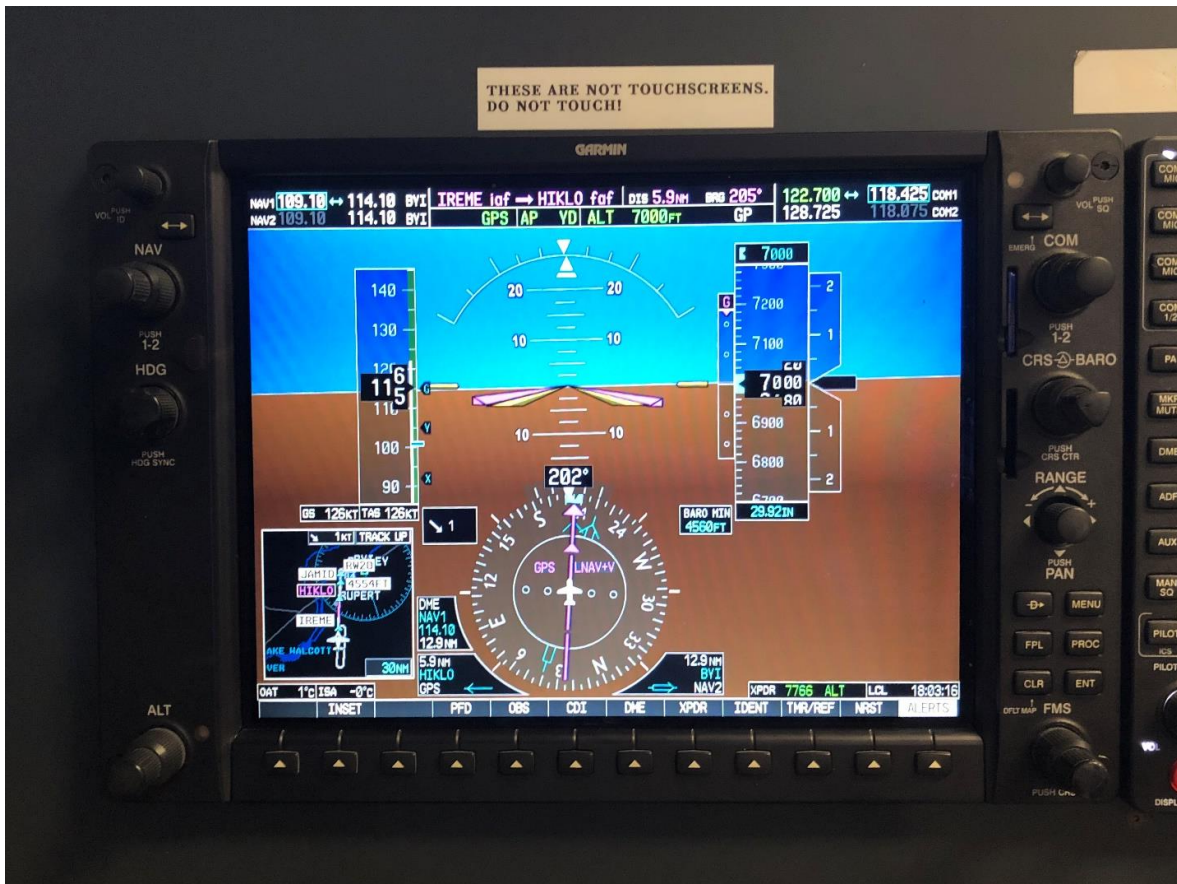
**Photo 1: Primary Flight Display (PFD) display of beginning AATD position.**

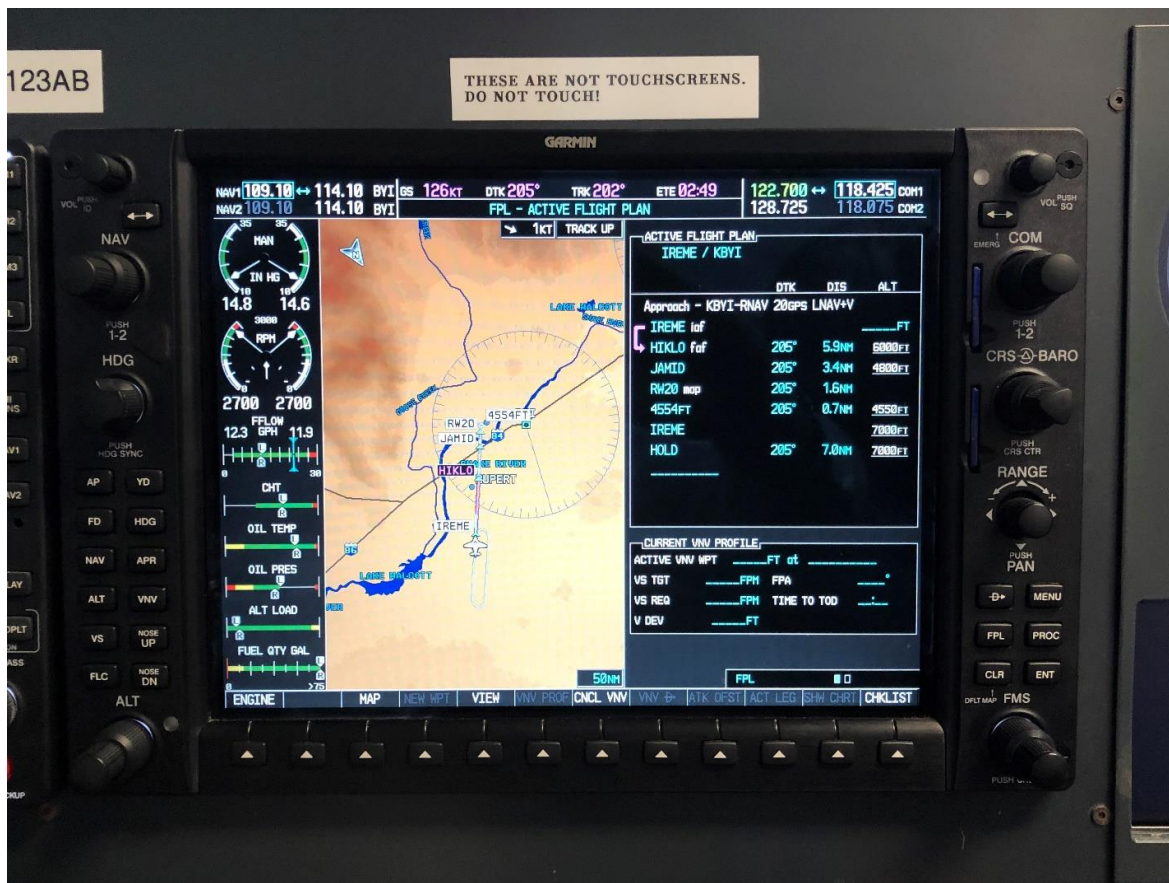
**Photo 2: Map display of beginning AATD position.**

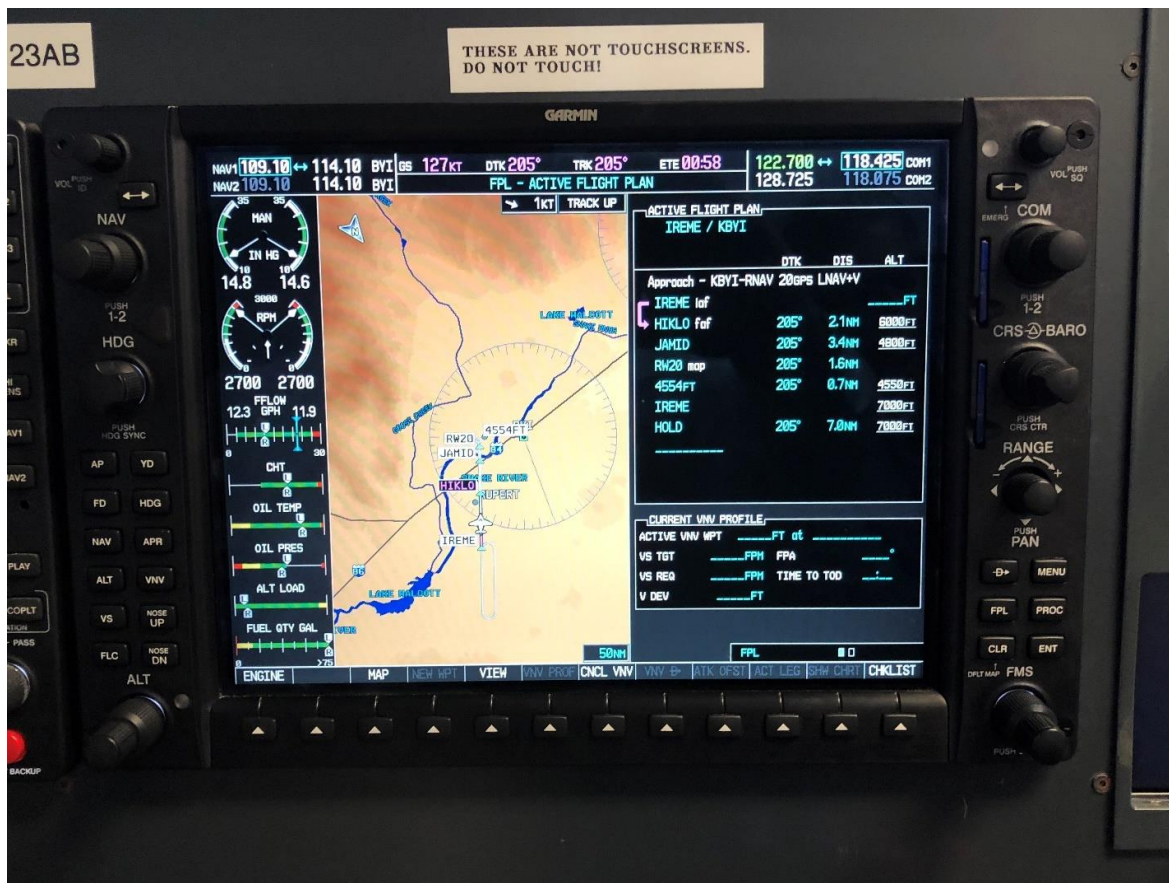
Photo 4: Map display of glide path intercept.

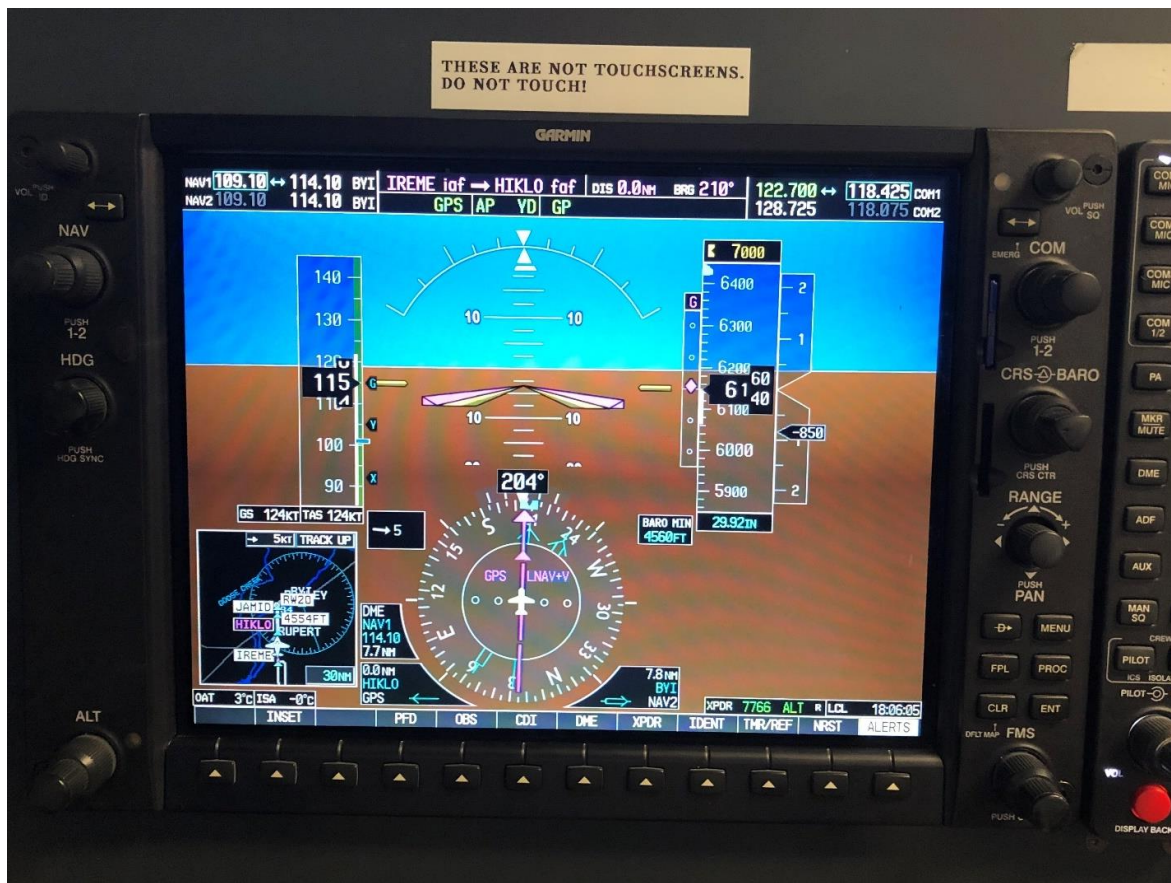
- At the HIKLO fix (FAF 6000') the GP deviation indicator remained centered and the altitude indicated 6,150 feet.

Photo 5: PFD display at HIKLO fix.

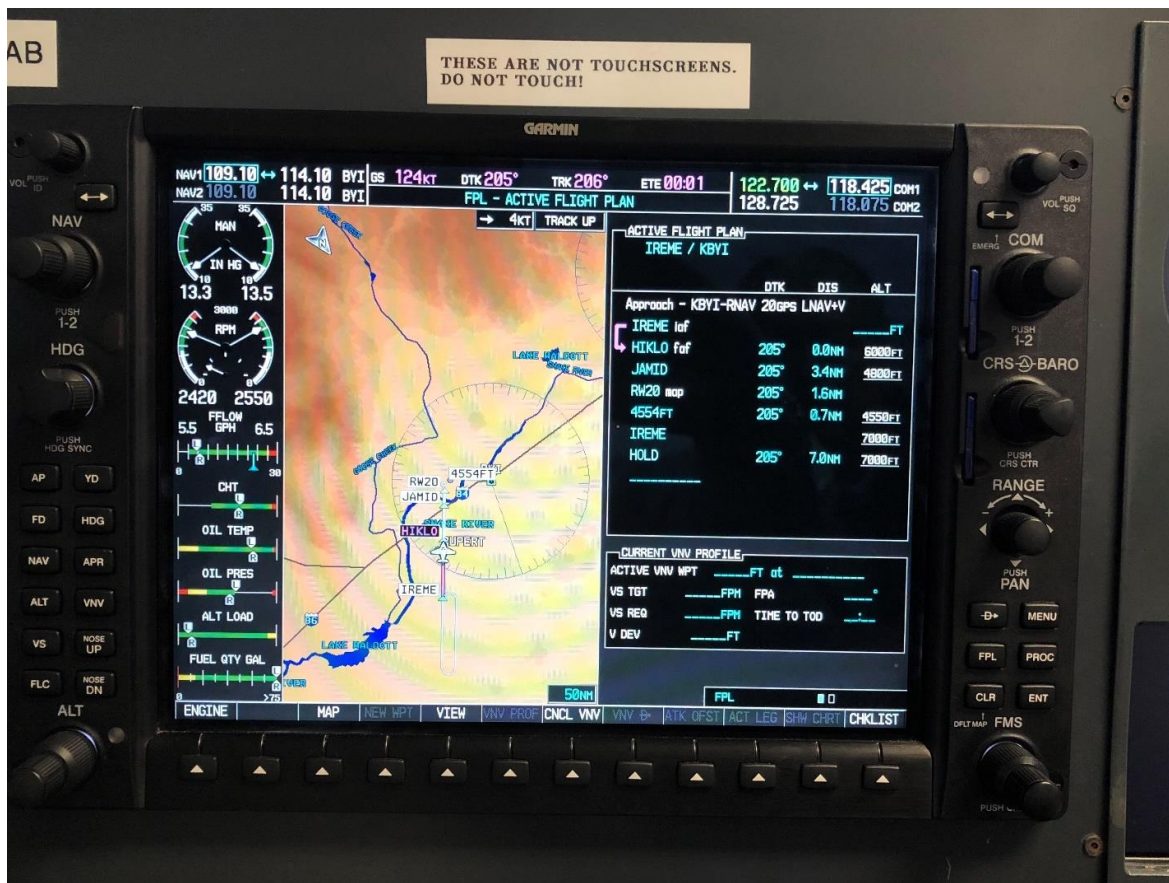
Photo 6: Map display at HIKLO fix.

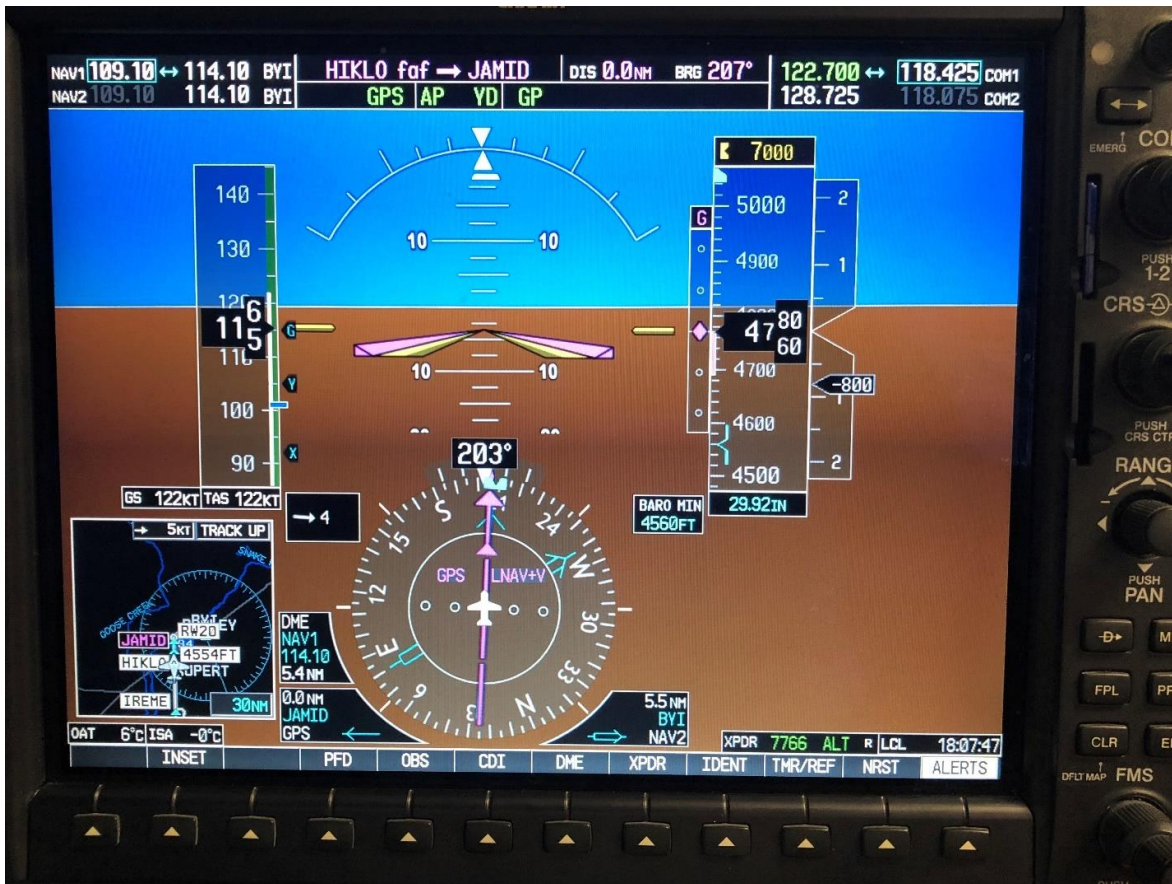
- At the JAMID fix (stepdown fix 4800') the GP deviation indicator remained centered at 4,780 feet.

Photo 7: PFD display at JAMID fix.

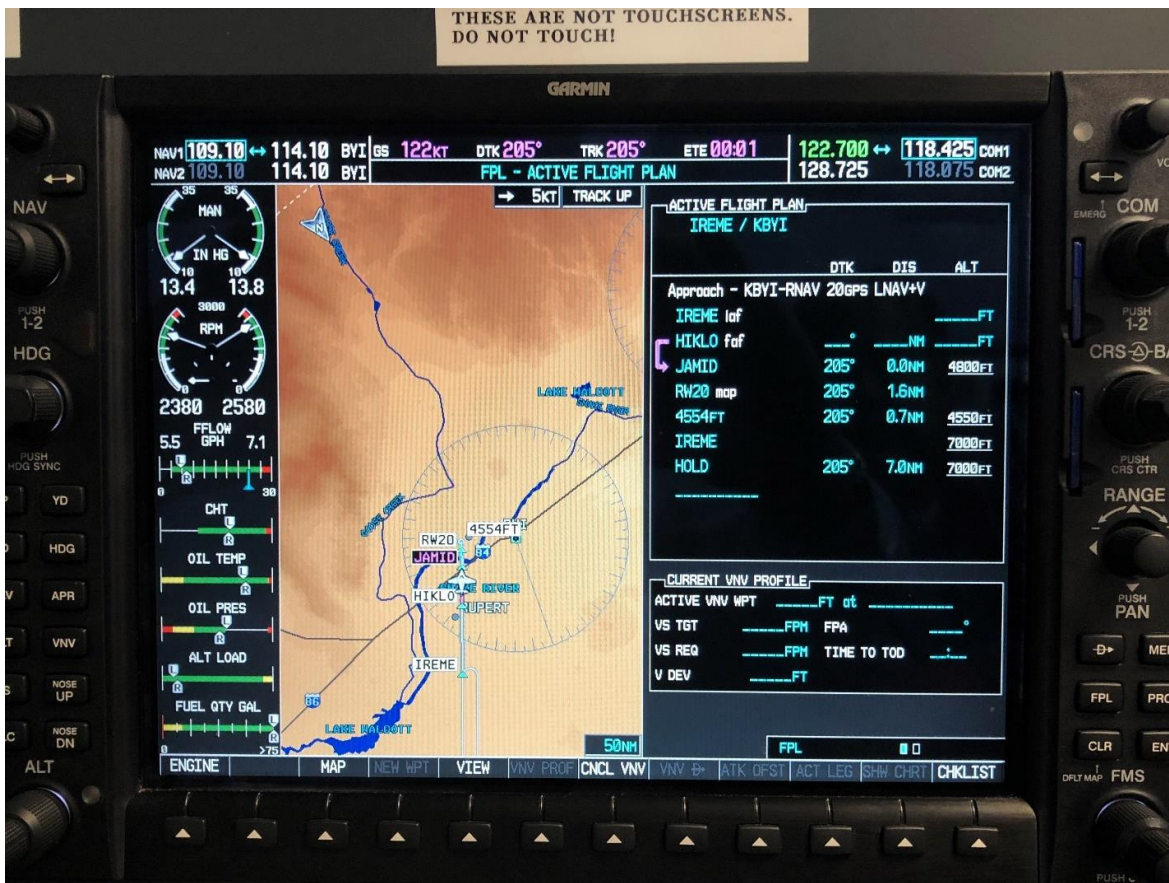
Photo 8: Map display at JAMID fix.

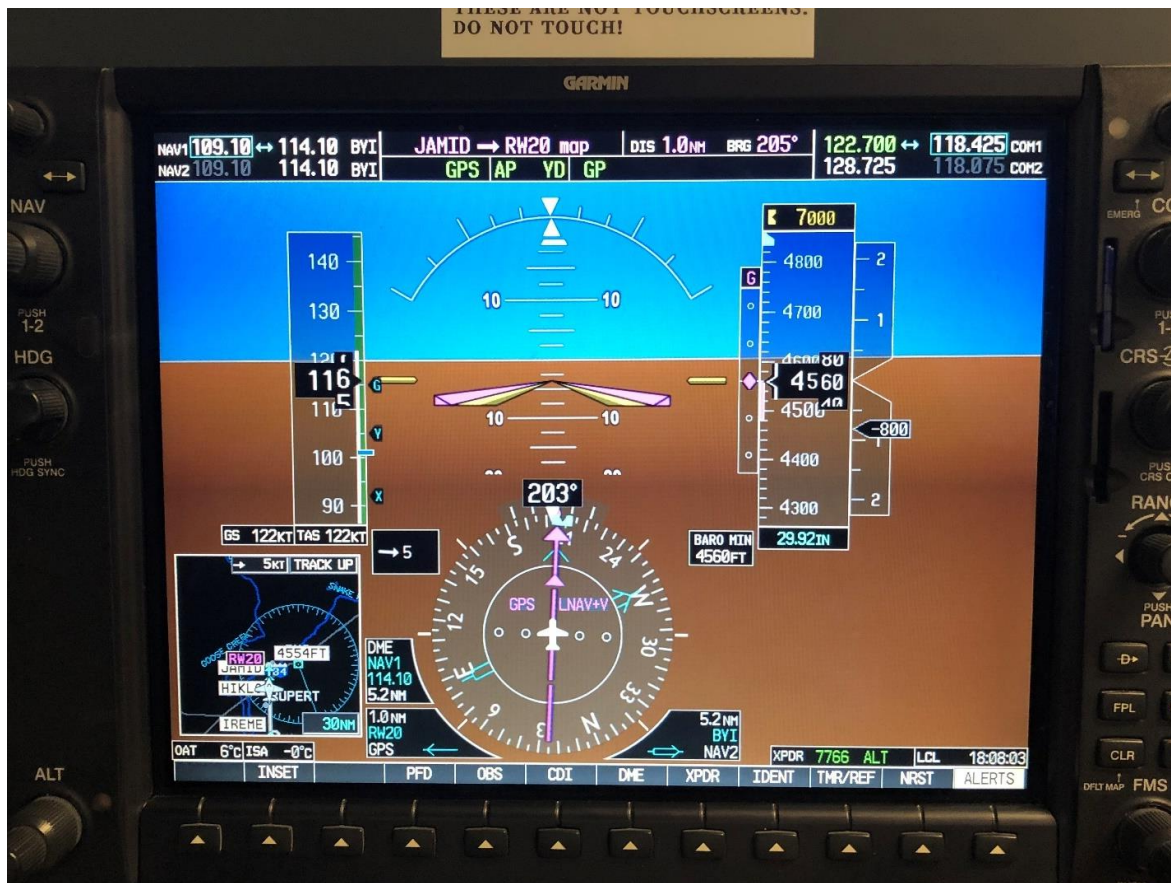
- At MDA (4560) the GP deviation indicator remained centered at 4,560 feet at a distance of 1.0 from runway 20.

Photo 9: PFD display when airplane reached the MDA.

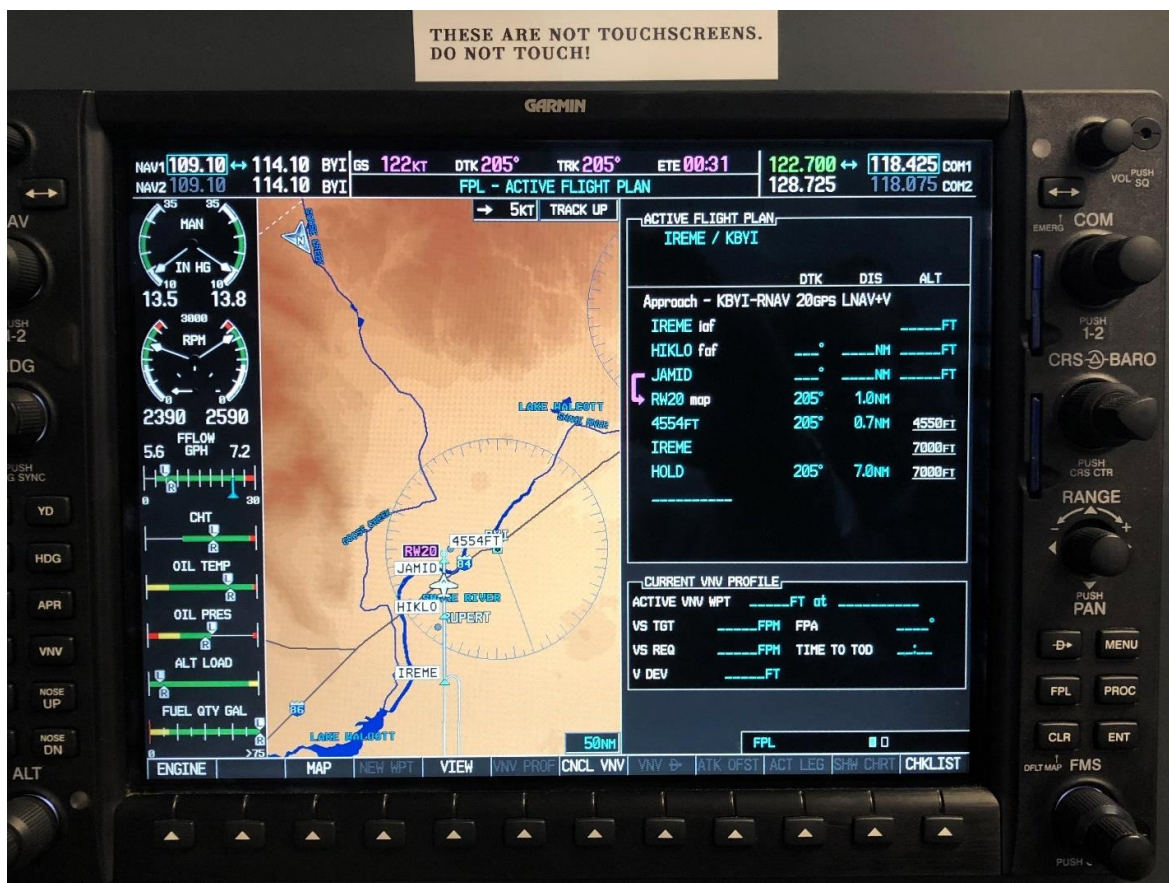
Photo 10: Map display when airplane reached the MDA.

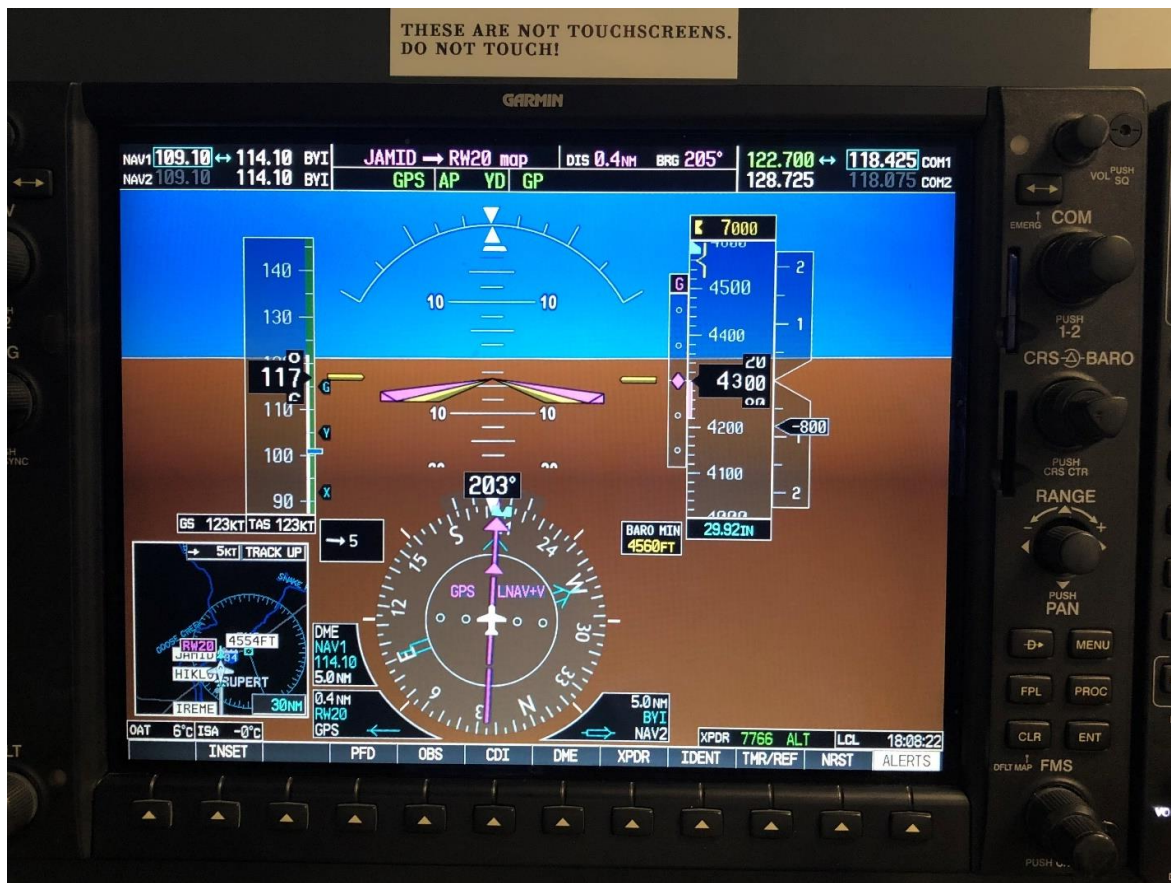
Photo 11: PFD display when airplane reached the accident site.

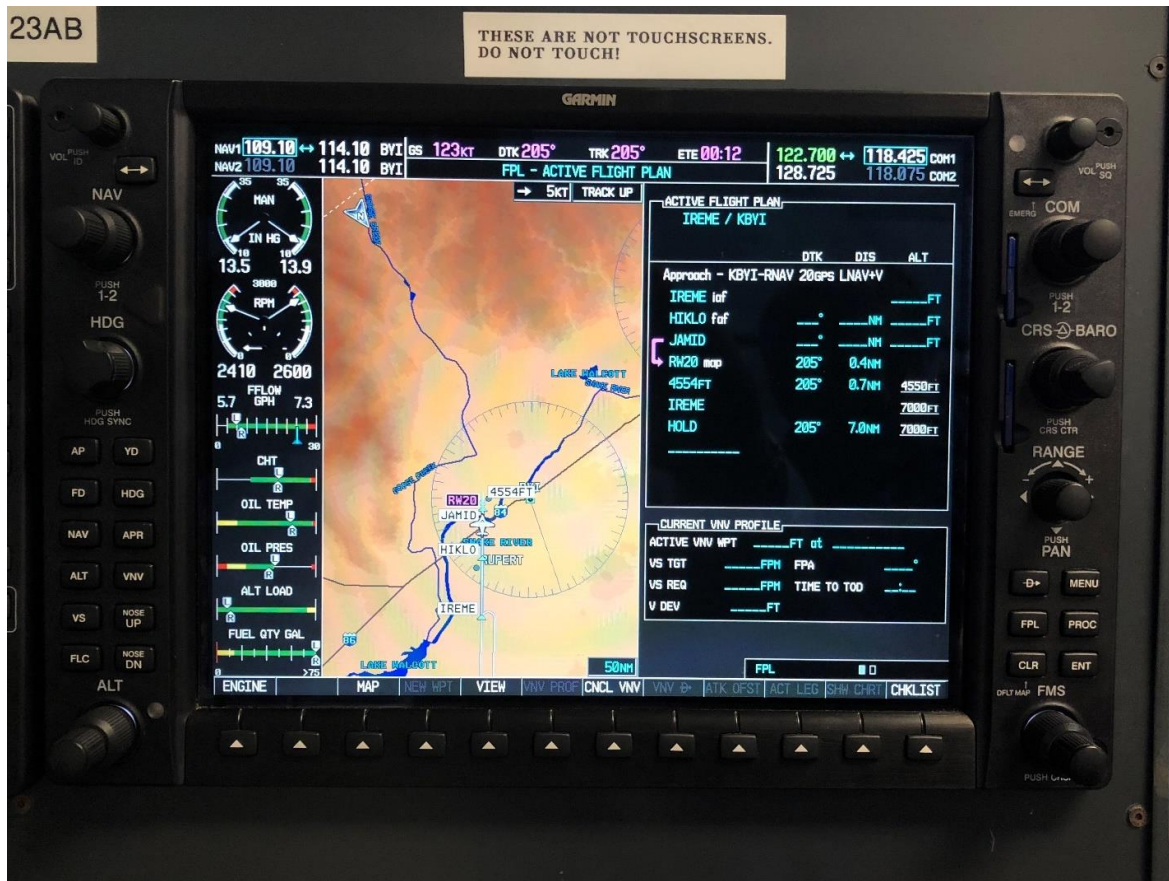
Photo 12: Map display when airplane reached the accident site.

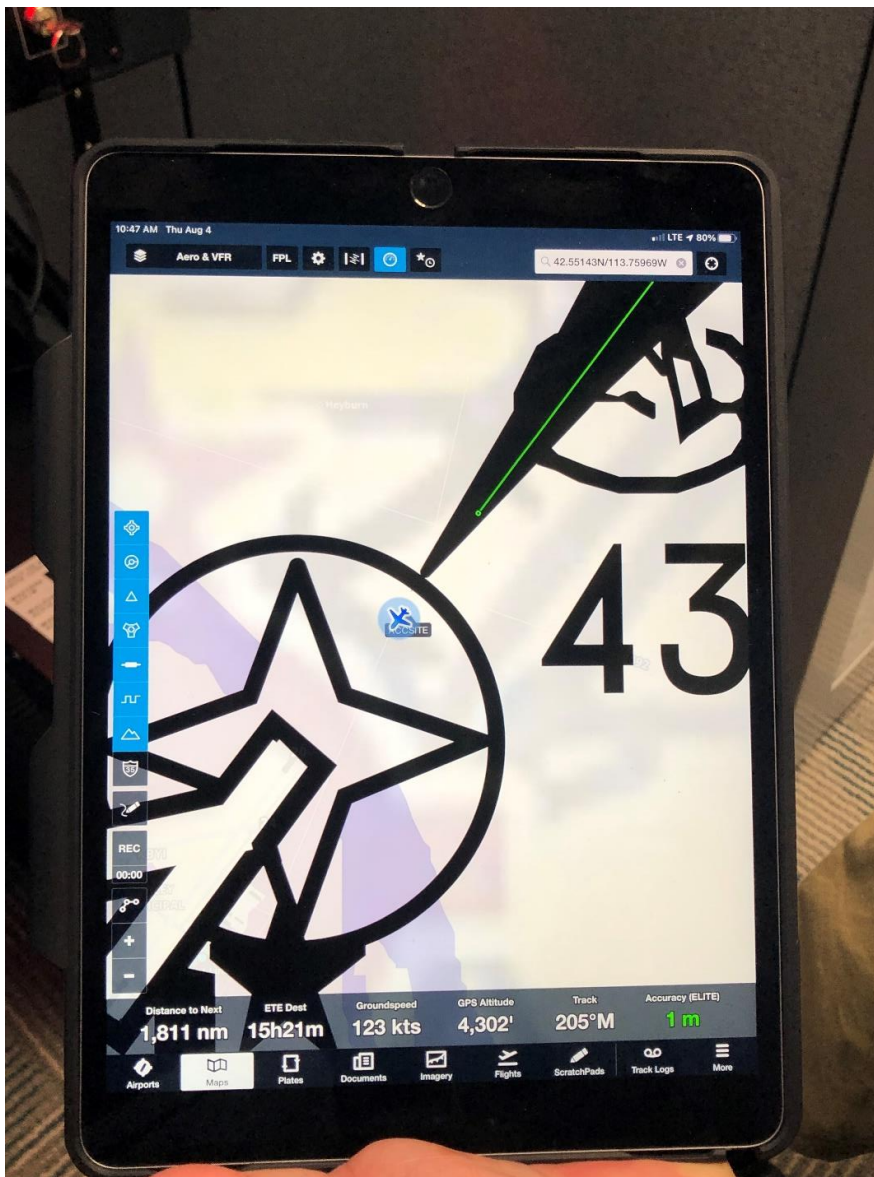
**Photo 13: Photo of FAA iPad (slaved to the AATD) showing accident location overlay on the RNAV (GPS) runway 20 approach.<sup>4</sup>**

<sup>4</sup> The app used on the iPad was Foreflight which was being fed GPS positional data from the Garmin 1000 unit to display "own-ship" position.

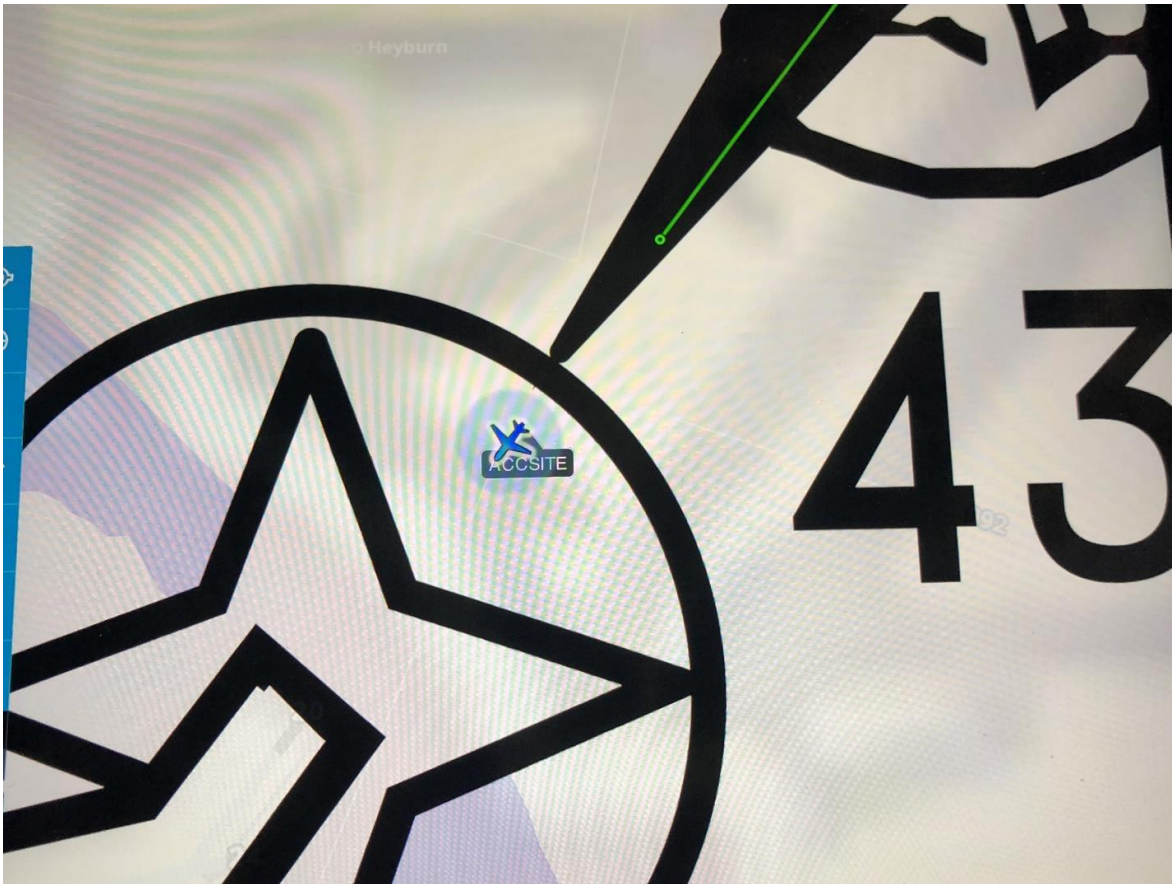
**Photo 14: Enlargement of previous photo.**

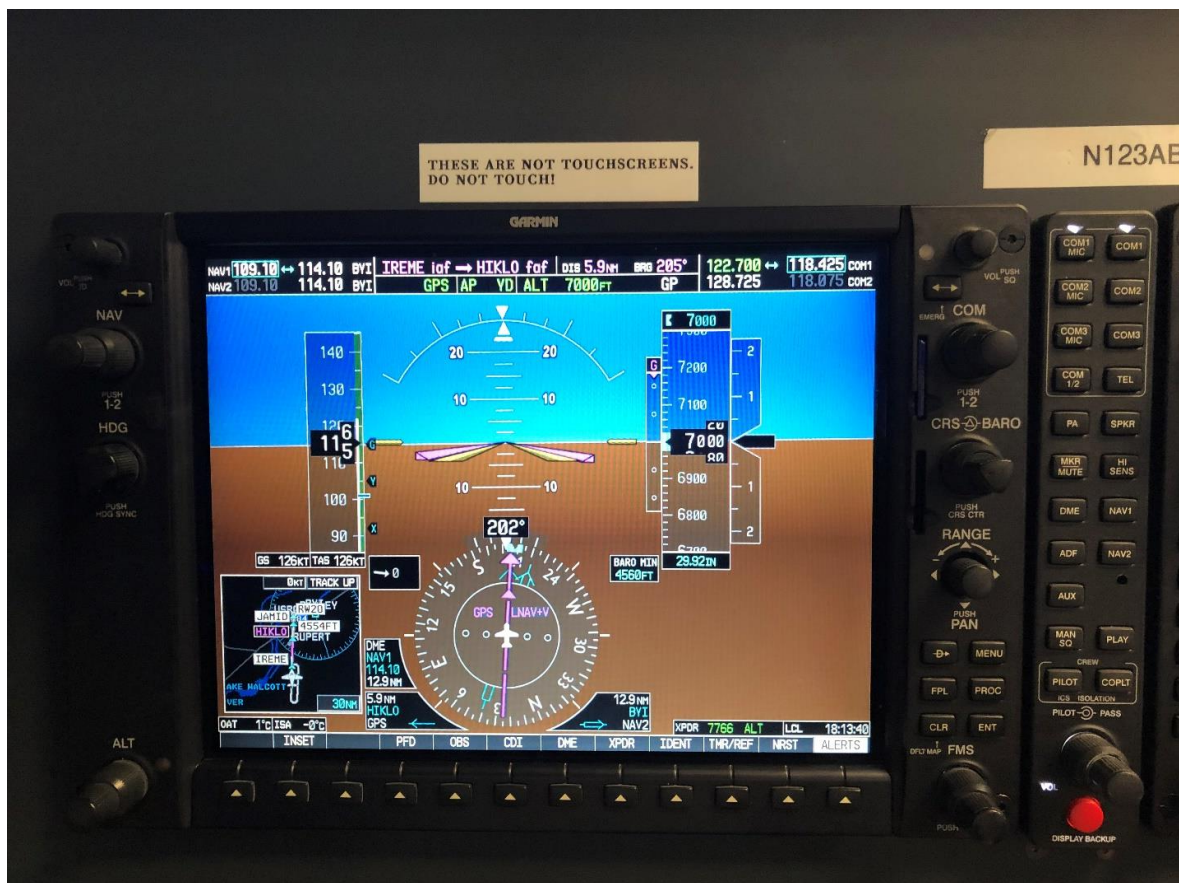
- Lateral and vertical guidance coupled to the autopilot
  - o Lateral mode indicated by "GPS" on the FMA. Vertical mode indicated by "GP" (glide path) on the FMA
  - o At IREME (IAF 7000') the GP came into view on the right side of the primary flight display (PFD) as the airplane passed IREME. GP deviation indication was full scale up at IREME.

Photo 15: PFD display at beginning of AATD run #3.

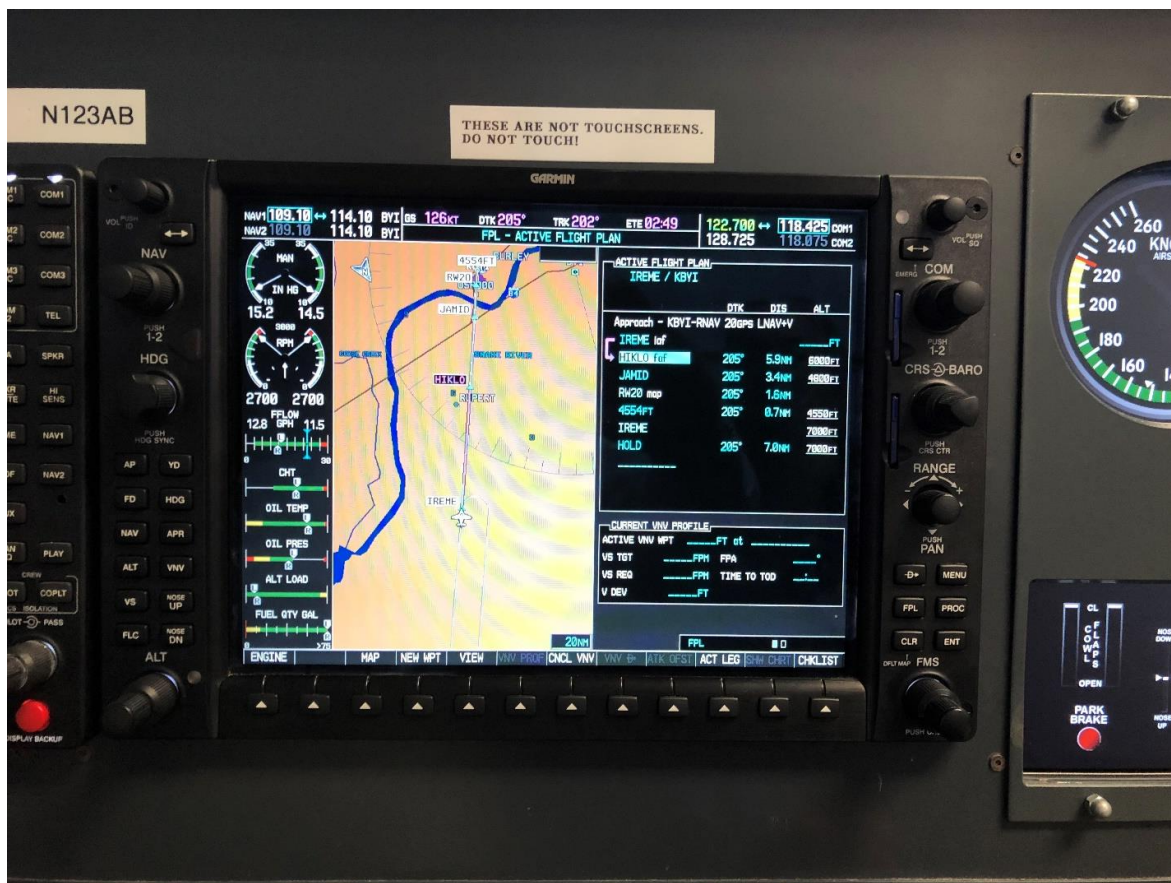
Photo 16: Map display at beginning of AATD run #3.

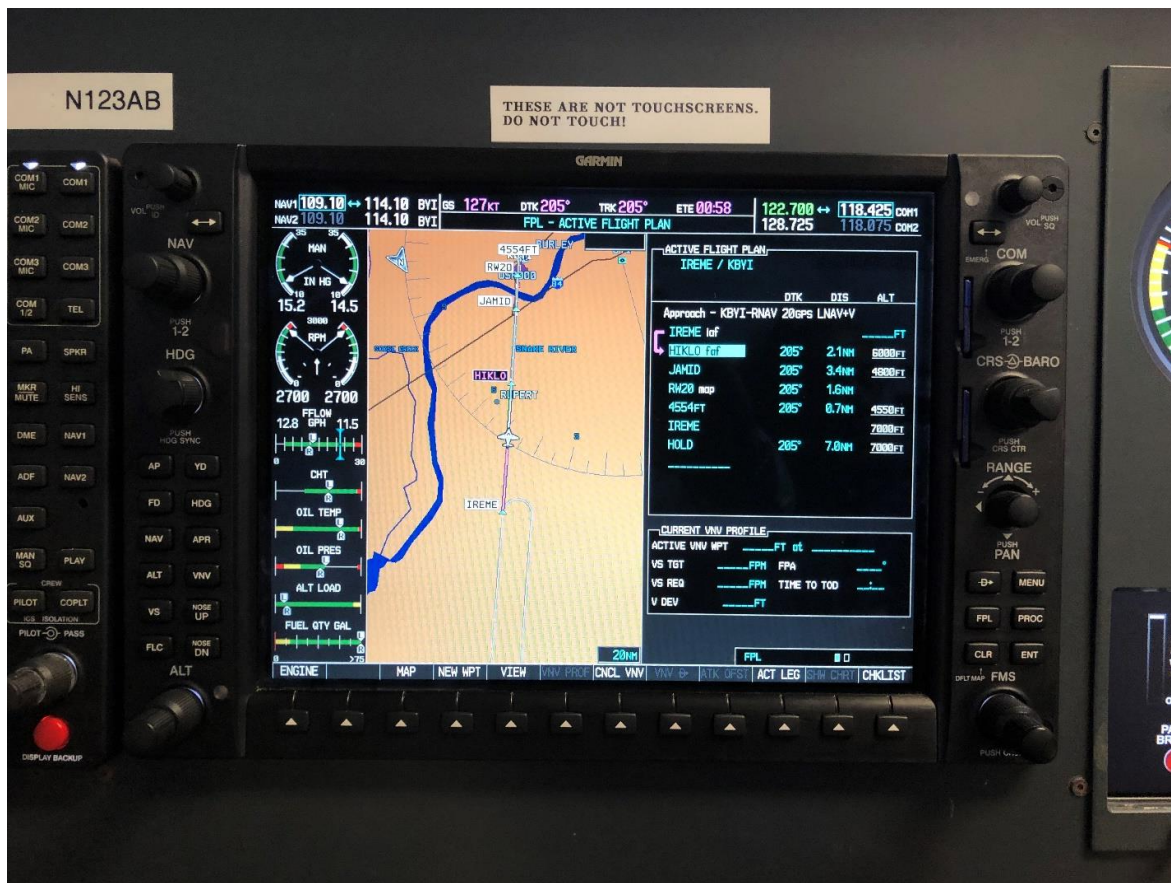
- o The airplane continued to maintain 7,000 feet until it reached 2.1 nm from the next fix (HIKLO). At that point the GP deviation indicator became centered and the airplane began descending on the approach.

**Photo 18: Map display at GP intercept.**

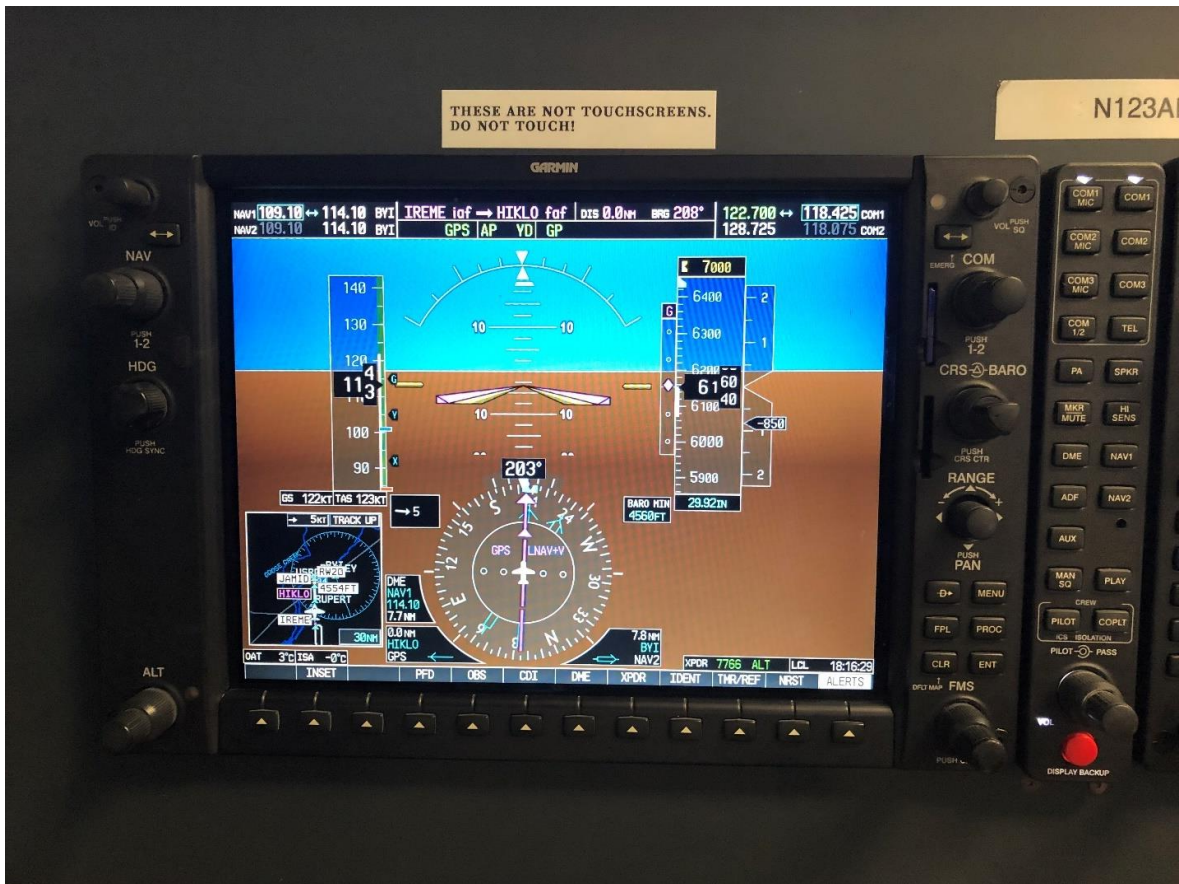
- At the HIKLO fix (FAF 6000') the GP deviation indicator remained centered and the altitude indicated 6,150 feet.

Photo 19: PFD display at HIKLO.

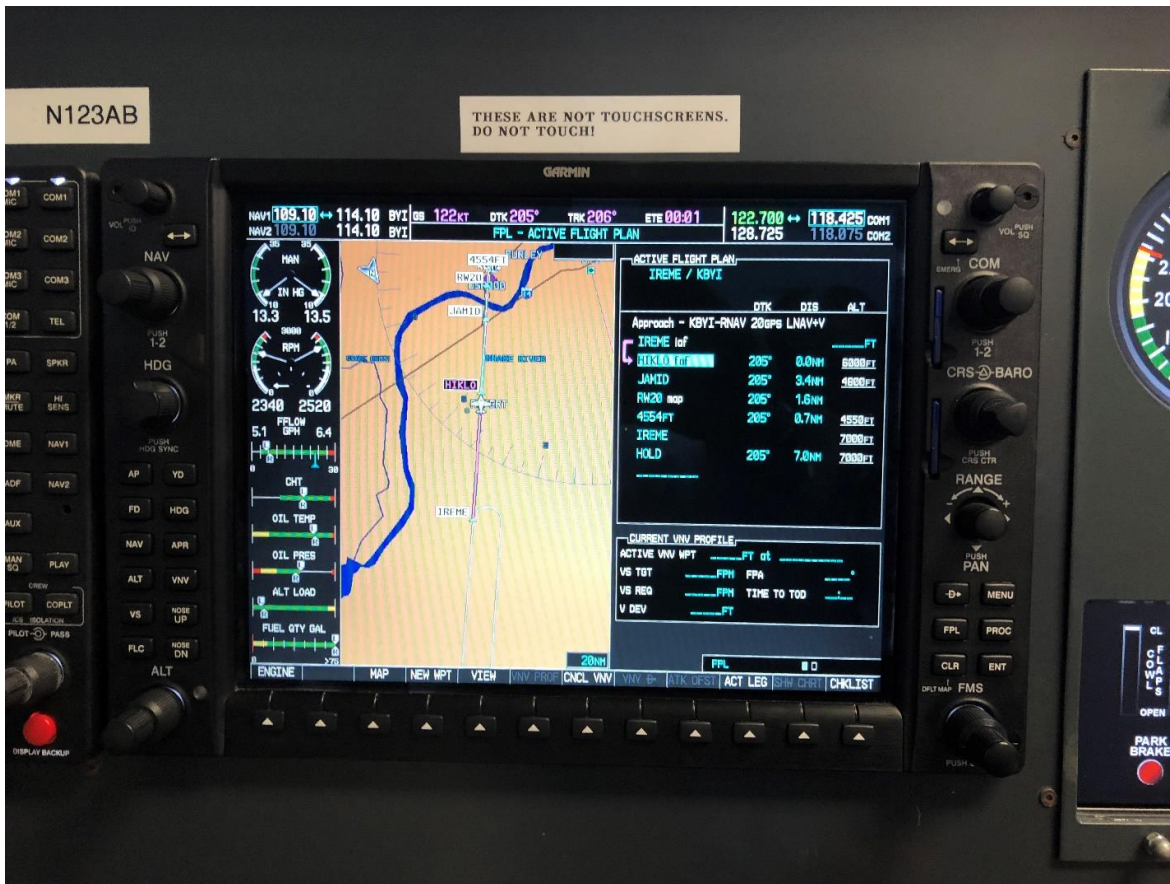
Photo 20: Map display at HIKLO.

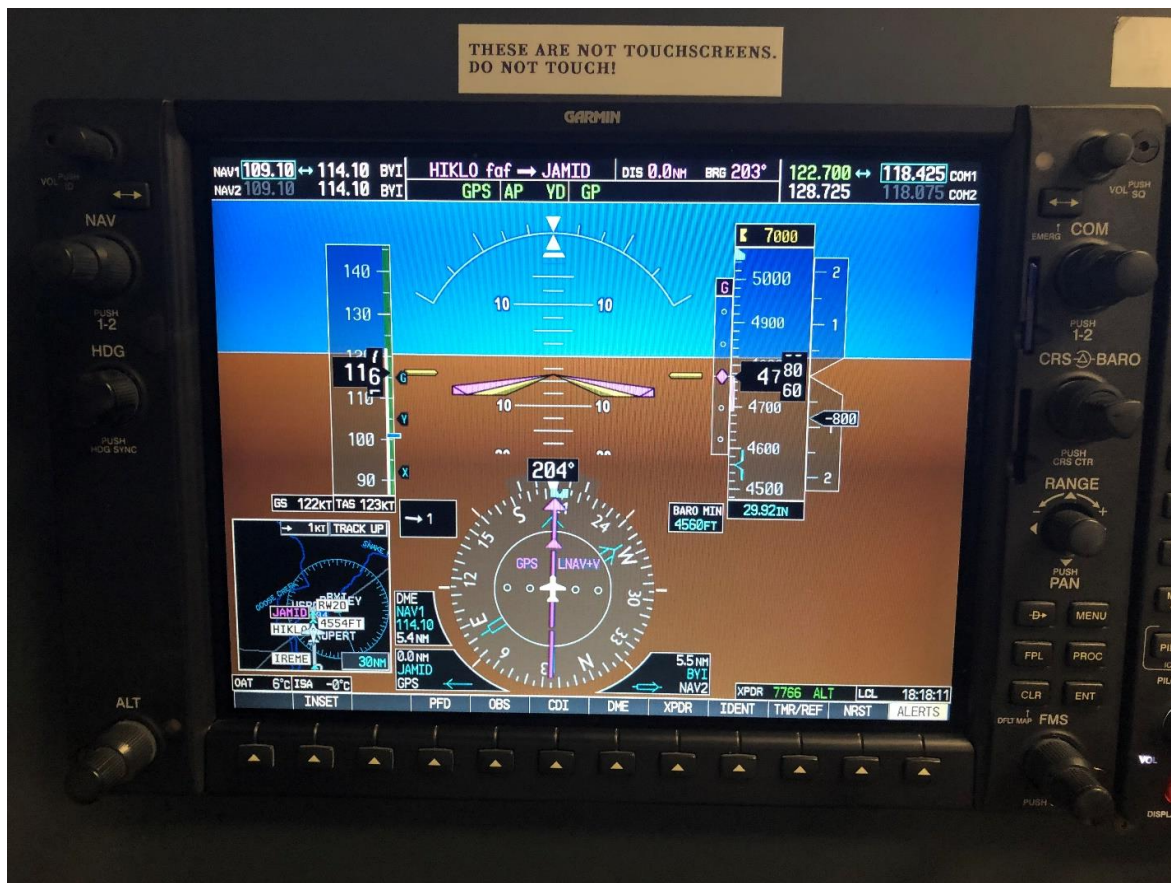
- At the JAMID fix (stepdown fix 4800') the GP deviation indicator remained centered at 4,780 feet.
- Note: at JAMID ADS-B altitude of accident flight indicated 4750'.

Photo 21: PFD display at JAMID fix.

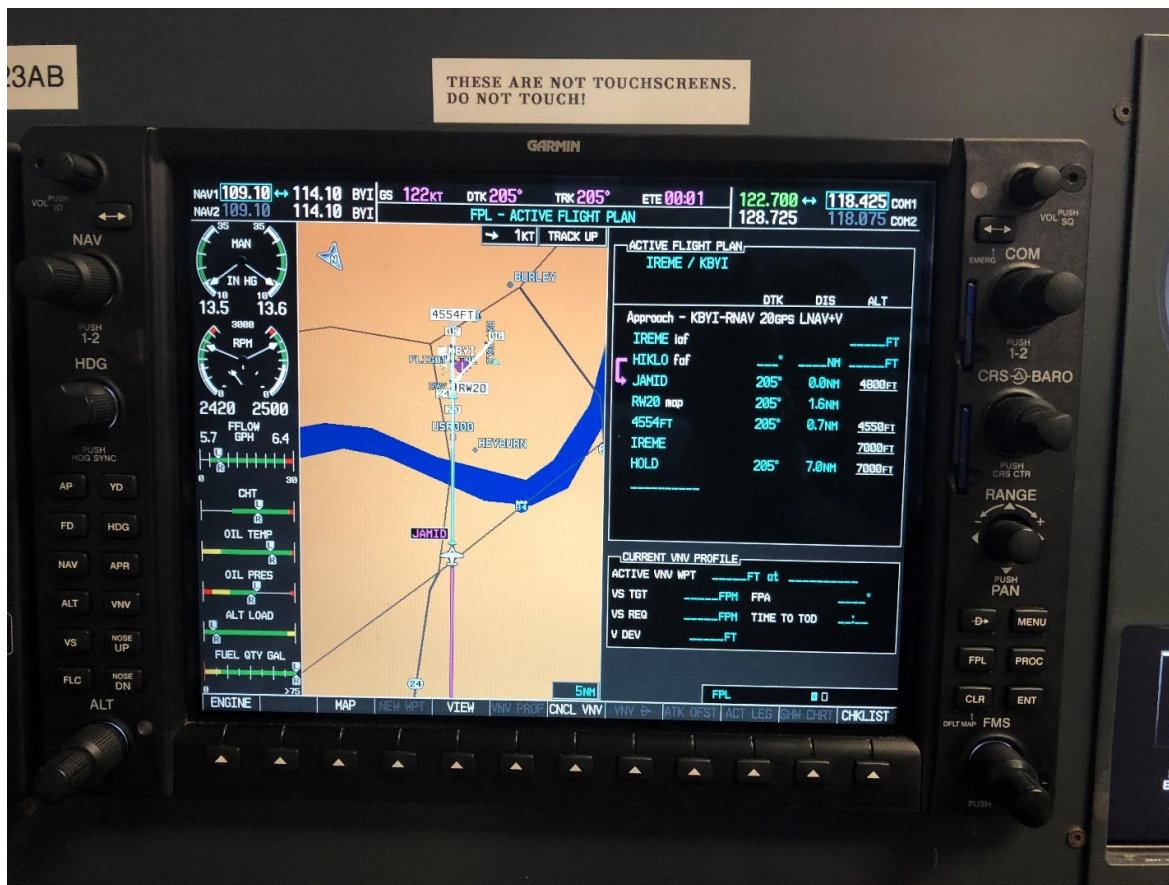
Photo 22: MAP Display at JAMID fix.

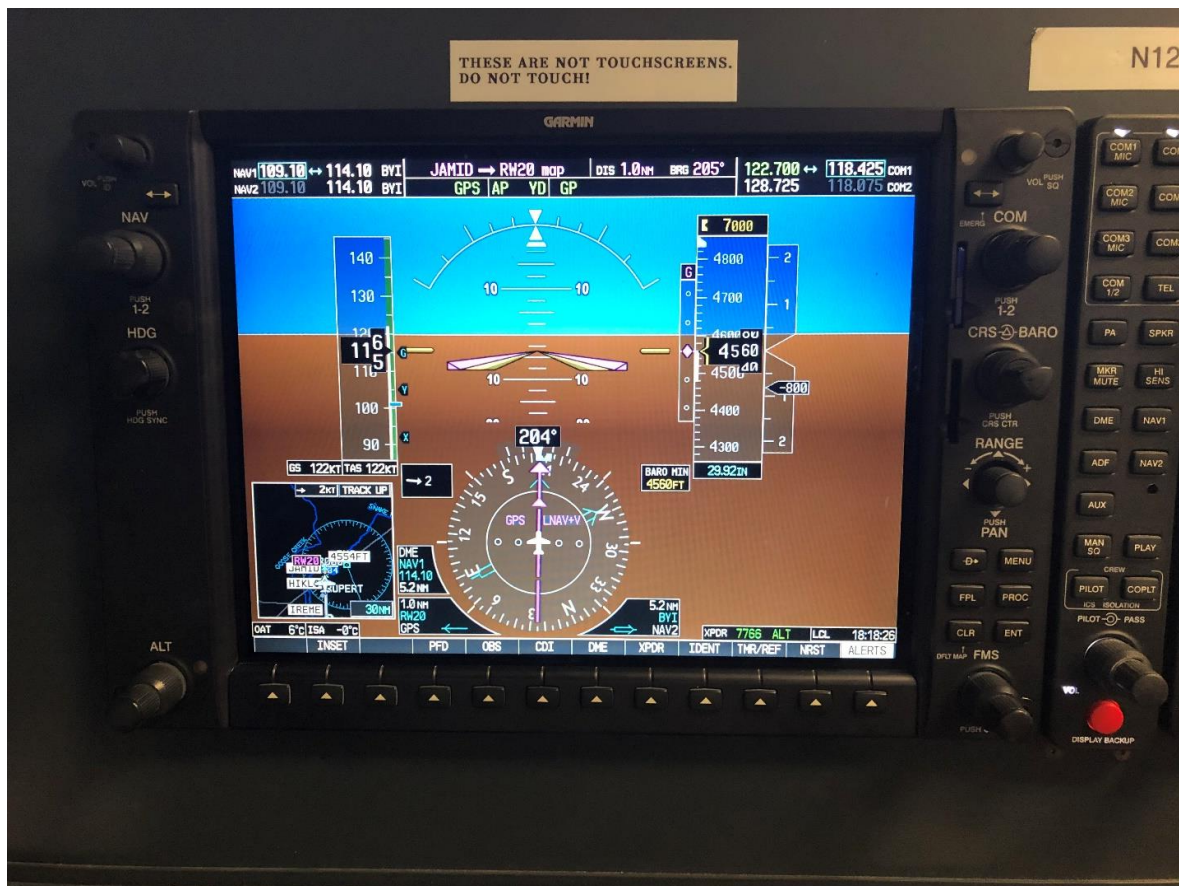
- At MDA (4560) the GP deviation indicator remained centered at 4,560 feet at a distance of 1.0 from runway 20.

Photo 23: PFD display at MDA.
