WPR22FA151

## **OPERATIONAL FACTORS**

Specialist's Factual Report - Attachment 12

FAA AATD Observation

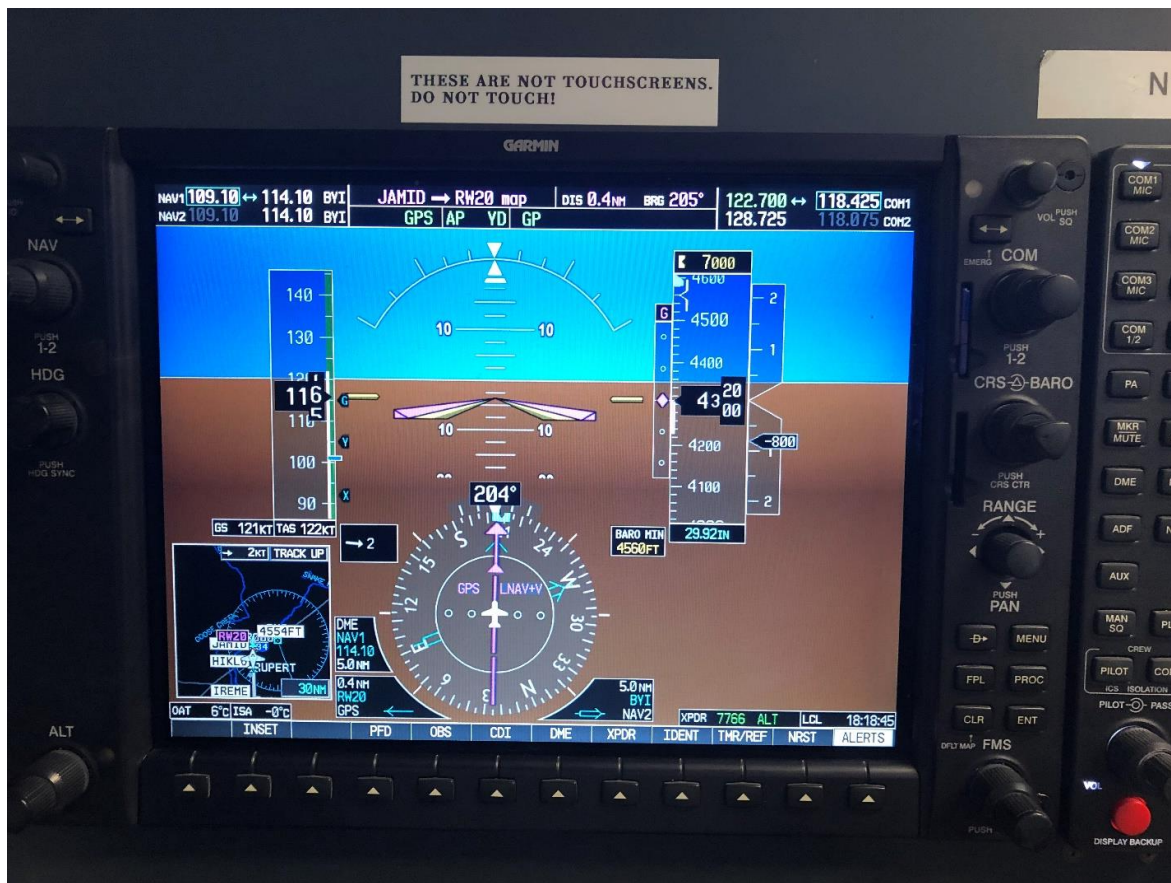
- At accident site: 0.4 nautical miles at 4,300 feet.

Photo 25: PFD display at accident site.

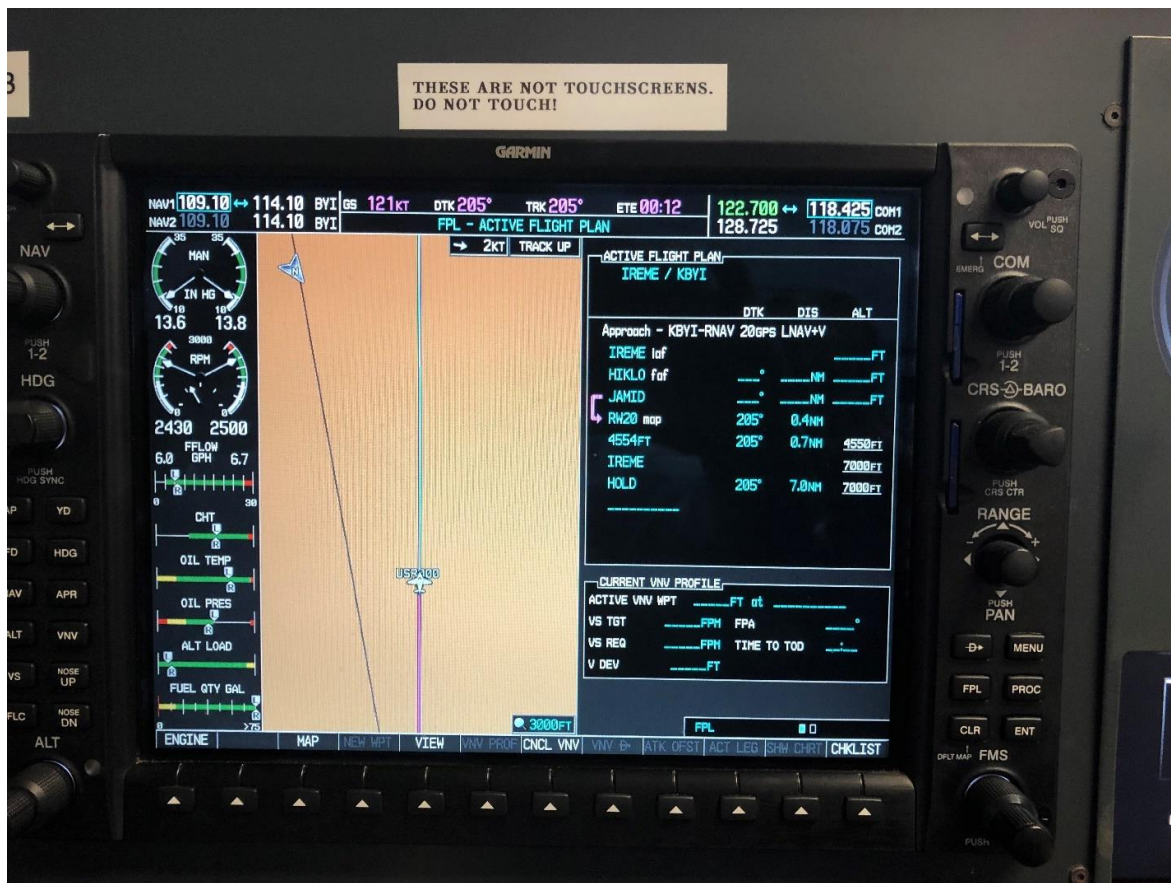
Photo 26: Map display at accident site.

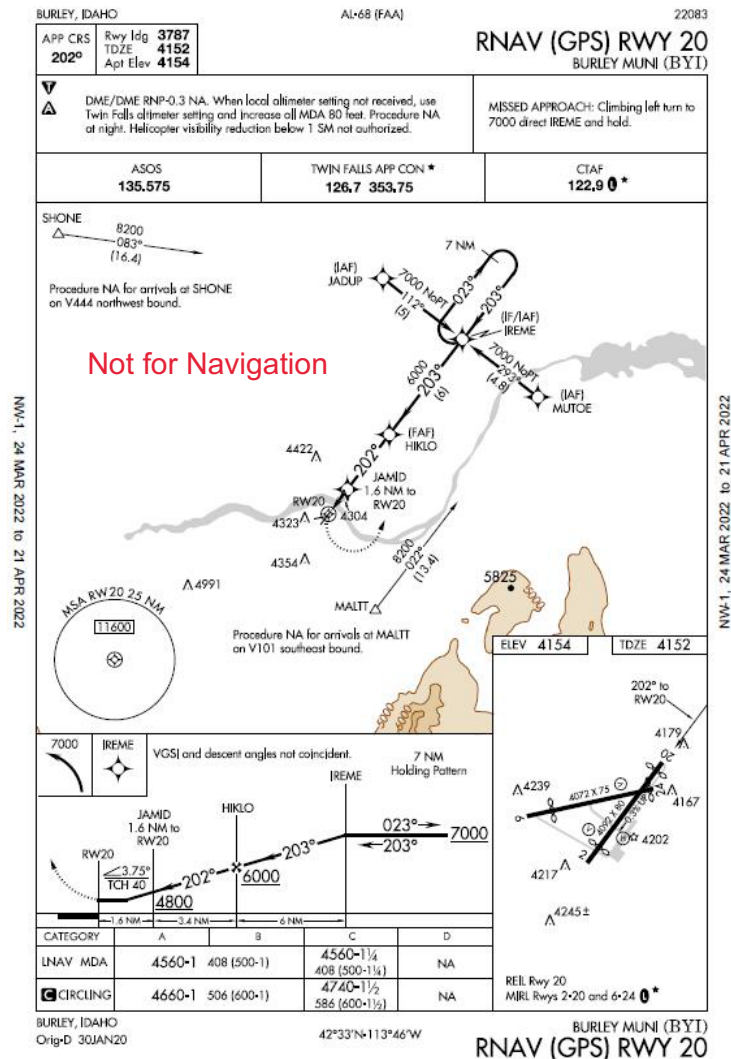
Figure 1: Jeppesen RNAV (GPS) Runway 20 Approach Chart.

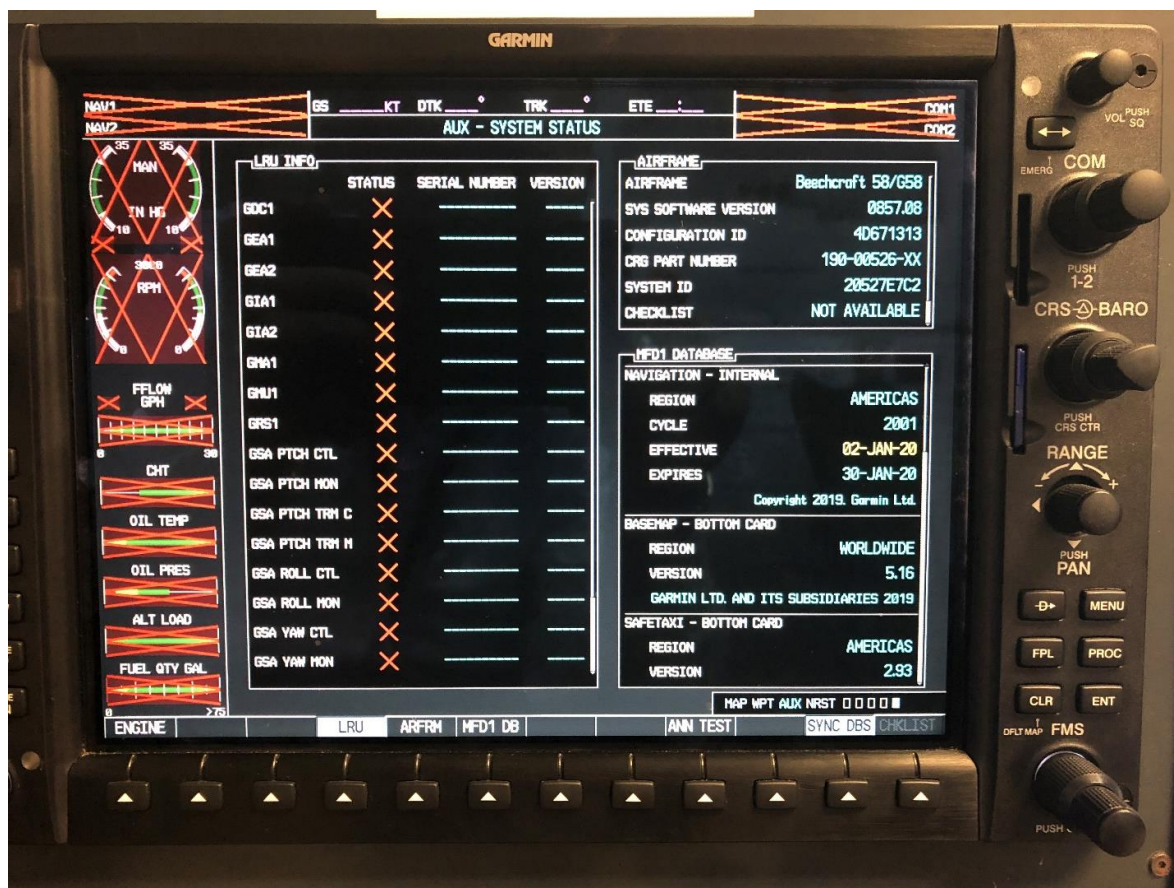
Photo 27: Garmin 1000 AUX Systems Page.

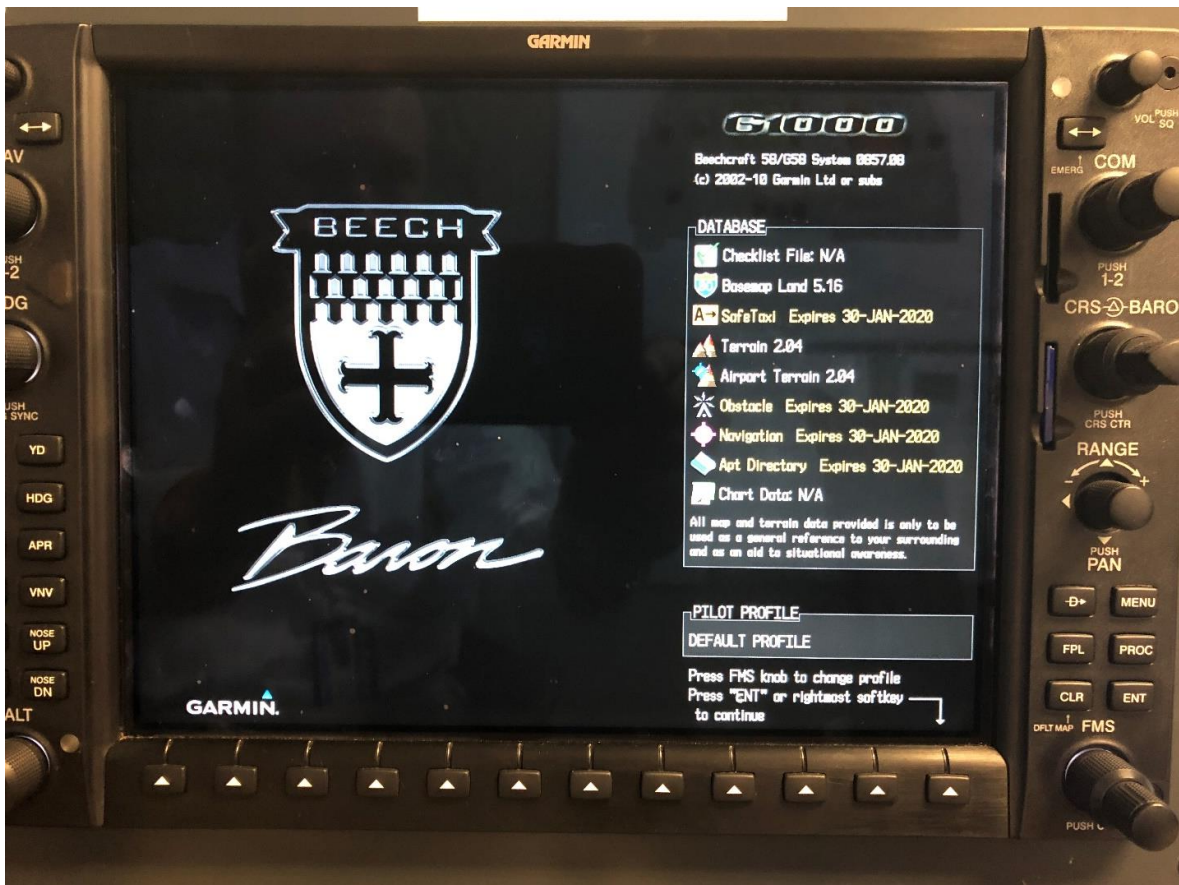
Photo 28: FAA AATD Specifications Page.
