## **NATIONAL TRANSPORTATION SAFETY BOARD**

### **Specialist's Factual Report**

## **METEOROLOGY**

WPR22FA172

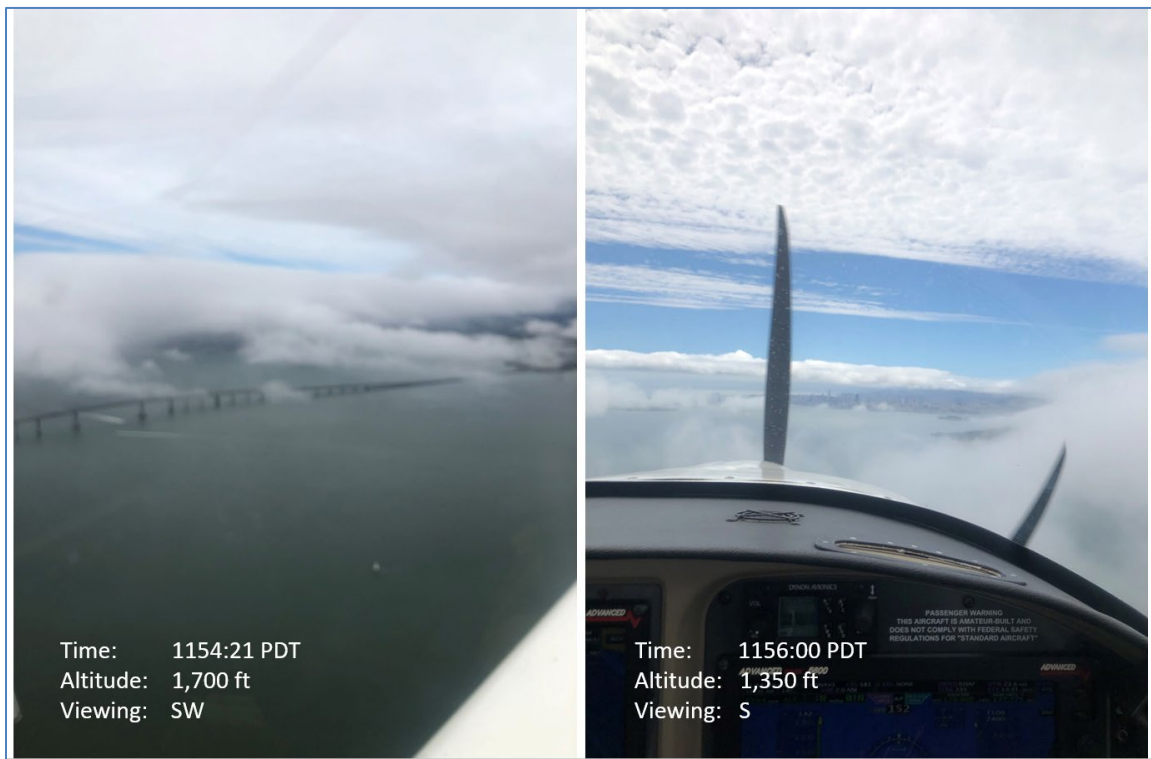
Figure 13 is camera image 1 (left) taken at 1154:21 PDT looking towards the southwest and viewing the Richmond Bridge and San Quentin and El Campo which are obscured by low stratiform clouds below the aircraft's altitude of 1,700 ft, with higher clouds above. Image 2 (right) at 1156:00 PDT looking southward towards San Francisco at 1,350 ft, with a low band of stratiform clouds off the right side of the aircraft with Angel and Alcatraz Islands visible in the image. The Golden Gate Bridge and the Marin Headlands are off to the right and obscured by low stratiform clouds.

**Figure 13 - Inflight image 1 at 1154 PDT (left) and image 2 at 1156 PDT (right).**

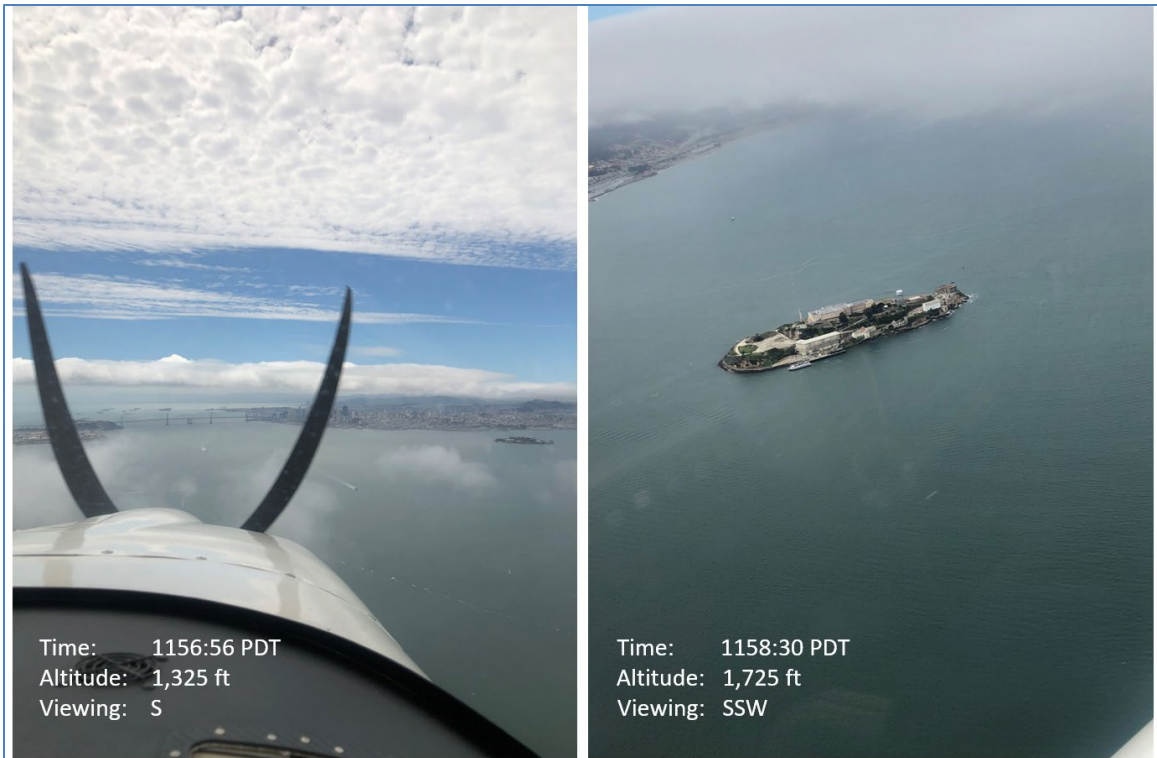
Figure 14 is the camera image 3 (left) at 1156:56 PDT at 1,325 ft viewing towards the south looking at the San Francisco-Oakland Bay Bridge and downtown San Francisco with a band of stratus clouds over the city. With several clouds immediately in the vicinity of the accident airplane. Image 4 (right) taken at 1158:30 PDT at 1,725 ft while the aircraft is beginning a right turn and viewing to the south-southwest and Alcatraz Island, with low stratus clouds and fog noted on the upper portion of the image.

**Figure 14 - Inflight image 3 at 1156:56 PDT (left) and image 4 at 1158:30 PDT (right).**

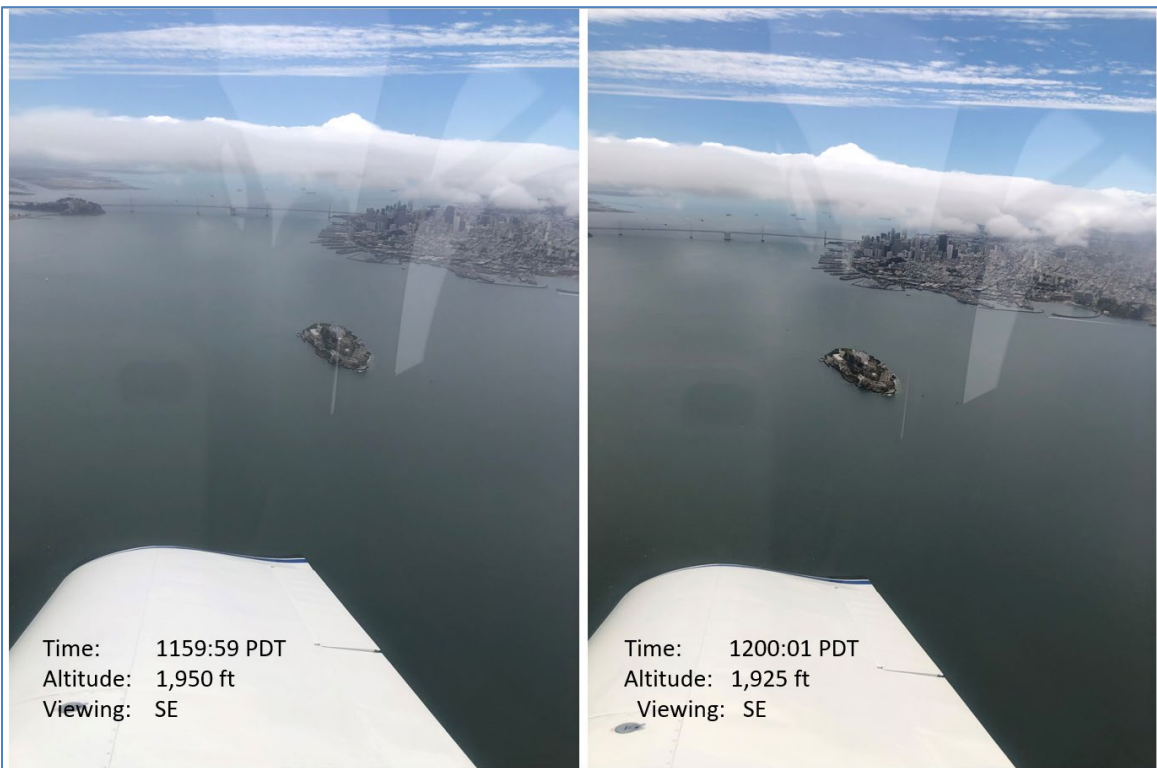
Figure 15 are the camera images 5 (left) and 6 (right) at 1159:59 and 1200:01 PDT respectively as the aircraft began to circle Alcatraz Island and looking towards the San Francisco-Oakland Bay Bridge and downtown San Francisco. A band of stratiform clouds near the accident airplane's altitude extends from the Pacific coast eastward over the northern portion of downtown San Francisco towards Treasure Island, and north of the Oakland Bridge.

**Figure 15 - Inflight images 5 at 1159:59 PDT (left) and image 6 at 1200:01 PDT (right).**

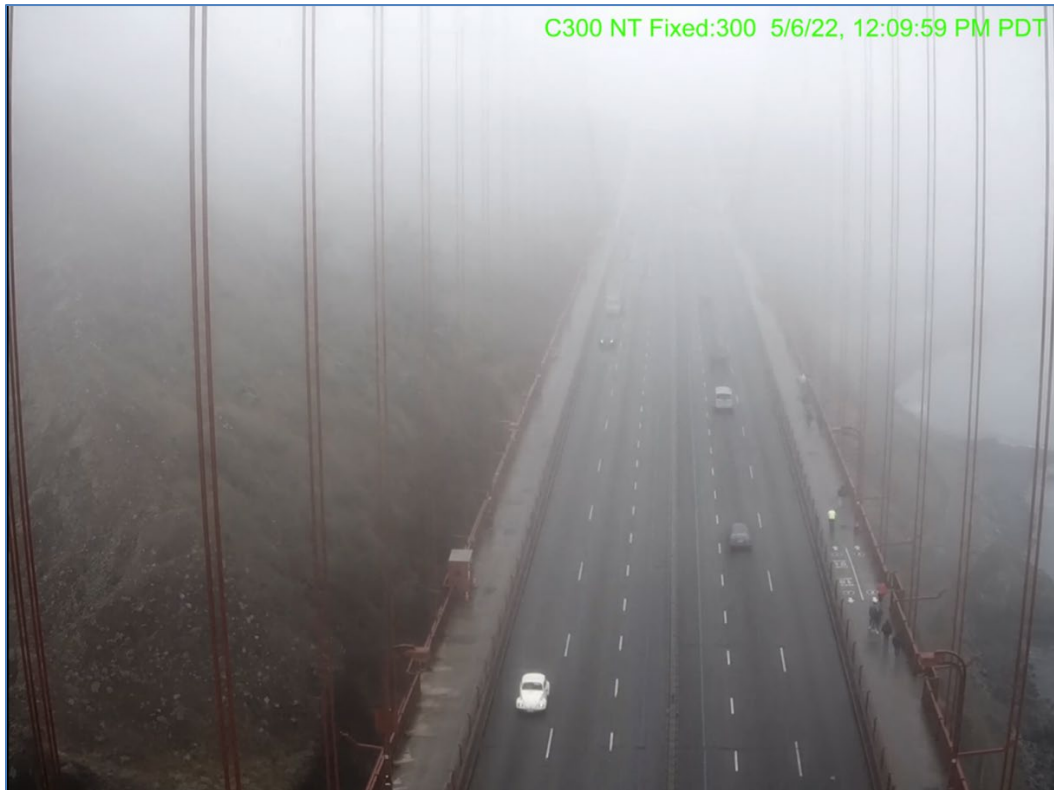
**Figure 17 - Camera #1 North Tower facing north towards entrance of bridge at 1209:59 PDT.**

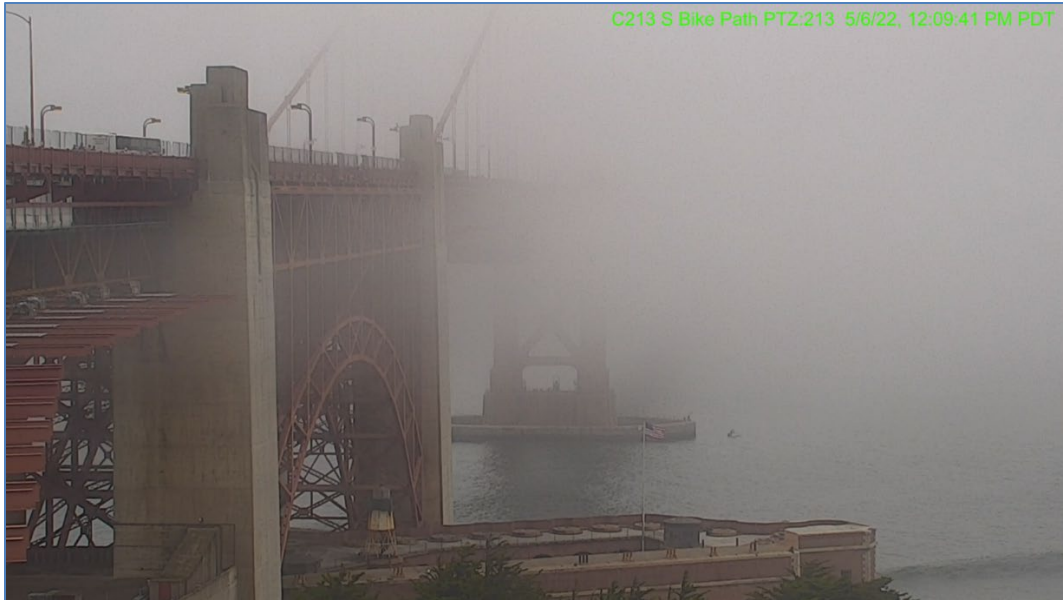
Figure 18 is a still from Camera #2 at 1209:41 PDT from the Battery East Trail near the south abutment overlook at the Golden Gate Bridge Vista Point South, at an elevation near 189 ft, looking northwest. The location was about 1.7 miles south-southeast of the accident site on the southern side of the bridge and facing towards the accident location. The image depicts a flag waving and indicating a westerly wind

of at least 10 knots with fog advecting by. The visibility<sup>21</sup> is estimated between 1/4 to 1/2 mile as the 1<sup>st</sup> tower of the bridge approximately 0.4 of a mile away or the main cables are never clearly identifiable, especially above the roadway. The vertical suspension cables are spaced every 50 ft and are not clearly identified beyond 500 ft.

**Figure 18 - Camera #2 Battery East Trail at Golden Gate Bridge Vista Point South facing northwest towards the accident site on the opposite side of the bridge at 1209:41 PDT.**

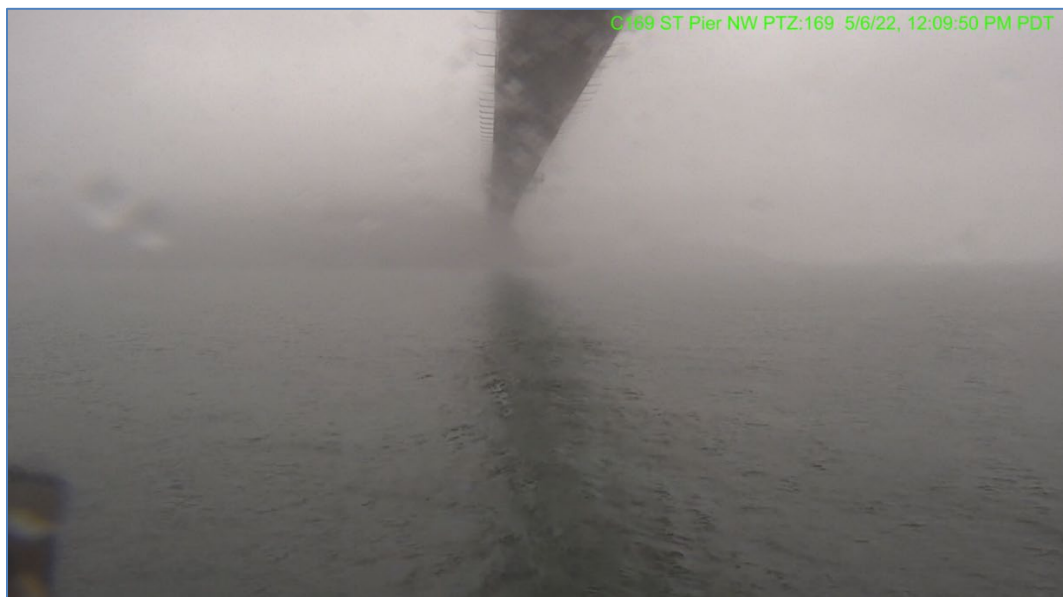
Figure 19 is a still of Camera #6 from the South Tower pier or fender at 1209:50 PDT looking northwestward and 1.36 miles south-southeast of the accident site, which was in the top left side of the frame. The image depicts visibility restricted in fog with the northside of the channel never clearly identifiable and the sky and the high terrain on the opposite side of the channel obscured by the fog and stratus. At no time during the period from 1157 through 1210 PDT was the aircraft visible from the camera or the northside of the channel.

**Figure 19 - Camera #6 C169 South Tower Fender facing north at 1209:50 PDT.**
