# NATIONAL TRANSPORTATION SAFETY BOARD

## Video Study

**NTSB Case Number:  
WPR22LA015**

Location: Alta Mesa Airpark, Wilton, California  
Date: October 14, 2021  
Time: 1600 Pacific daylight time  
Aircraft: WSK Mielec AN-2TD

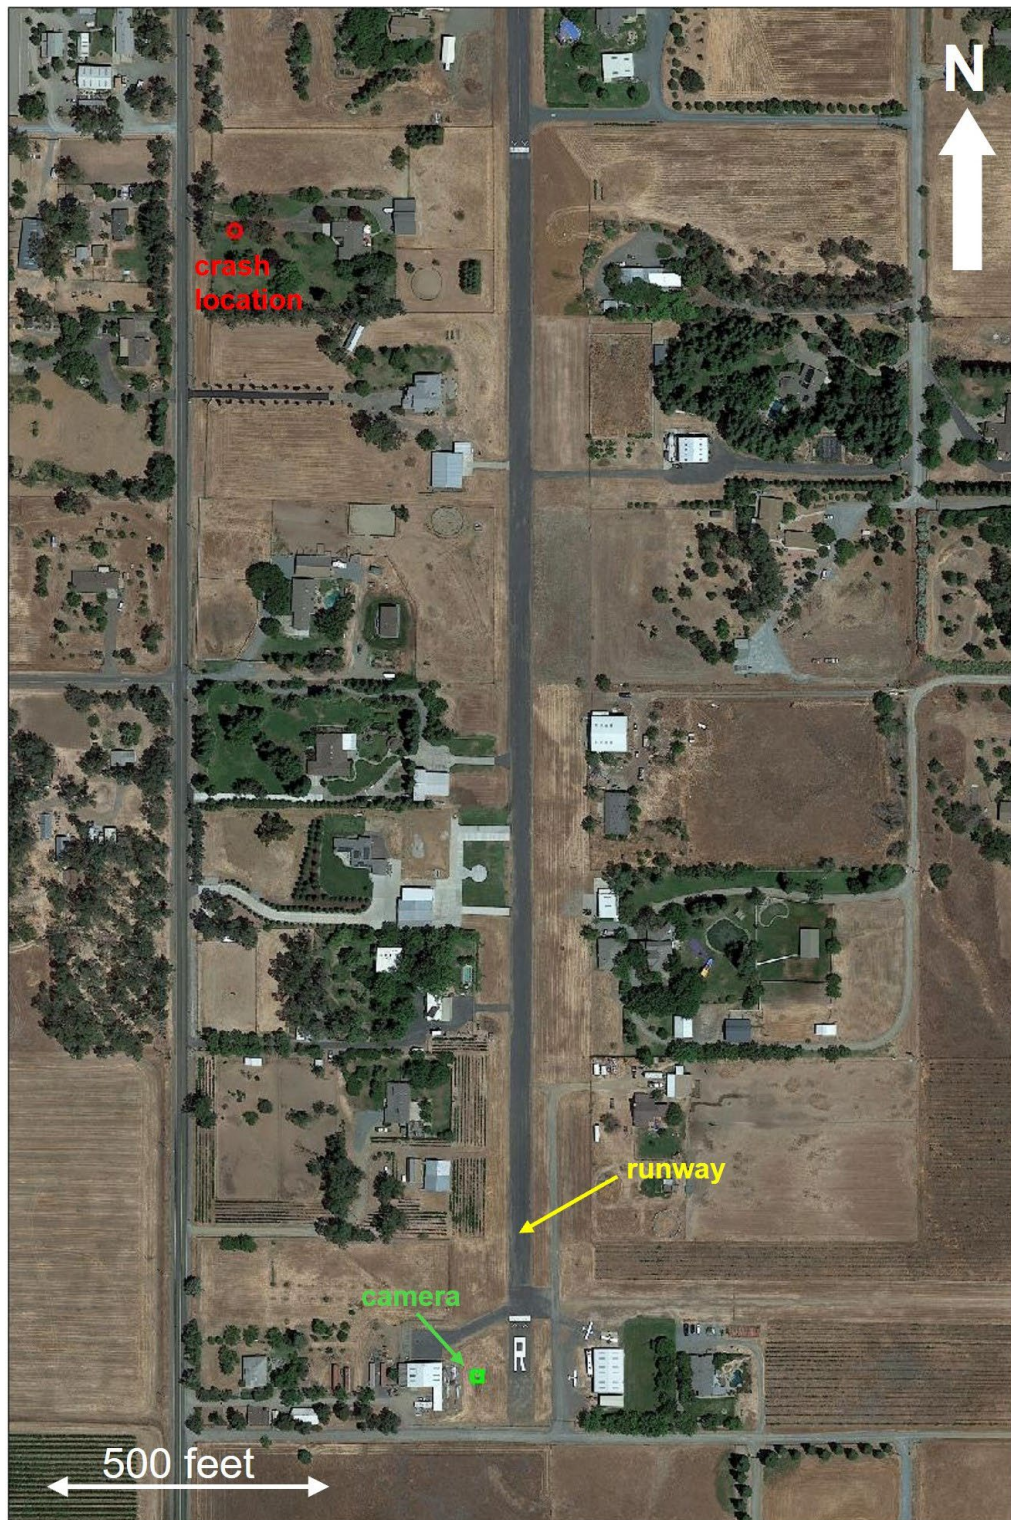
**Figure 1. Aerial View of the Alta Mesa Airpark**

Figure 1 shows an aerial view of the Alta Mesa Airpark. The camera location, the runway and the airplane crash location are marked in the figure. The airplane started its takeoff roll at the southern end of the runway, near the camera location. The camera was hand-held, and the camera holder was tracking the airplane as it moved north along the runway. To keep the airplane in the field of view, the camera holder was changing the yaw and the pitch orientation angles of the camera. The camera roll angle and the camera location were also changing slightly during the video. Figure 2 shows a frame from the video that was recorded at video time 47.5 seconds.

The estimation was based on references that were visible both in aerial views such as Figure 1 and in video frames such as the one in Figure 2. The references were the runway, the runway markings, the buildings seen in Figure 2, and trees. A computer program that simulates camera optics was used to project the references onto a frame from the video in an iterative process in which the unknown camera parameters were varied so as to align the projected references with their images. When the projected references were aligned optimally with their images in the frame, values of the camera parameters were their optimal estimates. At that point, the model of the camera optics was calibrated.

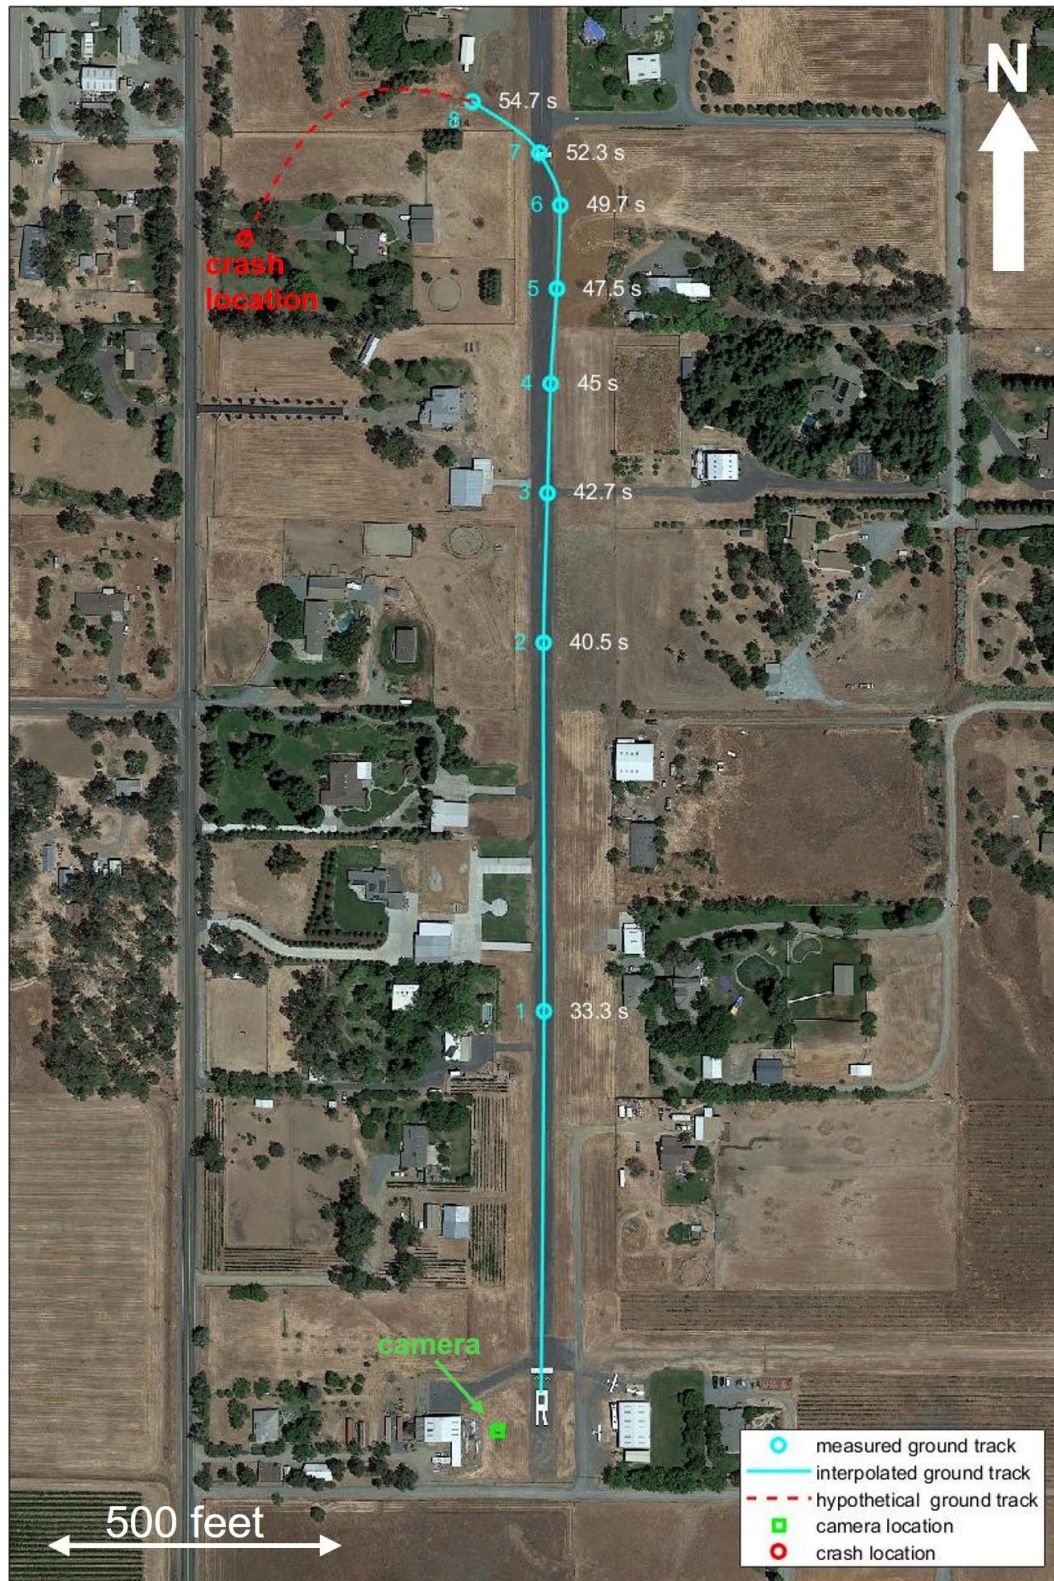
Figure 3. Estimated Ground Track of the Airplane

Figure 3 shows the estimated ground track of the airplane. The ground track locations corresponding to the eight analyzed video frames are marked in the figure as are the times when the airplane was at these locations. The ground track starts at the location where the airplane started its takeoff roll. At analyzed point No. 1, the three airplane tires were still on the runway. Analyzed point No. 2 is just past liftoff. At point No. 7, the airplane reached its maximum AGL altitude and was already turning left.

The locations along the runway and the times when the airplane was at these locations made it possible to estimate the ground speed. It was 66 knots at time 40.5 seconds (point No. 2), just past liftoff. When the airplane reached its maximum altitude at time 52.3 seconds (point No. 7), the speed was down to 19 knots. The ground speed deceleration during these 11.8 seconds was constant at about 4 knots/second. Past time 52.3 seconds, the ground speed was increasing because the airplane was descending.

At that time, the sound frequencies recorded by the second camera were not affected by the Doppler effect because there was no relative speed between the airplane and the camera. As can be seen in Figure 3, at that time the airplane was near the most northern point of its ground track. As can be seen in Figure 4, at that time the airplane was already descending toward ground impact. The frequency corresponding to BPF was 6055 blades/minutes based on spectrum analysis of the sound recorded with the second camera, resulting in an engine speed estimate of  $2200 \times 6055/6050=2202$  rpm.
