# National Transportation Safety Board

WPR22LA251

## **ONBOARD IMAGE, AUDIO AND DATA RECORDER**

Specialist's Factual Report

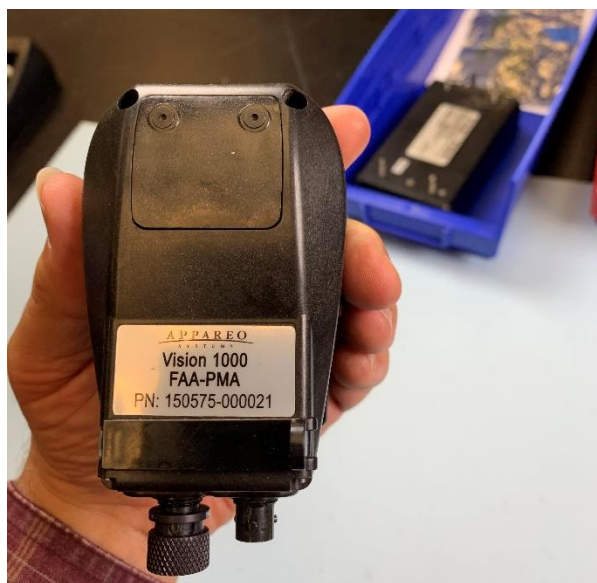
The device appeared undamaged and is pictured in Figure 1.

**Figure 1.** Photo of the Vision 1000 undamaged as received by the NTSB Vehicle Recorder Division.
