# National Transportation Safety Board

WPR22LA251

## **METEOROLOGY**

Group Chair's Factual Report

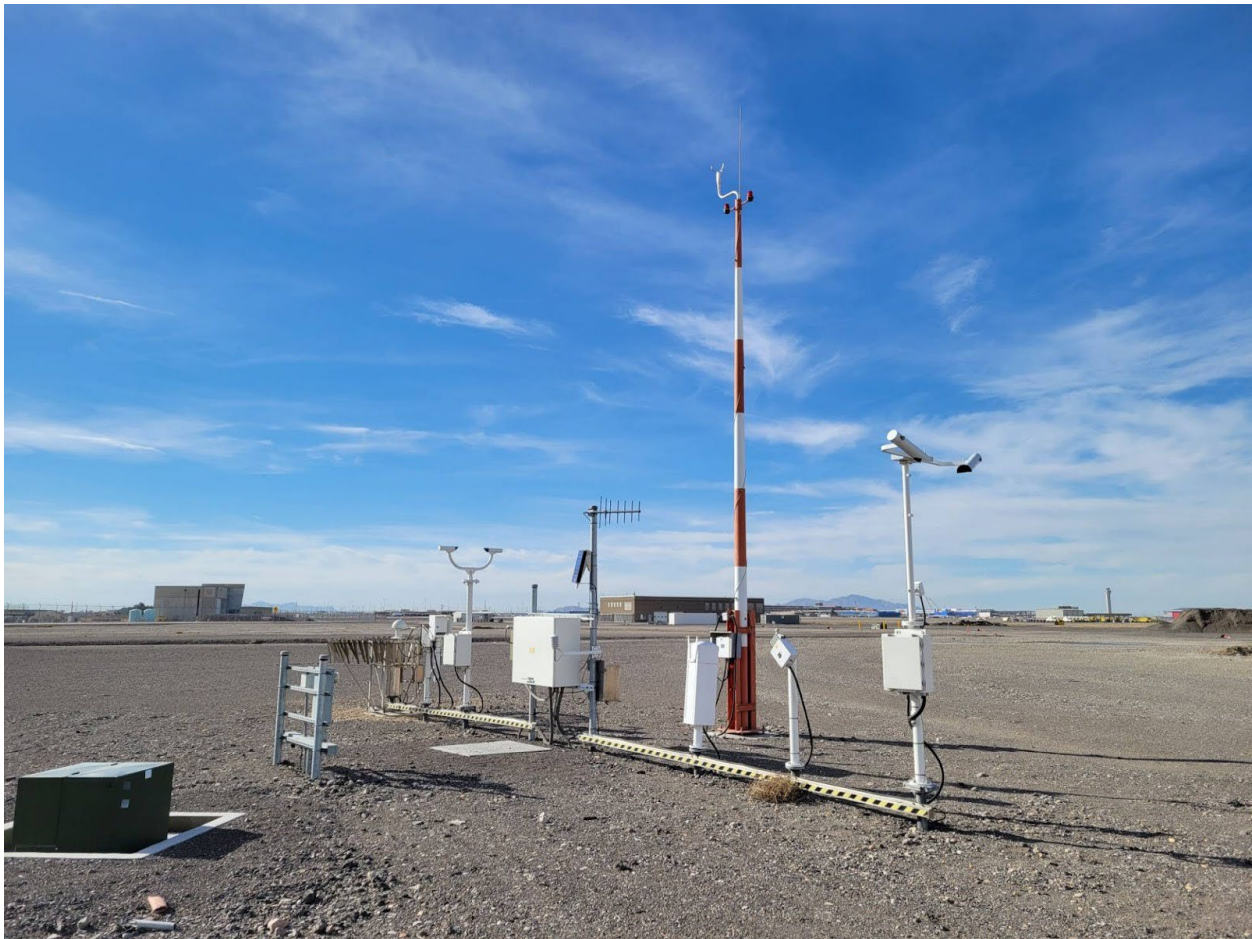
The observations from KSLC surrounding the accident time indicated VFR<sup>9</sup> conditions prevailed with thunderstorms and gusting winds to 48 knots at 1854 MDT. The one- and five-minute KSLC ASOS observations surrounding the accident timeframe can be found in attachment 1. Exemplar KSLC ASOS instrumentation imagery and a chart depicting the ASOS' location on the airport are provided in figures 6 and 7, respectively.

**Figure 6.** Exemplar image of KSLC ASOS instrumentation.

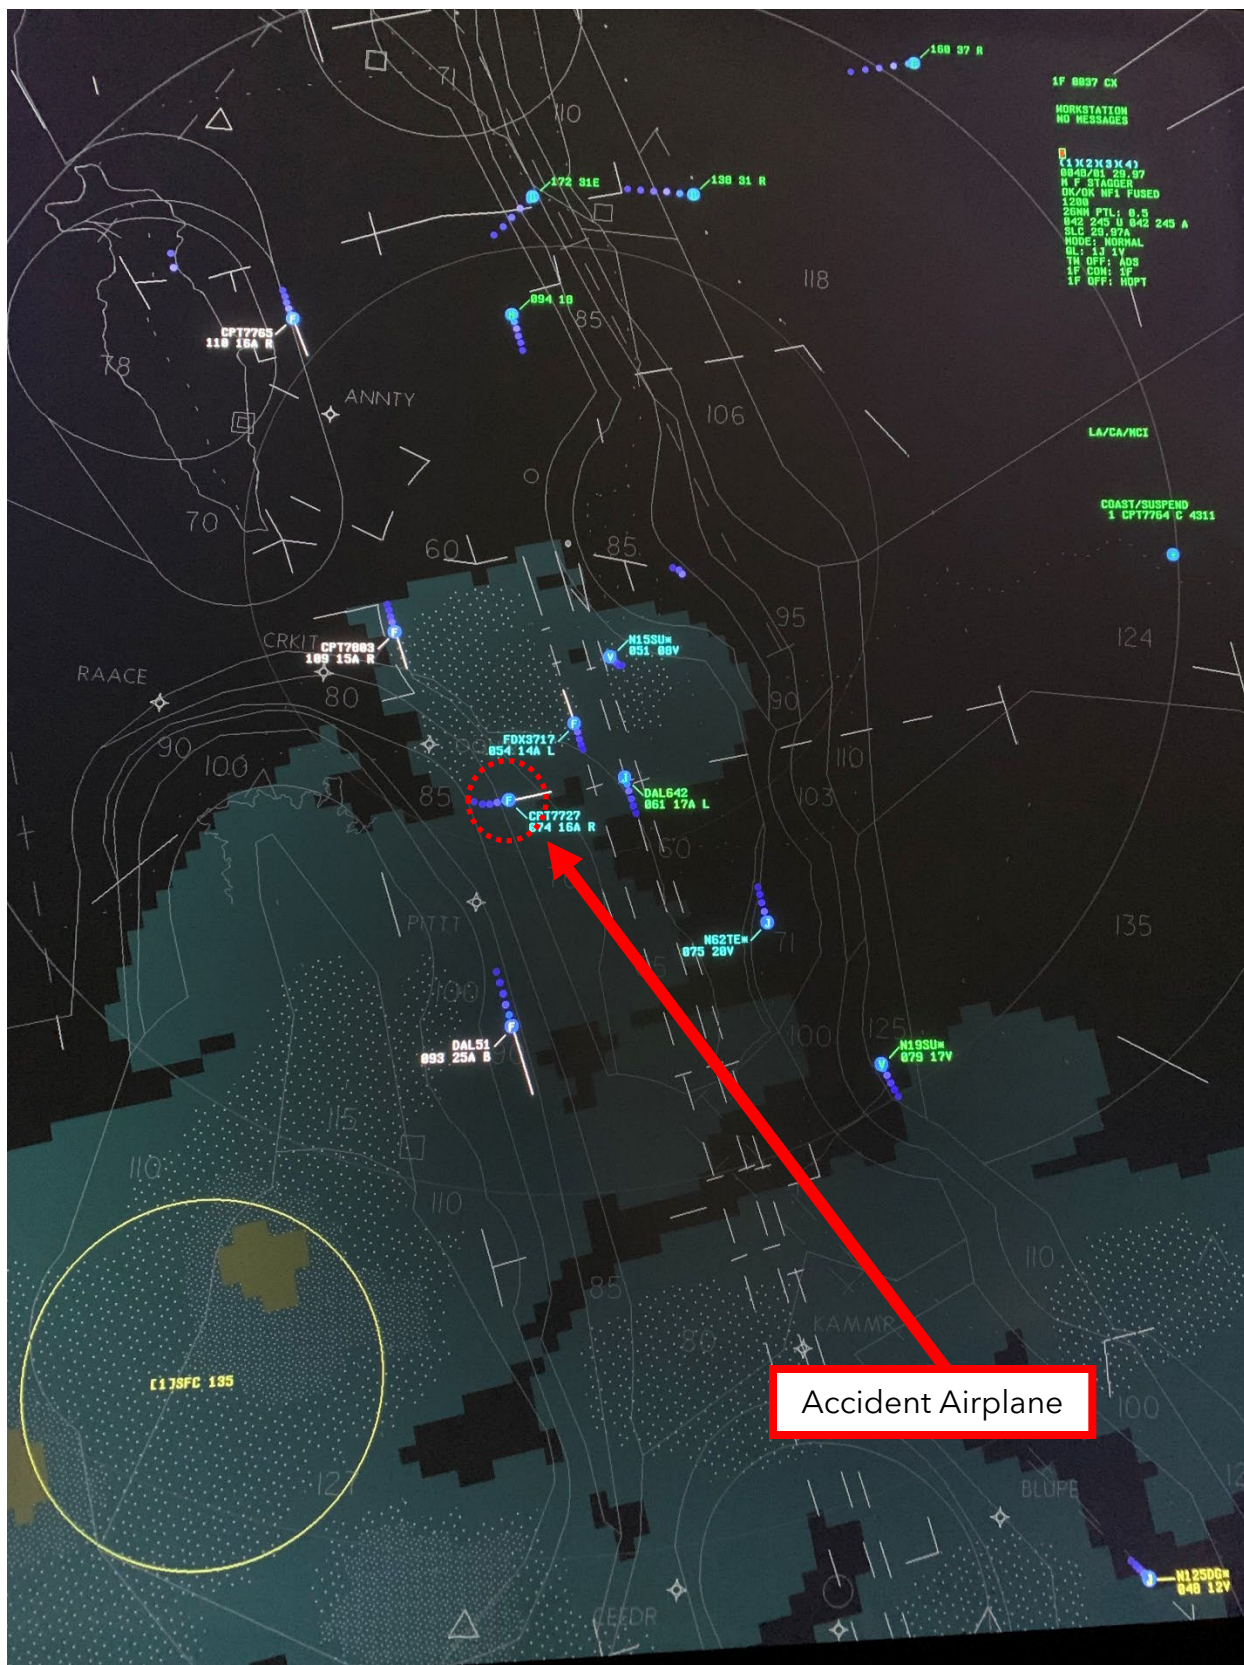
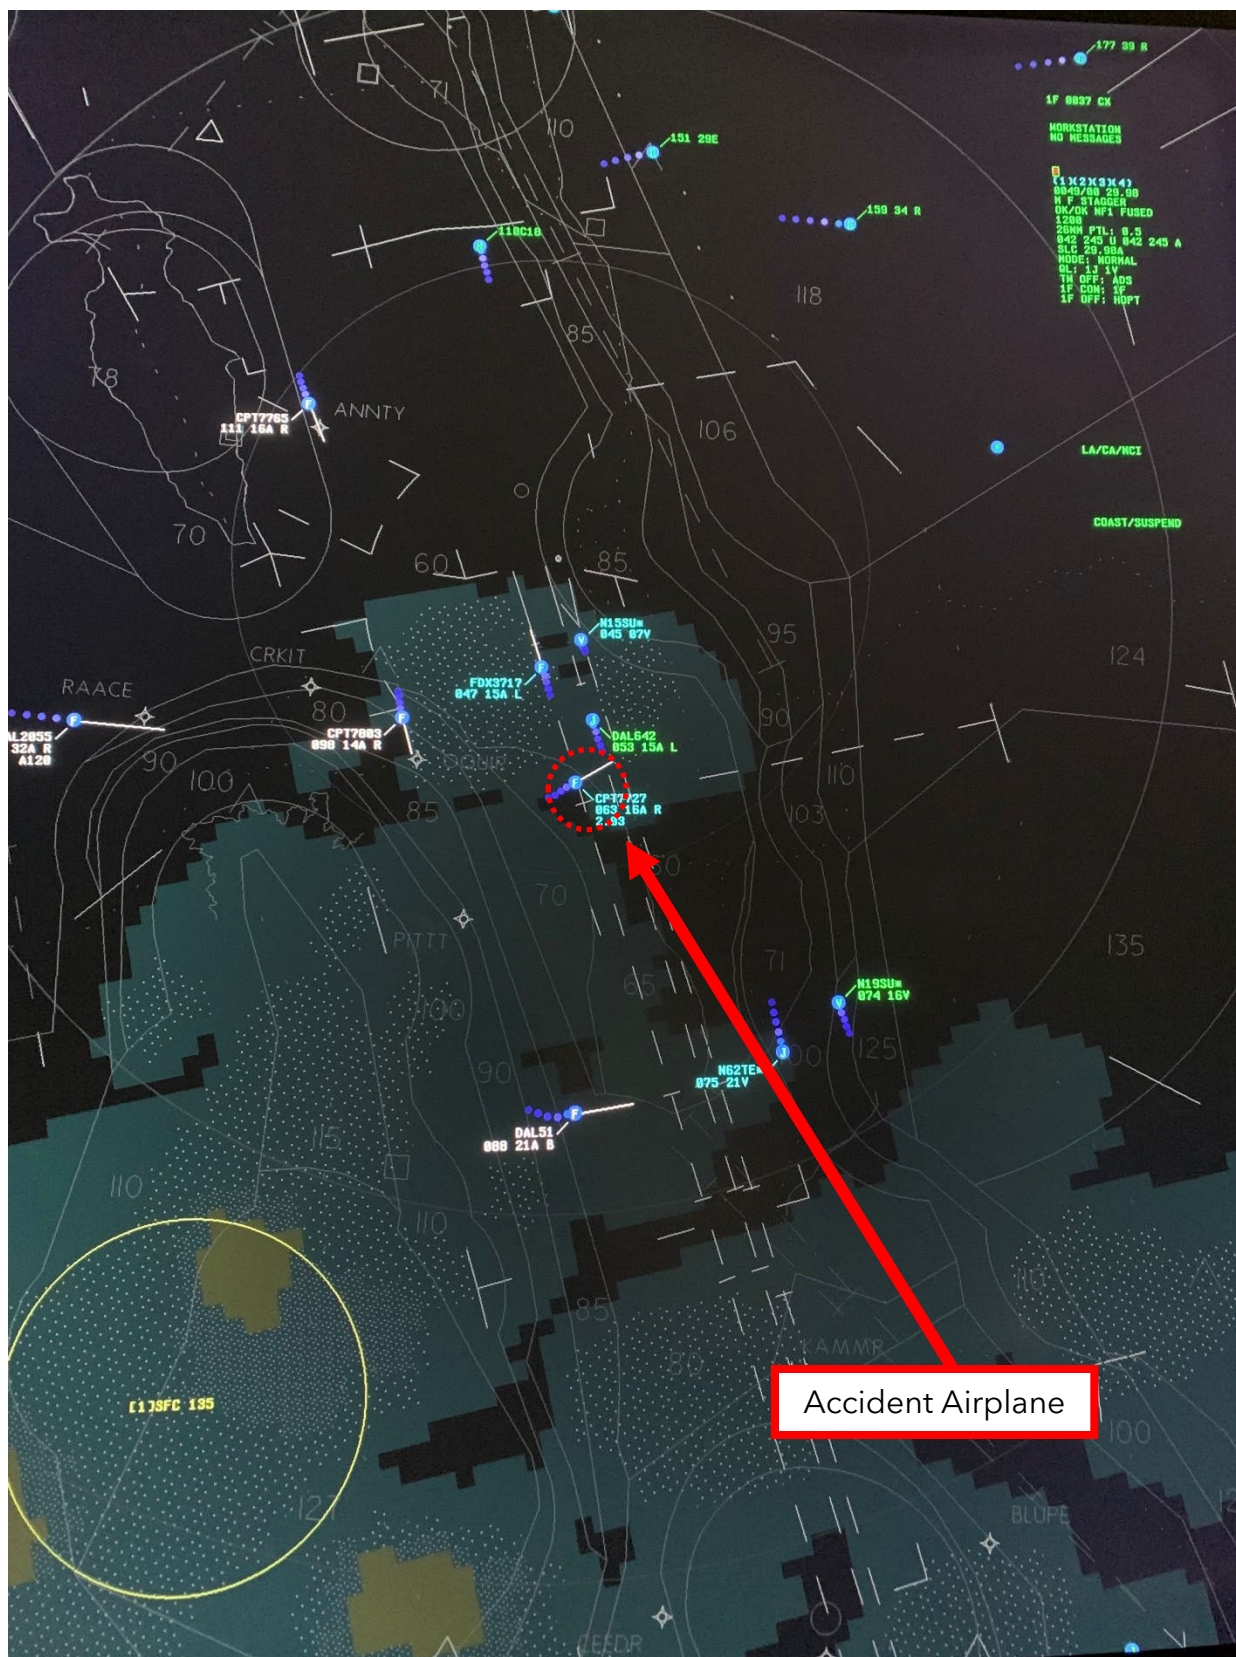
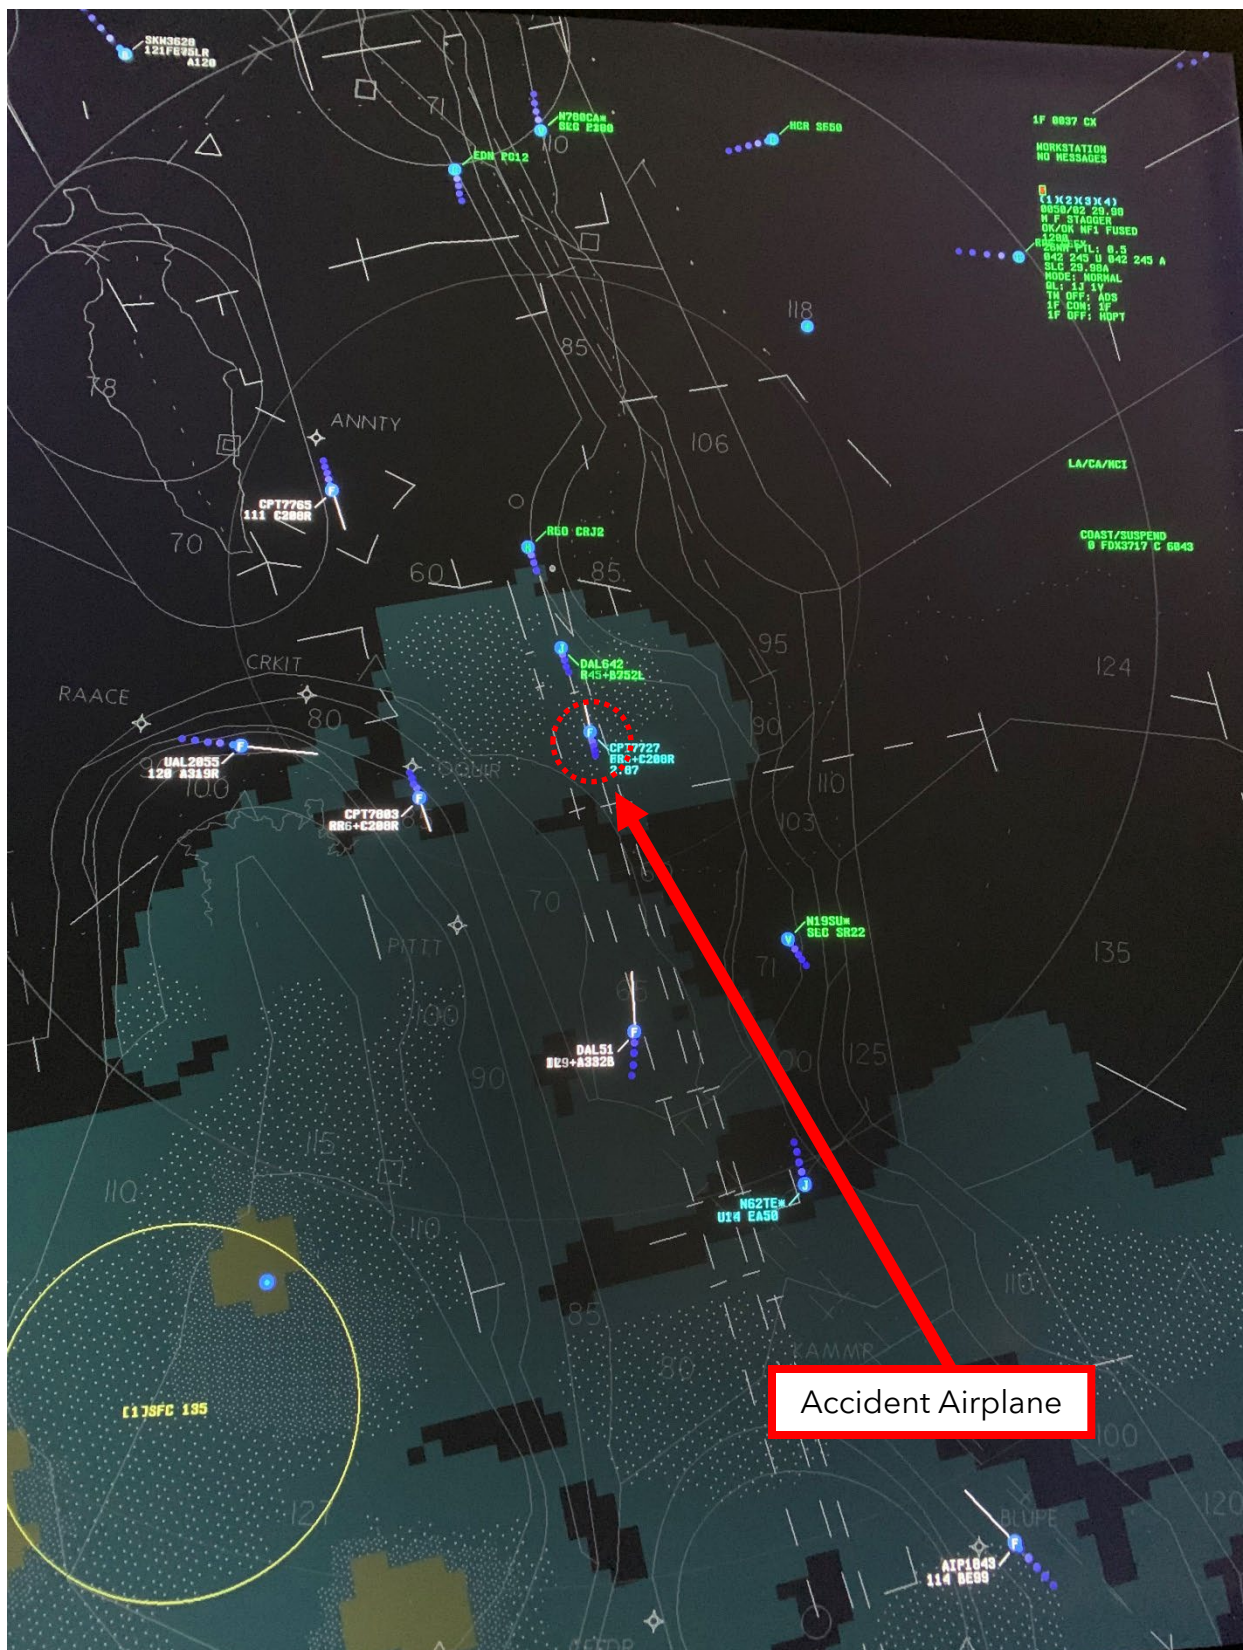
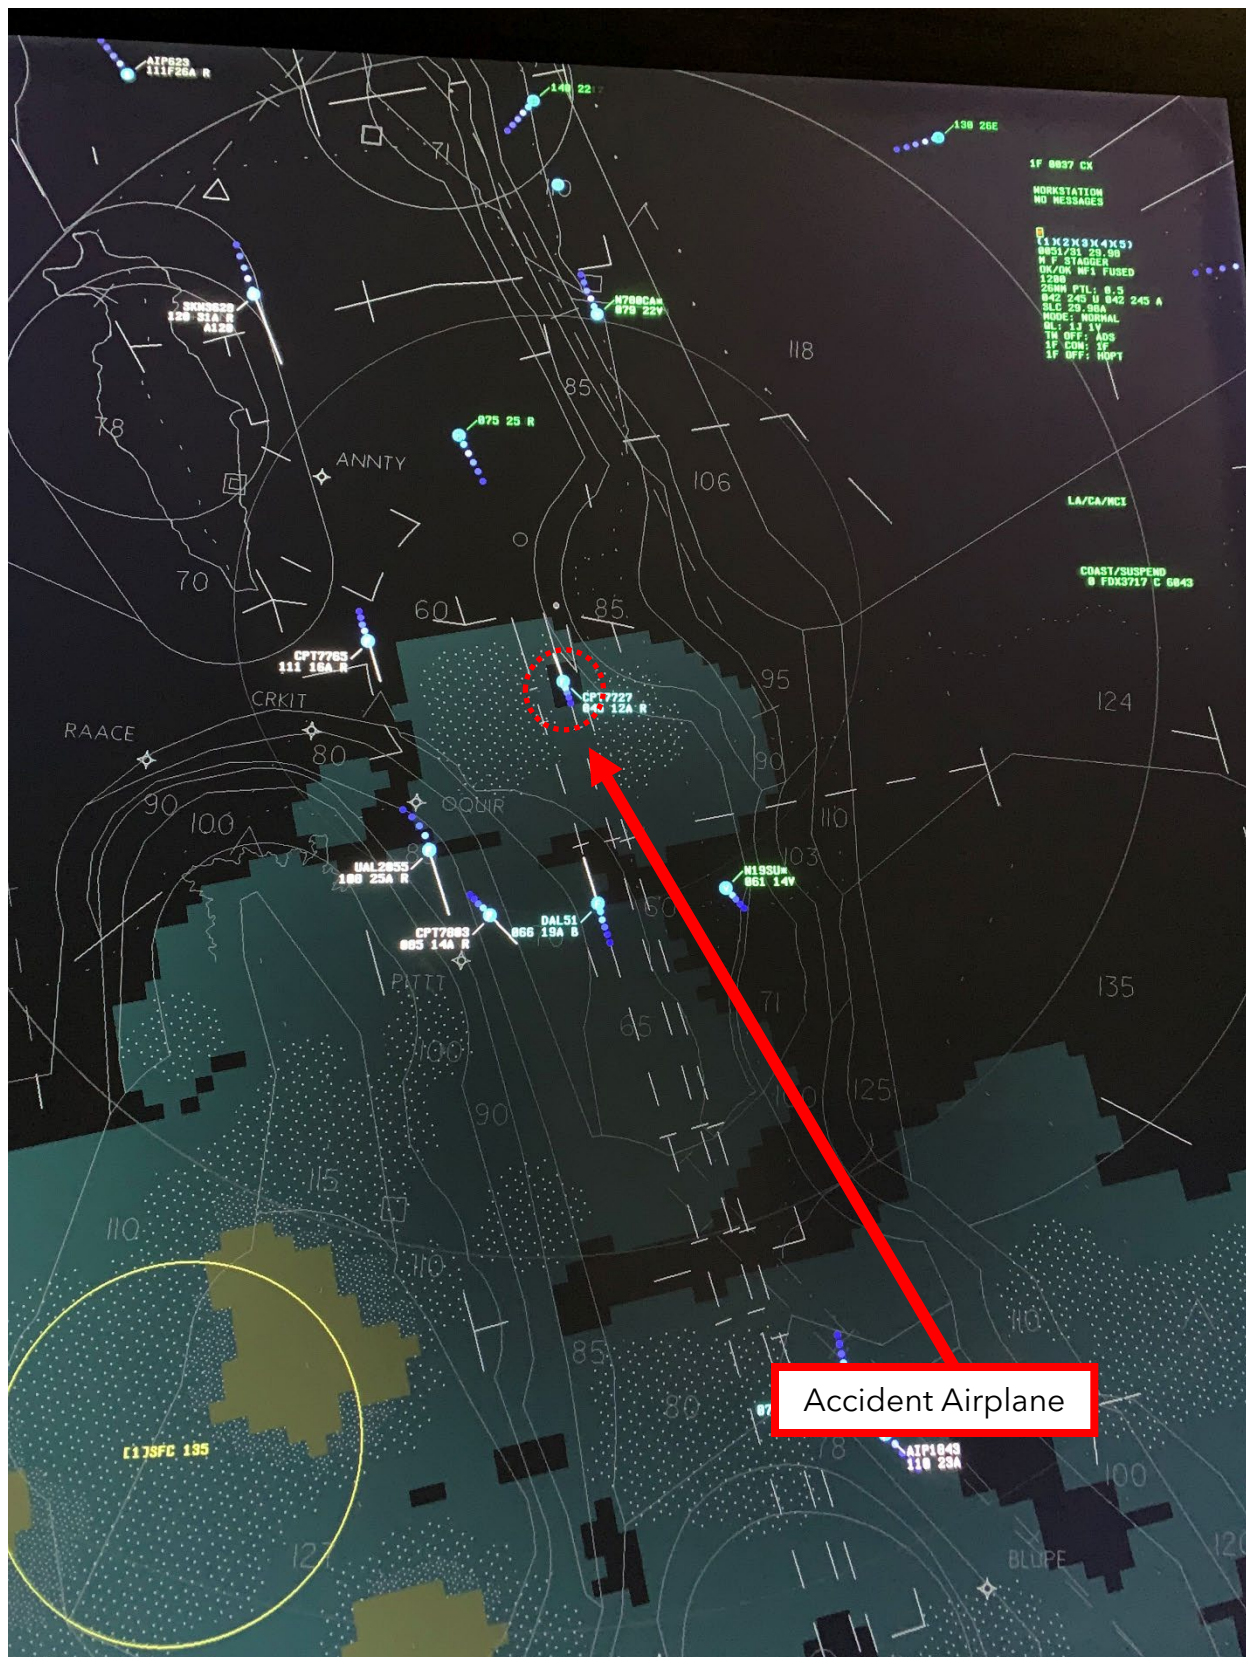
Figure 26 provides an exemplar view of what precipitation levels 1 through 6 look like on a STARS display of precipitation. Figures 27 through 30 show the STARS display of precipitation used and seen by the accident air traffic controller at around 1848, 1849, 1850, and 1851 MDT.

**Figure 28.** STARS weather and precipitation level display used and seen by the accident air traffic controller from around 1849 MDT.

**Figure 29.** STARS weather and precipitation level display used and seen by the accident air traffic controller from around 1850 MDT.

**Figure 30.** STARS weather and precipitation level display used and seen by the accident air traffic controller from 1851 MDT.

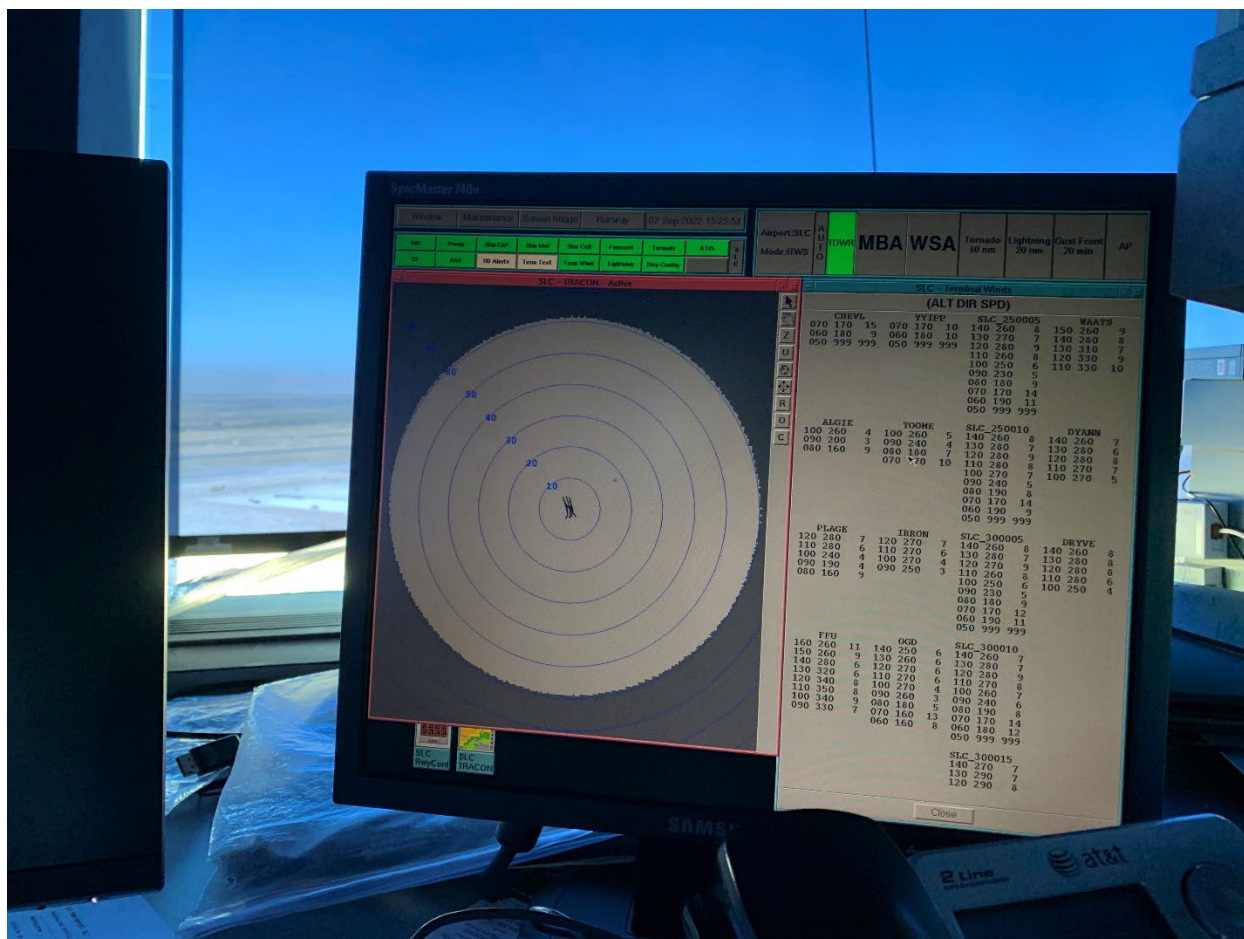
**Figure 31.** Exemplar view of the ITWS location in the SLC ATC Tower facility.

Integrated Terminal Weather System (ITWS)<sup>46</sup> information was not requested in time<sup>47</sup> to be retrieved for the accident timeframe. Exemplar views of the SLC ATC tower facility and S56 TRACON facility ITWS display locations are provided in figures 31 and 32. The SLC ATC tower facility ITWS display was located in the north end of the tower cab behind the supervisor position. The S56 TRACON facility ITWS display locations were on computer monitors at both the supervisor and traffic manager positions. An exemplar active weather day view of ITWS displayed data from S56 TRACON facility is provided in figure 33. The ITWS reference sheets for both TDWR and non-TDWR locations are provided in attachments 21 and 22. The historical development of the ITWS reference sheet is discussed in attachment 23.
