# National Transportation Safety Board

WPR23FA299

## **ELECTRONIC DEVICES**

Specialist's Factual Report

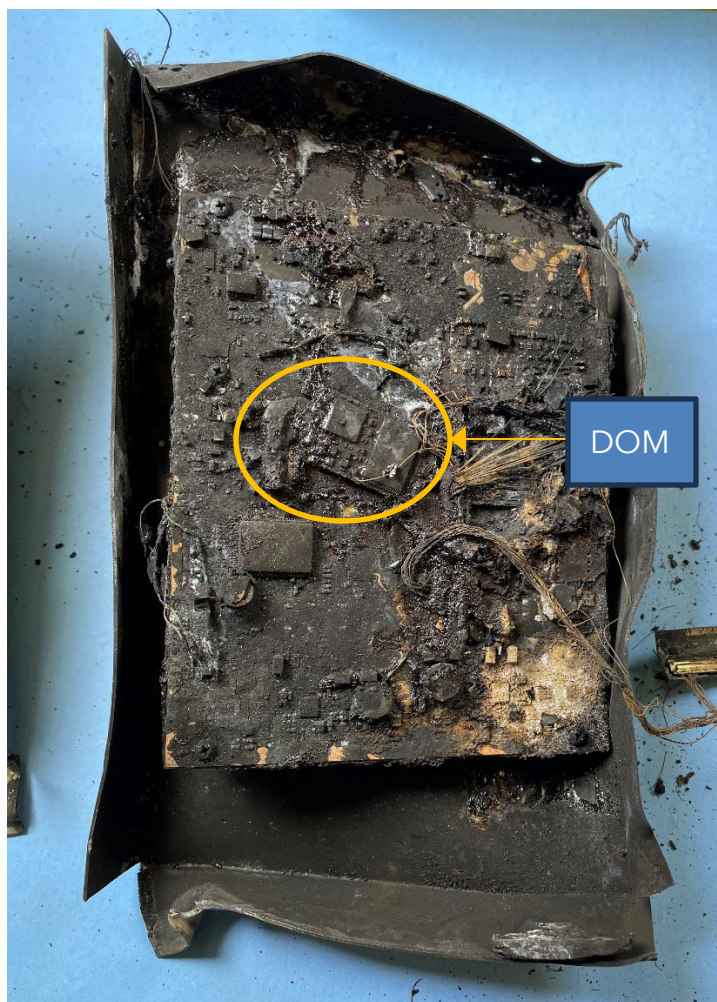
**Figure 1.** Photo of first Dynon as received with location of DOM device annotated.

Upon arrival at the Vehicle Recorder Laboratory, an exterior examination revealed both Dynon devices had sustained significant impact and thermal damage. The first unit, shown in figure 1 with the memory module annotated, was too significantly burned to attempt a recovery. The second unit, shown in figure 2, had also suffered fire damage, but the DOM was intact enough to attempt a recovery of data.

The DOM was installed in a laboratory SATA reader however no file system could not be mounted. A forensic image was created of the memory device and the data appeared to be random with no file structure. Multiple attempts were made to mount and access a valid file system, and none were successful. The heat damage was too extensive to allow for a successful recovery of the data.

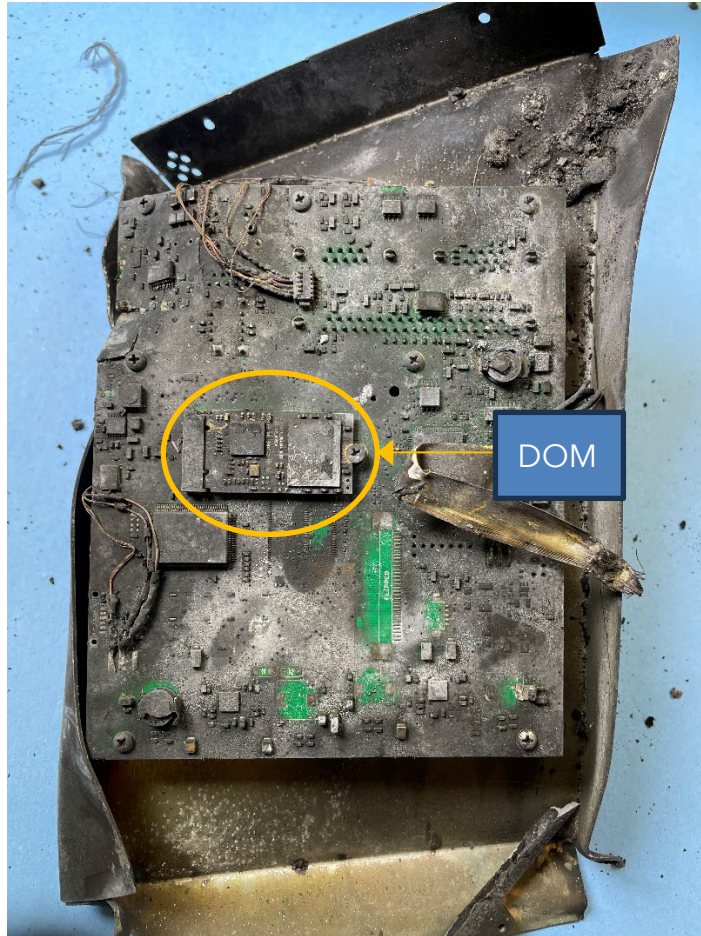
**Figure 2.** Photo of second Dynon device as received with burned SATA DOM annotated.

No data was recovered from either Dynon device.

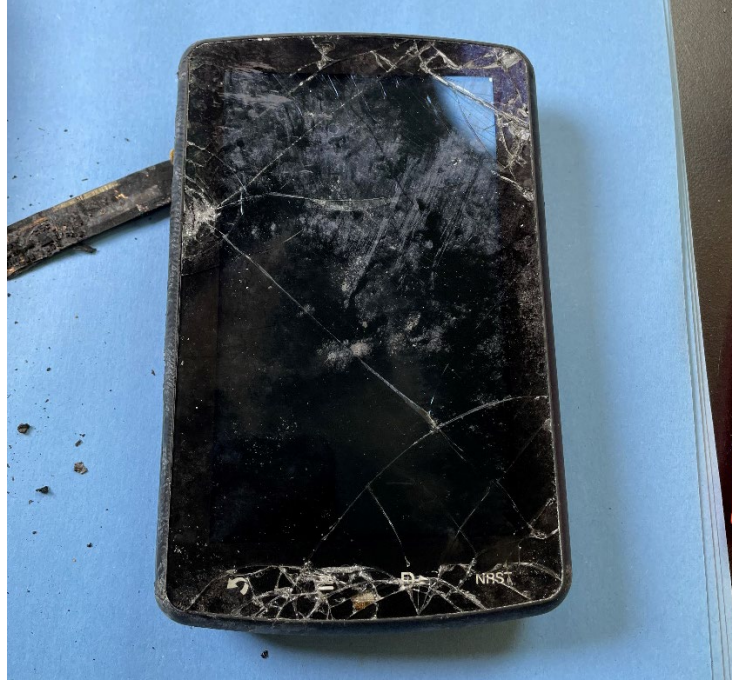
**Figure 3.** Garmin Aera 796 as received by the vehicle recorder laboratory.

Upon arrival at the Vehicle Recorder Laboratory, an exterior examination revealed that the Garmin had undergone mechanical impact damage. The screen was cracked and the unit could not be powered on. See figure 3 for the as-received condition of the device.

The unit was disassembled and the chip containing the device's memory was removed and read out in a laboratory chip reader.

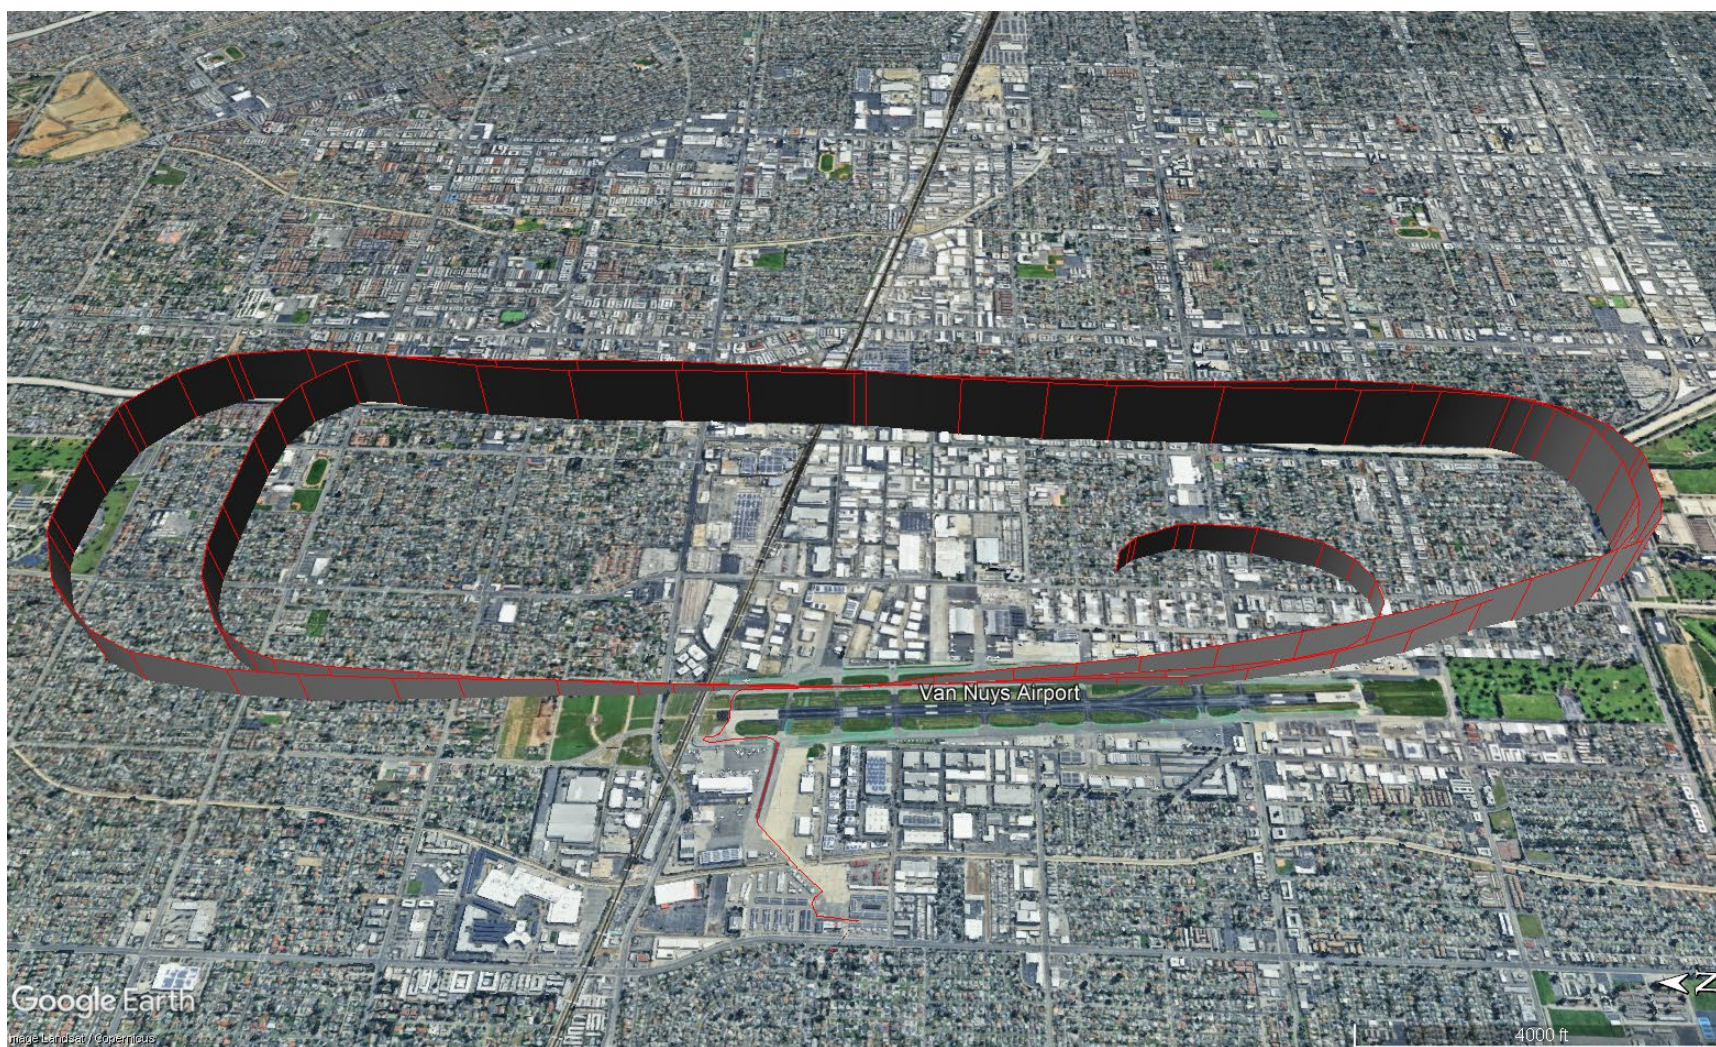
**Figure 4.** Map overlay of the accident flight recording.

Data obtained from the Garmin Aera 796 was used to produce the following overlay. Figures 4 and 5 are graphical overlays generated using Google Earth for the accident flight. The recorded data ended about a minute prior to the end of the flight, based on ADS-B data. Figure 4 shows the full accident flight and figure 5 shows the final portion of the recorded data with the wreckage location annotated. The weather and lighting conditions in Google Earth are not necessarily the weather and lighting conditions present at the time of the recording.

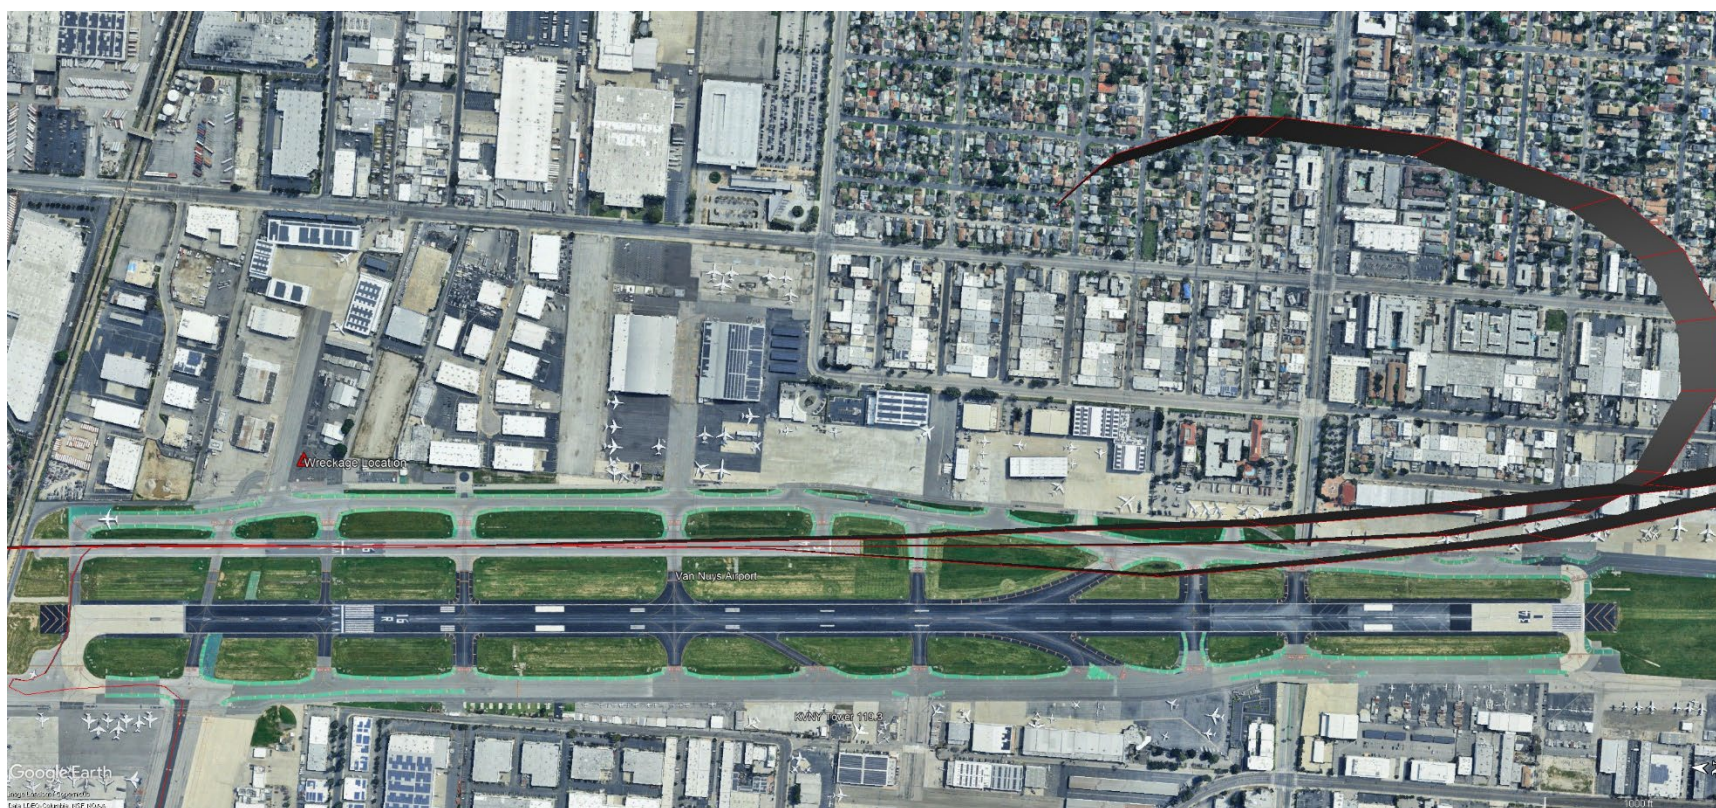
**Figure 5.** Final portion of recorded data with wreckage location annotated.
