# National Transportation Safety Board

WPR23FA301

## **ELECTRONIC FLIGHT INSTRUMENT SYSTEM (EFIS)**

Location: Idaho City, Idaho  
Date: August 4, 2023  
Time: 1010 mountain daylight time (MDT)  
1610 coordinated universal time (UTC)  
Airplane: Glasair Glastar, private operator, N617G

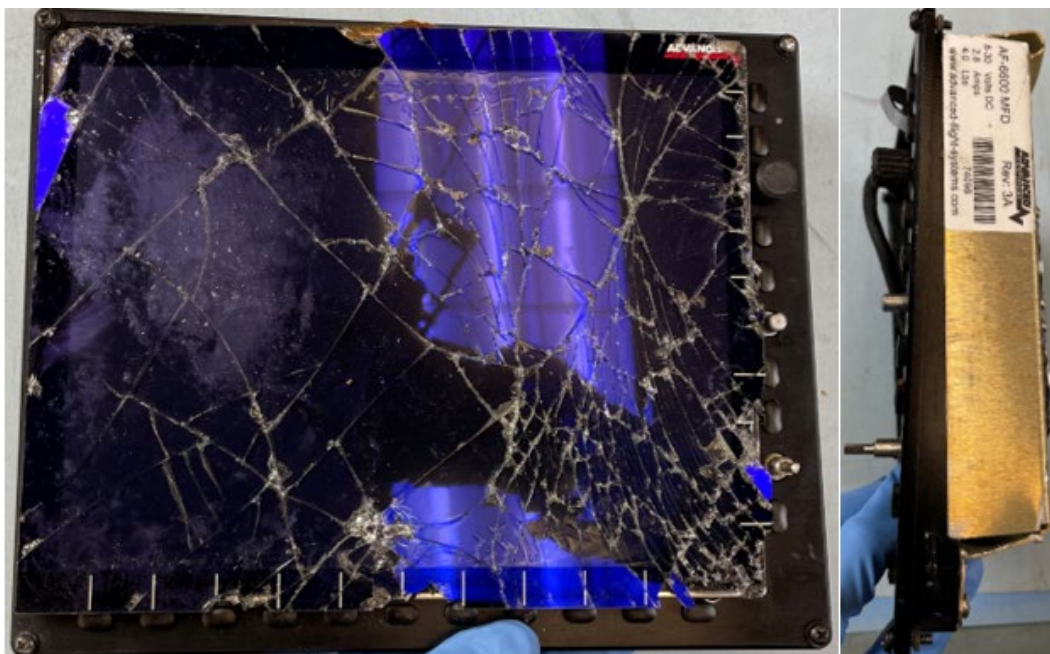
Upon arrival at the Vehicle Recorder Laboratory, the two EFIS's exhibited clear signs of impact damage. Figure 1 is AF-6600 with serial number 74095, and was able to power up normally, but the display screen was too damaged to navigate any of the menus. Figure 2 is AF-6600 with serial number 74098 which arrived with the display screen not attached to the unit. Therefore, both 16 GB M.2 SATA SSD cards (data storage) were removed and were downloaded normally using laboratory tools. Figure 3 shows the M.2 SATA card placement on the circuit board in the AF-6600.

**Figure 2.** AF-6600 serial number 74098 as received by the Vehicle Recorder's Lab.

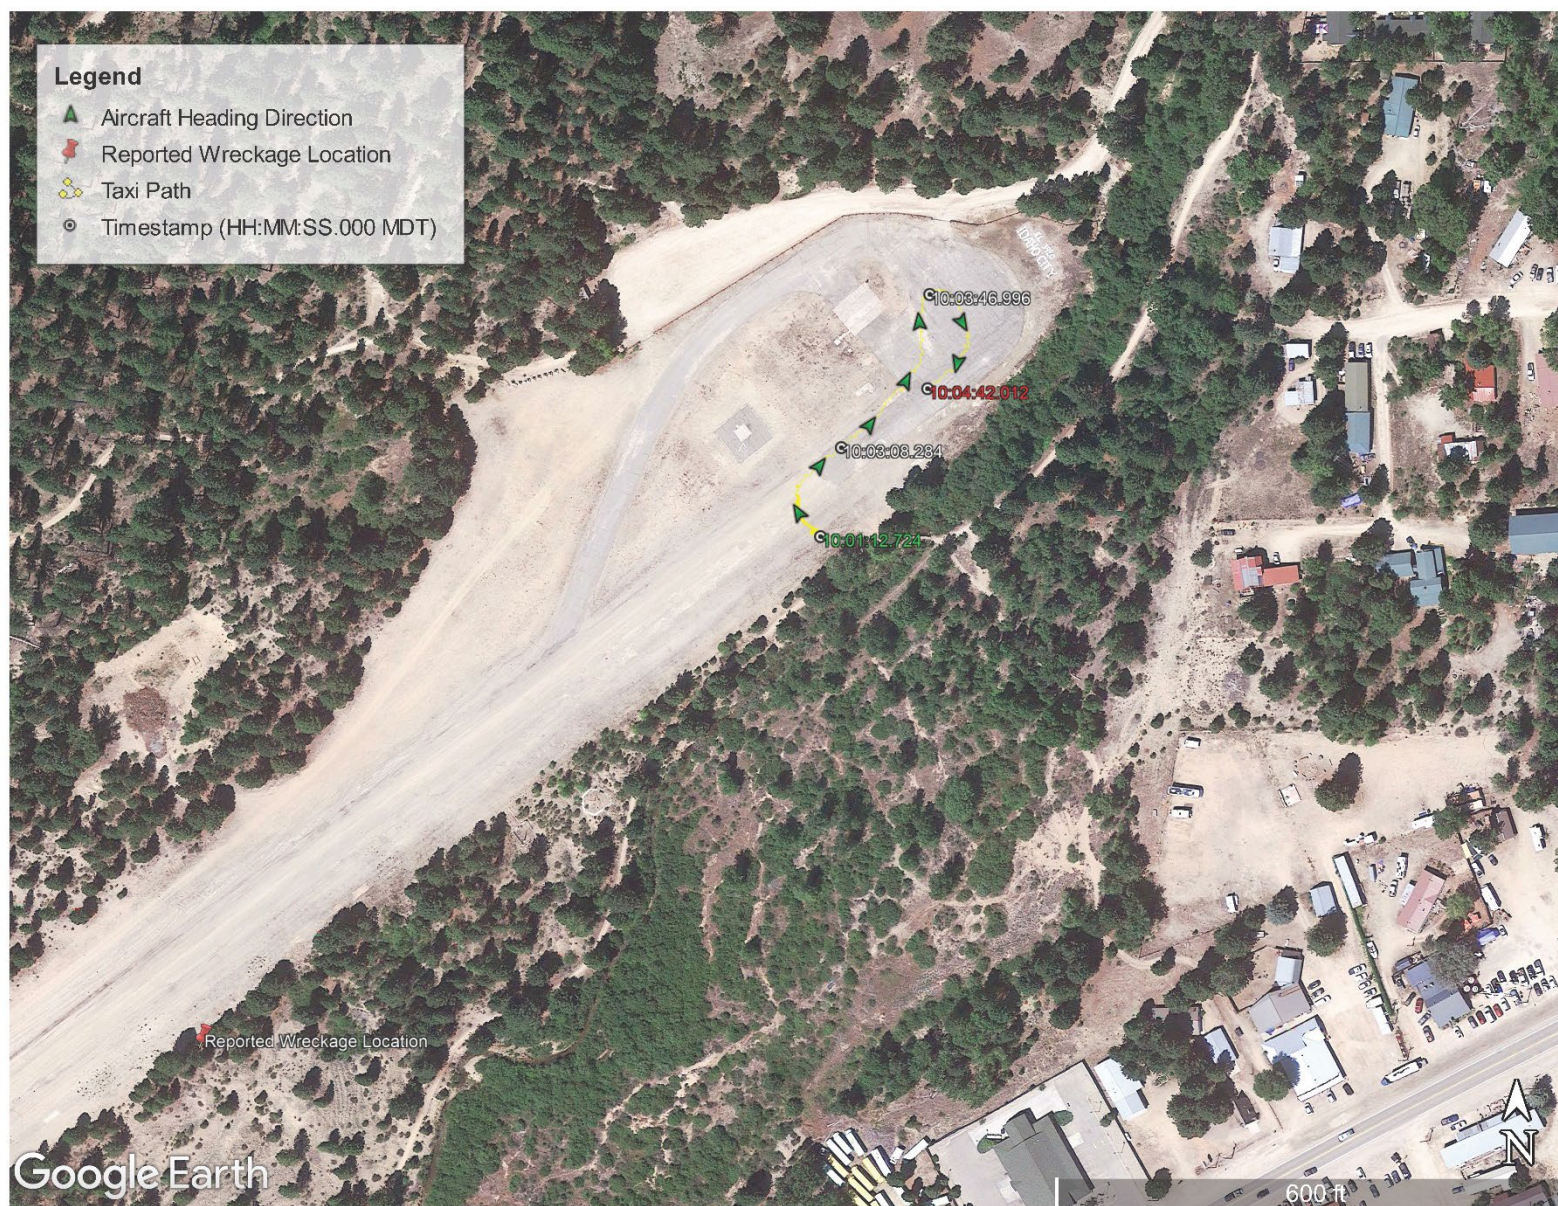
Figure 5 is a graphical overlay generated using Google Earth presenting the entire taxi at KU98 prior to the accident. Weather and lighting conditions in Google Earth are not necessarily the weather and lighting conditions present at the time of the recording.

**Figure 5.** Google Earth overlay of the event data. Note: the green point is the first data point, and the red point is the last data point.

- **10:01:12.724 MDT:** The unit began recording. The barometric setting was 30.07 inHg and did not change for the entire recording.
- **10:02:51.351 MDT:** Groundspeed was 1 knot and began to slowly increase.
- **10:04:30.946 MDT:** Groundspeed was 0 kts for approximately 5 seconds.
- **10:04:36.412 MDT:** Groundspeed began to increase more rapidly.
- **10:04:42.012 MDT:** Groundspeed was 12 kts and the magnetic heading was 213 deg. End of recorded data.

The corresponding tabular data used to create figures 4 and 5 are provided in electronic CSV format as attachment 1 to this report. The corresponding tabular data used to create figure 6 are provided in electronic CSV format as attachment 2 to this report.
