# National Transportation Safety Board

WPR23LA107

## **GLOBAL POSITIONING SYSTEM (GPS) DEVICE**

Specialist's Factual Report

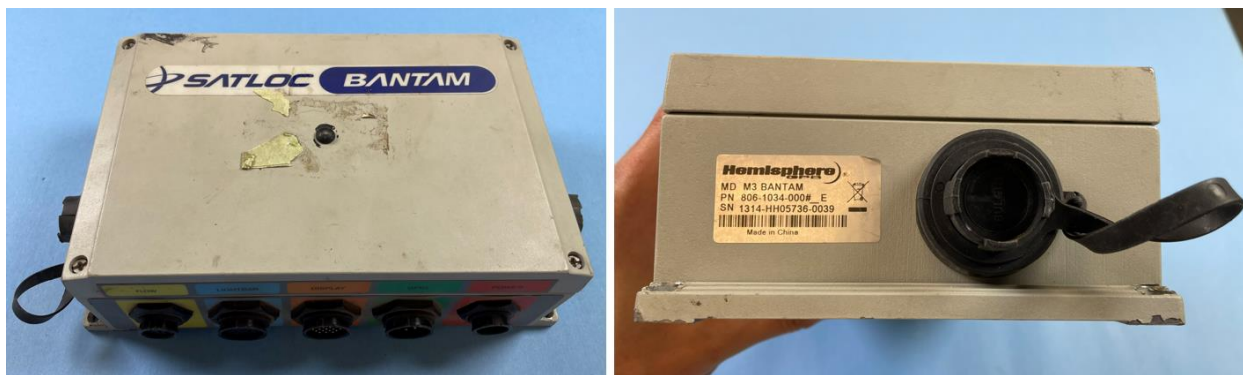
The Satloc M3 Bantam had no visible damage upon arrival at the Vehicle Recorder Division, as shown in figure 1. An internal CF card was recovered from the device, and data were extracted and converted into engineering unit data using laboratory tools.

**Figure 1.** Top and side views of the Satloc M3 Bantam as received.

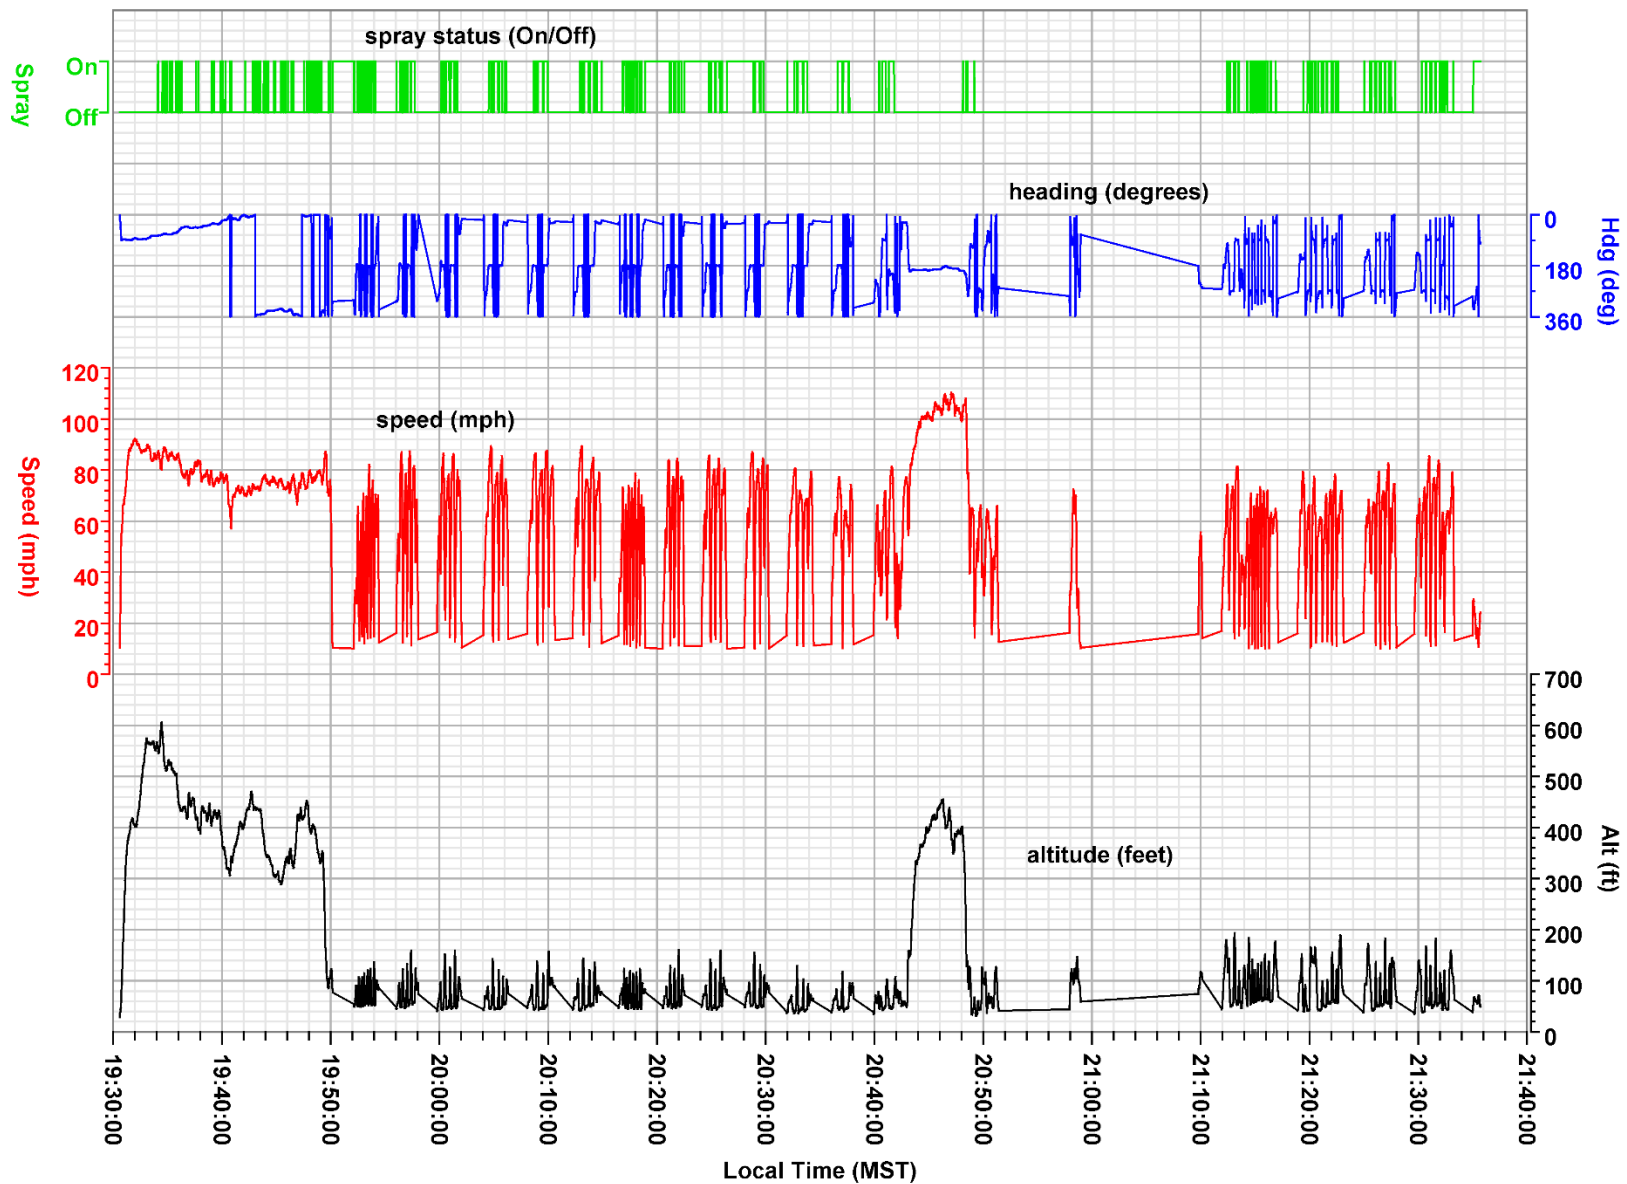
Figures 2 and 3 show data parameters plots of the accident flight. Figure 2 shows data parameters plot of the entire recording, and figure 3 shows the final portion from 21:29:00 MST to the end of the recording. The plots are configured

such that right turns are indicated by the trace moving toward the bottom of the page, left turns towards the top of the page, and nose up attitudes towards the top of the page.

**Figure 2.** Plot of data parameters for the entire accident flight recording.

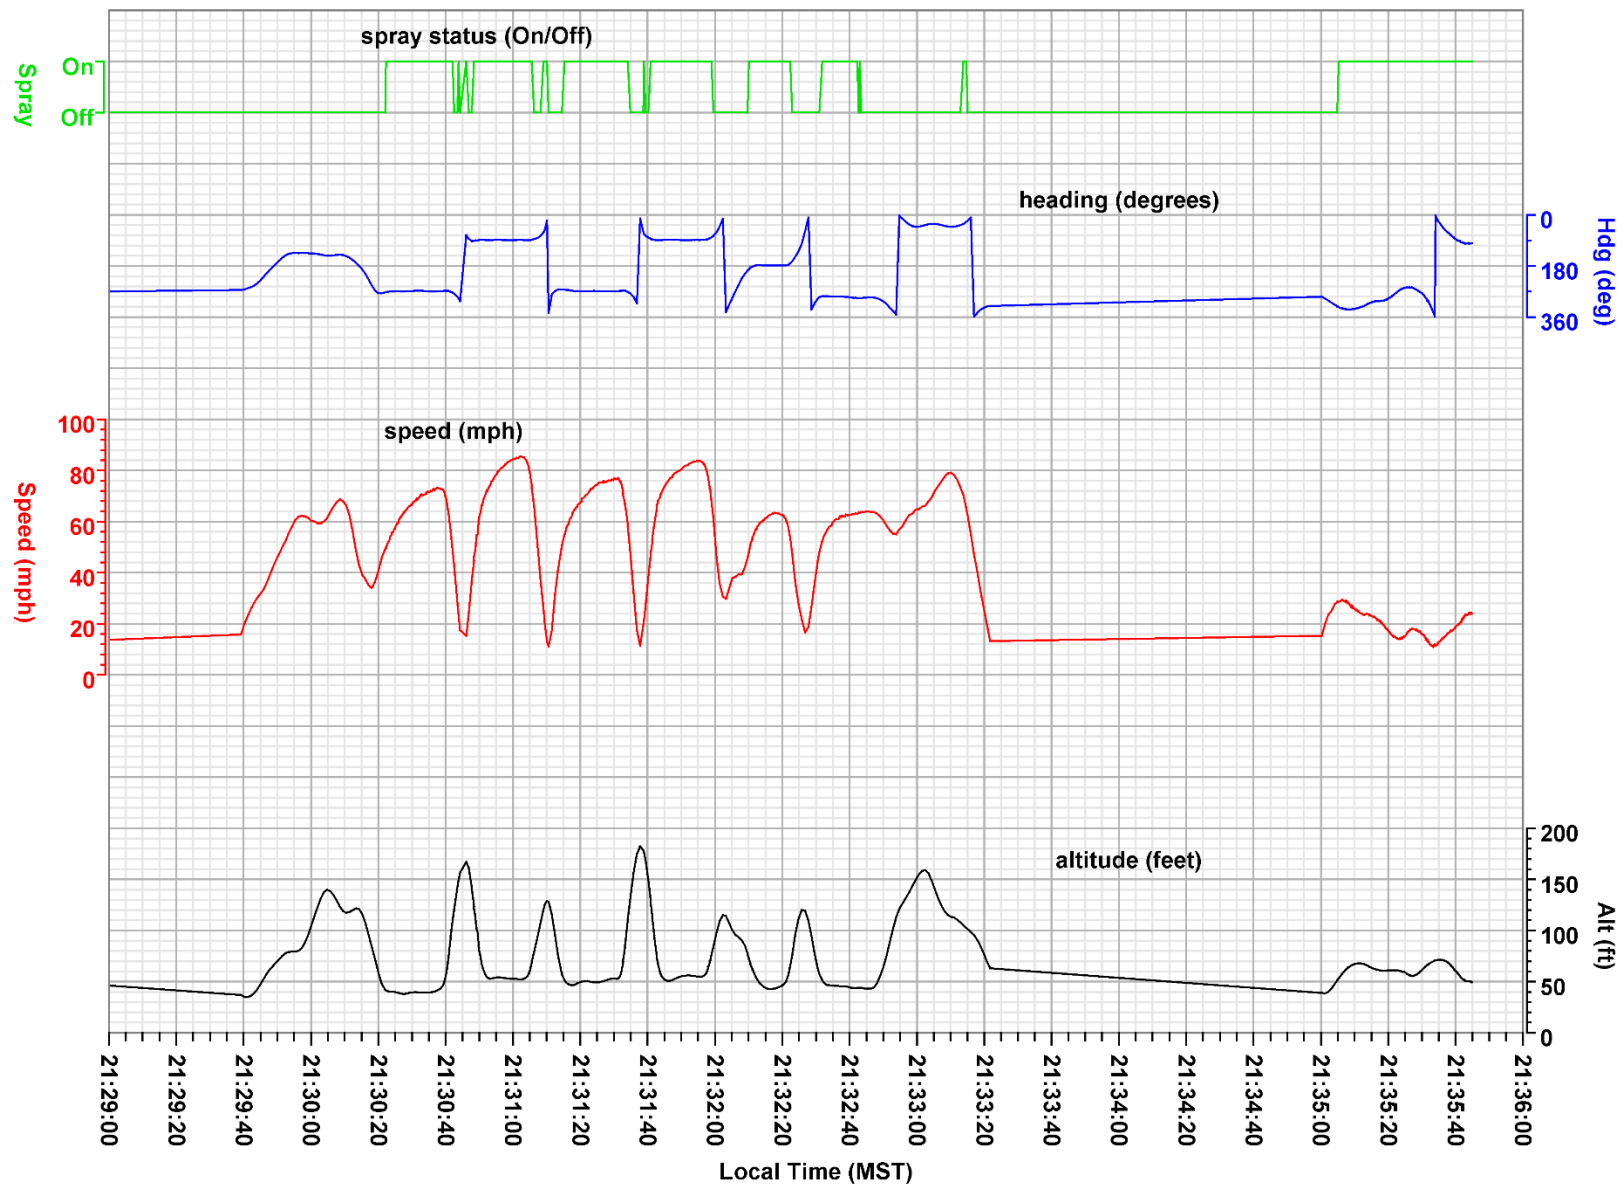
**Figure 3.** Plot of data parameters for the accident flight from 21:29:00 MST to the end of the recording.

The recorded data from the Satloc M3 Bantam indicated that the accident aircraft took off from Tri-Rotor AG Services at around 19:30:38 MST. The accident aircraft then travelled to the first sprayed area and started spraying at around 19:50:00 MST. At around 20:43:00 MST, the accident aircraft left the first sprayed area and travelled to the second sprayed area. The accident aircraft arrived at the second sprayed area at around 20:49:00 MST and started spraying. At 21:35:44, the last recorded data point prior to the crash, the accident aircraft was traveling at a groundspeed of approximately 24 mph and at an altitude of approximately 50 ft.

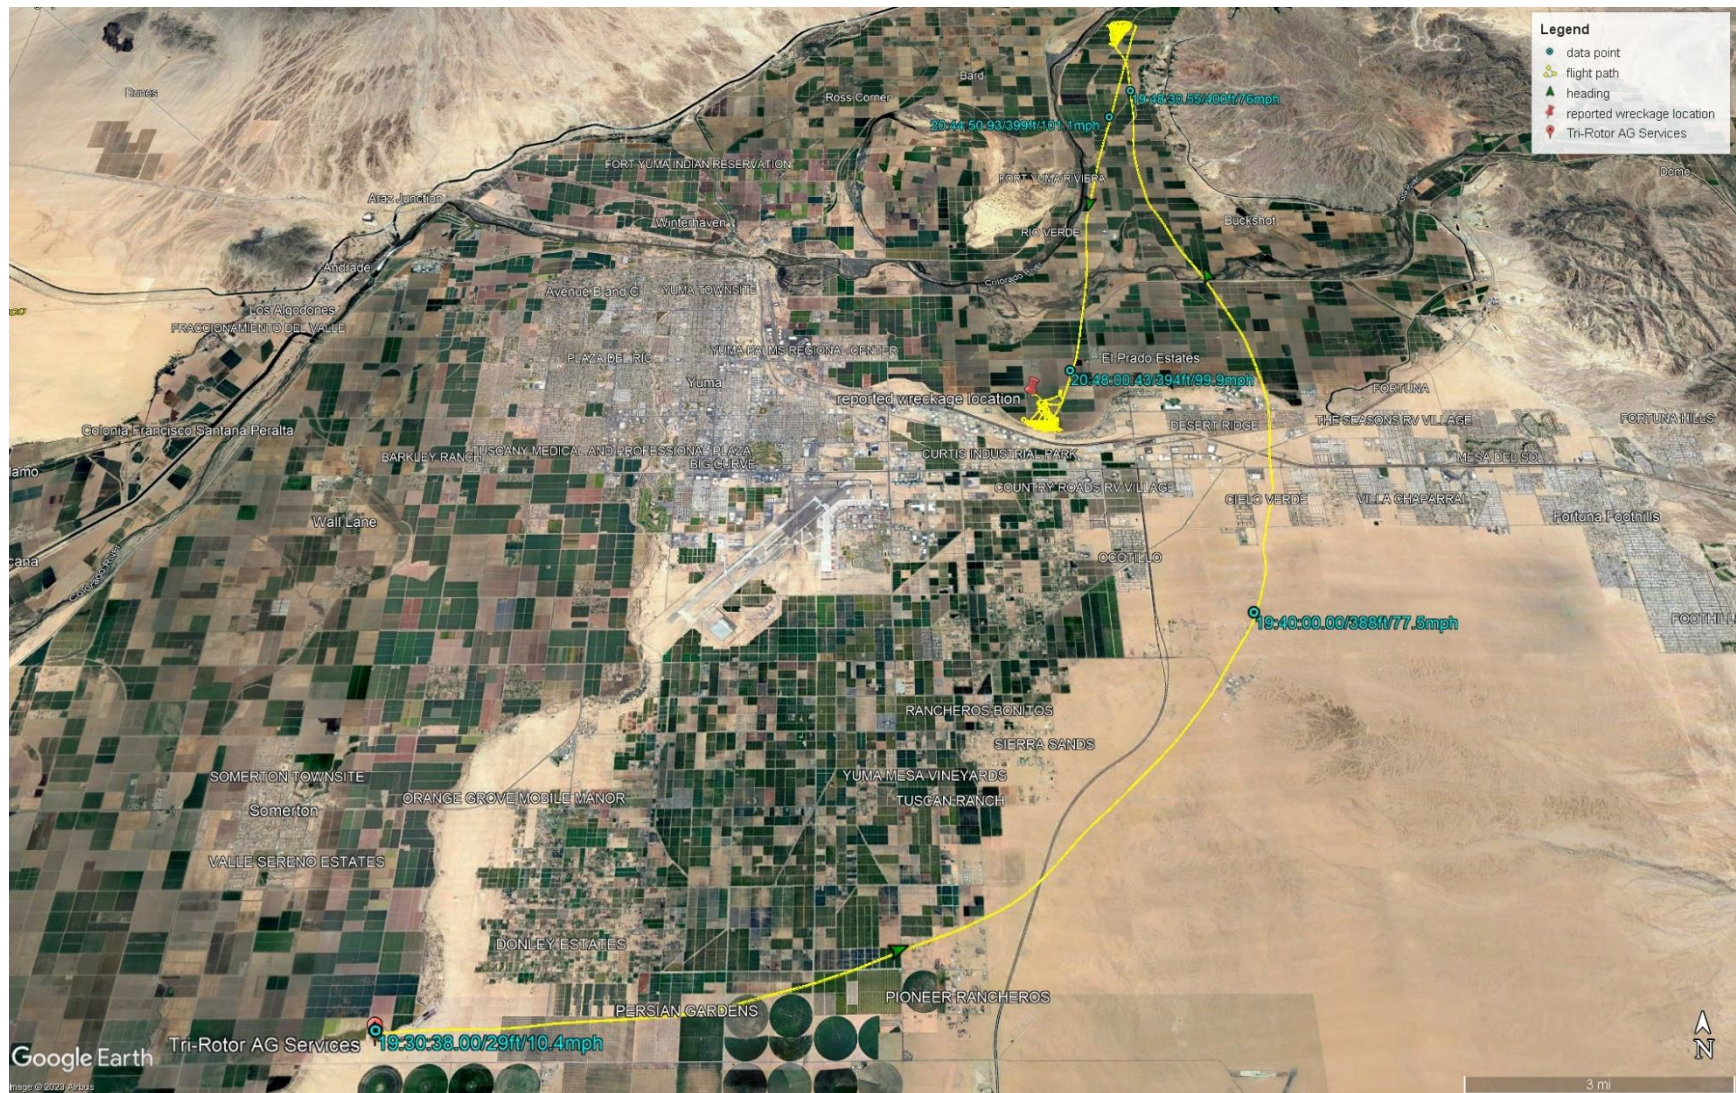
Figures 4 to 7 show Google Earth overlays of the accident flight. Figure 4 shows the entire flight recording. Figure 5 shows the two sprayed areas during the accident flight, and figures 6 and 7 show the final portion of the accident flight. The weather and lighting conditions in Google Earth are not necessarily the weather and lighting conditions present at the time of the recording.

**Figure 4.** Google Earth overfly of the entire accident flight recorded on February 6, 2023.

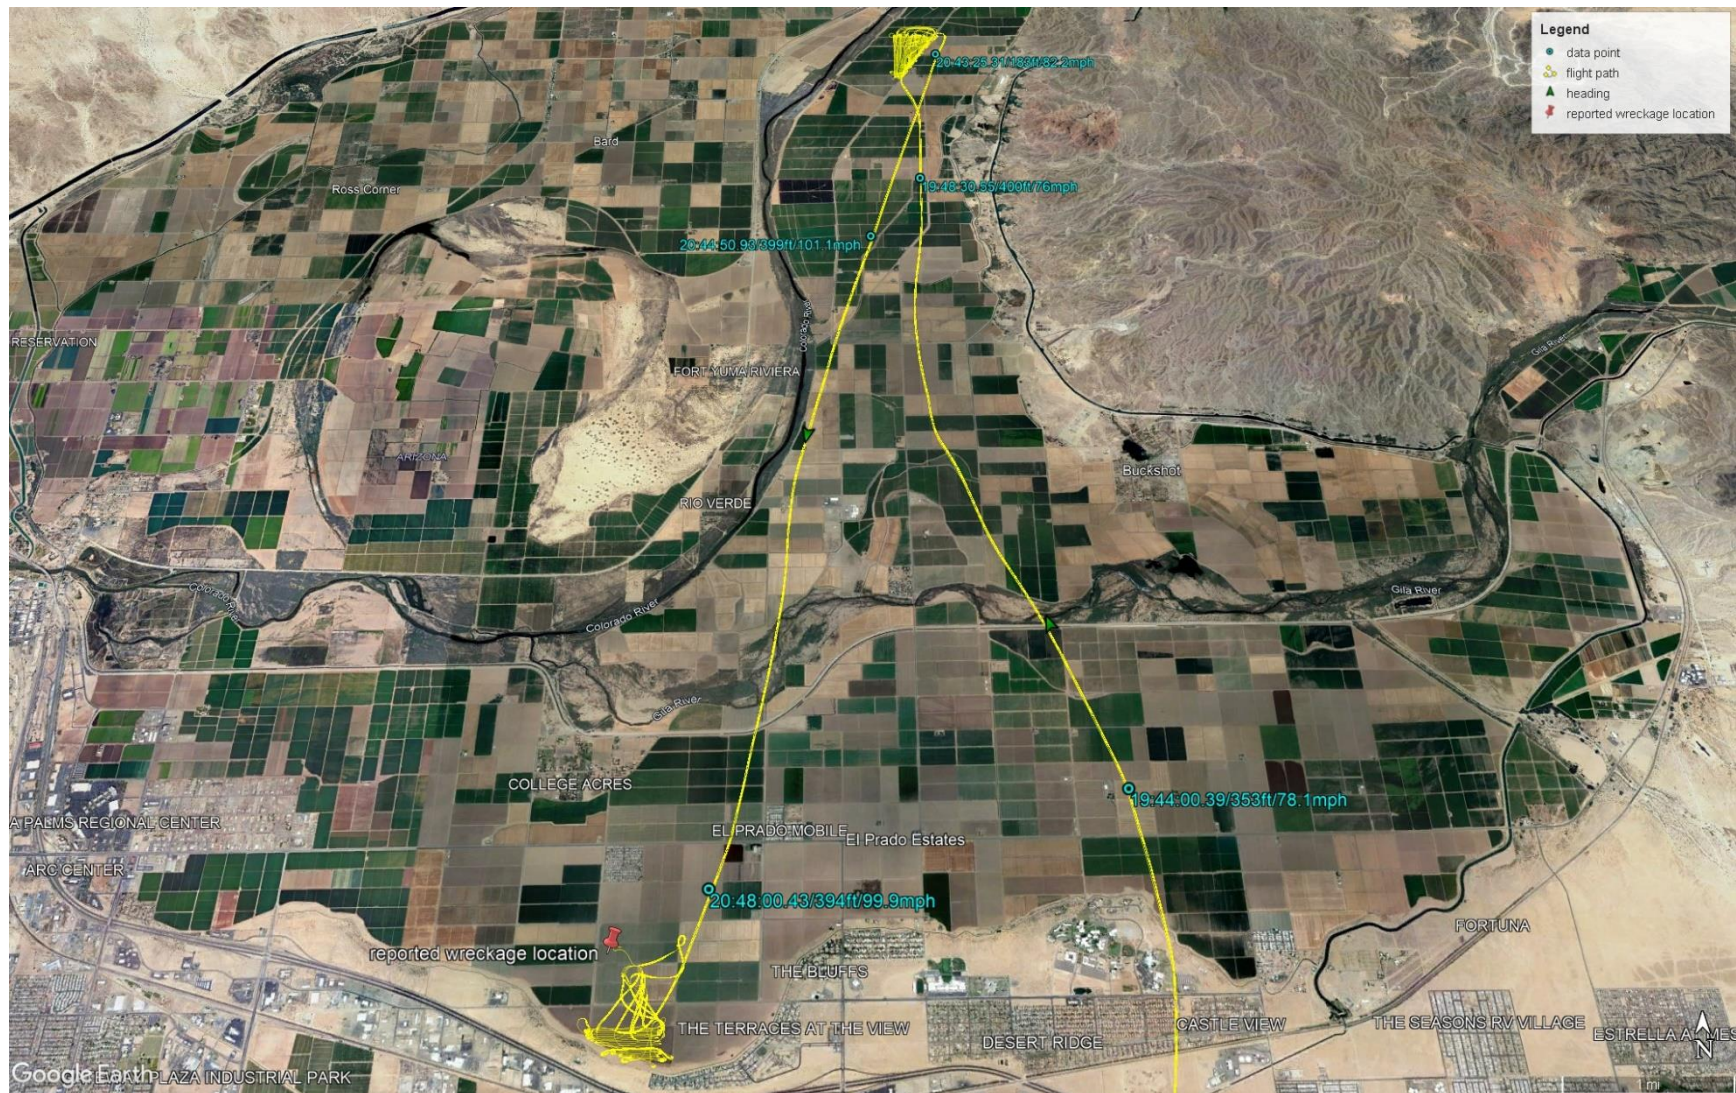
**Figure 5.** Google Earth overly showing the two areas being sprayed during the accident flight.

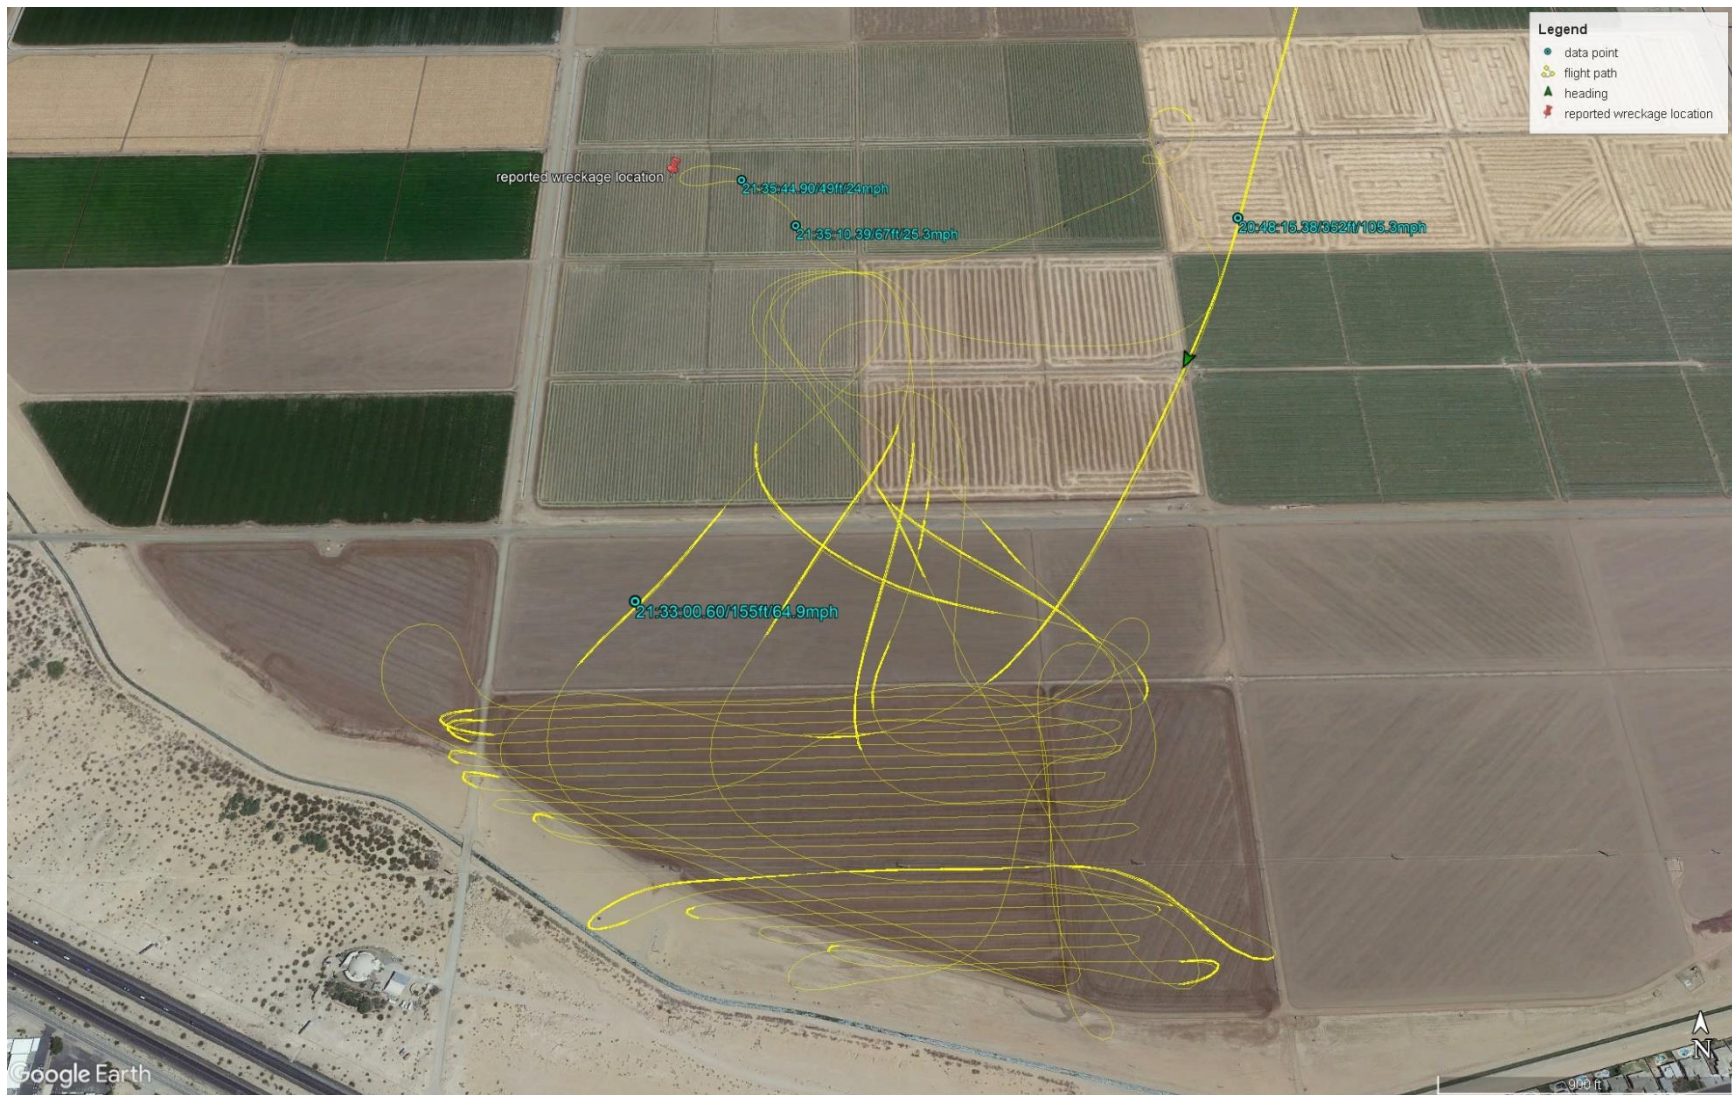
**Figure 6.** Google Earth overfly of the final portion of the accident flight.

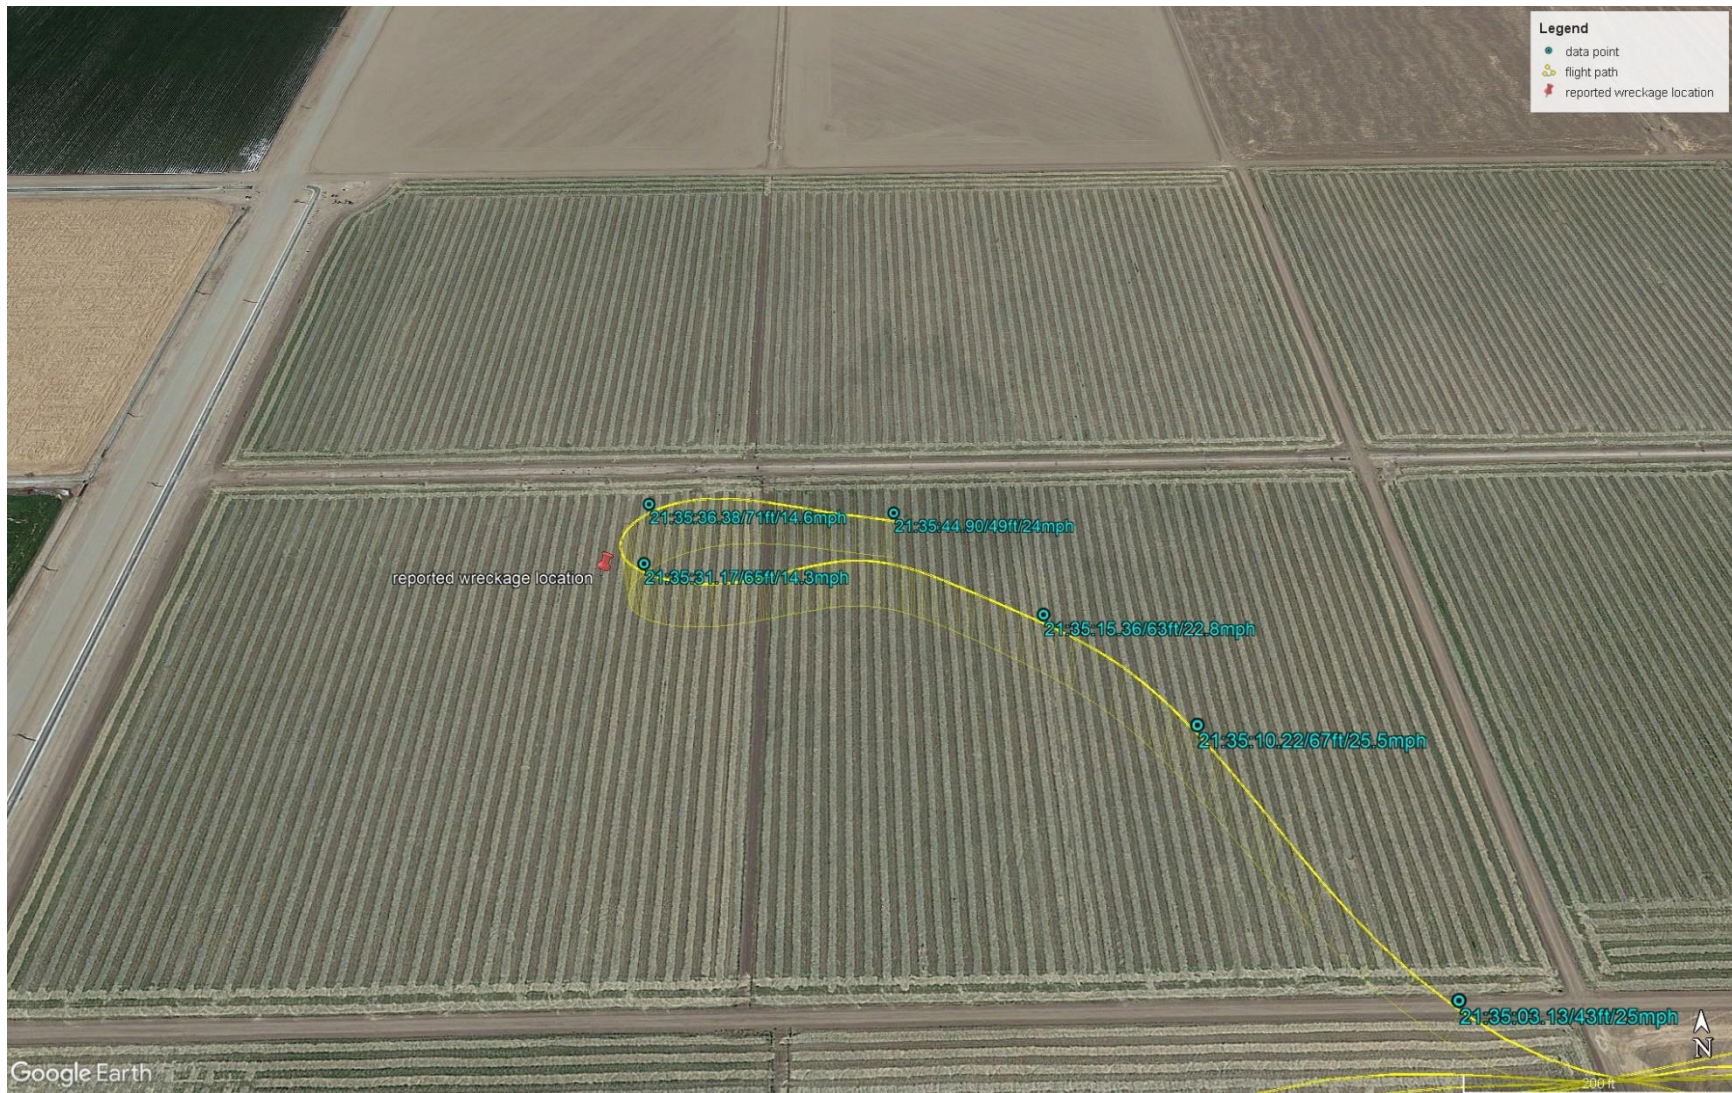
**Figure 7.** Google Earth overlay of the final portion of the accident flight near the reported wreckage location. Note that the terrain on Google Earth is turned off for this figure.
