WPR23LA149

## **MAINTENANCE RECORDS AND REPORTS**

Conditional inspection  
Date: 01/15/23  
Owner: Kelly Cyrus Stevens  
A/C type: RV-7  
Serial No: 73089  
N-number: N17NK  
Tach time  
Hobbs time

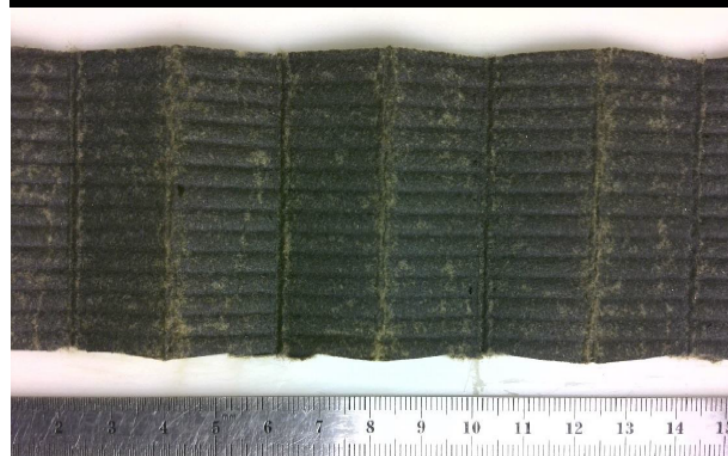
**Picture 1:**

An overview showing a representative sample of filter pleats.

The filter contained a significant amount of brass/bronze. While it's common to find visible metal in the oil filter of a young engine (due to break-in), the size and amount of the brass/bronze particles here can potentially show a problem.

Wrist-pin and rocker-arm bushing are two potential sources of the brass/bronze. The brass/bronze and aluminum could show wear at piston pin plug and bushing. Aluminum can also come from the pistons themselves. The ferrous metal (3 mg) removed from the pleats isn't cautionary, but it could be related to the other metals.

Close inspection of this engine to look for problems is advised. If no problems are noted, use short intervals and recheck the oil filter to look for improvement.
