# National Transportation Safety Board

WPR23LA338

## VIDEO STUDY

Location: Balch Camp, California  
Date: September 9, 2023  
Time: 13:45 Pacific daylight time  
Aircraft: Bell 212 helicopter

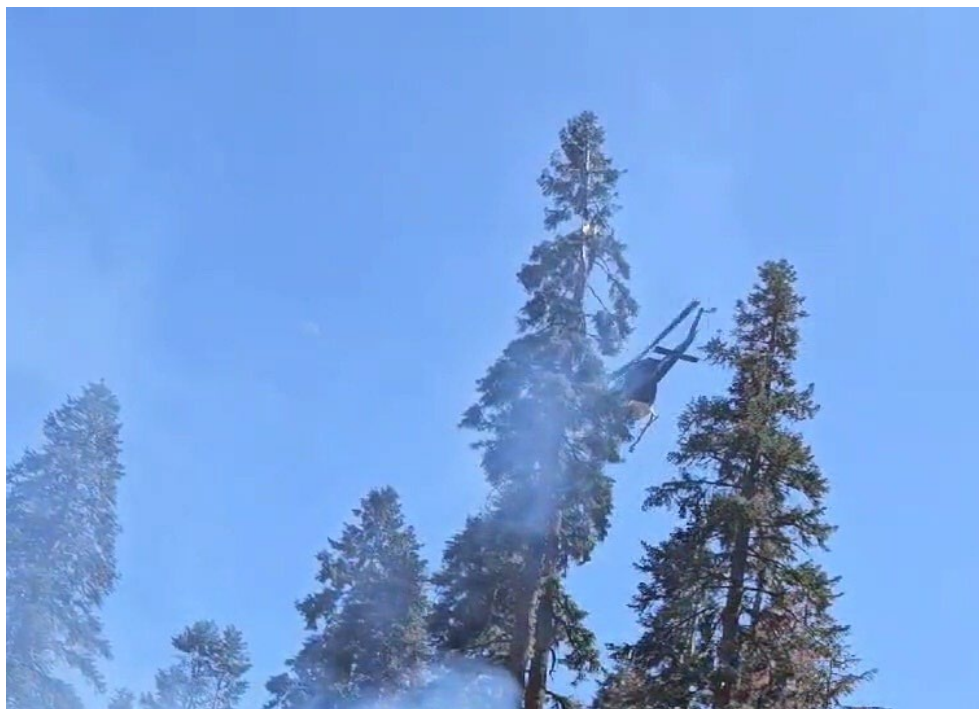
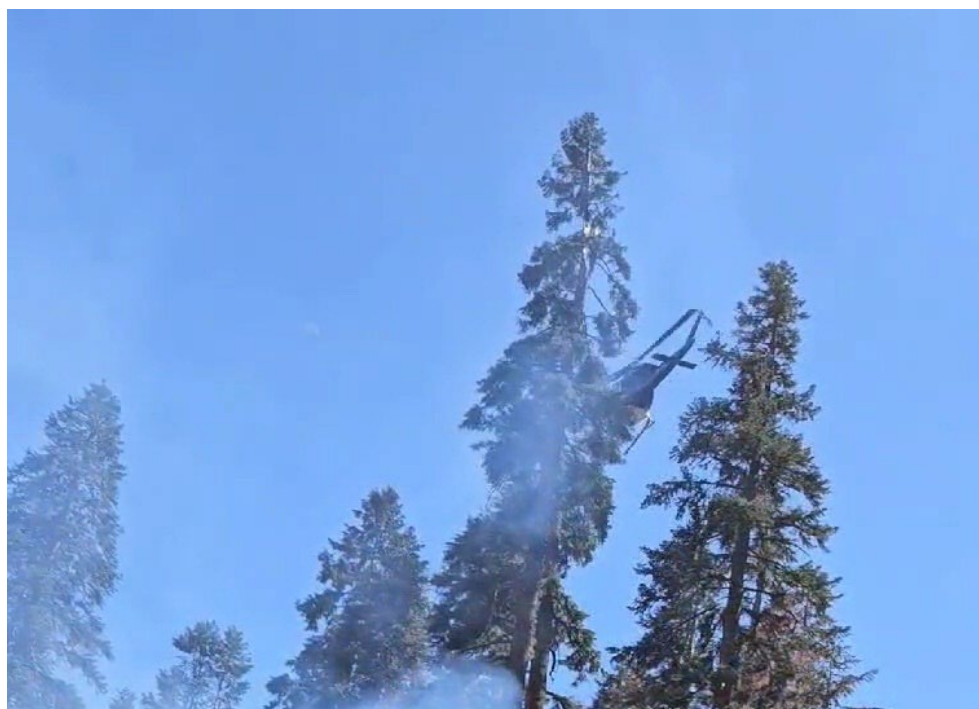
Since the sound spectrum analysis showed that the main rotor speed was decreasing, an easy-to-estimate speed case would be one where the rotor rotates  $180^\circ$  over three frame intervals. The main rotor speed corresponding to that situation would be  $324 \times 180/194.4=300$  rpm. Examination of the video reveals that it occurs between video frame 1352 and video frame 1355, corresponding to video times 45.066 seconds and 45.166 seconds. Figure 3 shows a segment of video frame No. 1352 and Figure 4 shows a segment of video frame No. 1355.

It is evident in these figures that the two-bladed main rotor rotated by  $180^\circ$  and each figure shows a different blade. Therefore, the main rotor speed estimate at time 45.12 seconds is 300 rpm. Figure 2 shows that the polynomial fit to the sound-
