# National Transportation Safety Board

WPR24FA010

## **COCKPIT DISPLAY - RECORDED FLIGHT DATA**

Specialist's Factual Report

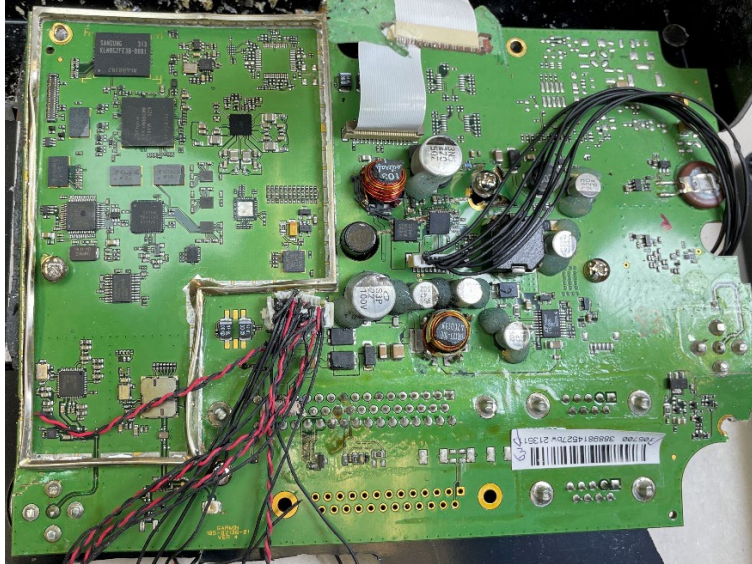
**Figure 1.** Garmin GDU 460 circuit board as received.

The device sustained impact damage during the accident event, rendering it inoperable. There was no SD card installed or recovered. The circuit board containing the NVM chip is shown in figure 1. The chip was removed and a binary image of the chip was created using laboratory tools. The image was written to a blank chip and subsequently installed on a lab surrogate circuit board. Data were exported normally to a laboratory SD card using the manufacturer's procedures.

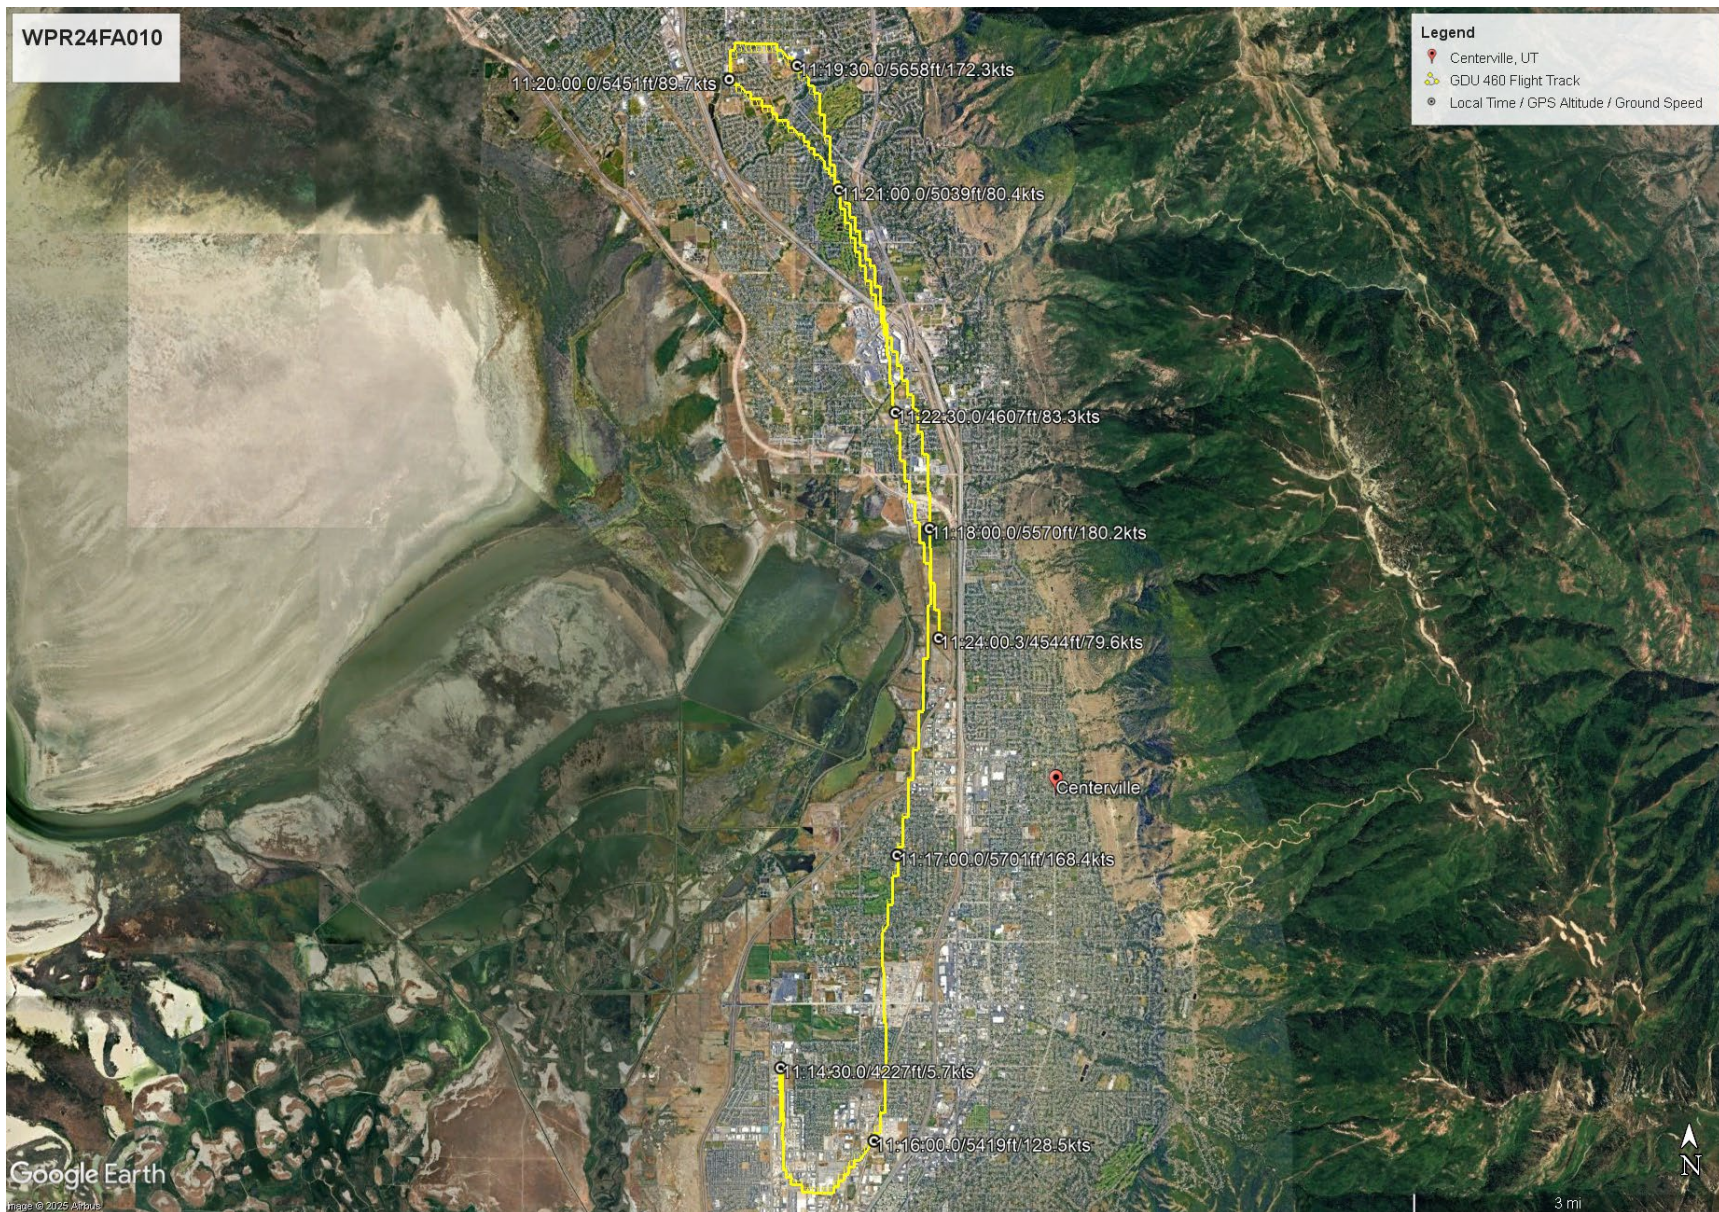
**Figure 2.** Google Earth overlay of the accident flight recorded on the Garmin GDU 460.

Figure 2 is a Google Earth overlay of the accident flight recorded on the Garmin GDU 460. The weather and lighting conditions in Google Earth are not necessarily the weather and lighting conditions present at the time of the accident flight. The appearance of the flight track may not be representative of the airplane's actual flight track and may be attributed to the update rate of GPS parameters as well as the software encoding of the GPS input to the device. GPS Altitude and Ground Speed are depicted for data points shown.
