# National Transportation Safety Board

WPR24FA056

## VIDEO STUDY

Location: Corona, California  
Date: December 16, 2023  
Time: 1951 PST (Pacific Standard Time)  
Aircraft: Van's RV-8

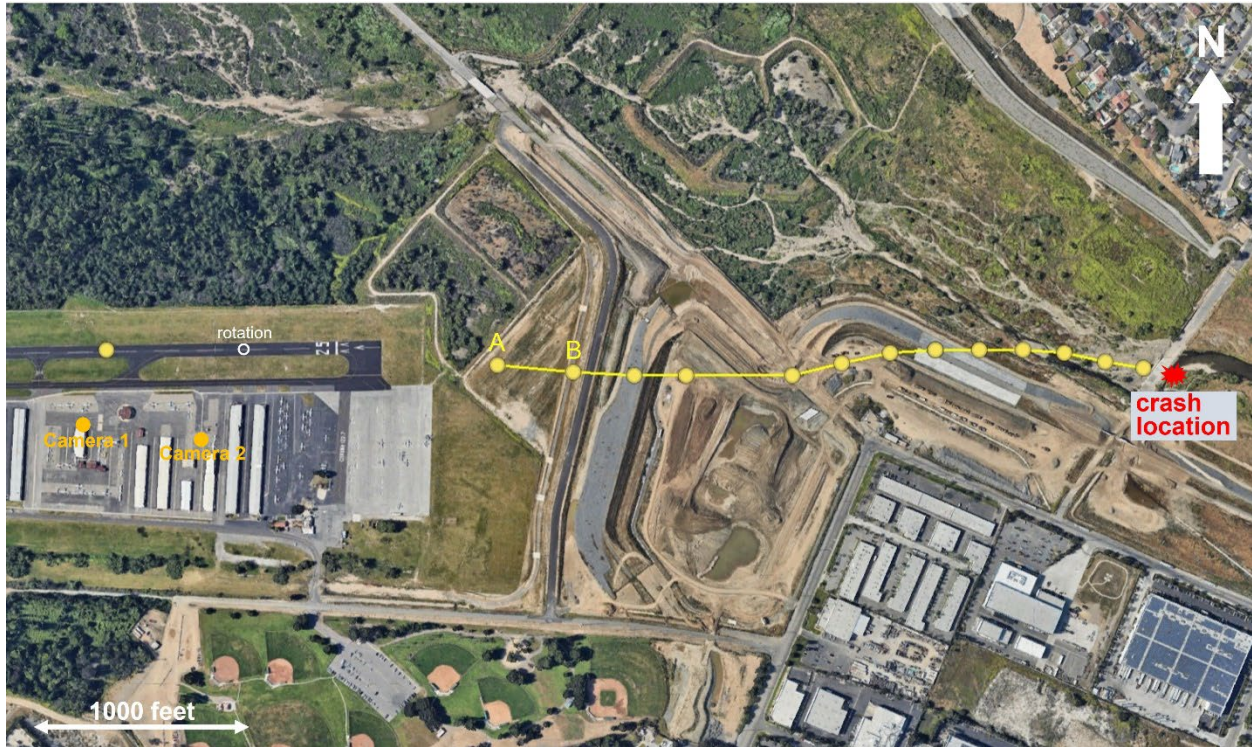
Figure 1 is an aerial view of the accident area. Fourteen ADS-B locations are marked in the figure by filled yellow circular markers. Also marked are the locations of the two cameras, the crash location, and the runway location where the airplane rotated. The speed of the airplane at the time of rotation and liftoff was estimated based on the runway markings seen in video No. 1 and in Figure 1. The centerline of

**Figure 1.** Aerial view of the accident area

Figure 3 is a plot of the flown distance of the airborne airplane based on ADS-B data. The first data point, at time 19:49:43, corresponds to point B marked in Figure 1. The flown distance at that point is the distance from point A to point B, which are shown in Figure 1. The ground speed of the airplane is the slope of a line passing through the data points in Figure 3. The red line in Figure 3 is a constant-speed fit to the data points between time 19:49:48 and time 19:51:10, the last time when ADS-B data was recorded. The estimated ground speed is 58 knots, 13 knots lower than the speed at the time of rotation and liftoff.

The estimation of camera model parameters is based on references that are visible both in aerial images such as the one in Figure 1 and in video frames such as the one in Figure 2. The references used for camera model calibration included markings on the ground, the taxiway, the runway and the hangar seen on the right in Figure 2.

The calibrated camera optics model was then used to estimate the locations of the airborne airplane at times corresponding to thirteen video frames that were analyzed. The first analyzed frame corresponded to location A marked in Figure 1. The last video frame corresponded to the last available ADS-B airplane location.

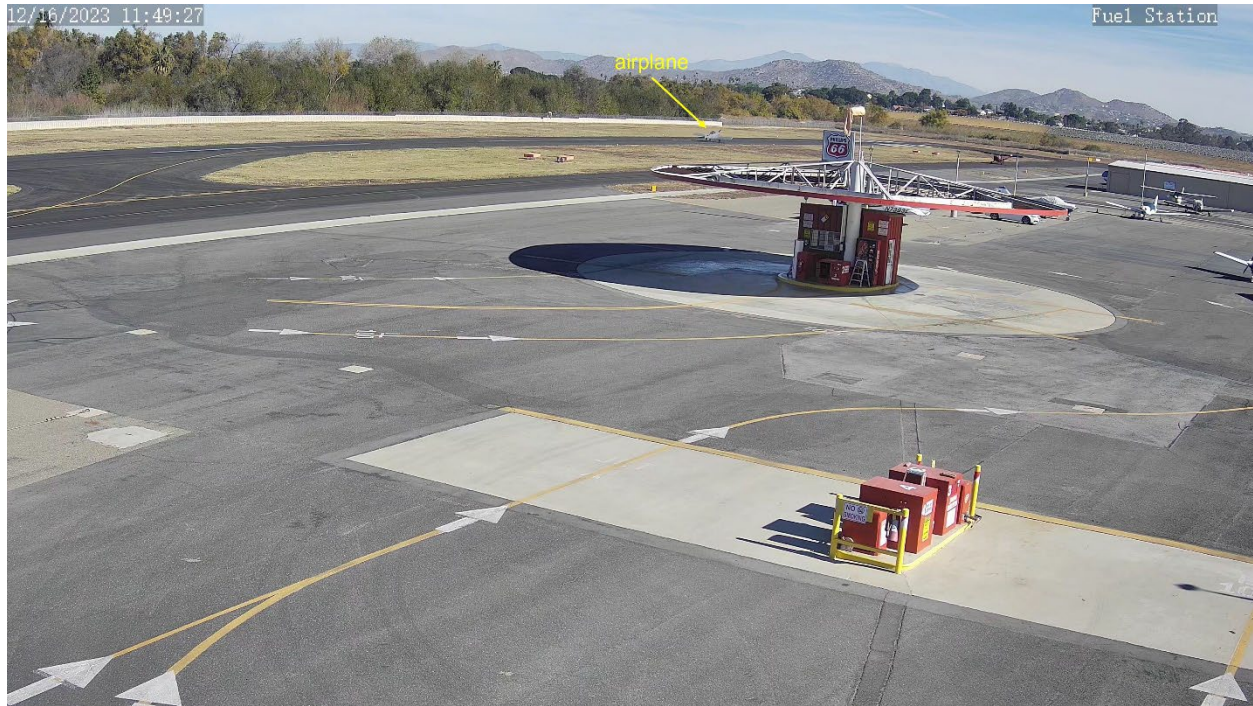
the runway was marked with 120-foot-long white lines followed by 80-foot-long gaps. Using these distances and the time it took to move these distances, it was estimated that the ground speed at the time of rotation and liftoff was about 71 knots. Figure 2 is a frame from the video recorded at the time of rotation. The image is barrel-distorted due to the wide field-of-view angle of the camera lens. The distortion of the video frames was corrected mathematically before analyzing the video.

**Figure 2.** Video frame recorded at the time of rotation
