# National Transportation Safety Board

WPR24FA123

## GLOBAL POSITIONING SYSTEM DEVICE

Specialist's Factual Report

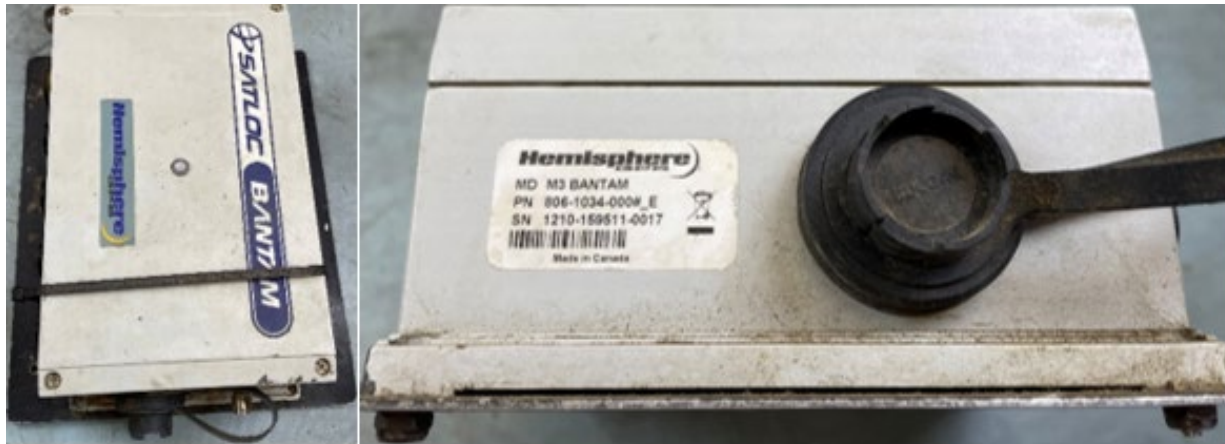
The Satloc M3 Bantam had no visible damage upon arrival at the NTSB Vehicle Recorder Laboratory, as shown in figure 1. An internal CF card was recovered from the device, and data were extracted. The file initially was unable to be converted into engineering unit data using laboratory tools. The file identified as the accident was sent to the manufacturer. The manufacturer reported that the file was corrupt and that only a select amount of data would be extracted. Upon receipt of the cleaned file, the accident file was converted into engineering unit data using laboratory tools.

**Figure 1.** Top and side views of the Satloc M3 Batam as received.
