# National Transportation Safety Board

WPR24FA238

## **ELECTRONIC DEVICES**

Location: Helena, Montana  
Date: July 10, 2024  
Time: 1210 mountain daylight time (MDT)  
1810 coordinated universal time (UTC)  
Airplane: Air Tractor AT-802A, N10122

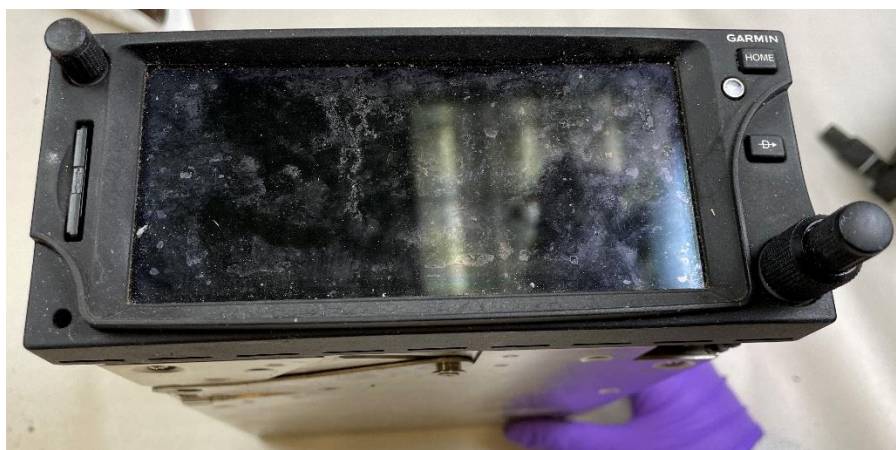
The Garmin GTN 635 as received upon arrival at the Vehicle Recorder Division is shown in Figure 2. The SD card containing historical data was removed and data were extracted normally.

**Figure 2.** Garmin GTN 635, as received.

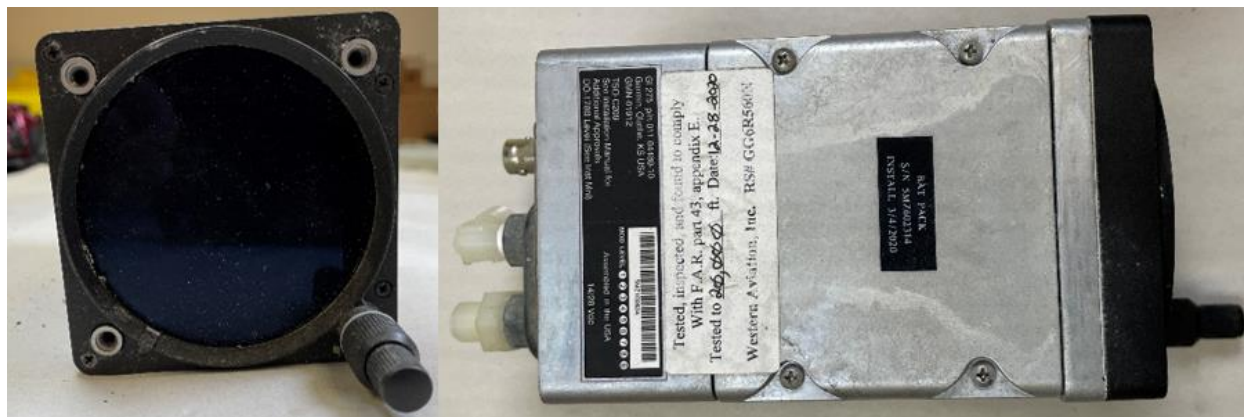
The Garmin GI 275 ADI and HSI as received upon arrival at the Vehicle Recorder Division are shown in Figure 3 and Figure 4 respectively. Data were recovered from the ADI unit, however, internal water damage to the HSI prevented data recovery, therefore, no data were recovered from the HSI.

**Figure 3.** Garmin GI 275 (ADI), as received.

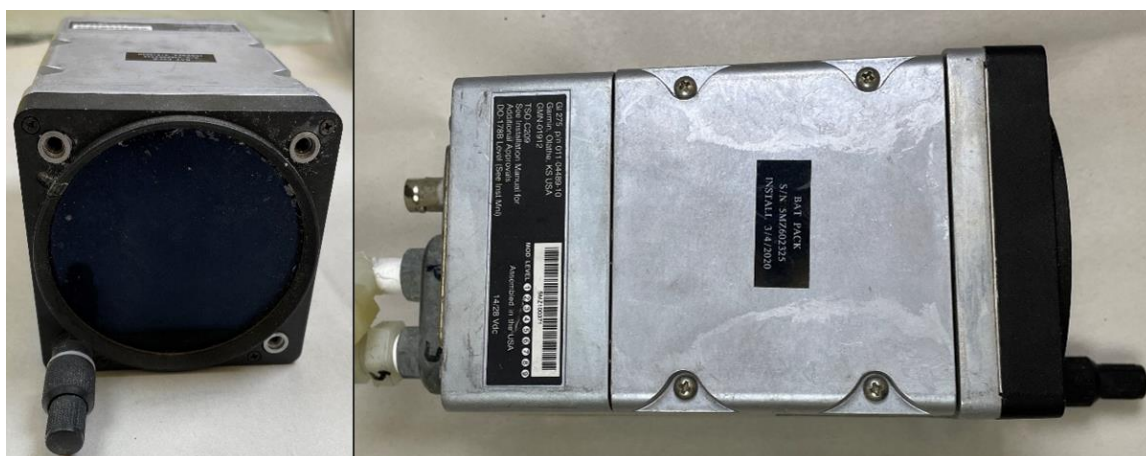
**Figure 4.** Garmin GI 275 (HSI), as received.

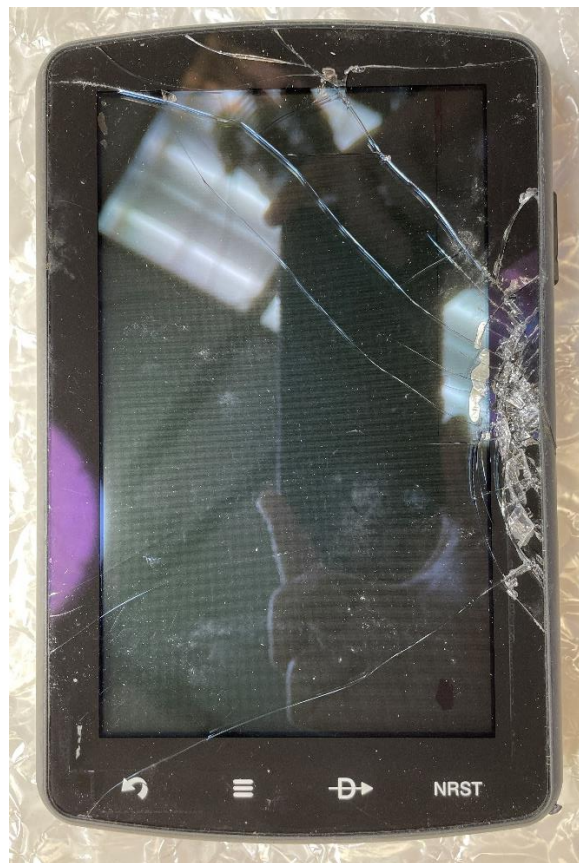
The Garmin aera 796 as received upon arrival at the Vehicle Recorder Division is shown in Figure 5. Internal water damage to the device prevented data recovery, therefore, no data were recovered.

**Figure 5.** Garmin aera 796 as received.

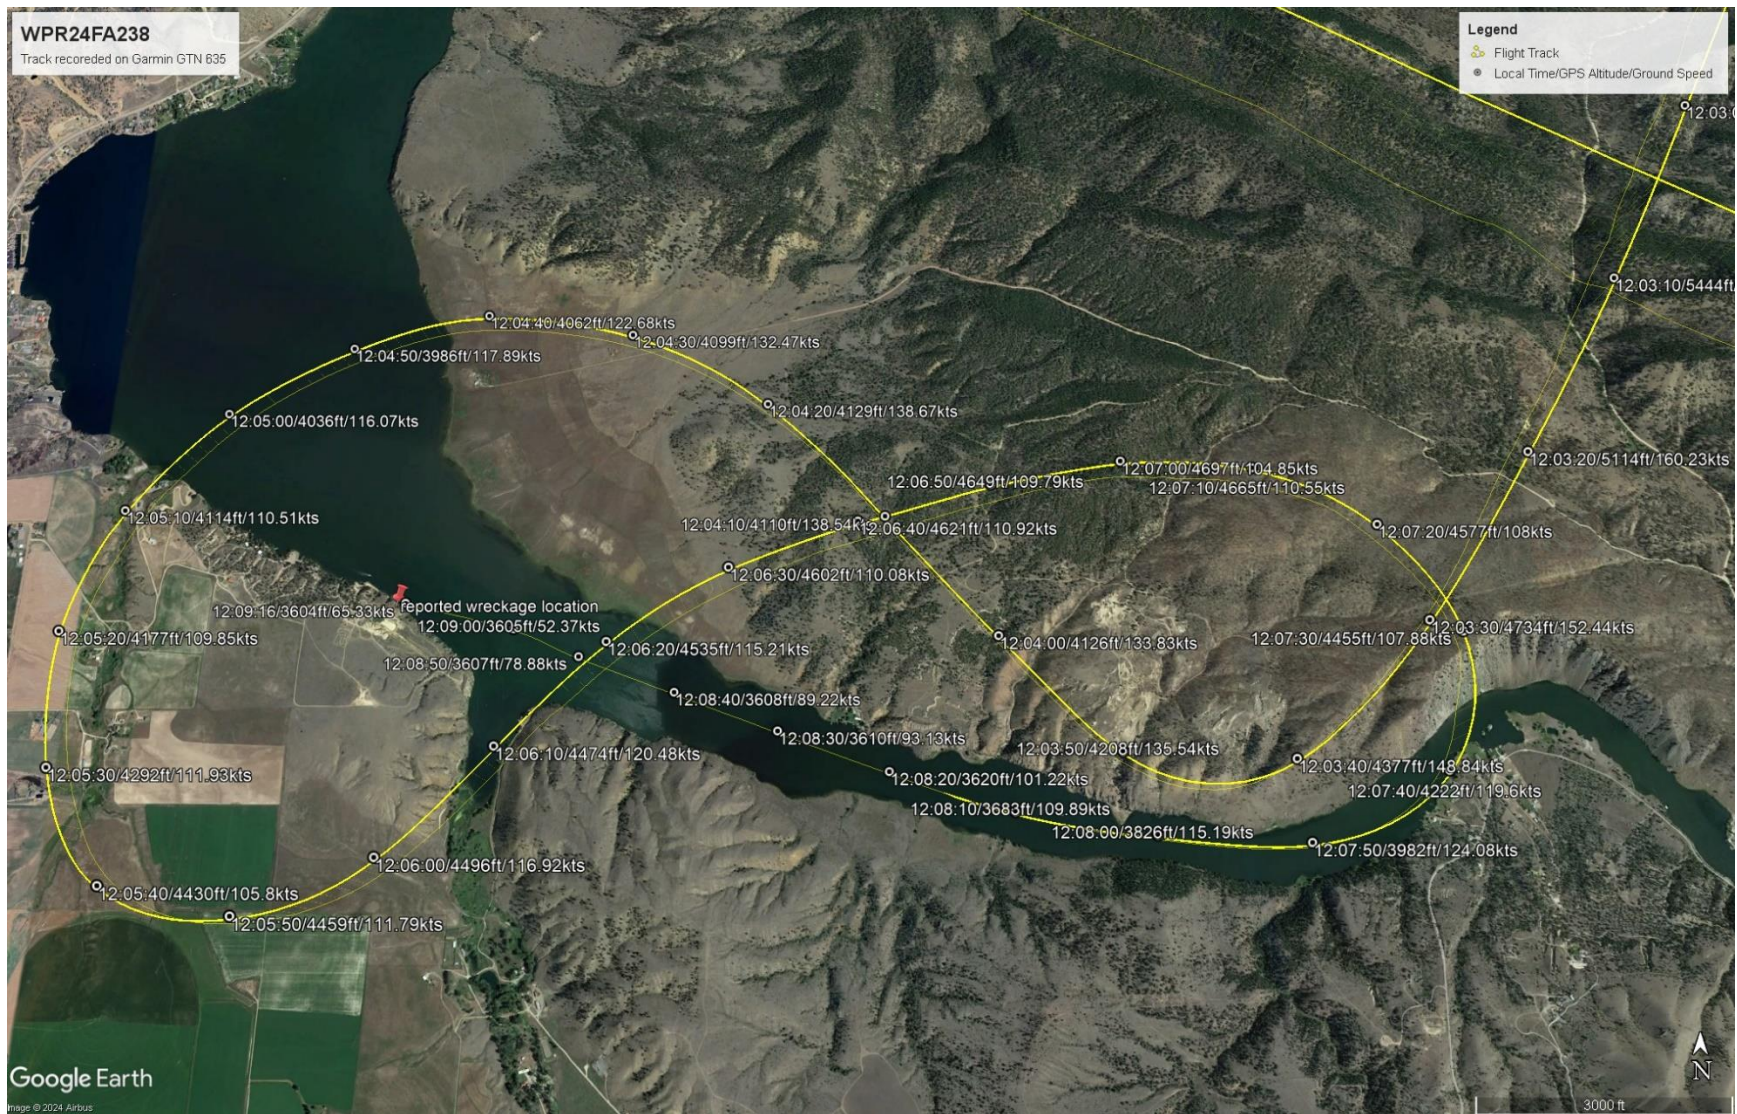
Figure 6 and Figure 7 are graphical overlays generated using Google Earth showing the accident flight. Weather and lighting conditions in Google Earth are not necessarily the weather and lighting conditions present at the time of the recording. Figure 6 is an overview of the entire session. Figure 7 shows approximately the final seven minutes of the flight and the reported wreckage location.

**Figure 7.** Google Earth overlay of the final seven minutes of the accident flight.
