**From:** [Brian Fuchs](#)  
**To:** [Eric Gutierrez](#)  
**Subject:** Materials Laboratory Email Factual (WPR24FA291)  
**Date:** Wednesday, October 9, 2024 11:26:38 AM  
**Attachments:** [Overall.JPG](#)  
[Bracket 1.JPG](#)  
[Bracket 2.JPG](#)  
[Bracket-Top.JPG](#)  
[Control Stick - End.JPG](#)

Several pieces of a flight control arrived at the NTSB Materials Laboratory. The larger piece consisted of a metal tube shaped to form an arc, a mass of gray metal attached to one end of tube, and a pair of wires running out the other end. One wire terminated in an electrical contact. The other terminated in a frayed end. A second electrical contact was submitted separately from the metal tube. A gray metal piece of bracket with fractures on opposite ends was also submitted.

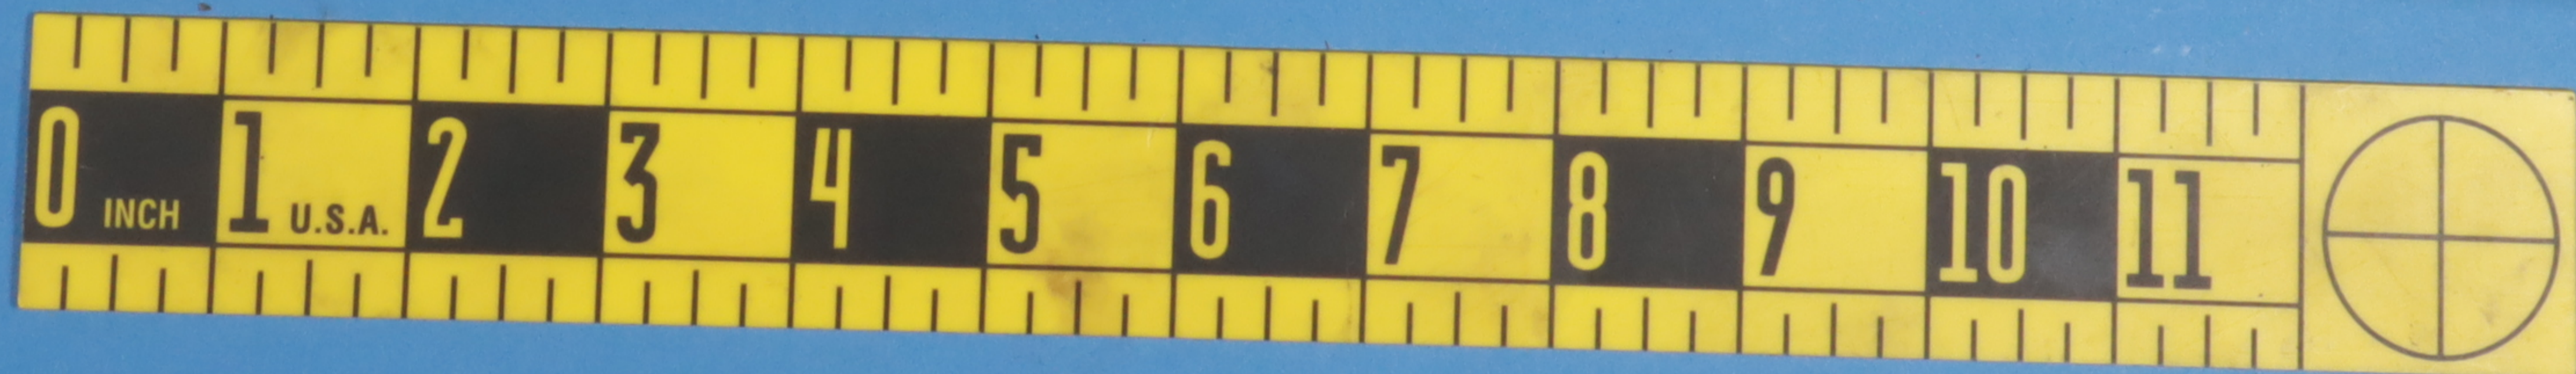
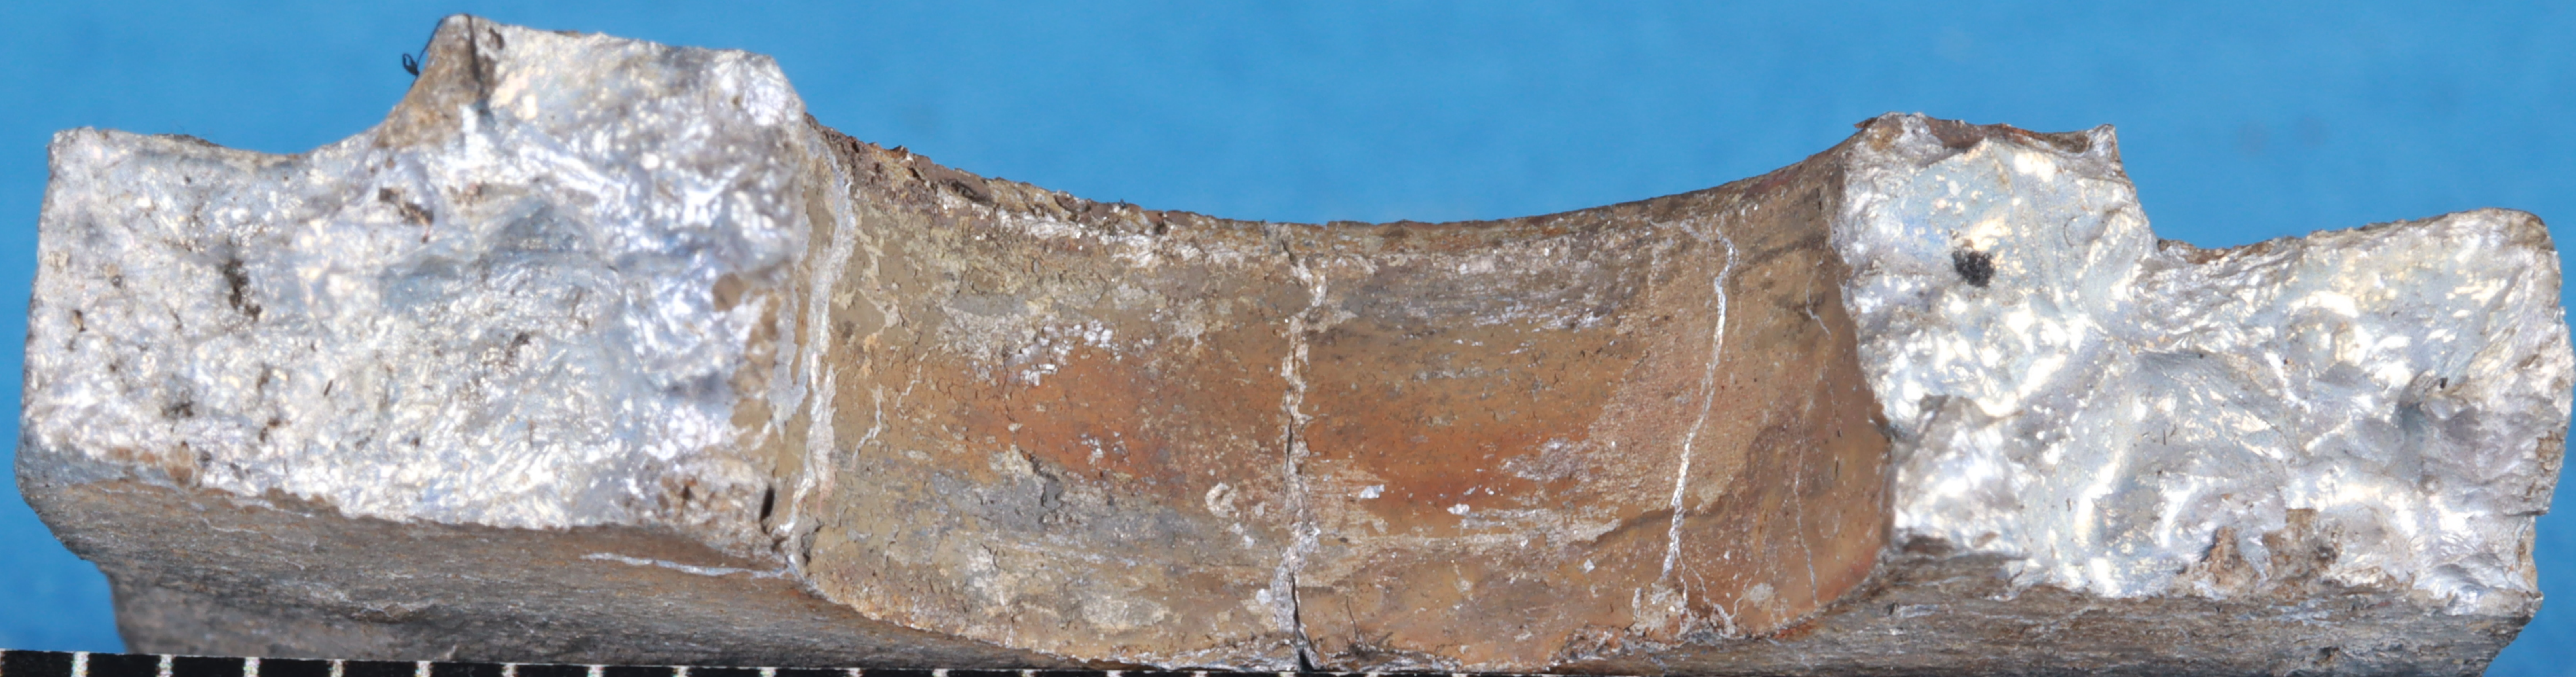
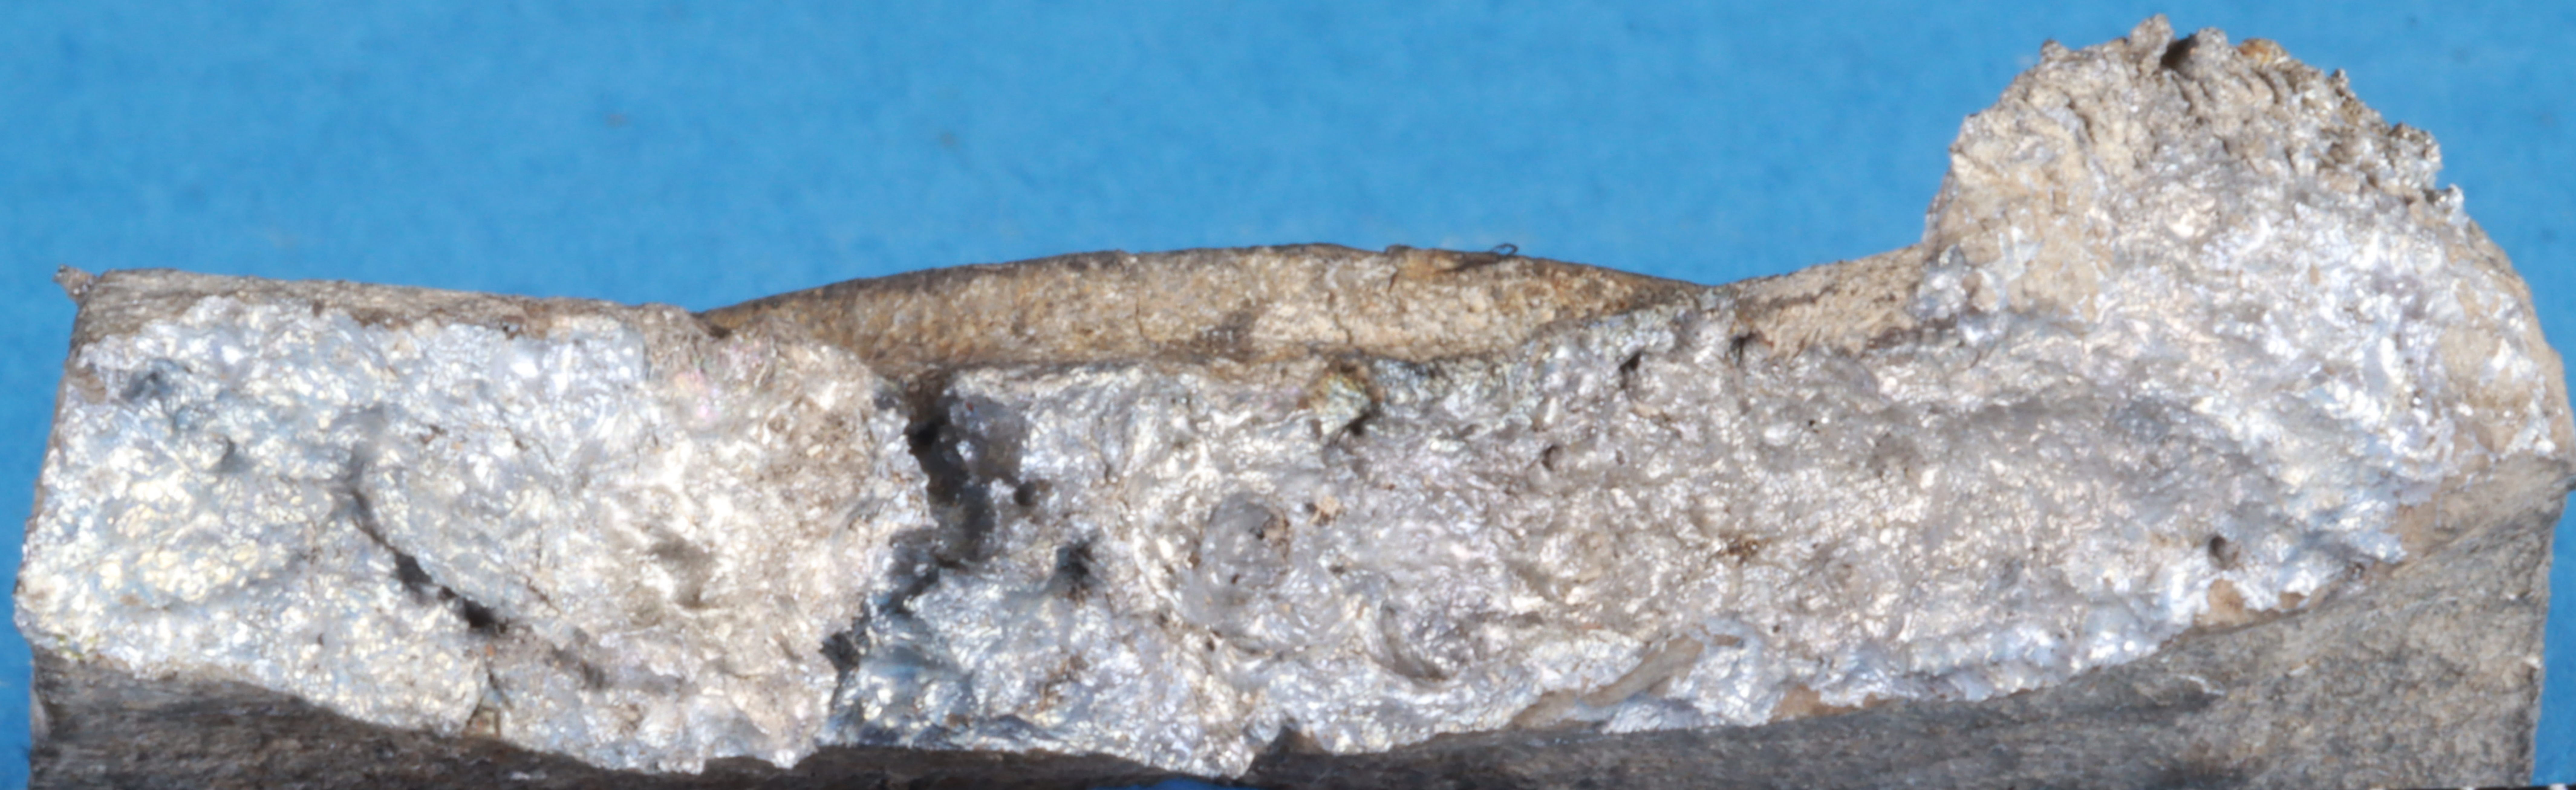
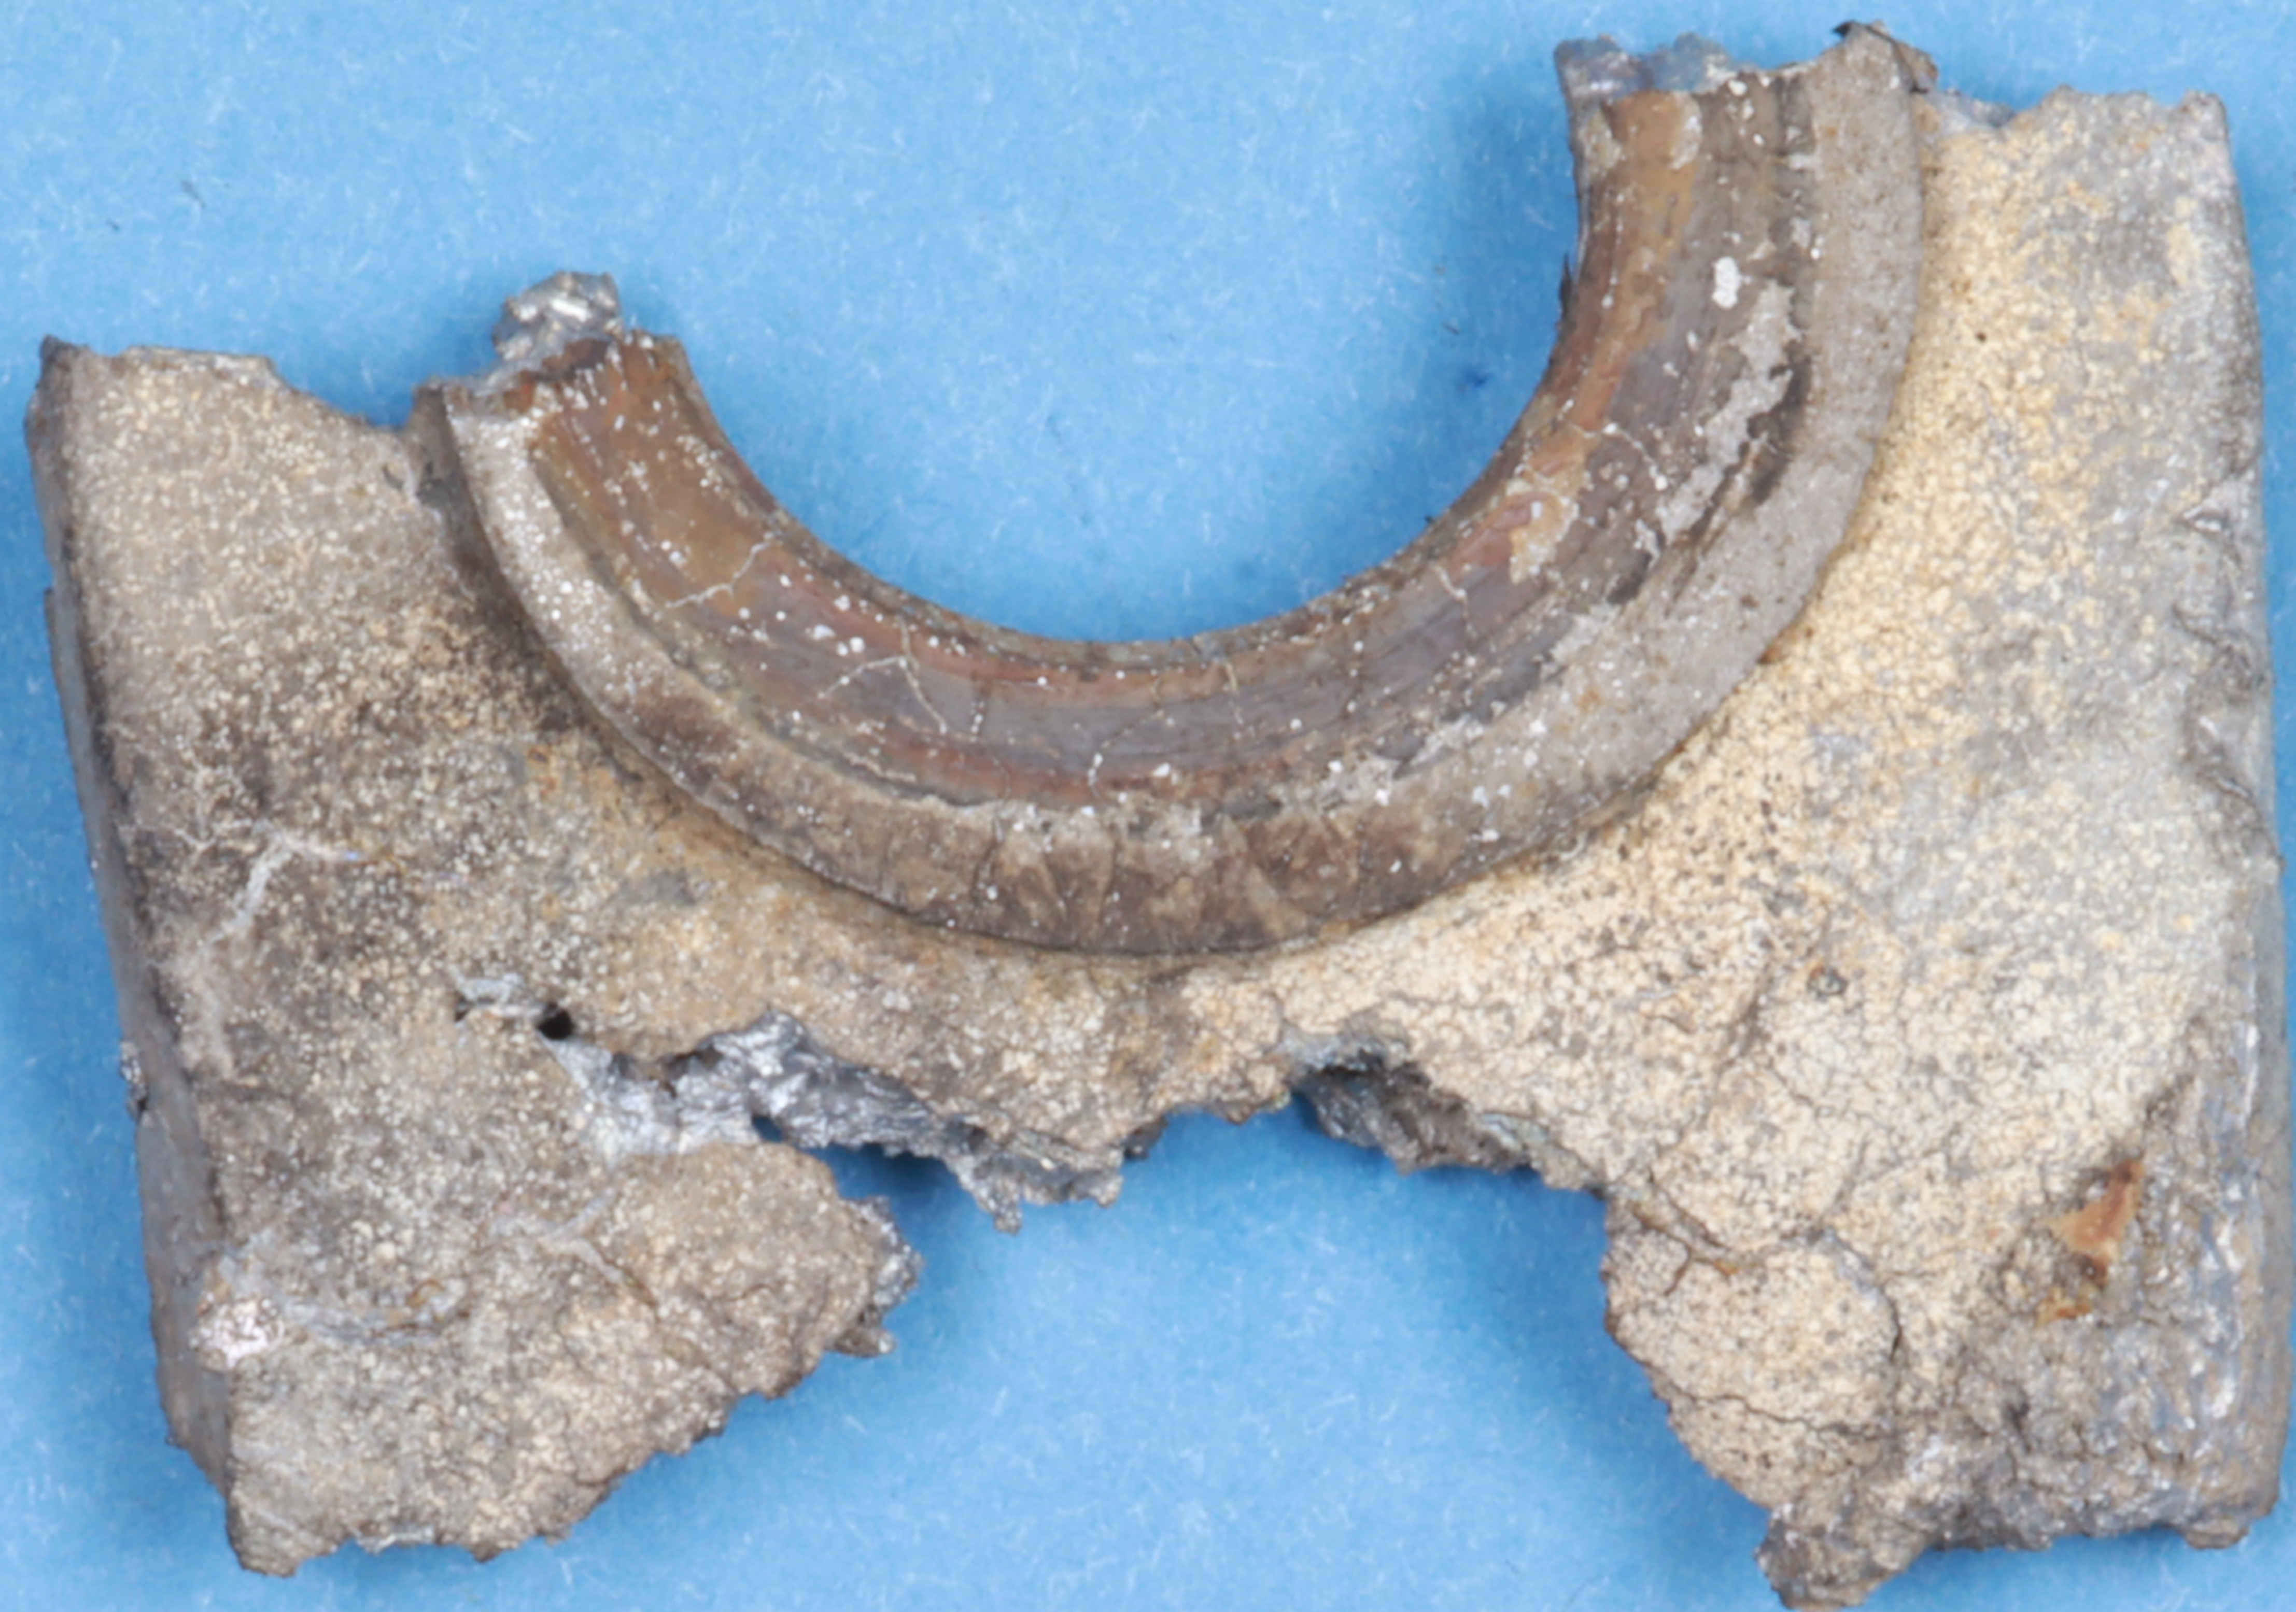
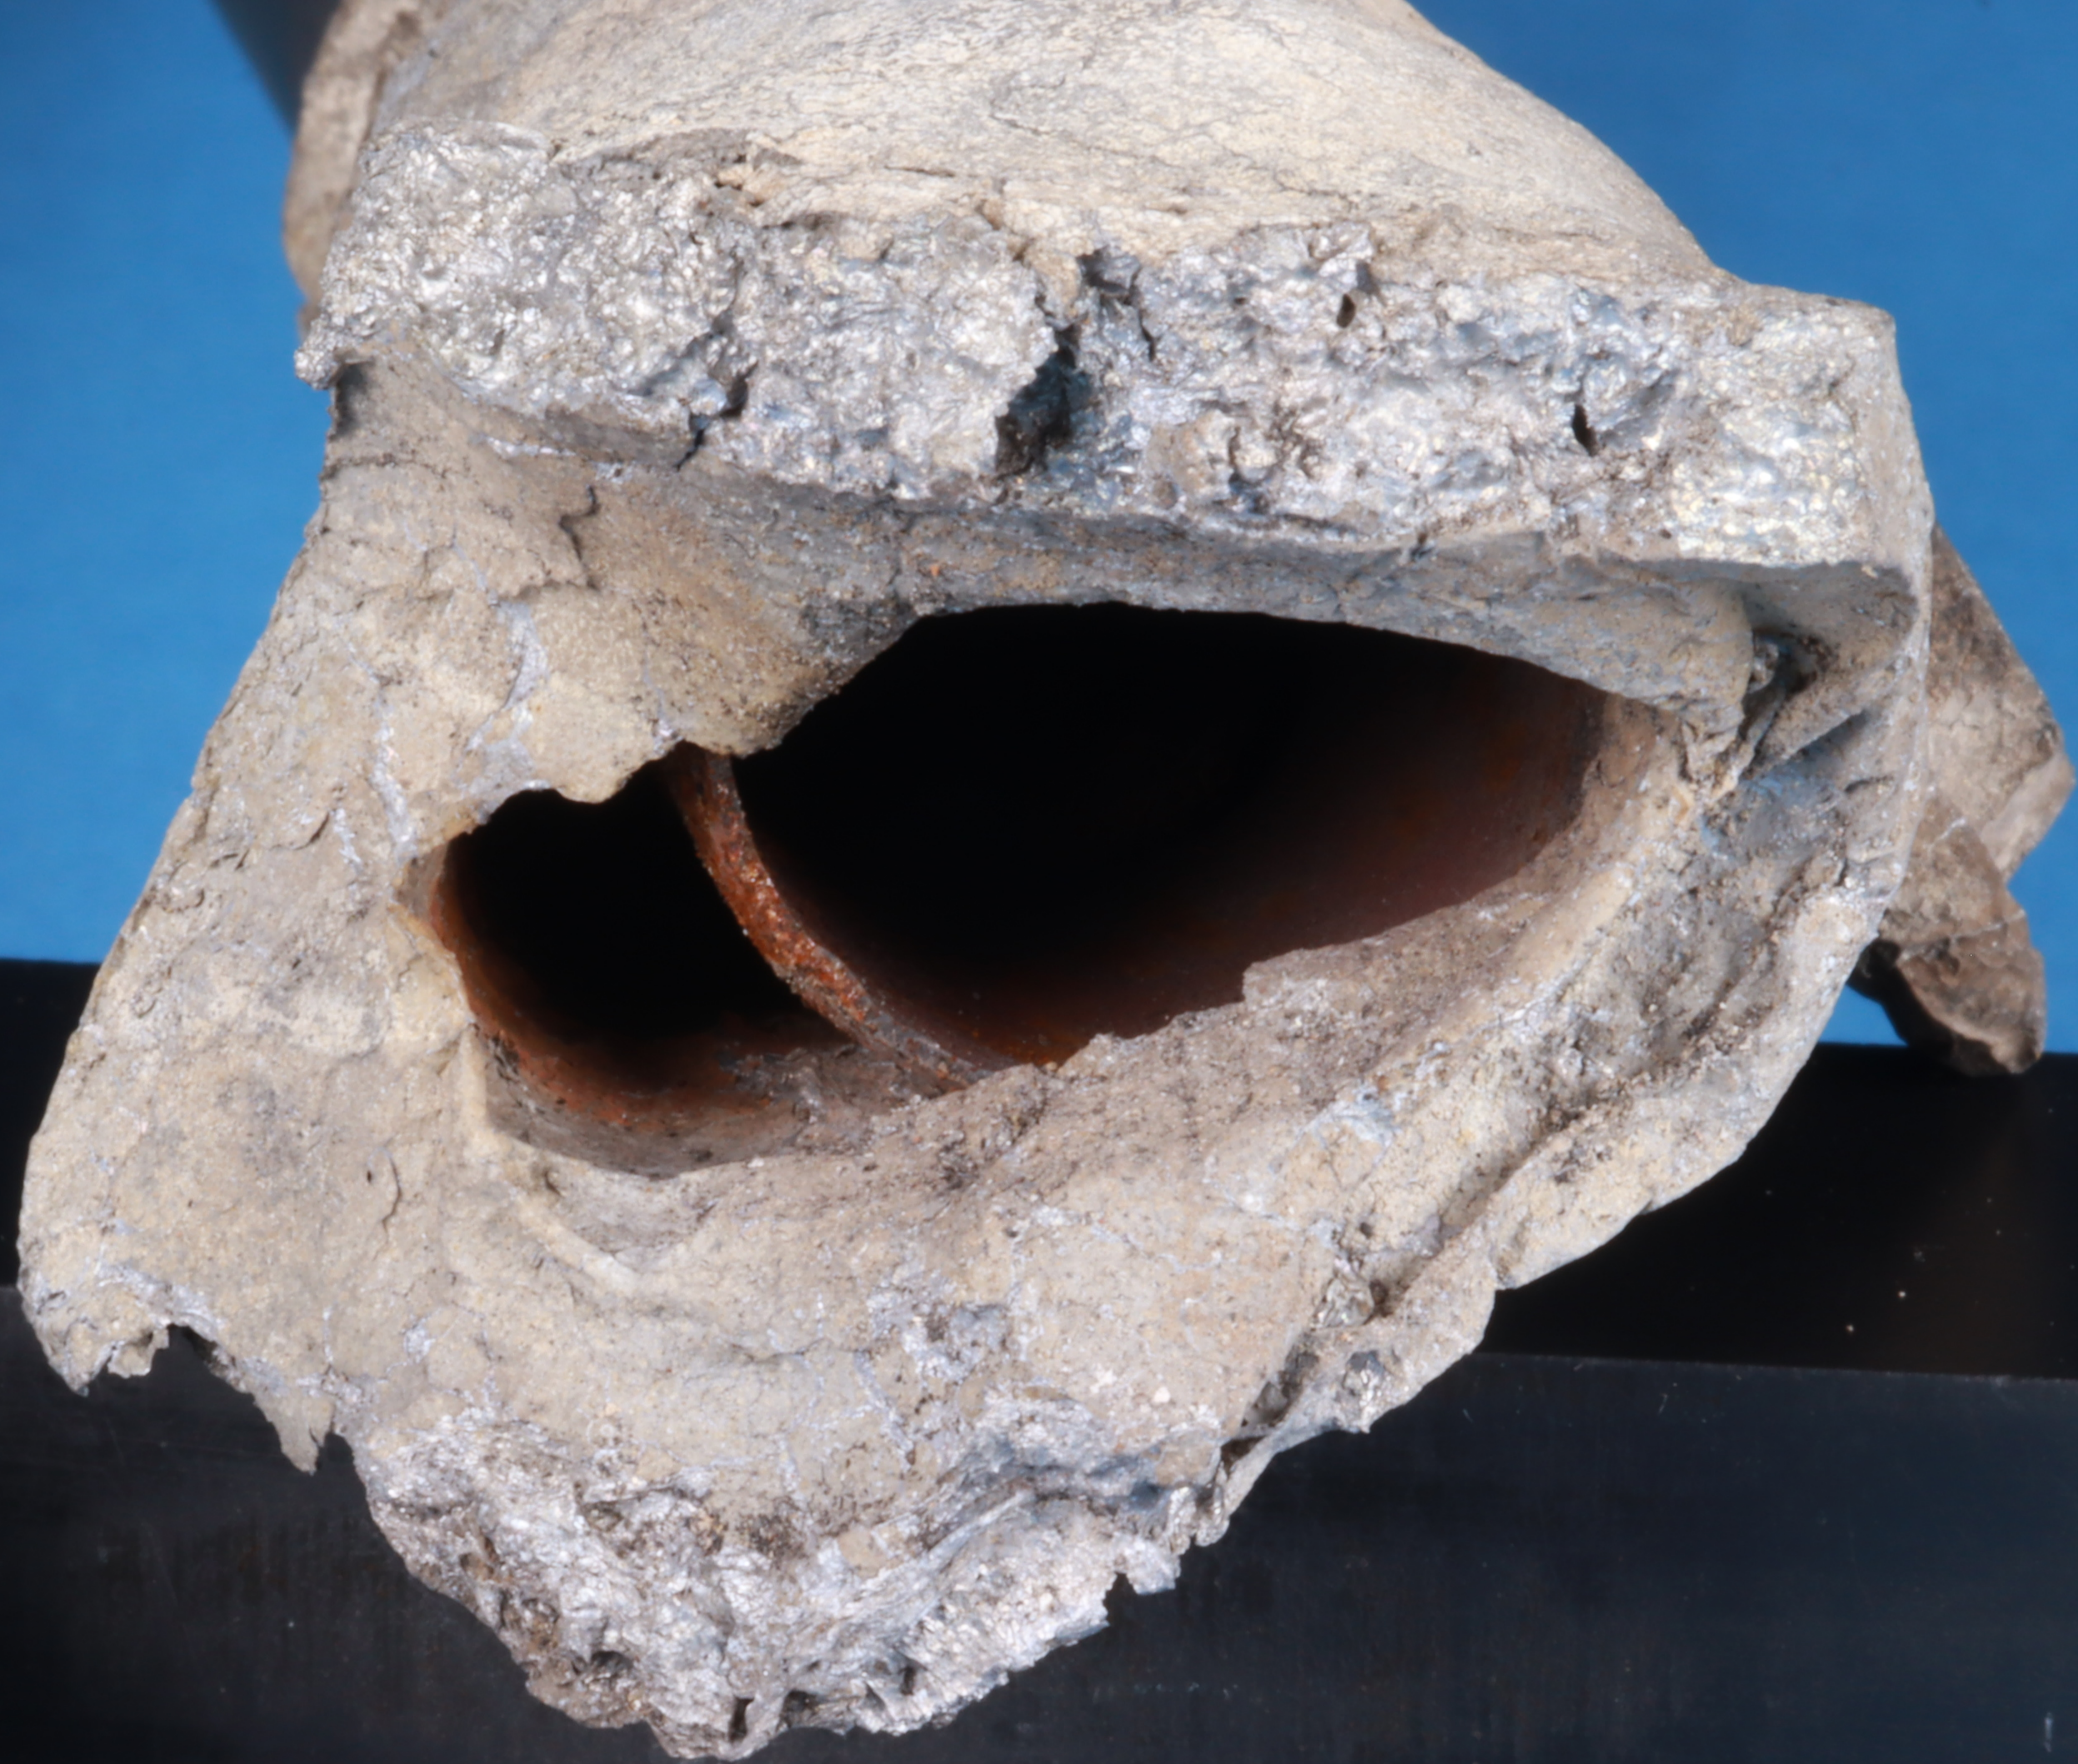
The gray mass at the end of the tube and gray bracket showed signs of melting and solidification, consistent with exposure to high temperatures for an extended time. All fracture surfaces examined (bracket piece and gray mass) showed evidence of melting and solidification.
