# National Transportation Safety Board

WPR24LA127

## **SOUND SPECTRUM**

Specialist's Study

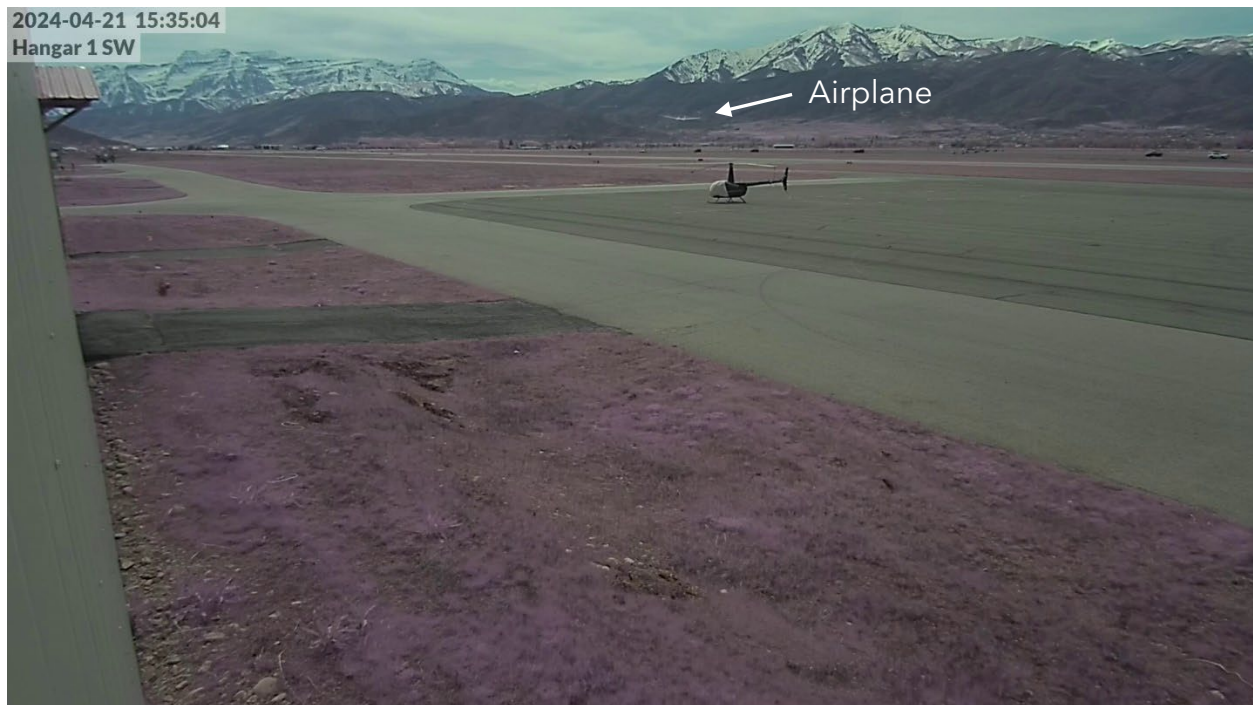
**Figure 1.** Frame from the video at video time 8s (time stamp 15:35:04). The airplane is indicated with an arrow.

Figure 1 is a frame from the video showing the accident flight. The video includes a date and time stamp in the upper left corner, along with a label "Hangar 1 SW". The video lasts 97 seconds, beginning at time stamp 15:34:56 and running through time stamp 15:36:33. The video had 1920 x 1080 resolution and an average frame rate of 15 frames per second (fps). Sound was recorded at a rate of 11025 samples per second. Wind noise overwhelmed the recorded sound at some times during the video. The sound of the engine decreased substantially about video time 34 s (time stamp 15:35:31), and it was undetectable thereafter. The sounds of ground impact were heard during video time 41 – 43 s (time stamp 15:35:37 – 15:35:39).

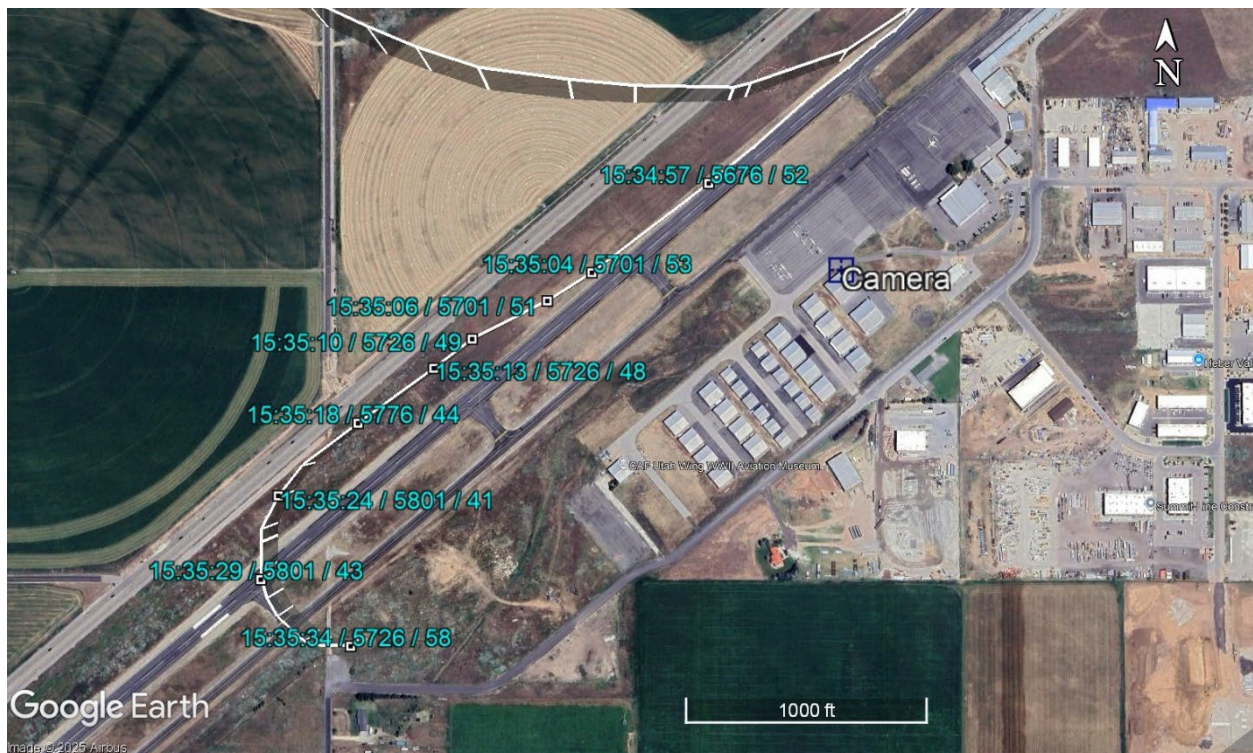
**Figure 2.** Accident flight track from ADS-B data on a Google Earth background. The position of the camera on an airport building is indicated. Annotations on the flight track show the time MDT, altitude above mean sea level in feet and groundspeed in knots.

Figure 2 is an overhead view of Heber Valley Airport (KHCR), showing the position of the video camera and the ADS-B flight track for the second takeoff leading to the accident. Points are annotated with the time, MSL altitude in ft and groundspeed in kt. By comparing the position of the airplane relative to landmarks visible in the video with the ADS-B positions, it was estimated that the time stamp in the video is within 2 seconds of the ADS-B time.

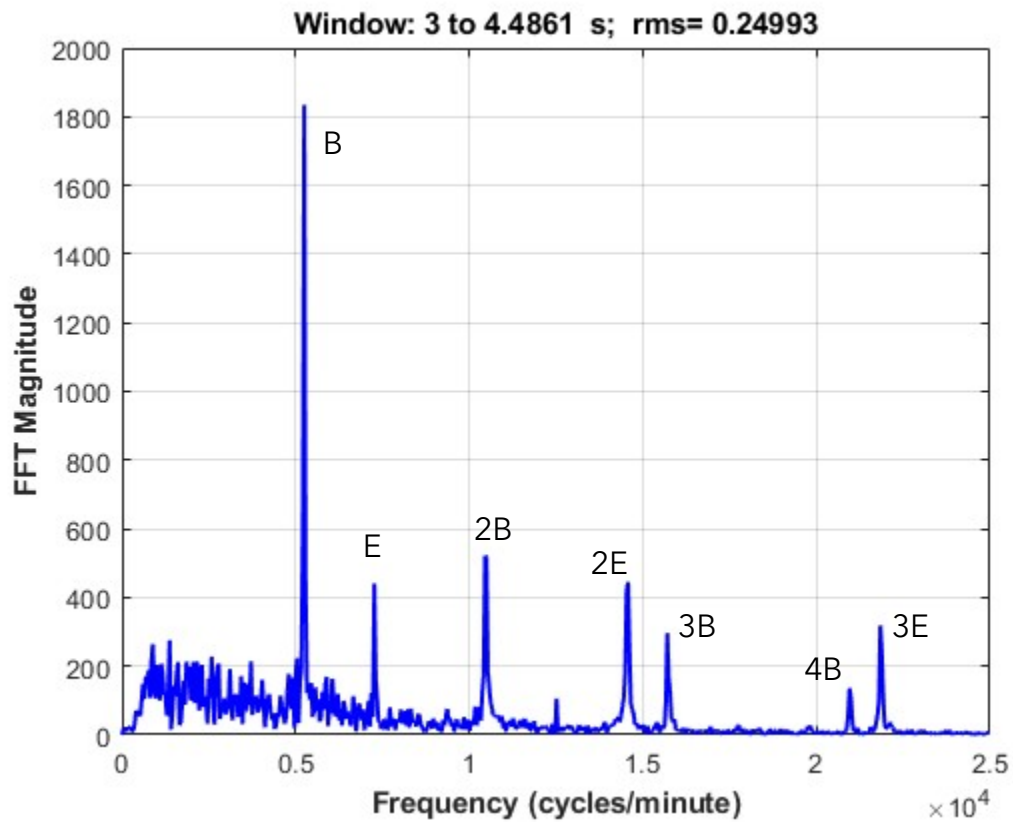
**Figure 3.** Example spectrum from the window beginning at video time 3 s. The blade passage frequency is indicated by the letter B, and the engine rotation rate is indicated by the letter E. Peaks for higher harmonics are indicated with numbers multiplying B or E.

As an example, Figure 3 shows the spectrum from the window beginning at video time 3 s. The BPF of 5249 CPM is indicated with the letter B, and the engine

rotation rate of 7267 CPM is indicated with the letter E. The second, third and fourth harmonics of the BPF at 10457 CPM, 15706 CPM and 20954 CPM are indicated by 2B, 3B and 4B, and the second and third harmonics of the engine rotation at 14575 CPM and 21843 CPM are indicated by 2E and 3E.

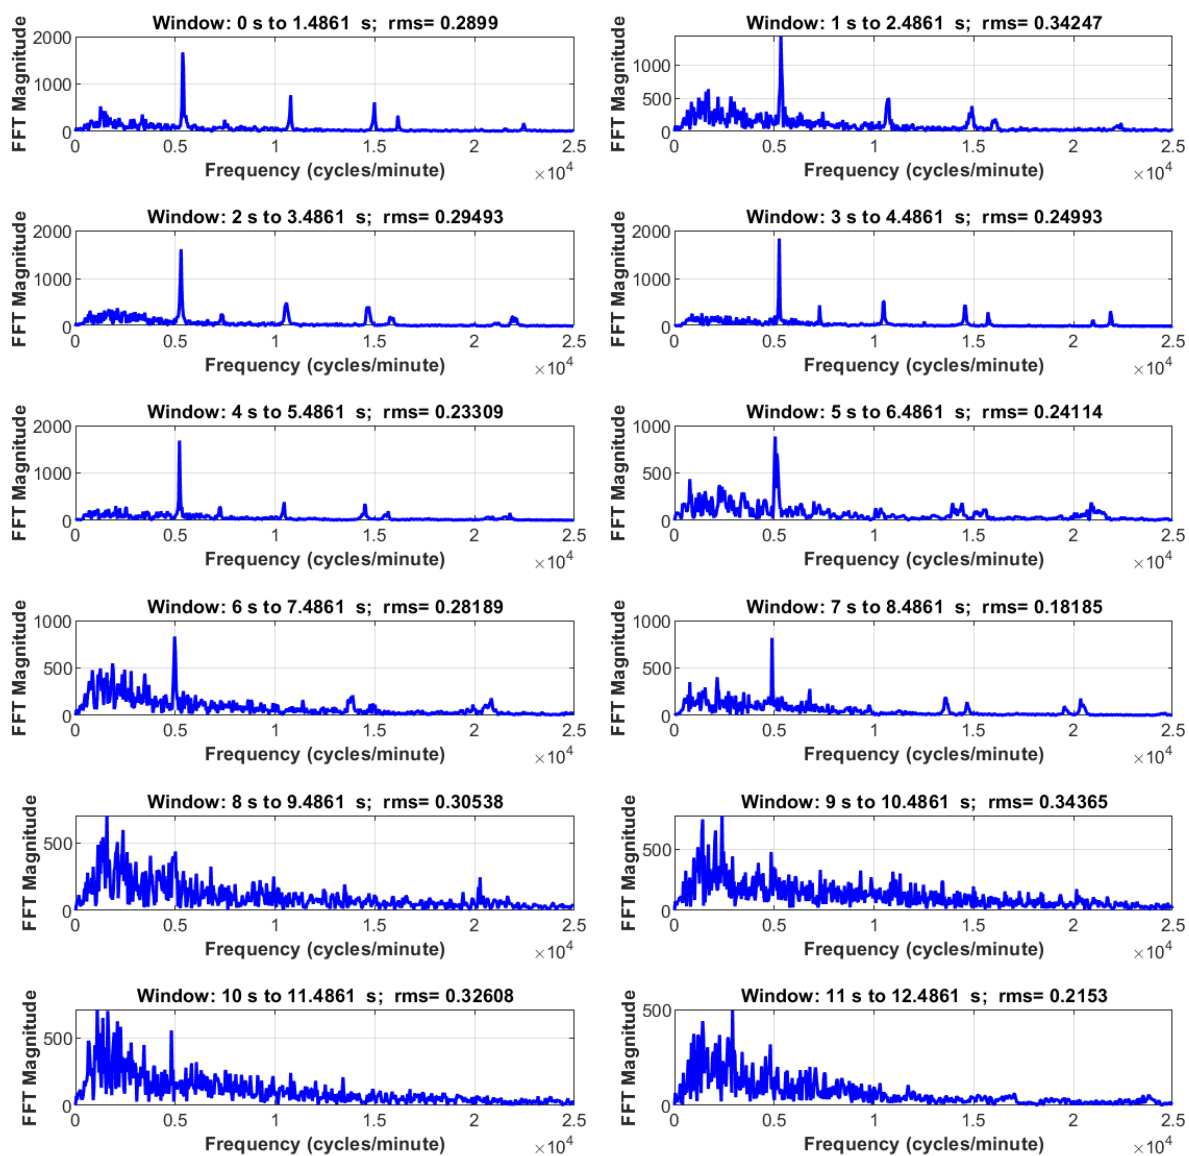
**Figure 4.** Spectra for windows beginning every second for video times 0 s through 11 s. FFT magnitudes are auto-scaled.

Figures 4 through 7 show spectra from windows beginning every second starting from video time 0 s through video time 47 s (time stamps 15:34:56 through 15:35:43). The FFT magnitude in Figures 4 through 7 are auto-scaled to the largest values, so the magnitudes of separate graphs might not be directly comparable. The lower frequency components were sometimes overwhelmed by wind noise, but the second and/or third harmonics of the engine were generally identifiable. The decreased engine sound observed about video time 34 s correlates with the disappearance of the higher harmonic peaks in the spectra from windows beginning after video time 33 s. Figure 8 shows the engine rotation rate recorded in the video, as calculated from the second and third harmonics.

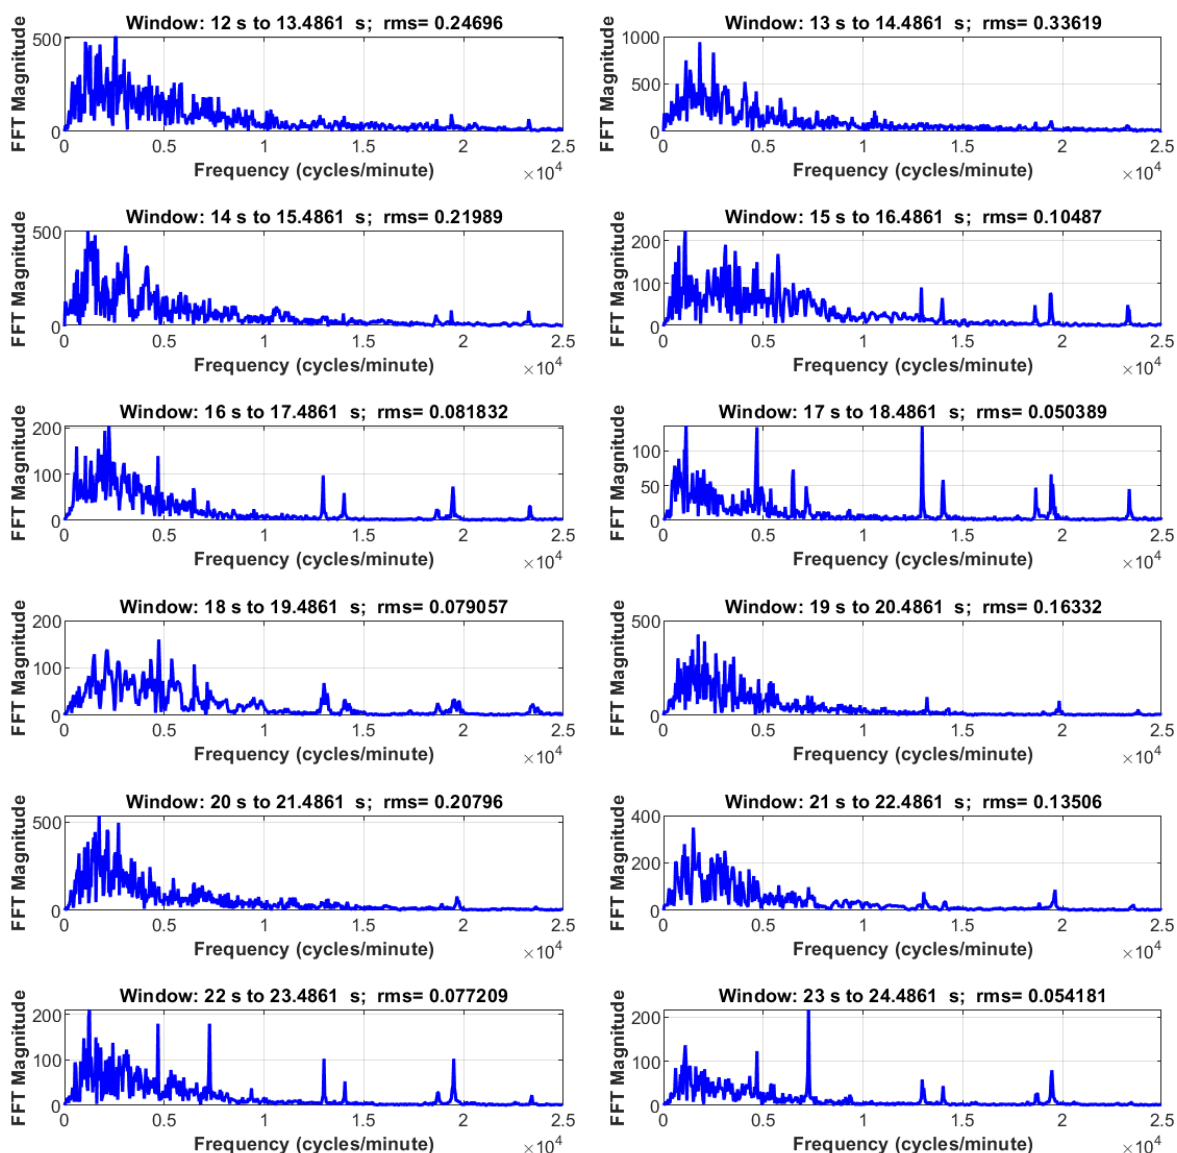
**Figure 5.** Spectra for windows beginning every second for video times 12 s through 23 s. A strong peak from an unknown source was observed beginning in the window at video time 22 s. FFT magnitudes are auto-scaled.

A very strong peak is visible in the spectra beginning in the window starting at video time 22 s and extending to video time 45 s. The frequency of that peak decreased approximately linearly from 7267 CPM at 22 s to 6622 CPM at 45 s. The peak is indicated in Figure 10, which shows the spectrum beginning at video time 33 s, just before the sound of the engine was no longer audible. The peak is labeled U for unknown in Figure 10, and it occurs at 6944 CPM. All the engine peaks and blade passage peaks are also still visible and labeled as in Figure 3; the unknown peak is not associated with the engine or propeller. This peak stopped appearing in the spectra after the sounds of ground impact, so it could have been a sound coming from the airplane, but it also might have had another source. A sound associated with that frequency peak was not readily apparent when listening to the audio. Figure 11 shows the recorded unknown peak frequency along with the engine data from Figure 8.

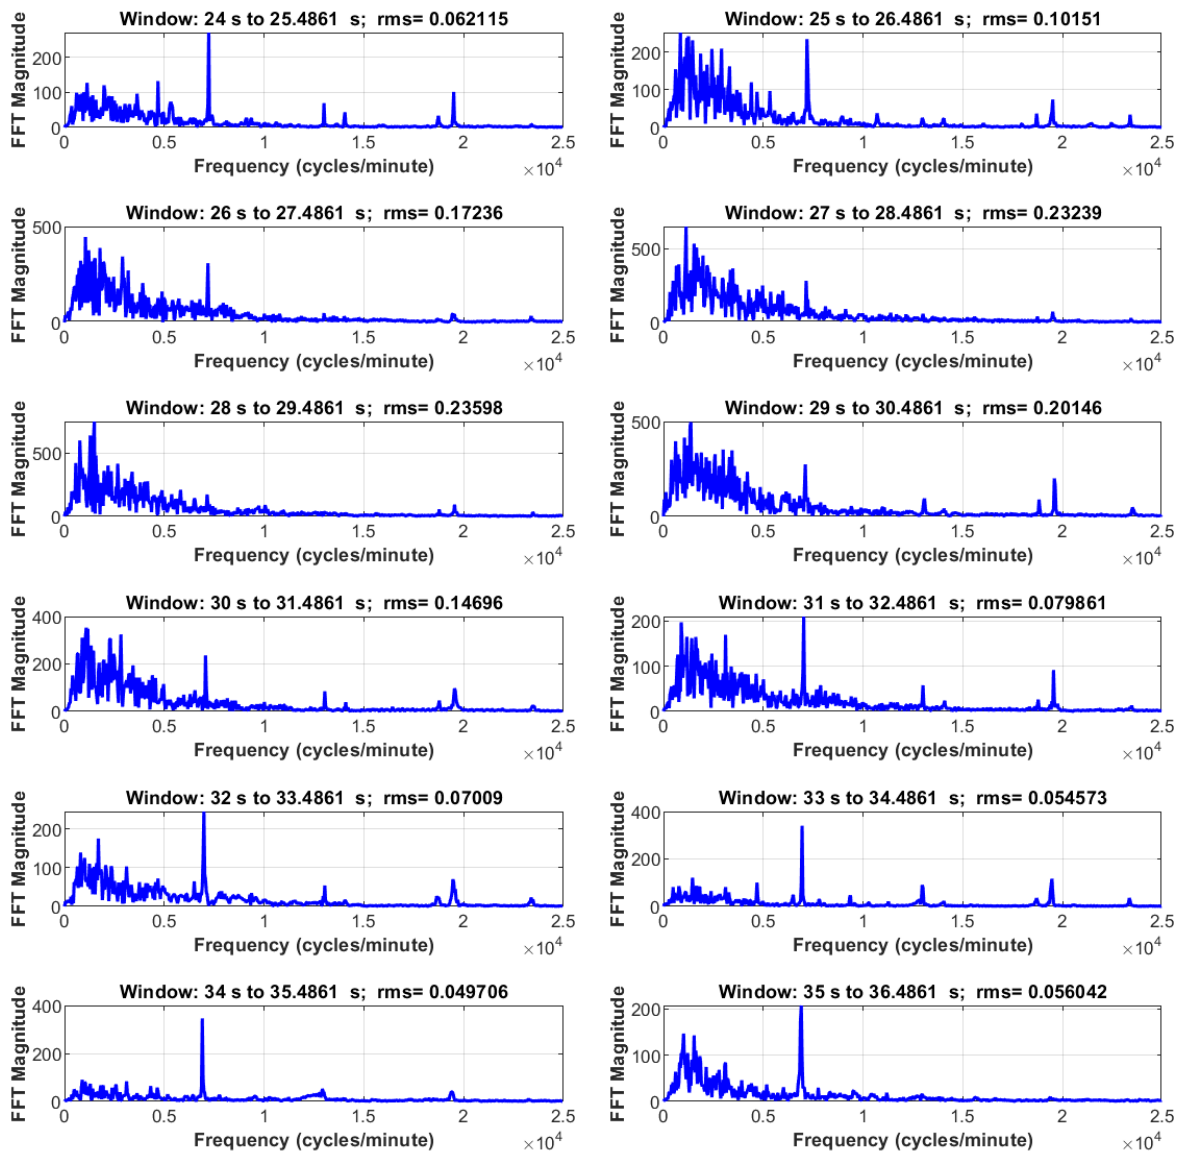
**Figure 6.** Spectra for windows beginning every second for video times 24 s through 35 s. Peaks for the engine and propeller were no longer observed after video time 34 s. FFT magnitudes are auto-scaled.

The data show that the engine was near the maximum takeoff rotation rate of 7500 RPM in the first 4 s of the video, subsequently decreasing to near the maximum continuous rotation rate of 6900 RPM between video times 12 s and 27 s (with a brief increase in rotation rate at video time 19 s). After that, the engine rotation rate decreased steadily until it was no longer heard after video time 34 s.

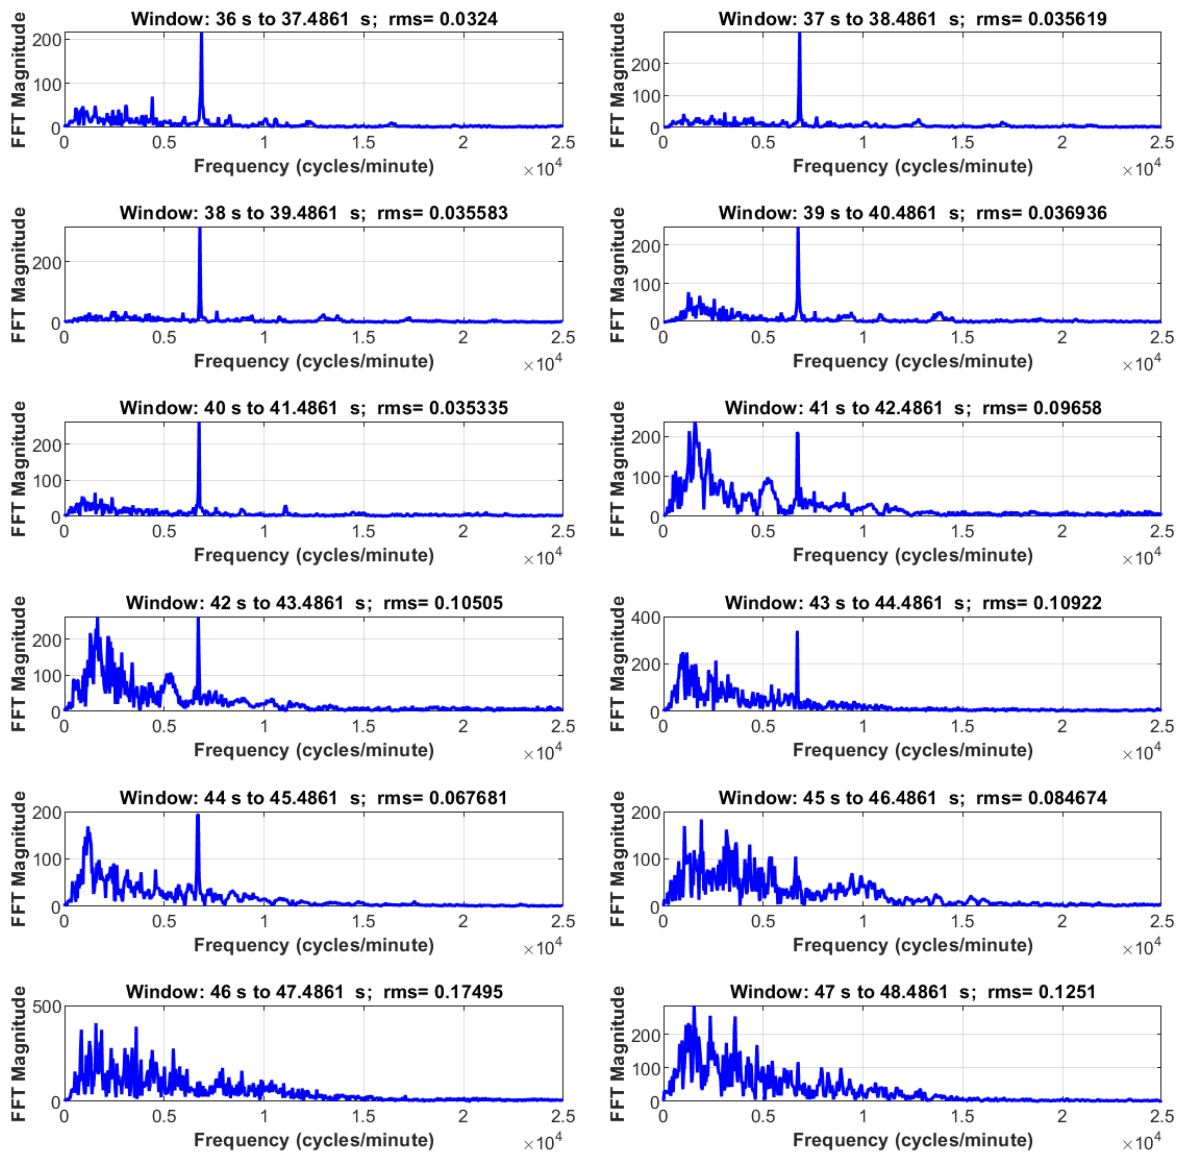
**Figure 7.** Spectra for windows beginning every second for video times 36 s through 47 s. Sounds of ground impact were heard during video time 41 – 43 s. FFT magnitudes are auto-scaled.

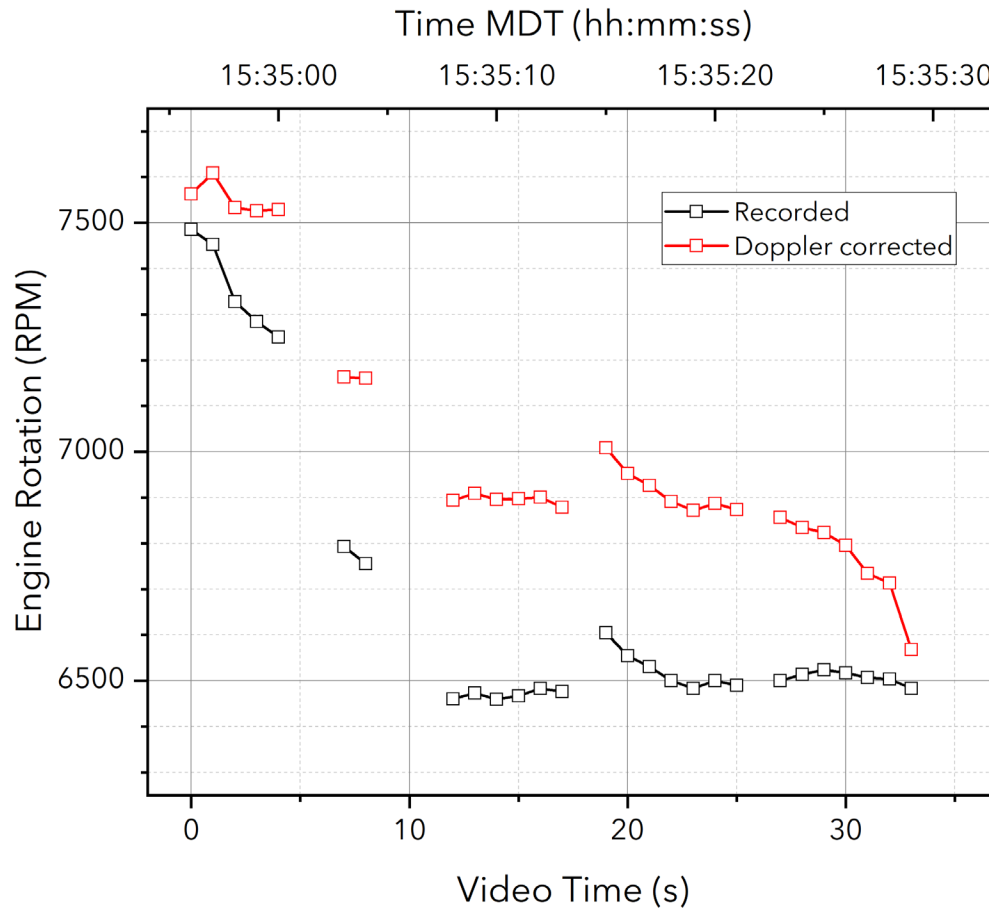
**Figure 8.** Recorded engine rotation rate calculated from the peaks for the second and third engine harmonics in the spectra shown in Figures 4 - 7, along with the engine rotation rate corrected for the Doppler shift as calculated from the ADS-B data.

The airplane was moving relative to the camera, causing a Doppler shift to the frequencies. The ADS-B flight track data was used to estimate a Doppler correction, which varied between 0.936 and 1.068 during the video. The Doppler correction applied to the engine rotation is shown in Figure 8, and the Doppler correction itself is shown in Figure 9.

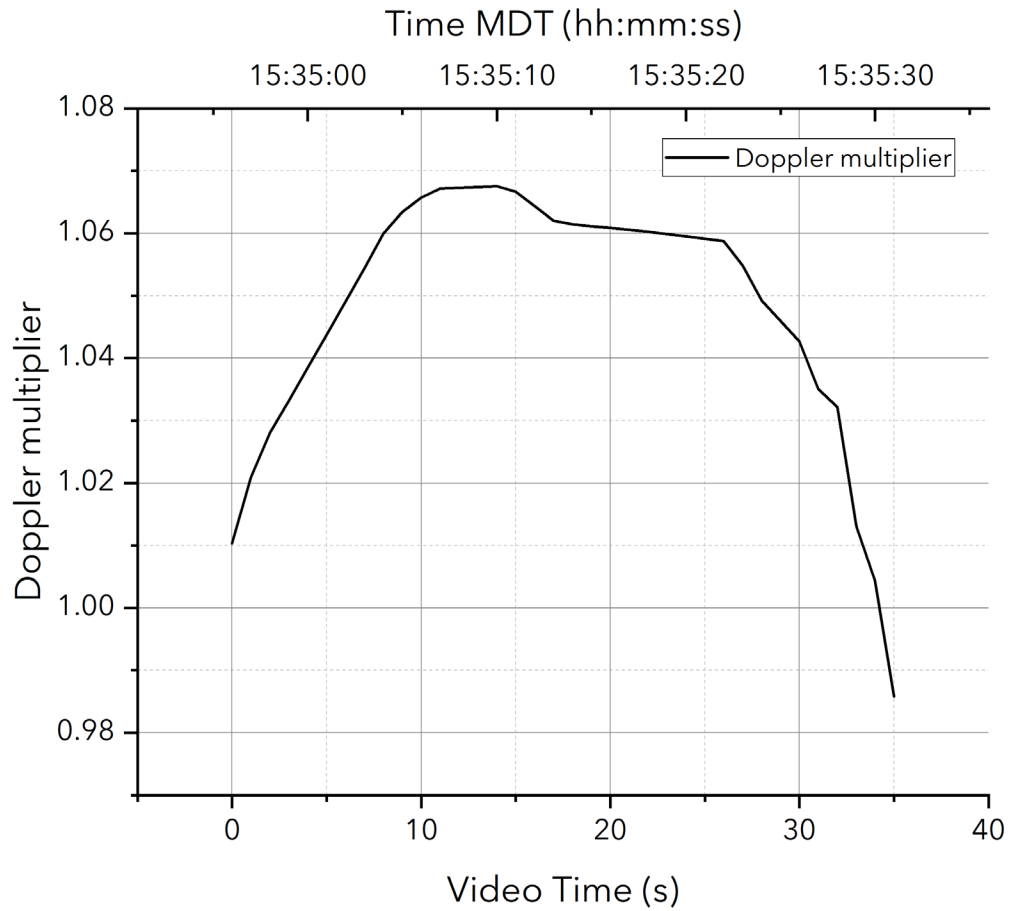
**Figure 9.** The Doppler multiplier used to correct the recorded engine rotation rate, as calculated from the ADS-B data.

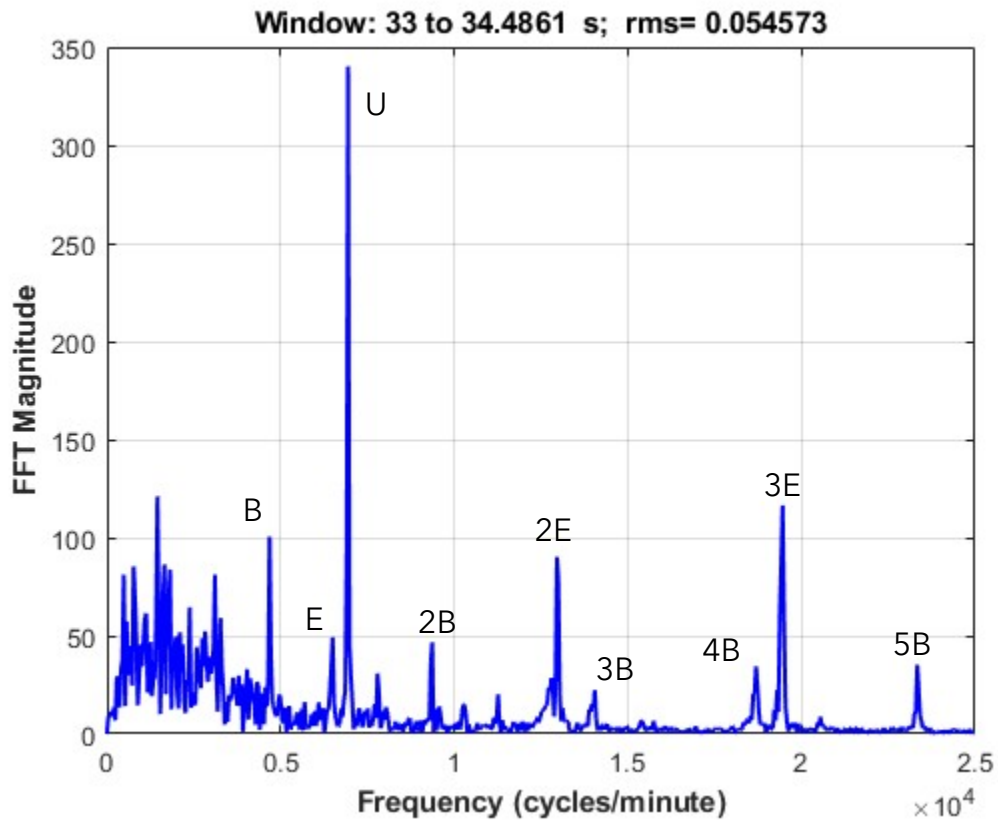
**Figure 10.** Example spectrum from the window beginning at video time 33 s, with a strong peak from an unknown source indicated by the letter U. The blade passage frequency is indicated by the letter B, and the engine rotation rate is indicated by the letter E. Peaks for higher harmonics are indicated with numbers multiplying B or E.

A strong peak from an unknown source was visible in the spectra from video time 22 s to video time 45 s. This peak was not associated with the engine or propeller. A sound associated with that frequency peak was not readily apparent when listening to the audio.

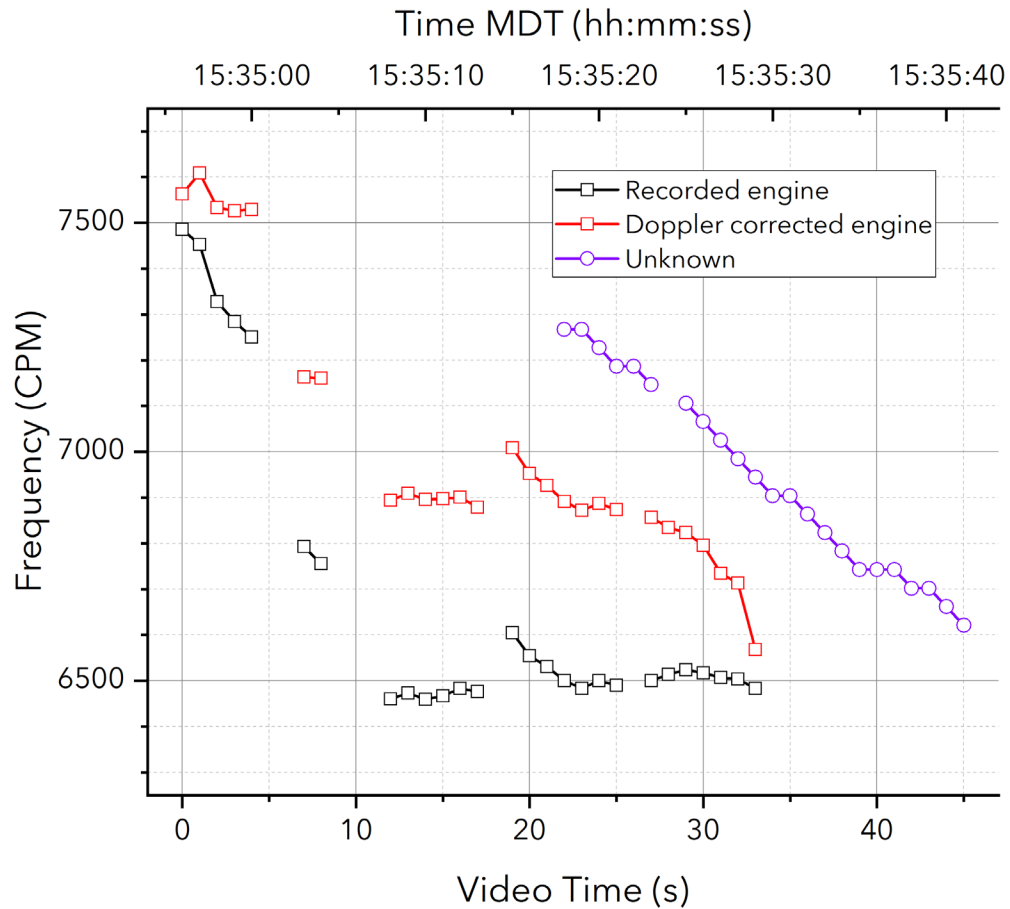
**Figure 11.** Frequency of the strong peak from an unknown source compared with the recorded engine rotation rate and the Doppler corrected engine rotation rate from Figure 8.
